Planning and Land Use Committee Report

Subject: **Development Permit Application #000347 for 845 Yates Street**
Application to remove existing tile on the east elevation and apply a painted mural.

RDH Building Engineering Limited was retained by Strata Plan VIS 6115 to review the condition of the tile and adhered thin stone applied to the east exterior concrete wall of the building known as the Wave, located at 845 Yates Street, Victoria, BC (refer to RDH proposal dated November 30, 2011).

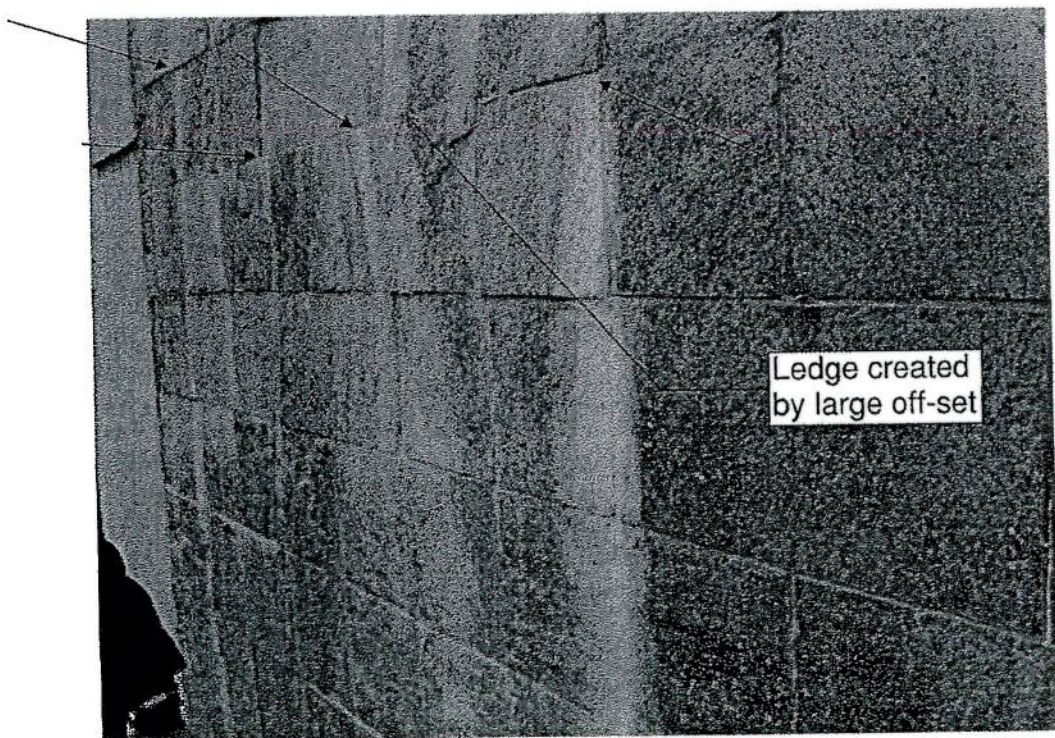
Photo 6

- Cracks and gaps in the grout at stone joints were widespread (Photo 7).
- Efflorescence (white staining) at stone joints was widespread (Photo 6).
- At locations of prior stone removal, observations were made of large areas of undisturbed notched mortar (Photo 8 & 9).

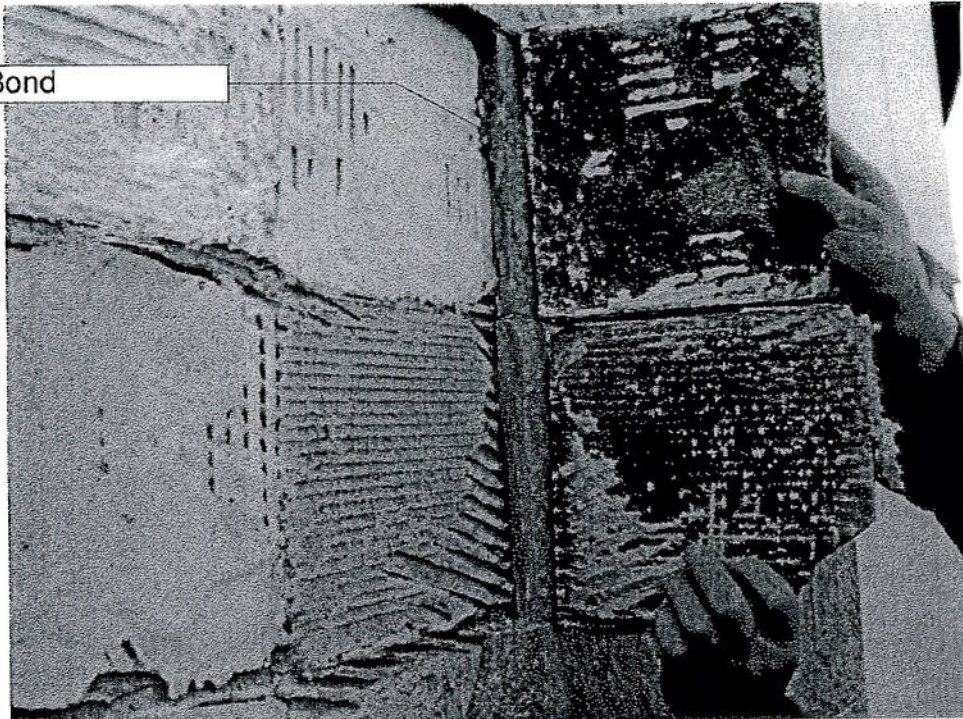
Photo 9

Poor Bond

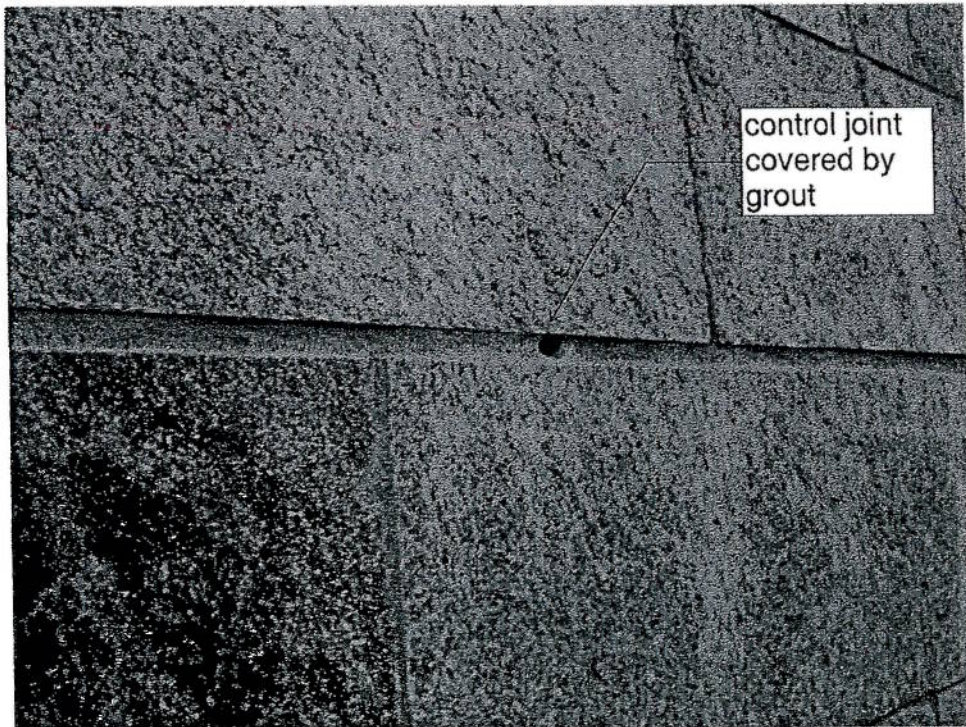
Photo 10

control joint
covered by
grout

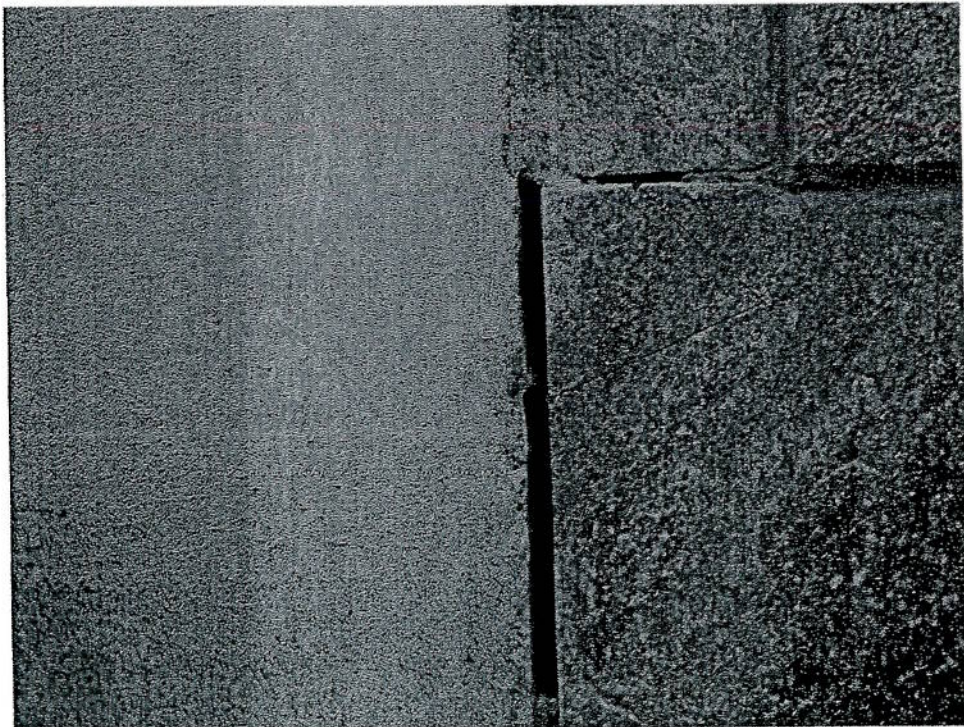
Photo 12

- The joint between the stone and the concrete structure was filled with mortar. The mortar had failed in locations providing an opening for water entry (Photo 12).

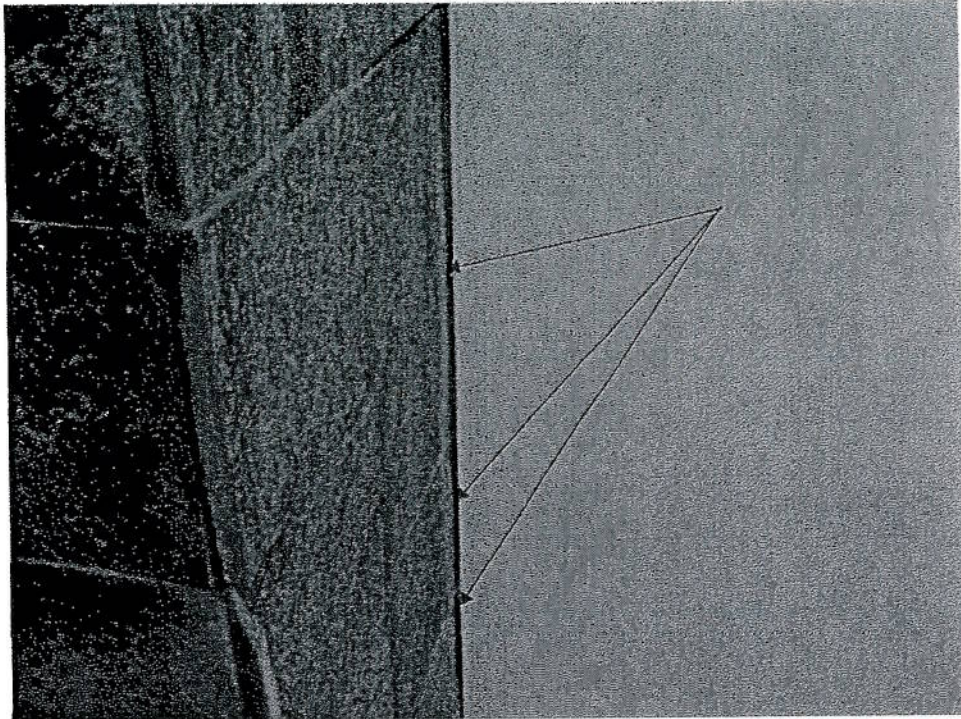
Photo 13

- The joint between the stone and an adjacent cladding panel was filled with mortar. The mortar has failed in locations providing an opening for water entry (Photo 13).

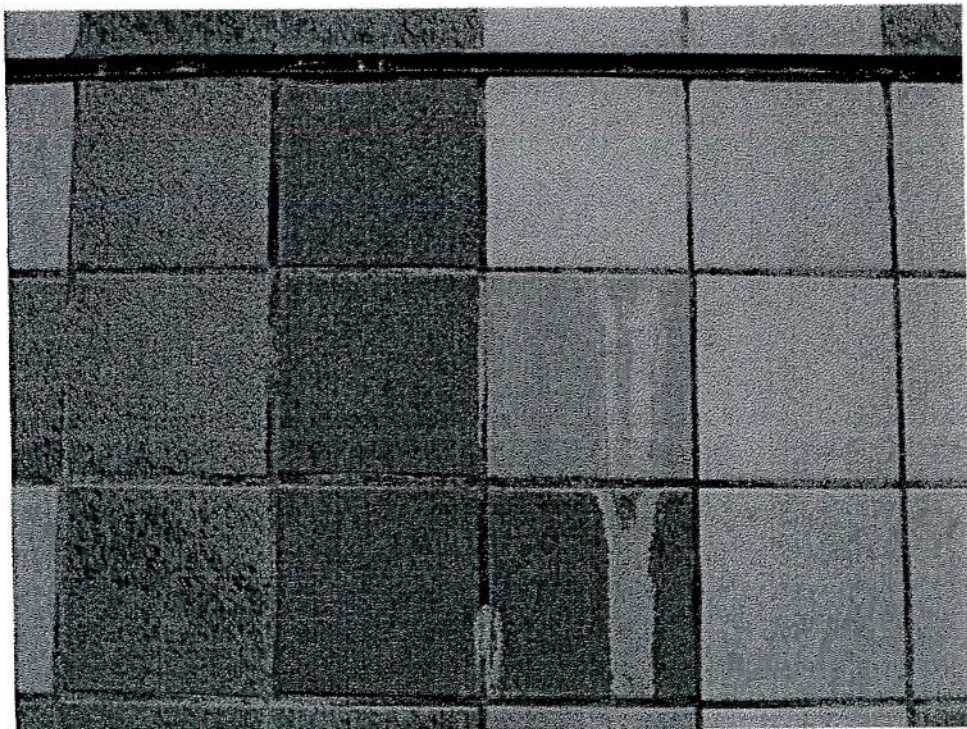
Photo 14

- The tile can be described a "100x 100 mm vitreous through coloured clay tile".
- The width of grout joints in the tile varied from 1/8 to 3/8 of an inch (Photo 14).
- Metal control joints were installed in the tile (Photo 14 & 15).
- Cracks and gaps in the grout between tiles were observed (Photo 14, 16 & 17).

- White staining was observed on the surface of the tiles. The stains originate from joints between tiles (Photo 14 & 18).
- Removal of "hollow" sounding tiles confirmed poor adhesion (Photo 19 & 20).
- The mortar at locations of tile removal appear compressed and in contact with the back of the tiles (Photo 21).
- Tile and concrete interfaces were not sealed to prevent water entry (Photo 22 & 23).
- Removed tiles revealed poor mortar adhesion (Photo 24).

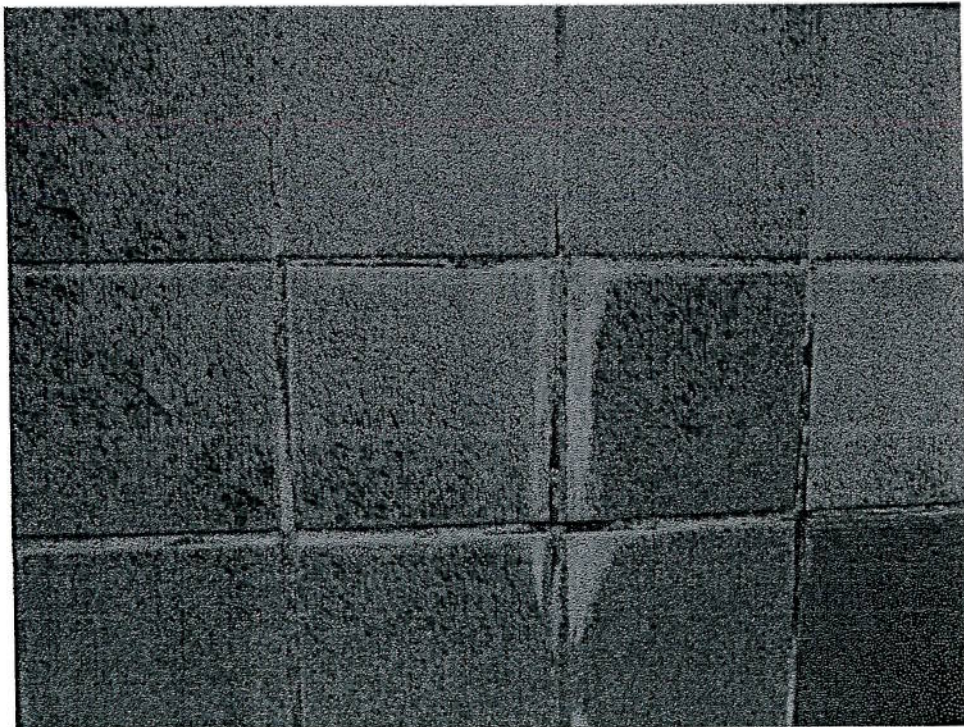
Photo 18

White stains on the surface of the tile/stone is an indication that an excessive amount of moisture is present behind the surface of the tile/stone causing dissolved salts to wash to the exterior and reform on the tile/stone surface – causing the white stain (efflorescence). Although this efflorescence can be washed away it is an indication of a moisture problem that needs to be resolved to prevent ongoing deterioration of the mortar from erosion and/or freeze/thaw damage.
