Talbot Mackenzie & Associates

Re: Proposed subdivision at 1322 Rockland Avenue.

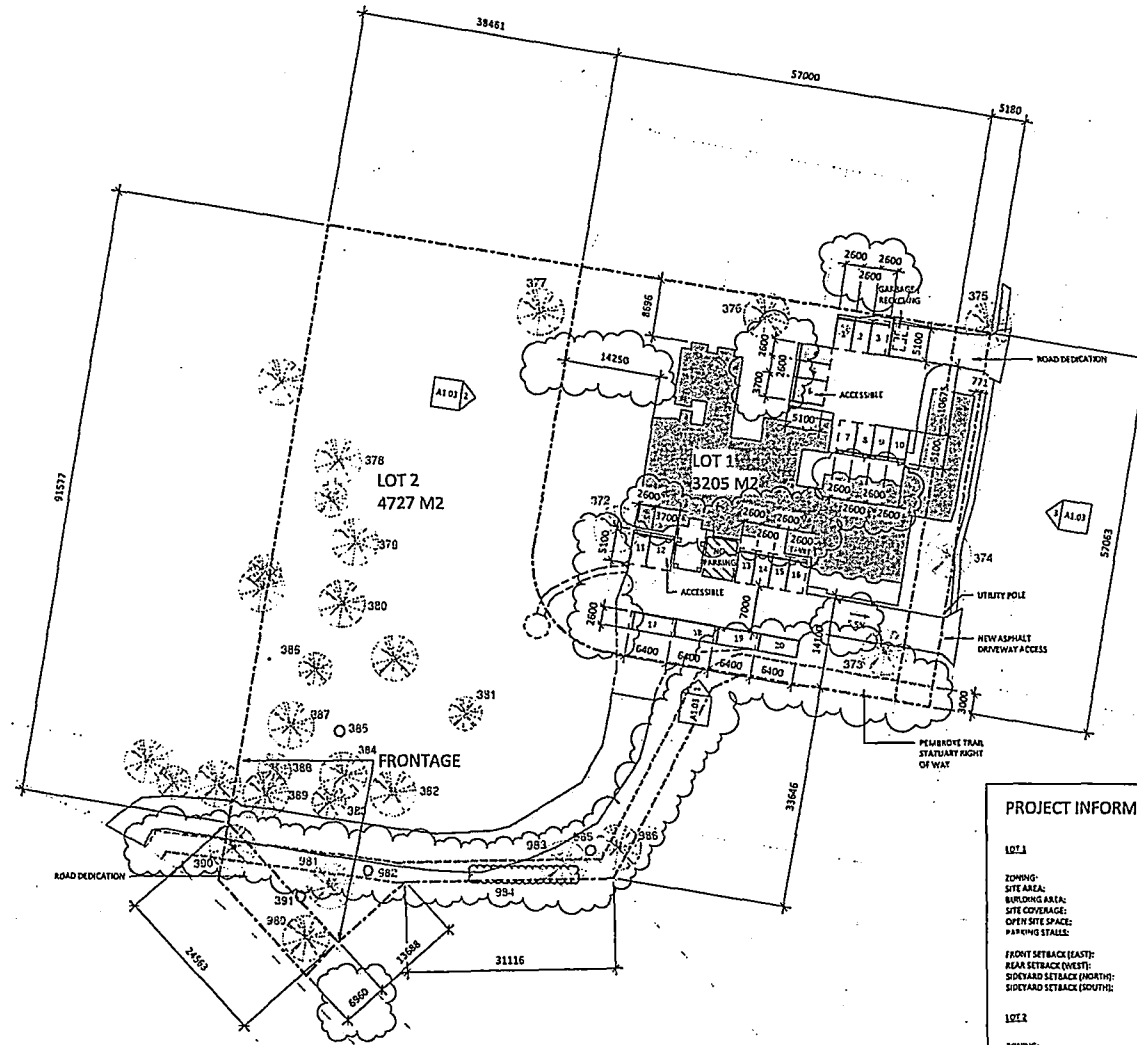
A1.03

Proposed New Driveway off Royal Terrace: On the plans provided, the driveway is shown within the critical root zone of Gary Oak number 373 and it may be necessary to remove the tree. If the tree is to be retained the driveway will have to be constructed using floating permeable techniques. Once more details are made available and we have a better understanding of the fill that will be necessary, we can provide a potential design that will allow for air and water exchange to the critical root zone of the tree.

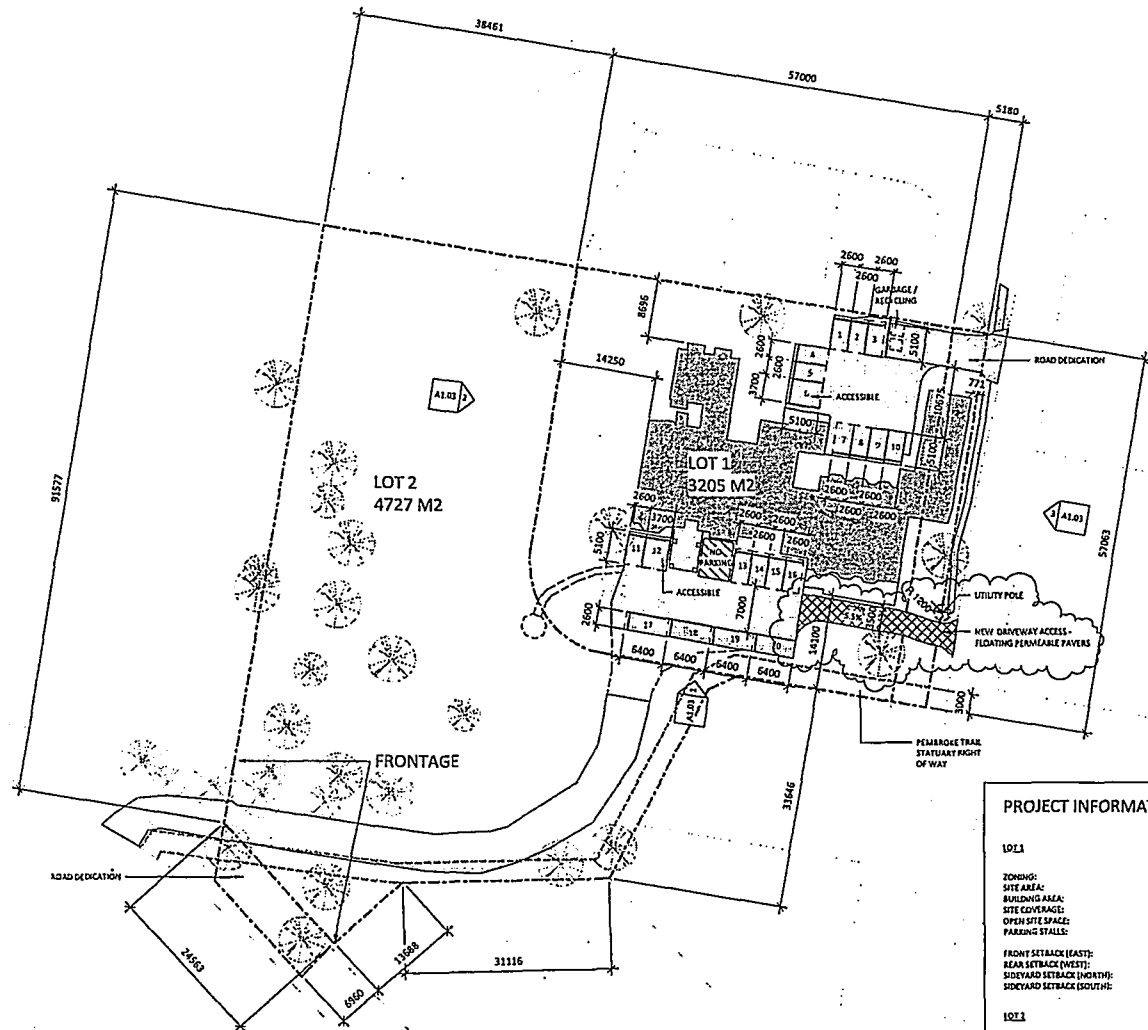
A1.03

Observations: The majority of the proposed driveway will be located within an area that has had a retaining wall installed, fill soil added and a laurel hedge planted (see attached sketch 1). There will be a portion of the driveway nearest the road that will be installed where there is no existing retaining wall.

Although no exploratory excavations were completed behind the retaining wall, we anticipate the wall was likely installed due to shallow soils and existing rock as a means to provide a suitable planting area for the hedge. Due to the previous soil disturbance and retaining wall installation in this area, we do not anticipate the proposed new driveway will have any negative impact on the health or stability of the tree beyond the impacts that may have already occurred historically providing the driveway is installed using the following specifications.

Recommendations: We recommend that any excavation for the proposed driveway be completed under the direction of the project arborist and may involve a combination of digging by hand and small machine excavation. This will include the removal of any portions of rock wall that must be removed and the removal of the existing laurel hedge. If any roots from Garry oak 373 are encountered during the excavation the proposed new driveway must be designed to retain them.

The amount of fill soil that can be removed without encountering roots from the oak tree will dictate the final design of the new driveway. We recommend using the following floating driveway specifications to minimize any impacts the proposed new driveway may have on Garry oak 373. We do not anticipate that any significant roots will be encountered from Garry oak 374.

There is a portion of the proposed new driveway that will be constructed on municipal property in the road dedication area. If during the excavation, significant roots are encountered that cannot be pruned without negatively impacting the tree, we recommend that floating permeable construction techniques be incorporated, if permitted by the City.
