**AMENDED AGENDA
PLANNING AND LAND USE COMMITTEE
MEETING OF JUNE 5, 2014, AT 9:00 A.M.
COUNCIL CHAMBERS
CITY HALL, 1 CENTENNIAL SQUARE**

2. Rezoning Application # 00442 for 253 and 259 Esquimalt Road (The Roundhouse) 3 - 14
--D. Day, Director of Sustainable Planning & Community Development

Neighbourhood: Downtown Recommendation: Proceed with Rezoning and Development Permit
- [Addenda]
3. Development Permit # 000347 for 845 Yates Street (The Wave) 37 - 83
--D. Day, Director of Sustainable Planning & Community Development

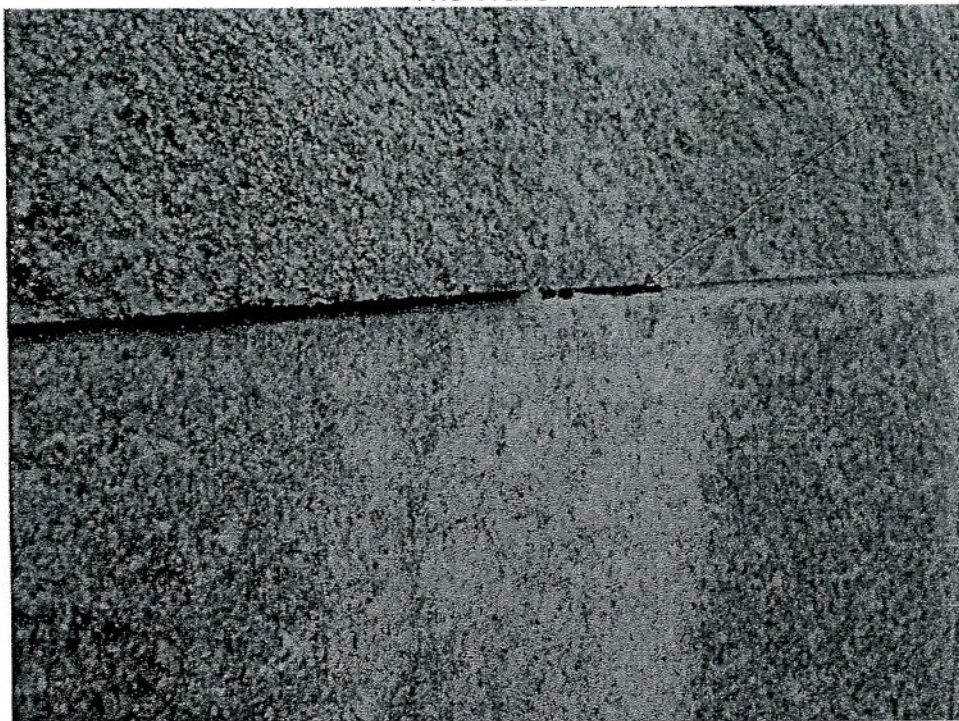
Photo 7

- Cracks and gaps in the grout at stone joints were widespread (Photo 7).
- Efflorescence (white staining) at stone joints was widespread (Photo 6).
- At locations of prior stone removal, observations were made of large areas of undisturbed notched mortar (Photo 8 & 9).

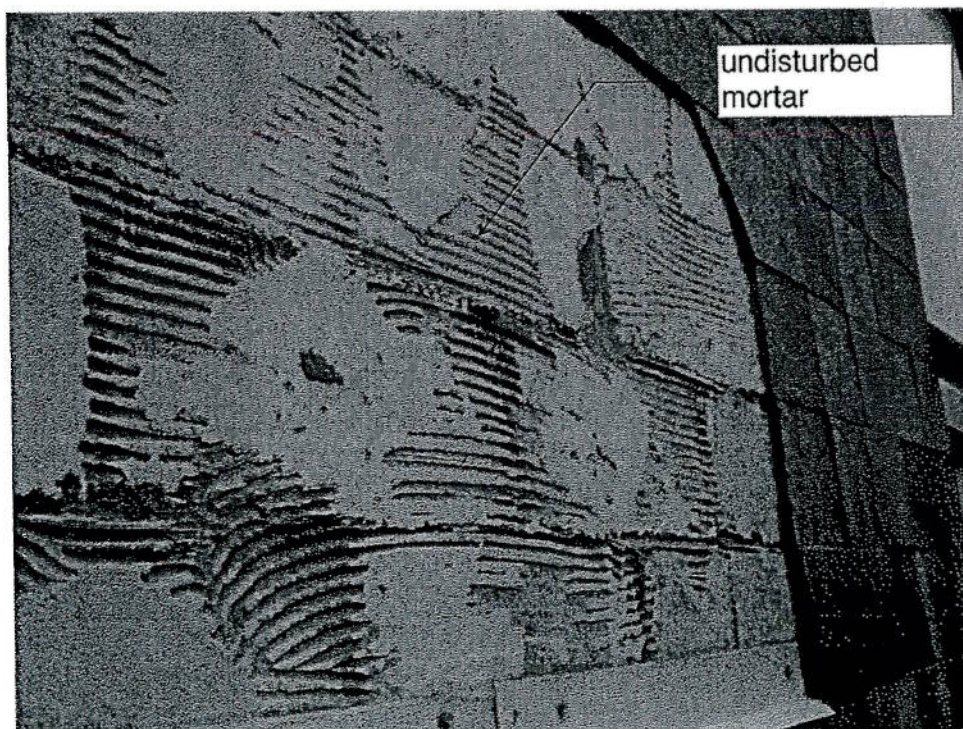
Photo 8

undisturbed
mortar

- cracks and gaps in the grout at stone/tile joints were widespread
- removal of "hollow" sounding stone/tile units revealed poor adhesion
- the joint between the stone and the concrete structure was filled with mortar. The mortar had failed in locations providing an opening for water entry.

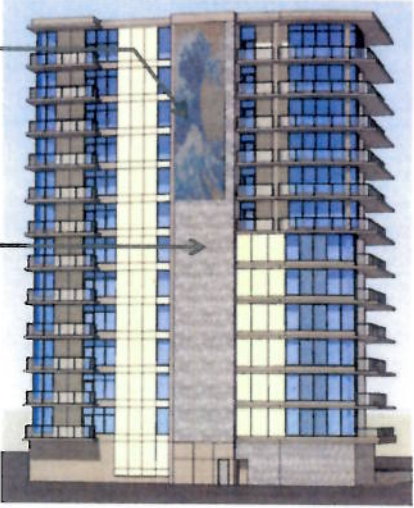
Wave mosaic made up of 100mm x 100mm (4"x 4") through coloured clay tiles

200mm x 200mm or 400mm x 15mm (8" x 8" or 16" x 5/8") thin stone

→ **Option 1 – New Tile Mosaic and Stone Cladding**

- Based on existing materials and form
- Will require a only a Minor Amendment to the existing Development Permit
 - Shorter approval process than a full Development Permit
 - Less expensive approval process than a Development Permit
- Highest construction costs of all options
- Least risk in the Approval Process

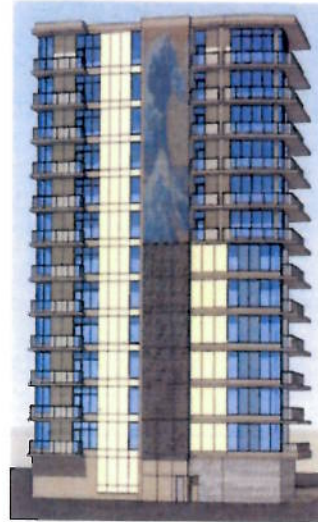
→ Option 3 – Painted Mural and Painted Concrete

- Material changes: tile & stone to paint
- Painted in a gridded pattern to replicate tile
- Will require a full Development Permit
 - Longer, more involved approval process - City states 3 to 6 months
 - Higher application fees and more consultant involvement (costs)
- Most uncertainty in municipal approval process

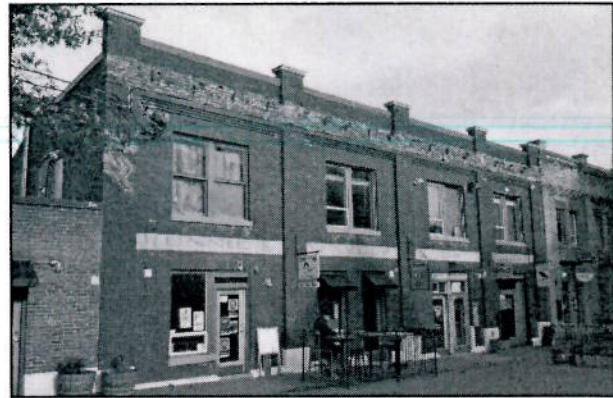
This Fernwood / Gladstone landmark is a two-storey, flat-roofed complex consisting of three brick buildings constructed between 1911 and 1941. The corner building of grey brick has paired and single windows. The upper floor windows have multi-lights-over-one, the lower have transoms. There is an inset bay on the far end of the Fernwood façade above a bricked-up larger segmental arched entrance, formerly to the stables. There is an inset bay on either side of the diagonal corner entrance. All windows and doors have flat brick lintels. Above the windows on the second floor is a corbelled brick frieze. The Fernwood façade has four bays, the Gladstone has three, all separated by pilasters

1284-98 Gladstone, centre building after removal of wooden mansard 2011
VHF / Brigitte Clark

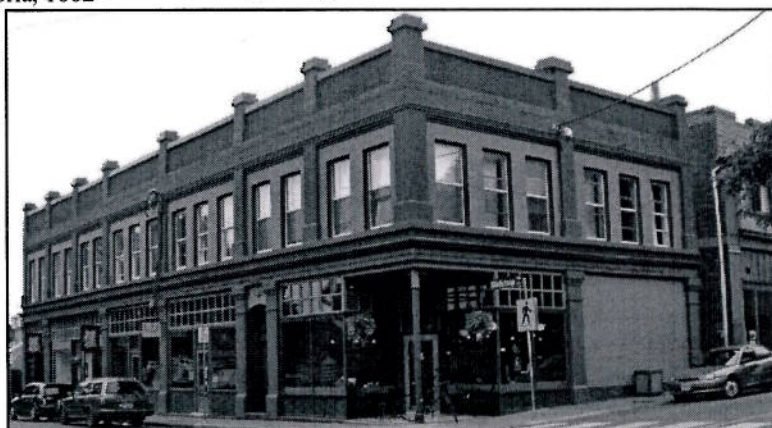
1301-1311 Gladstone, rehabilitated, R - 1921-23 Fernwood Rd, 2010 VHF / Terrance Merx

This is a two-storey painted brick building with two façades and a corner recessed entry. A steel post supports the corner of the upper floor. The Fernwood façade has two bays on the upper floor and one on the lower. The corner entry has glass display windows on either side. The Gladstone façade has seven upper bays, and four bays and two entrances on the lower floor. The lower bays have central shop entrances and display windows, with two levels of clerestory windows above. The bays are all separated by pilasters with concrete bases and capitals. The upper floor capitals are above the parapet. A stringcourse divides the first and second floors; the metal cornice below the parapet was removed because it had rusted away. The windows have flat brick lintels on Fernwood and Gladstone, and segmental arches at the rear. The upper floor was and is apartments.

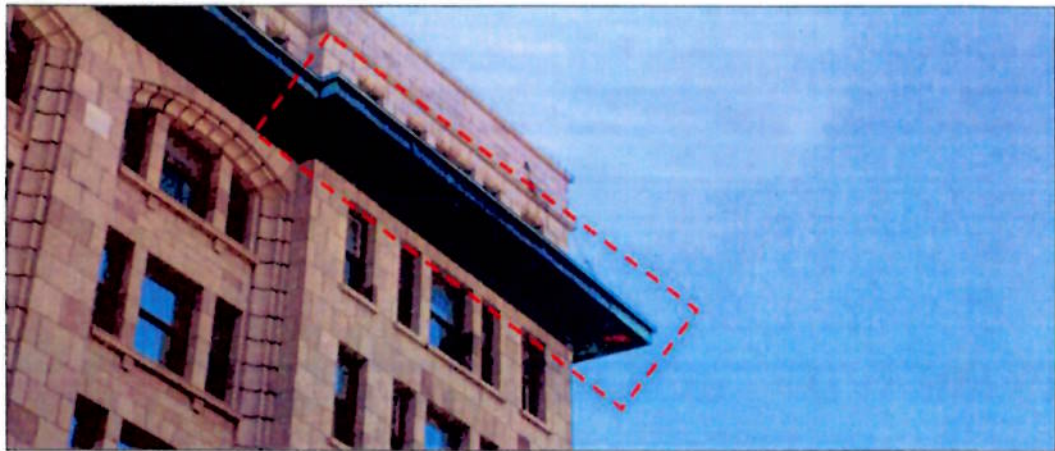
Photo 1 - North East Cornice

On July 17, 2013, RJC visited the site with Lorne James of Jawl Properties to complete a visual review of the cornice. Subsequent to this review, RJC visited the site on July 23, 2013 to review portions of removed interior wall, exposing the backside of the exterior masonry wall adjacent to the cornice.

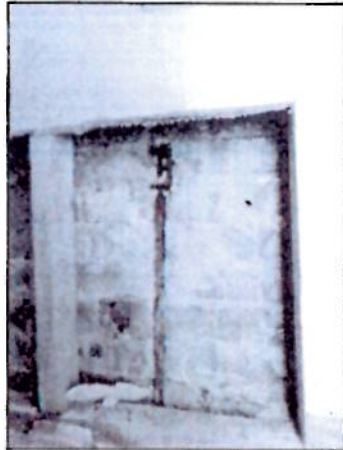
Photo 2- Tension Rod

The steel outrigger was visible to the inside, as was the reinforcing steel. The outrigger has corroded, and has experienced a loss of section of approximately 50% and spalling brick was observed adjacent to the steel outrigger section. RJC has confirmed the original reinforcing steel ties shown in the 1972 drawings prepared by Cooper, Tanner, and Associates Ltd. are present. These ties were not noted during the investigation completed by Church in 1997.

The current assembly relies on the compressive strength of the masonry brick wall, and the tensile resistance of the embedded steel rod to restrain the steel outrigger. Over time, water has been able to penetrate the roof cornice, and enter the masonry wall. This has resulted in corrosion of the steel member, which has resulted in cracked masonry units, and failed/displaced mortar joints. Given the general condition of the masonry brick wall, it is recommended that the new system not rely on the masonry to resist compressive loads unless the wall is re-pointed, and/or re built as required. The steel outrigger section has undergone significant section loss due to corrosion, and no longer has the capacity required to resist the required design loads. Replacement of the steel outrigger is required.

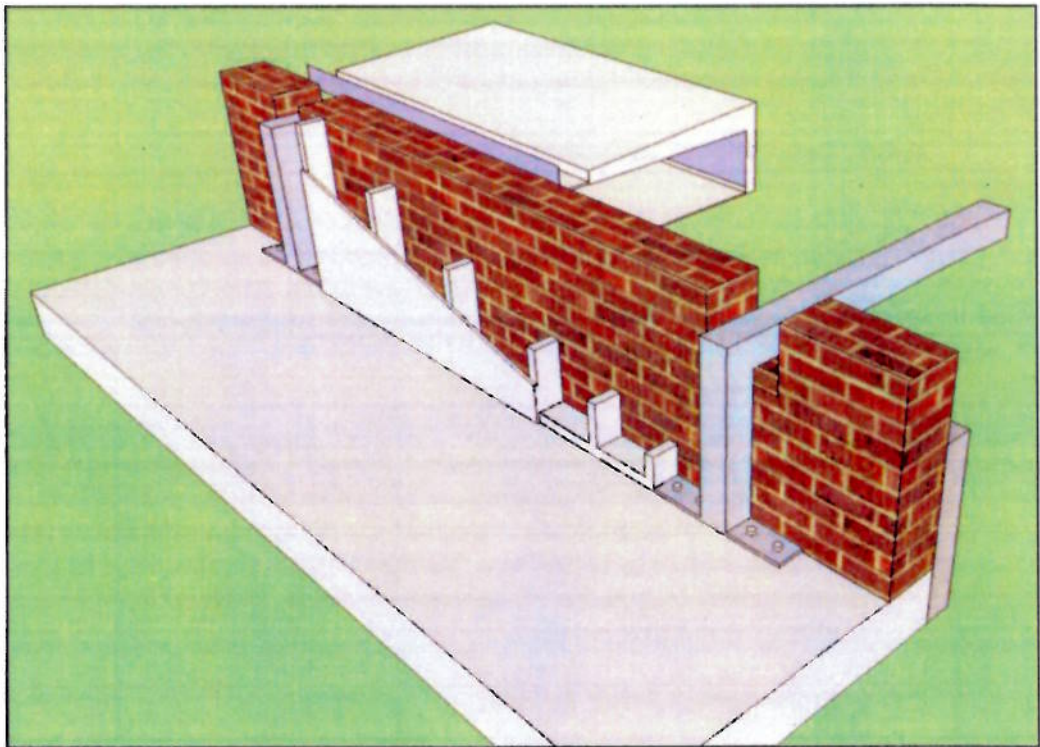
Figure 2 - Proposed Cornice System

The proposed replacement system consists of a fabricated steel outrigger support which would be bolted to the structural concrete slab. The steel HSS section would be approximately an 89x89x4.8, and the steel base plate would likely require 4-5/8" diameter anchor bolts. It is anticipated that the steel framing would be concealed from the interior by the existing stud wall furring as shown in Figure 2.

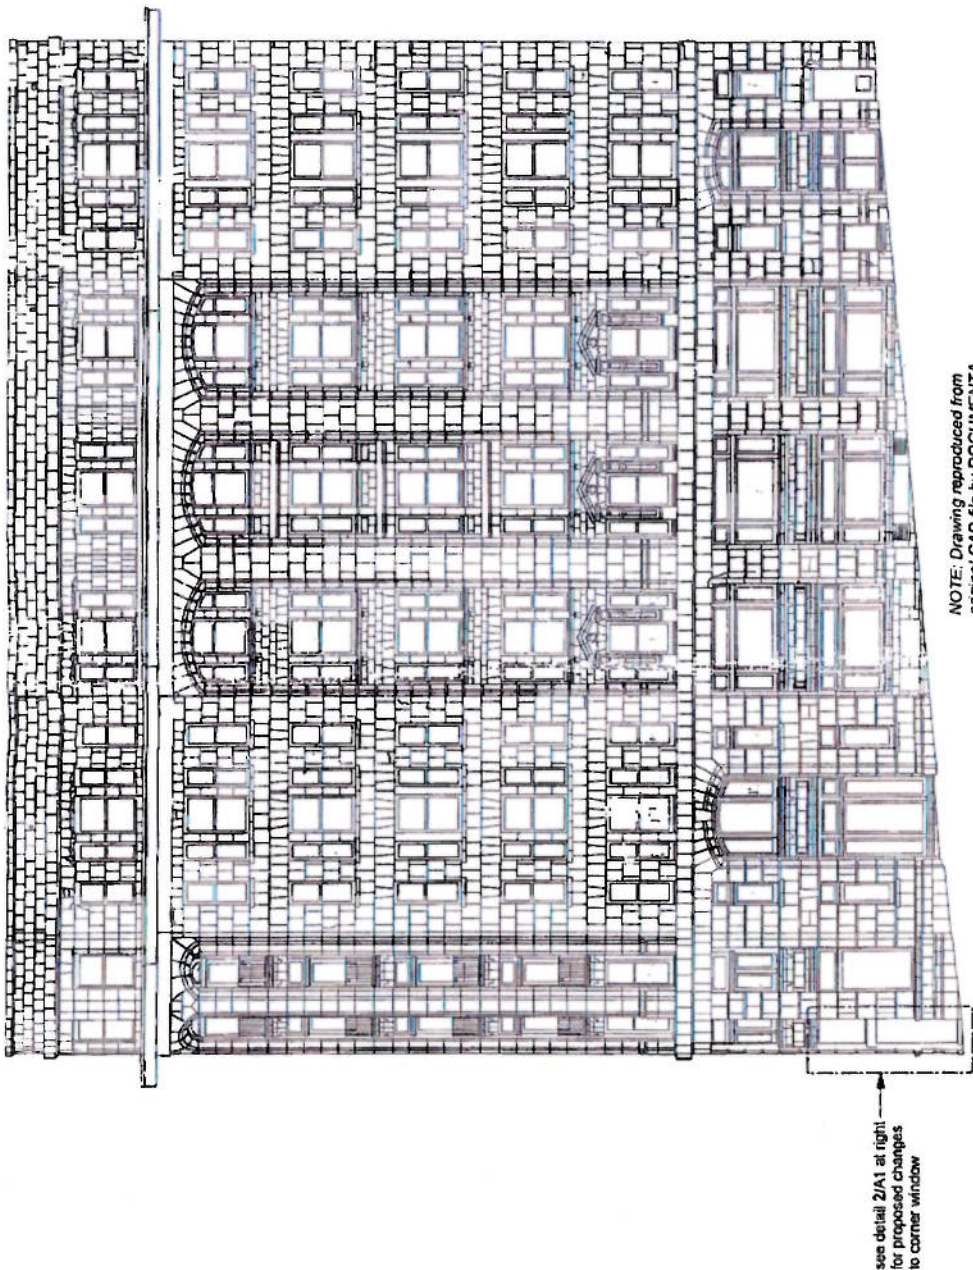
3 Gordon St. - Existing Facade (East) 1:150

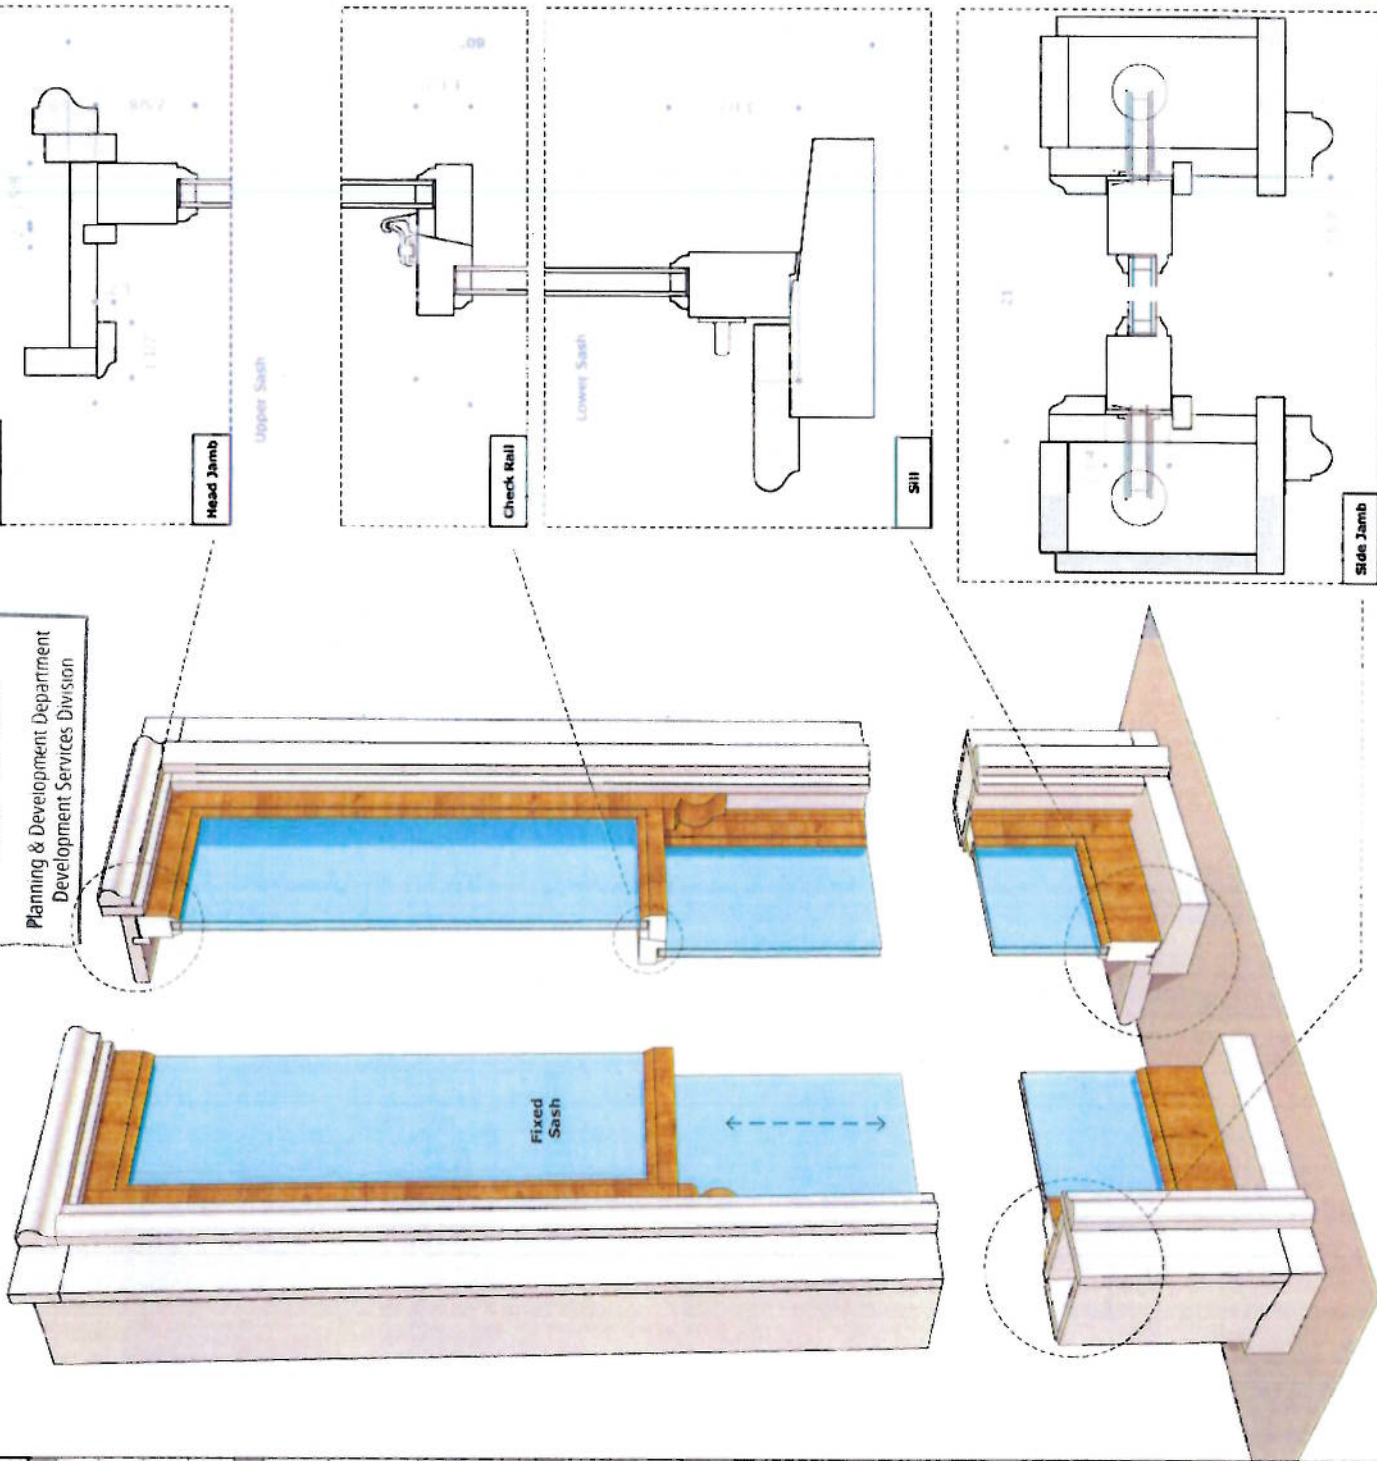
Sash Replacement - Box + 4" Jamb
SK-BOX + 4"
