Annex A: Douglas Street Bus Zones

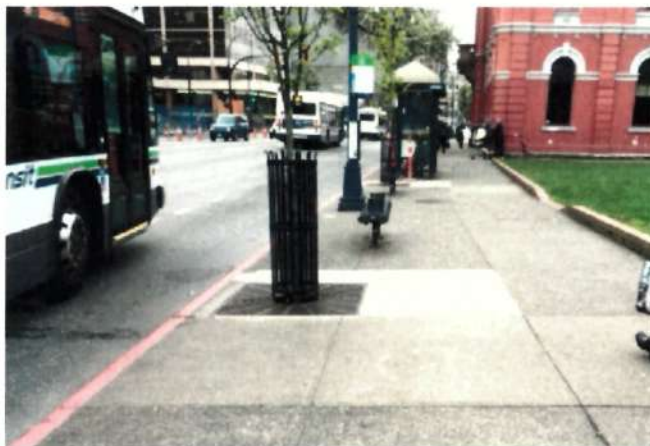
Figure 1: Douglas Street Sidewalk at Bus Zone Centennial Square Frontage

Douglas Street between Pandora Avenue and Fisgard Street (Centennial Square frontage):

The current curb height at this bus stop is less than the standard 155mm curb height. When buses with wheelchair ramps and kneeling capabilities stop at this location, the wheelchair ramp exceeds 5% - AWG members have expressed concerns about the potential for wheelchair users falling/losing their balance as they enter/exit a bus.

This sidewalk is not currently identified as a priority area for reconstruction, based on the condition of the existing concrete, or in conjunction with any road re-surfacing project.

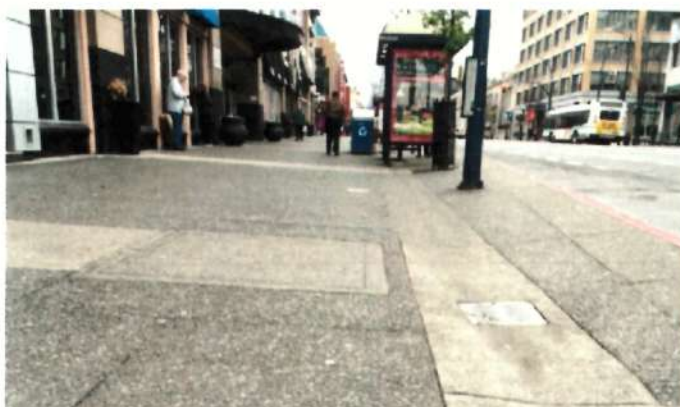
Figure 2: Douglas Street Sidewalk at Bus Zone Bay Centre Frontage

Douglas Street between View Street and Fort Street (Bay Centre frontage):

The current cross-fall of the sidewalk between the existing curb and the in-sidewalk trench drain in this block varies from 5-7%. This sidewalk was reconstructed in the late 1990's as part of a revitalization project – the sidewalk drainage design (with a V-gutter/trench drain) was selected to ensure sidewalk grades matched existing storefront doorway elevations, while minimizing the scope of road reconstruction. Staff note the same sidewalk design (V-gutter/trench) is also employed on the west side of Douglas Street between View Street and Yates Street.

When buses with wheelchair ramps and kneeling capabilities stop at this location, the wheelchair ramp exceeds 5% - AWG members have expressed safety/falling concerns.

This sidewalk is not currently identified as a priority area for reconstruction, based on the condition of the existing concrete, or in combination with road re-surfacing project.
