### E.5 727 Yates Street - Heritage Alteration Permit with Variances Application No. 00008 (Downtown)

The proposal is to present Council with information, analysis and recommendations regarding a Heritage Alteration Permit with Variances Application for the property located at 727 Yates Street, also known as the Hall Block.

# HALL BLOCK

727-729 YATES STREET, VICTORIA, BC

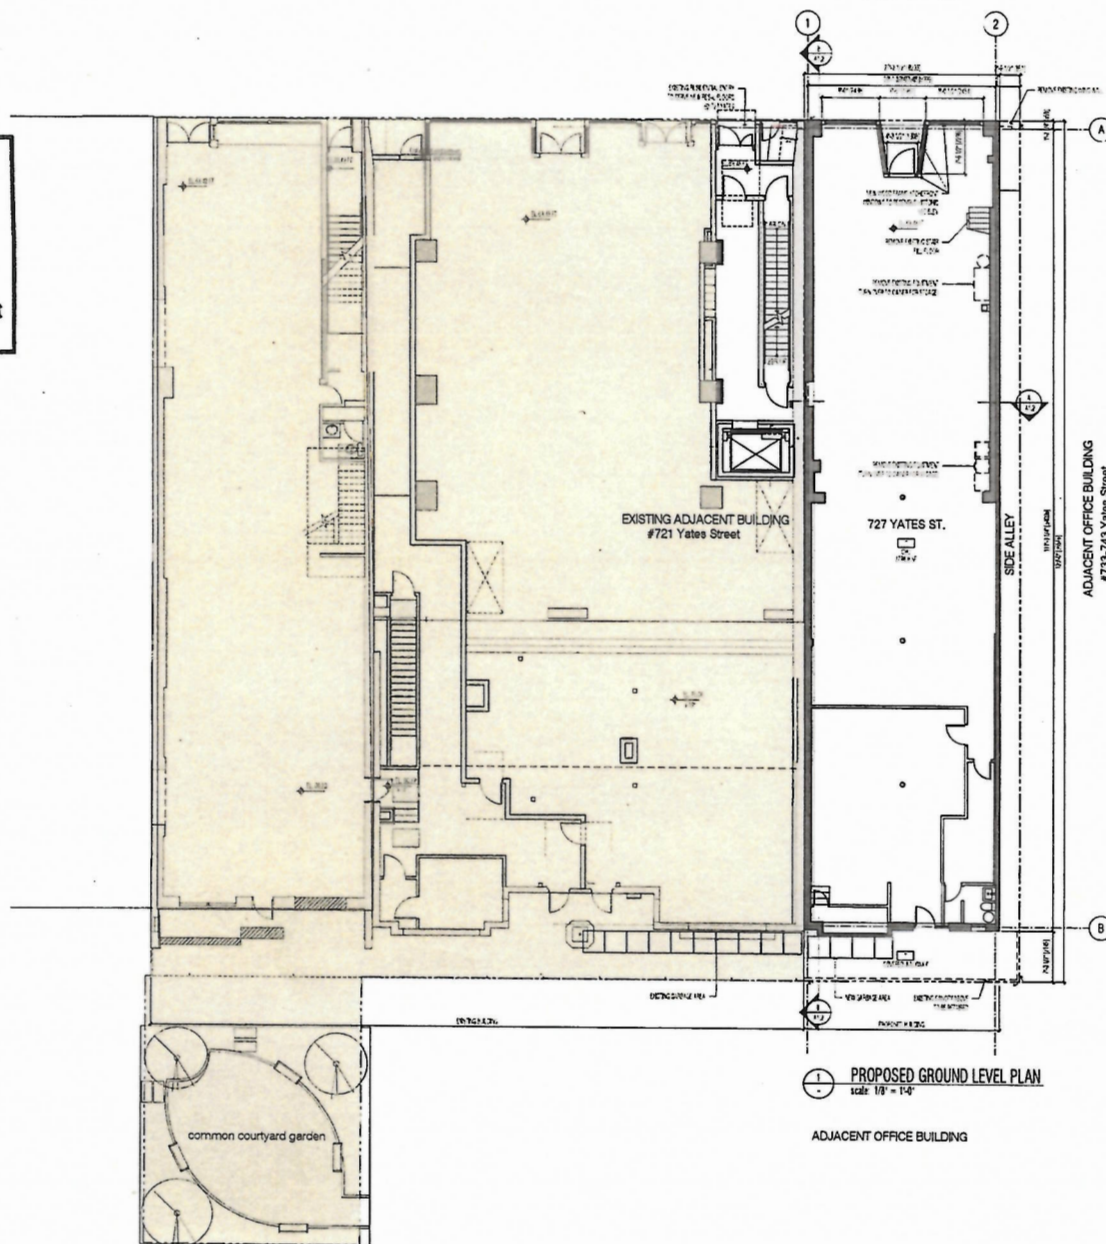
1 PROPOSED GROUND LEVEL PLAN  
scale: 1/8" = 1'-0"

ADJACENT OFFICE BUILDING

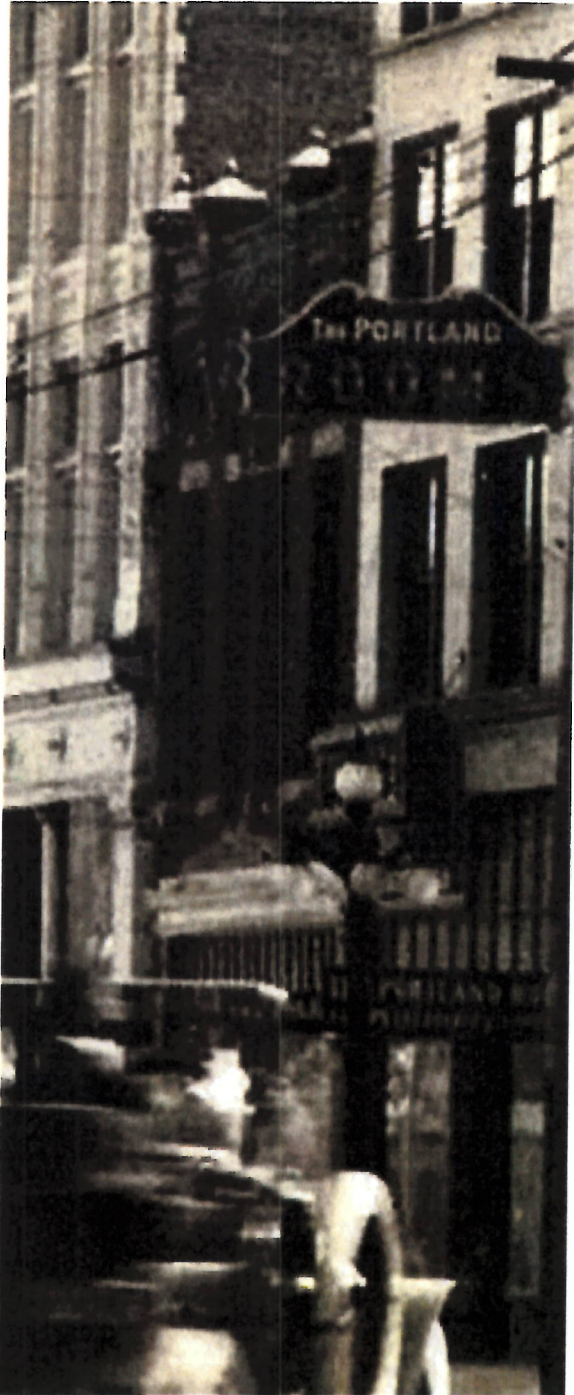
*Detail photo showing historic front facade of the Hall Block and adjacent buildings along Yates Street. Note original storefront with transom ribbon, architectural metal cornice, and window openings with sandstone sill. (BC Archives, E-02737)*

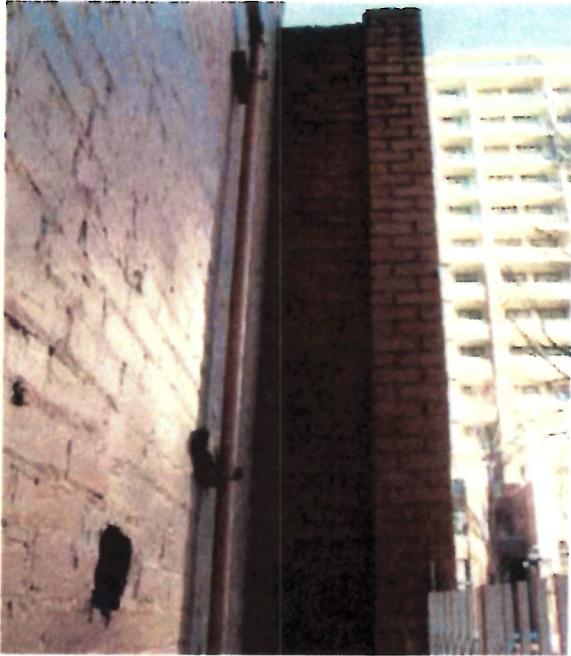
*Detail photo of storefront wall east extension, as viewed from behind along the side pathway.*

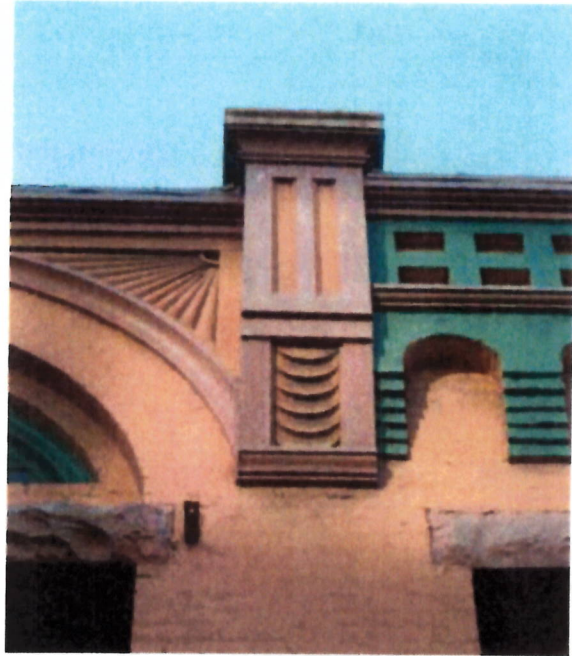
*Detail photo showing existing conditions of parapet with architectural metalwork and original masonry elements.*

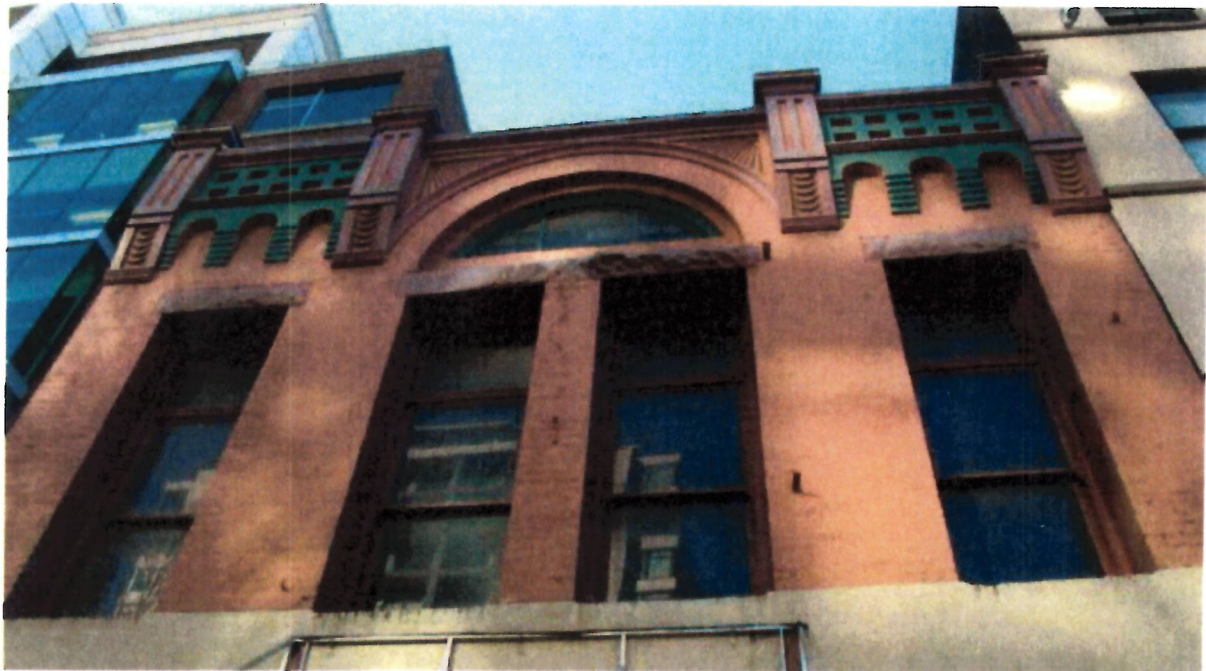
*Detail photo showing existing condition of the masonry elements and architectural metalwork above storefront level of the historic front facade. Note existing parged concrete cladding at window sill to be removed.*

Above the storefront, the historic front facade features surviving, original brick masonry units, with later painted finish that is similarly applied to the east and side elevations. The window openings feature surviving sandstone lintels with rock-faced finish, with the central bay window openings characterized by an extended stone lintel and an arched window opening with brick mould. Most of the original features of the parapet wall are also extant. It features original masonry detailing, with late-Victorian decorative elements in brick and architectural metalwork.

In general, the later cladding and surviving, original masonry elements above the storefront level appear to be in good condition, with signs of minor deterioration in localized areas, as evident by spalling, mortar deterioration (or loss altogether), peeling paint, holes in various sizes from redundant fasteners, discolouration, bird deposit staining, and some biological growth.

The exterior masonry of the historic front facade of the Hall Block are important character-defining elements of the heritage asset that should be preserved, and repaired as required. As part of the proposed rehabilitation scheme, deteriorated and missing masonry features of the historic front facade will be restored based on evidences from archival materials.

- Retain sound exterior masonry or deteriorated exterior masonry that can be repaired.
- Cleaning, repair and repointing specifications to be reviewed by Heritage Consultant.

- Overall cleaning of the masonry on the exterior front façade and rear elevation should be carried out. Do not use any abrasive methods that may damage the fireskin surfaces. Use a soft natural bristle brush and mild water rinse. Only approved chemical restoration cleaners may be used. Sandblasting or any other abrasive cleaning method of any kind is not permitted.

- If repointing of brickwork is required, rake out loose mortar material to a uniform depth. Take care that the arrises of the brick are not damaged. Work should only be undertaken by skilled masons. Do not use power tools to cut or grind joints; hand-held grinders may be used for the initial raking of horizontal joints after test samples have been undertaken and only if approved by the Heritage Consultant. Repoint mortar joints with new mortar that matches existing in consistency, composition, strength, colour and pointing profile; note the finely tooled profile of the original mortar joints.

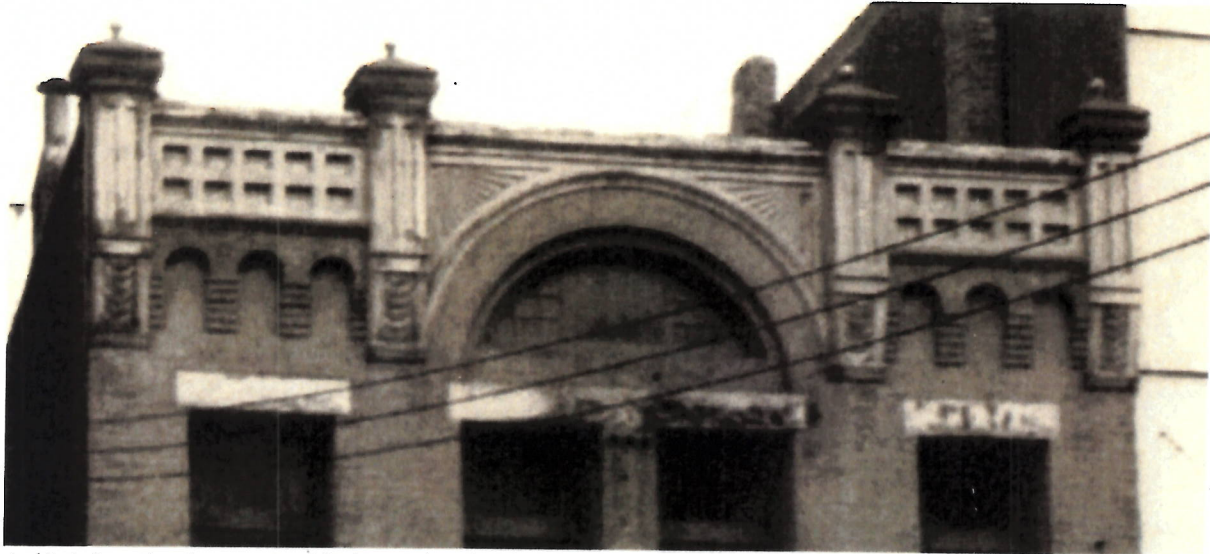
*Archival photo showing parapet of the historic front facade with original architectural metalwork.*

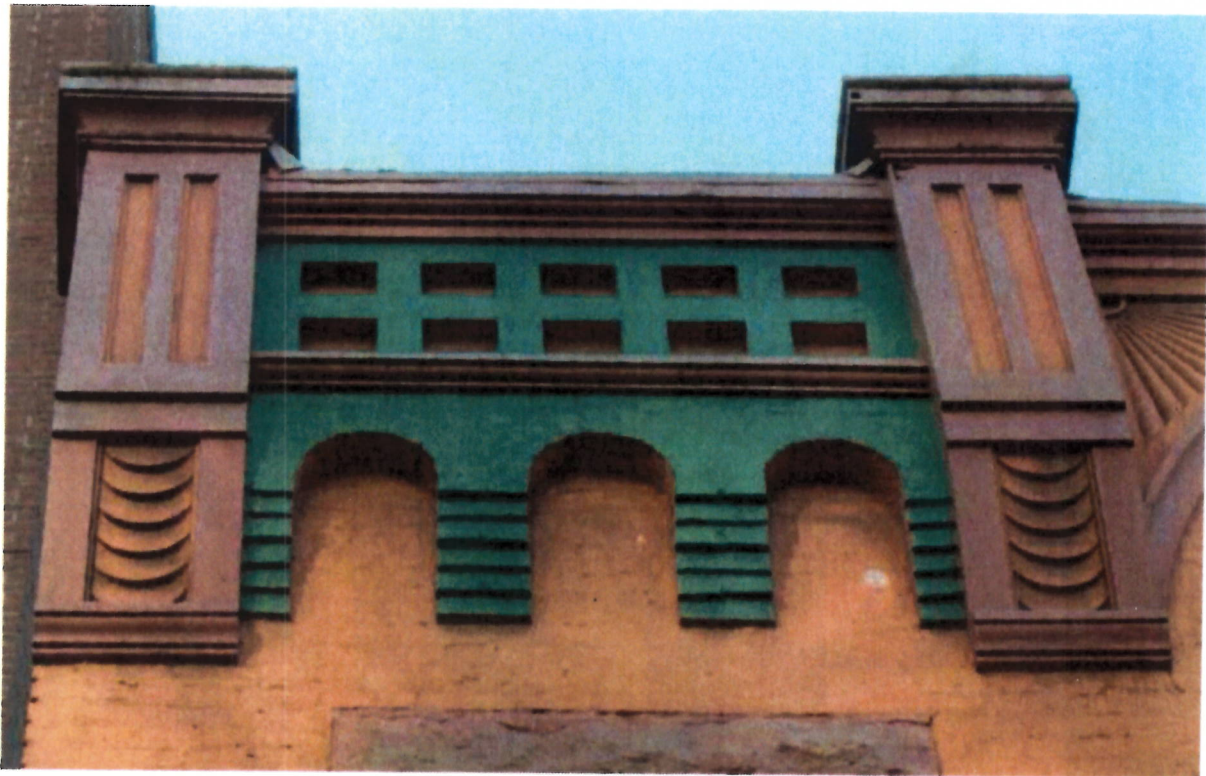
*Existing condition of rehabilitated architectural metalwork that resembles original based on archival photos.*

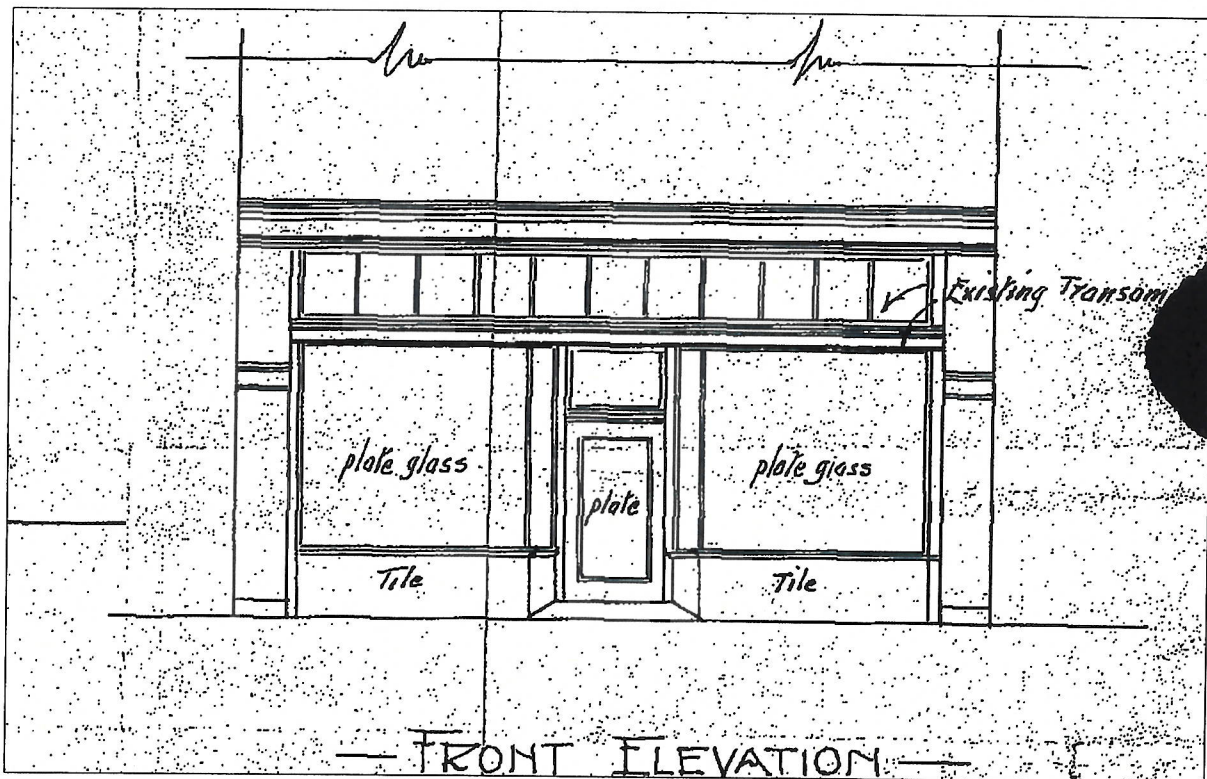
Archival drawing showing historically appropriate storefront configuration of Hall Block, with original character-defining elements along Yates Street.

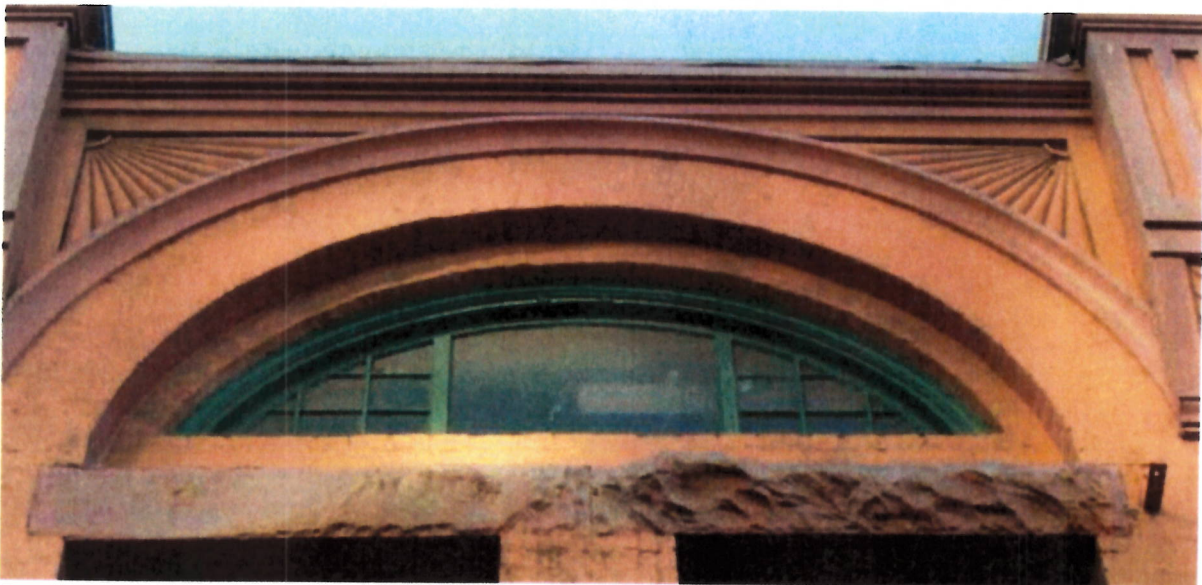
The historic front facade of the Hall Block features four original, tall window openings above the storefront level, characterized by surviving, original double-hung wood window assemblies with fixed, transom light. Above the paired window openings at the central bay is an arched window opening that is characterized by true divided multi-light, fixed wood window assembly.

In general, the extant original windows are in good condition, with minor signs of deterioration as a result of natural weathering. All original wood windows contribute to the historic character of the Hall Block, and should be preserved, and repaired as necessary.

Top: Photo showing typical existing condition of original double-hung wood window assembly with transom light.

Bottom: Photo showing arched window opening and original multi-light wood-window assembly at central bay of the Hall Block.

- Inspect for condition and complete detailed inventory to determine extent of recommended repair.
- Retain existing window sashes; repair as required.
- Preserve and repair as required, using in kind repair techniques where feasible.

- Overhaul, tighten/reinforce joints. Repair frame, trim and counterbalances.
- Each window should be made weather tight by re-puttying and weather-stripping as necessary.

- Retain historic glass, where possible. Where broken glass exists in historic wood-sash windows, the broken glass should be replaced. When removing broken glass, the exterior putty should be carefully chipped off with a chisel and the glazier's points should be removed. The wood where the new glass will be rested on should be scraped and cleaned well, and given a coat of linseed oil to prevent the wood from absorbing the oil from the new putty. The new glass should be cut 1/16-1/8th smaller than the opening to allow for expansion and irregularities in the opening,
