WATSON & MCGREGOR BUILDING

645-651 JOHNSON STREET, VICTORIA, BC

CONSERVATION PLAN

FEBRUARY 2018

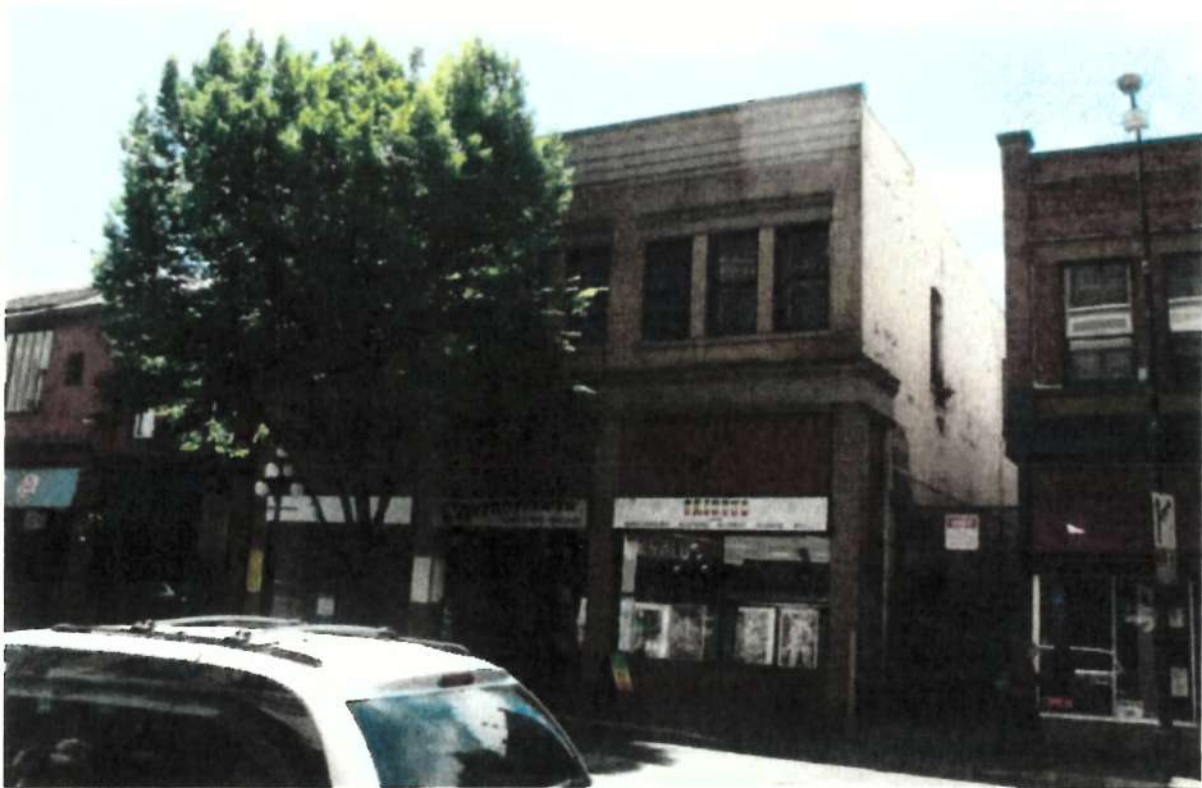
Top (right) and bottom: Photos showing partial front and side (laneway) elevations, as viewed from Johnson Street.

Along the historic front facade, the tan bricks appear to be in fair condition, with signs of weathering caused by water ingress and moisture saturation, as evidenced by efflorescence, staining and discolouration, organic growth, and brick spalling. Other notable signs of deterioration include stepped cracking and mortar loss in localized areas.

Similar deteriorating conditions were noted along the side elevation to the west, in addition to peeling of paint. Further assessment is required to determine the feasibility of removing the existing paint finish, which may include abatement of hazardous materials, without causing significant damage to the brick face underneath.

- Preserve the brick whenever possible, and replace in kind brickwork that is too deteriorated for safe use.
- Undertake complete condition survey of condition of all brick surfaces.

- Cleaning, repair and repointing specifications to be reviewed by Heritage Consultant.
- All redundant metal inserts and services mounted on the exterior walls should be removed or reconfigured.

- Any holes in the brick should be filled or replaced to match existing.
- Overall cleaning of the brick on the exterior walls should be carried out. Do not use any abrasive methods that may damage the fireskin surfaces. Use a soft natural bristle brush and mild water rinse. Only approved chemical restoration cleaners may be used. Sandblasting or any other abrasive cleaning method of any kind is not permitted.

- Repoint the brickwork by raking out loose mortar material to a uniform depth. Take care that the arises of the brick are not damaged. Work should only be undertaken by skilled masons. Do not use power tools to cut or grind joints; hand-held grinders may be used for the initial raking of horizontal joints after test samples have been undertaken and only if approved by the Heritage Consultant. Repoint mortar joints with new mortar that matches existing in consistency, composition, strength, colour and pointing profile; note the finely tooled profile of the original mortar joints.

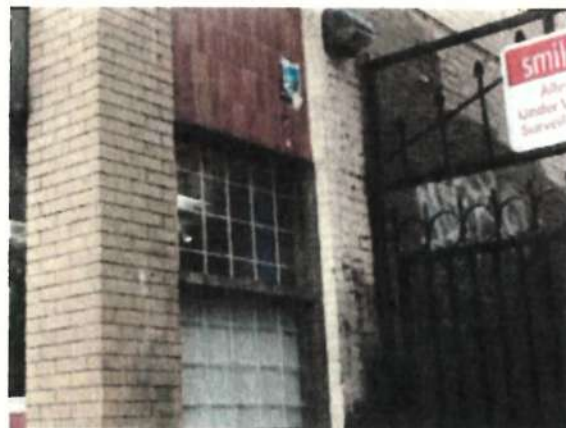
Photo showing storefront return, and partial masonry wall along the laneway elevation to the east; note tilework at the storefront transom that are not original and should be removed.

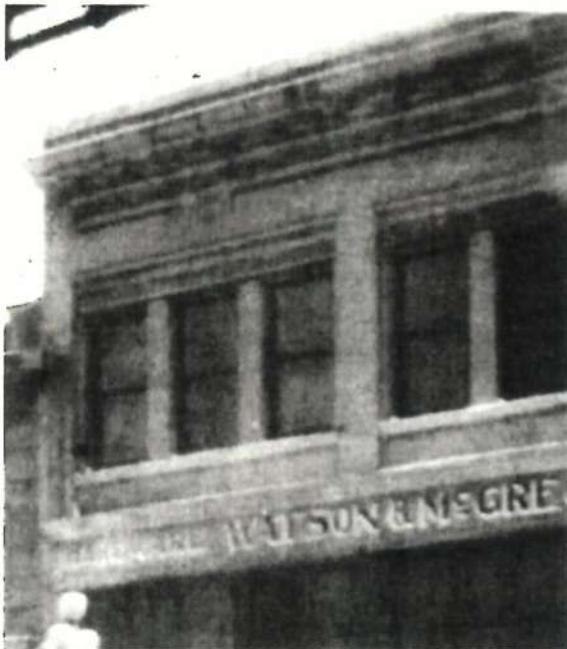
The Watson & McGregor Building originally featured a large, projecting metal cornice along the parapet level of the historic front facade, with partial return along the laneway elevation to the west. The original parapet cornice is no longer extant, and has been subsequently replaced with overlapping horizontal bands of unsympathetic flat, metal flashing that does not contribute to the historic character of the building.

The lower street facade features a modest storefront cornice with a continuous signband, similarly including a partial return along the laneway elevation to the west. All efforts should be made to restore the missing cornices and storefront signband based on archival photos.

Detail photo showing project metal cornice at parapet level, and the storefront cornice with signband at the lower street facade, circa 1913 [Collection Nancy Davis; Hallmark Society Files]

- Remove unsympathetic cornice replacements, and restore missing metal cornices with historically appropriate profile based on archival photos, as possible.

- The current attachment of all sheet metal cornices should be inspected, and should be re-anchored as appropriate.
- Repair and stabilize deteriorated architectural metal elements by structural reinforcement or correction of unsafe conditions, as required, until any additional work is undertaken. Repairs should be physically and visually compatible.
- The sheet metal work will be cleaned and prepared for repainting. Apply appropriate primer for galvanized surfaces. Paint in historically appropriate colour, based on colour schedule prepared by Heritage Consultant.

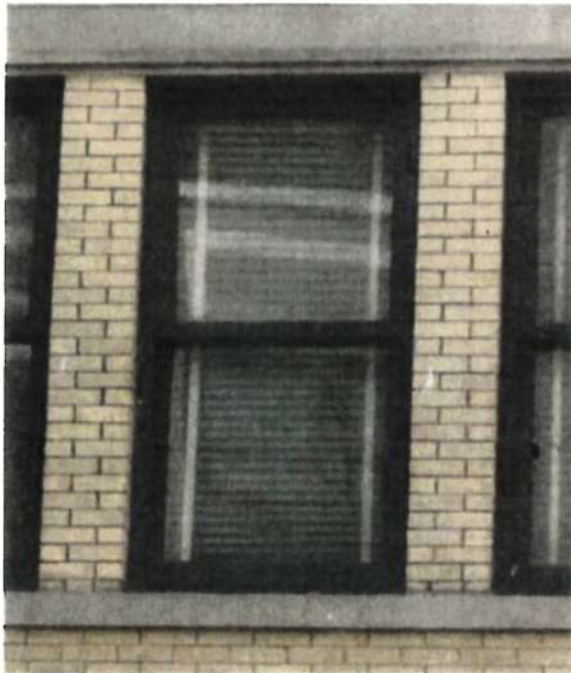
Based on the initial visual review from the ground level, the existing wood windows appear to be intact and in good to fair condition that show varying degrees of deterioration. Further review and assessment are required to confirm the existing condition of each assemblies, and to determine the appropriate extent of conservation work required.

Typical existing condition of double-hung wood sash window at upper level.

- Inspect for condition and complete detailed inventory to determine extent of recommended repair or replacement.
- Retain existing window sashes; repair as required; install replacement matching sashes where missing or beyond repair.
- Preserve and repair as required, using in kind repair techniques where feasible.
- Overhaul, tighten/reinforce joints. Repair frame, trim and counterbalances.
- Each window should be made weather tight by re-puttying and weather-stripping as necessary.
- Retain historic glass, where possible. Where broken glass exists in historic wood-sash windows, the broken glass should be replaced.

When removing broken glass, the exterior putty should be carefully chipped off with a chisel and the glazier's points should be removed. The wood where the new glass will be rested on should be scraped and cleaned well, and given a coat of linseed oil to prevent the wood from absorbing the oil from the new putty. The new glass should be cut 1/16-1/8th smaller than the opening to allow for expansion and irregularities in the opening, to ensure the glazing does not crack due to natural forces. Window repairs should be undertaken by a contractor skilled in heritage restoration.

- Replacement glass should be visually and physically compatible with existing.
- Prime and repaint as required in appropriate colour, based on colour schedule devised by Heritage Consultant.

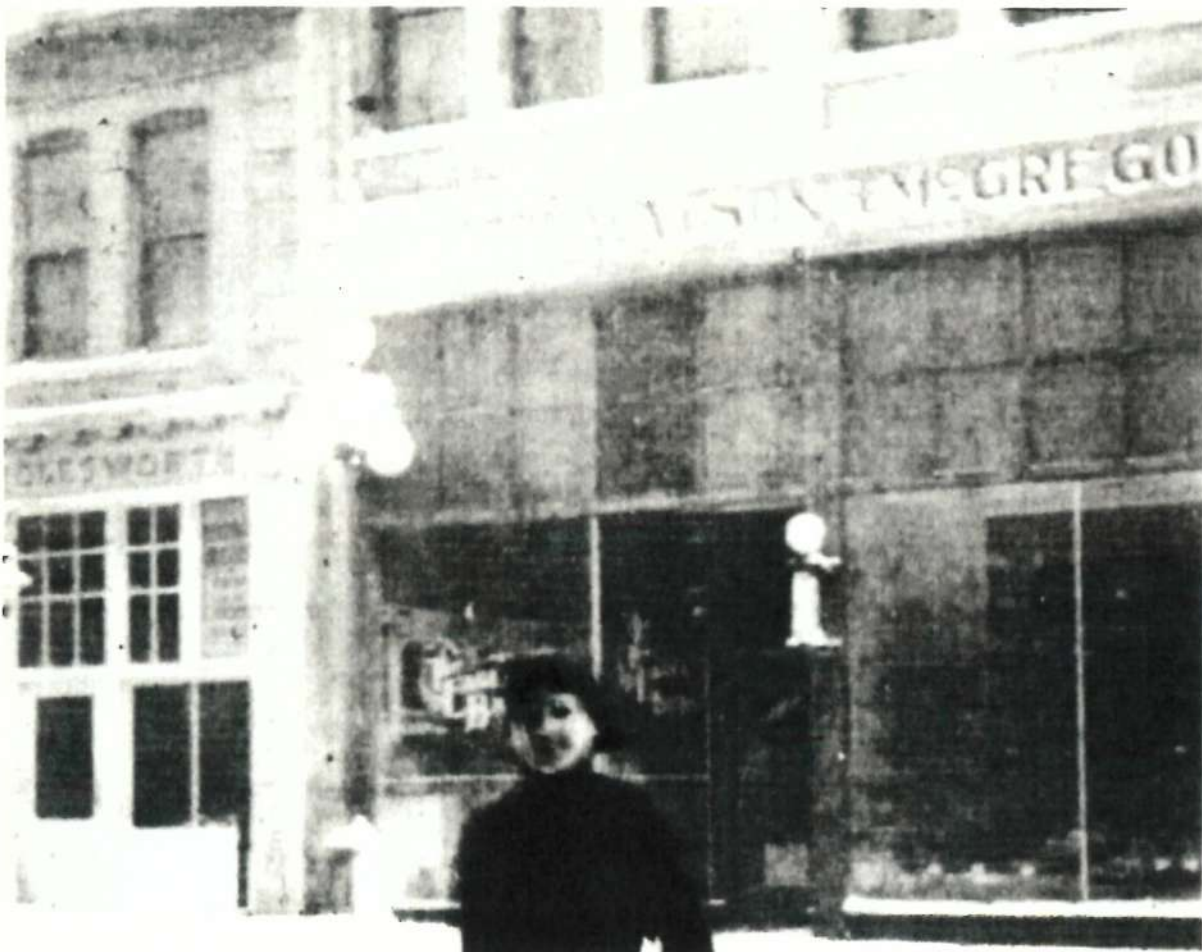
Detail photo showing original storefront configuration, circa 1913. [Collection Nancy Davis; Hallmark Society Files]

- Reinstall a rehabilitated wooden storefront system. Reference the historic design as noted in archival images and original architectural drawings. The design of the rehabilitated storefronts should resemble the original historic precedents.
- Integrate commercial signs and new lighting systems as required.
- Provide new accessible entryways for the ground floor, as required.
