**840 Fort Street**

**HERITAGE CONSERVATION PLAN**

August 1<sup>st</sup>, 2018  
#1027.003

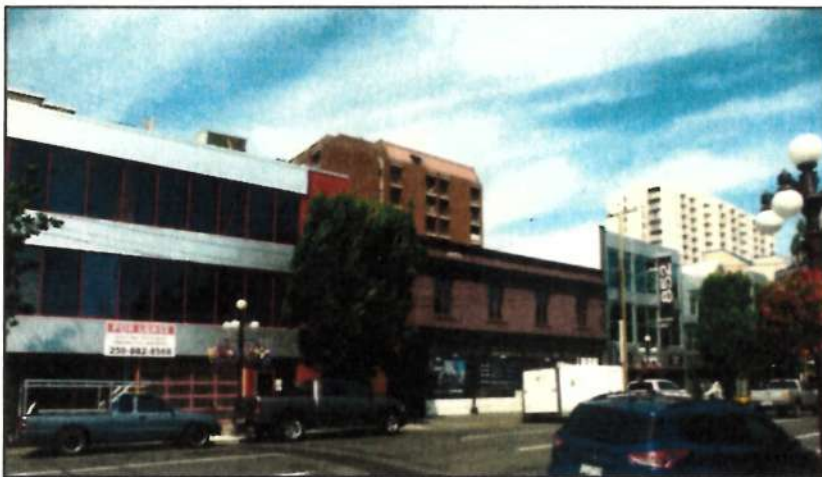
840 Fort Street exists at the south end of a lot on the north side of upper Fort Street. The historic facade contributes significantly to the varied streetscape identified as a character defining element.

It is intended that the facade as it currently exists will be retained along with a short set back of both side walls.

The redevelopment of the lot is to be undertaken with great care to the preservation of the existing facade maintaining both the historic materials and construction in the current configuration.

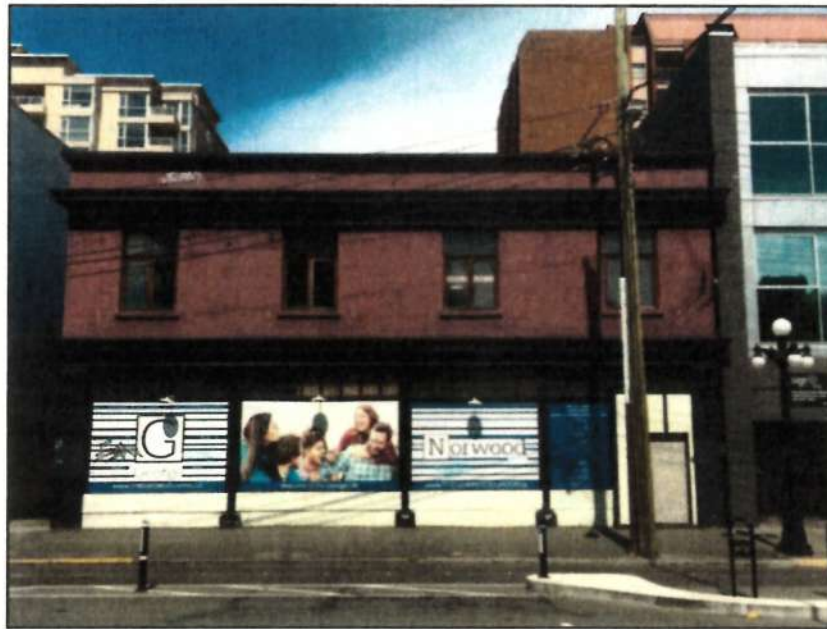
The façade is a good example of Edwardian commercial design and materials, relying on simple, material geometry and assembly symmetry for its character defining form.

The masonry wall along with the location and orientation of the primary assemblies will be preserved. The wood frame storefront glazing will be rehabilitated to accommodate improved access from the sidewalk and provide for multiple points of egress.

All rehabilitation work is to be sympathetic to the original design and materials while providing improved features. It is recommended that the storefront glazing utilize wood framing to reflect the historic character of the original retail space.

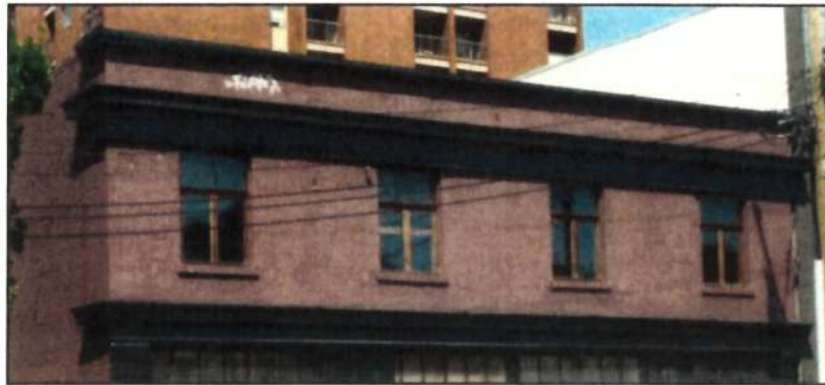
The painted, exterior clay brick walls support three tiers of restored sheet metal cornice. Both the clay brick masonry and sheet metal cornices are identified as a character defining elements, though the cornices are contemporary replicas and not original.

The existing clay brick façade including short returns on both side elevations as well as the sheet metal cornice are intended to remain unchanged. Any observed deterioration will be repaired using historically sensitive materials and methods.

It is recommended that all work on the exterior walls be minimized, completing renewal work only where necessary. Any restoration work that is undertaken is to be completed with materials that match with the original and existing materials.

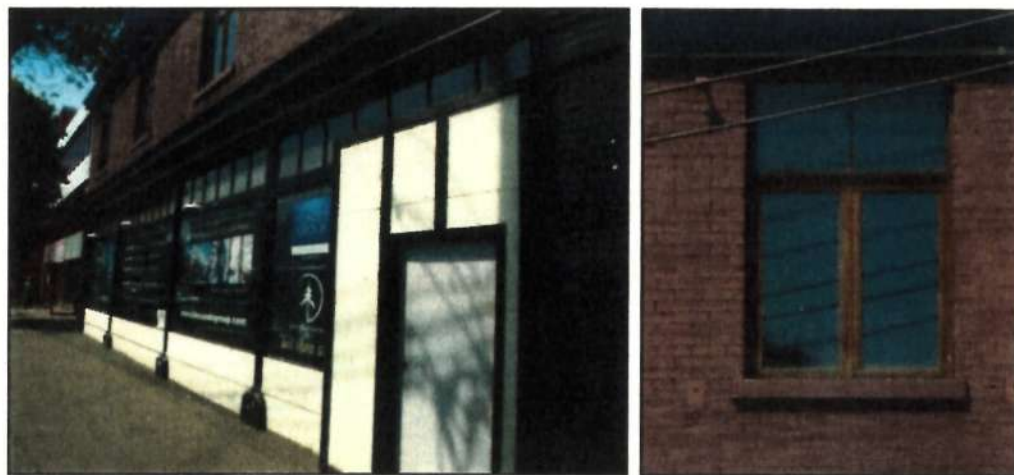
The fenestration, excepting the location of the cast iron columns and multi-lite transom windows, is not original to the building. The upper wood frame windows reflect a historic design with historic wood frames but both the drawings by C.W. Elwood and the earliest known photograph of the building show a single lower lite beneath double upper lites. The storefront glazing also shows the main entrance in a central bay and accessed by a flight of steps.

The cast iron columns and transom glazing will be preserved as they are with new storefront glazing infilled to support improved and additional egress. The main entrance will be restored to its original location though lowered to be at grade. Two additional entrances will provide egress through each side bay. The upper wood framed windows, despite not being original, will be preserved.

It is recommended that all work on the fenestration and trim material be minimized, retaining as much of the original/existing material as possible. The rehabilitation work that is undertaken is to be completed with materials that match with the original and existing materials.
