J.1.b.b 645-651 Johnson Street - Heritage Designation
Application No. 000177 (Downtown)

WATSON & MCGREGOR BUILDING

645-651 JOHNSON STREET, VICTORIA, BC

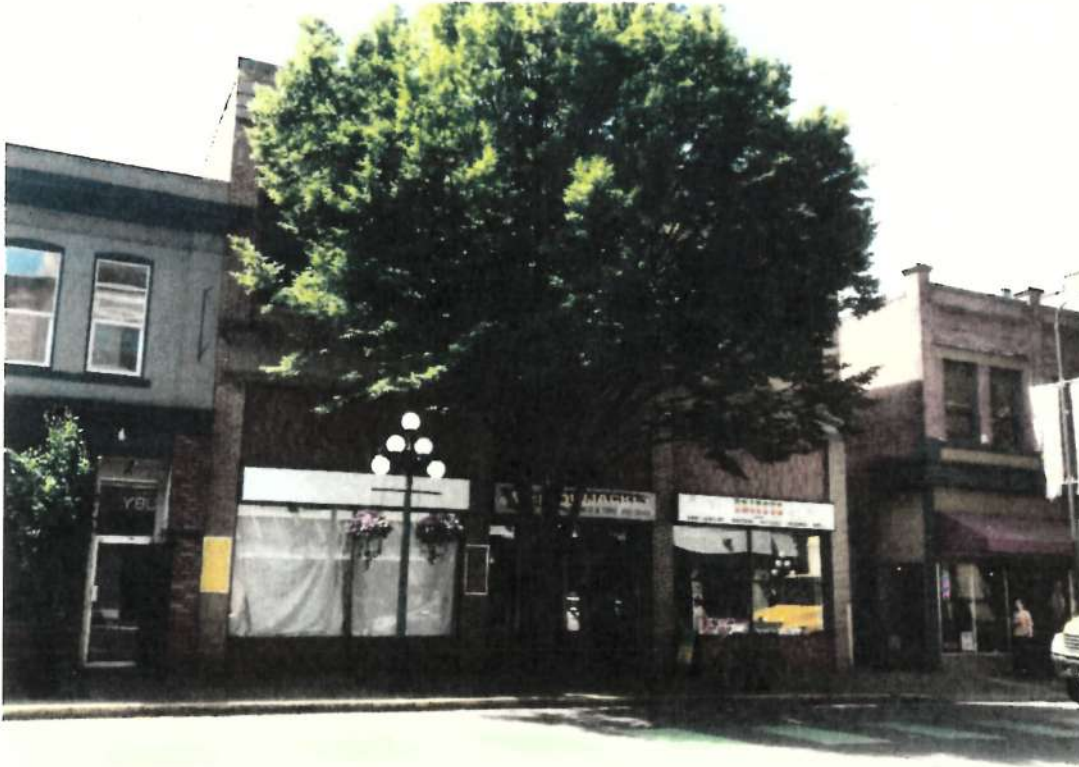
North Façade along Johnson Street

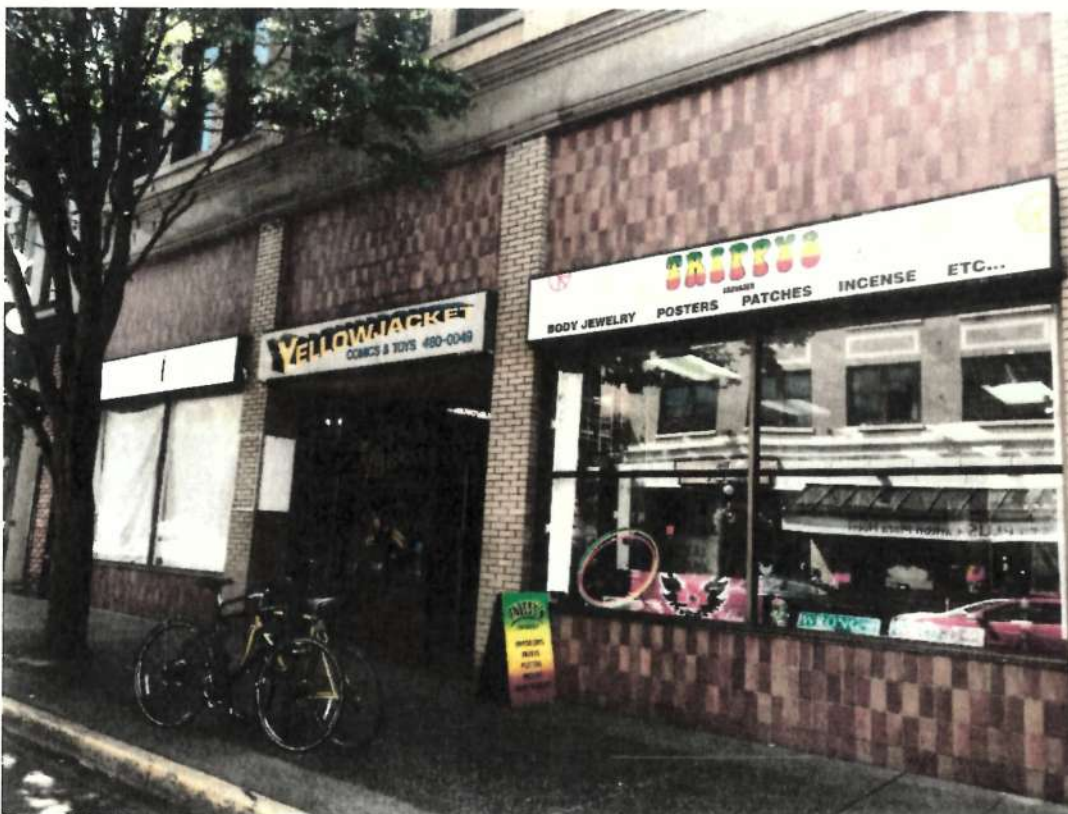
Lower North Façade with Central Entry

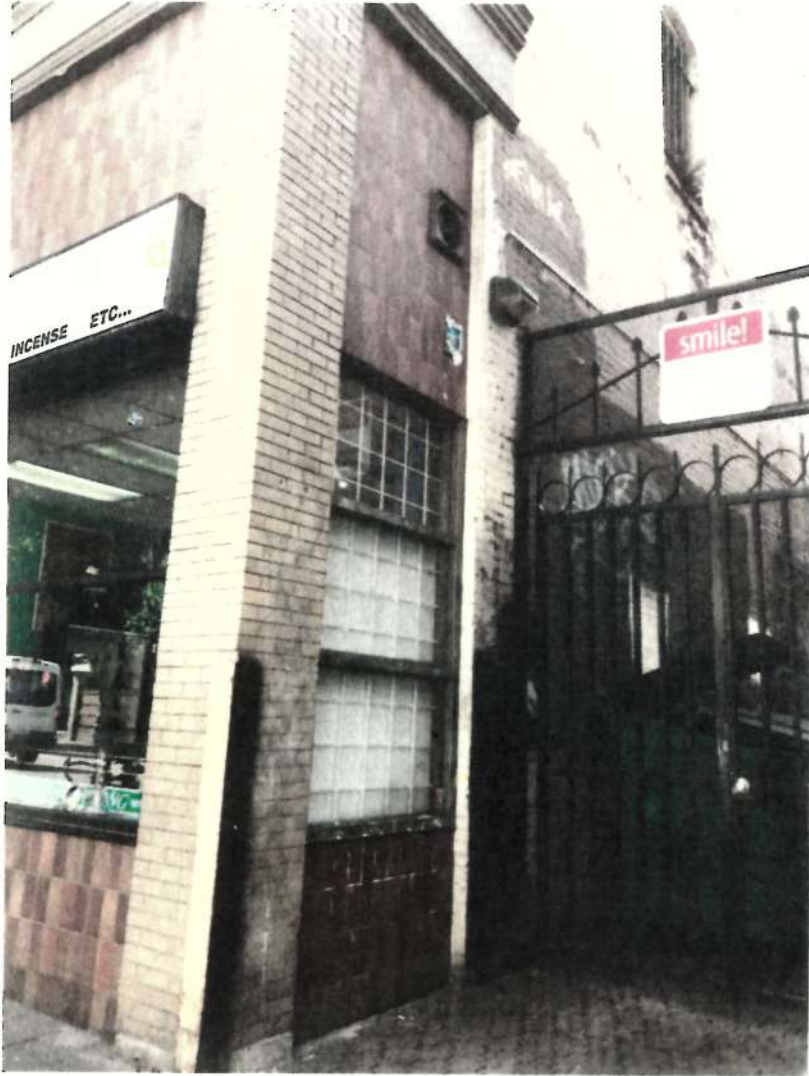
Northwest Corner

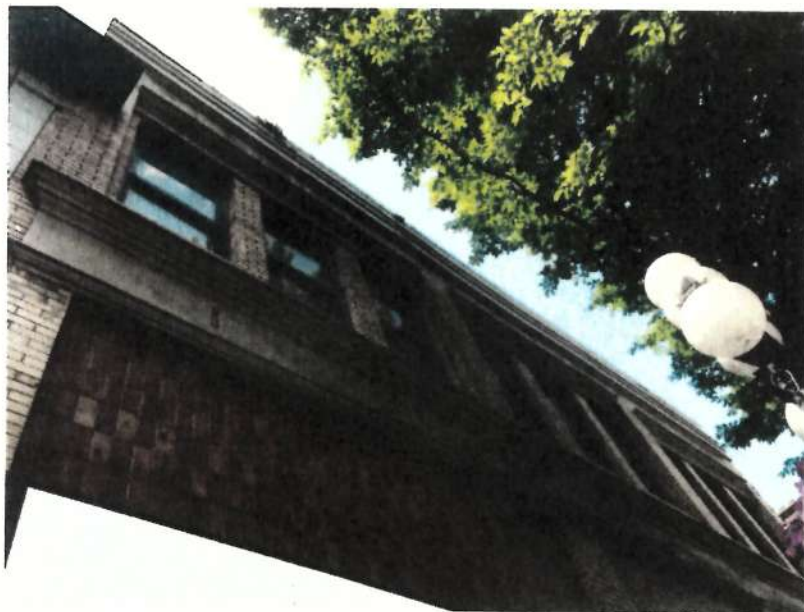
Upper North Facade

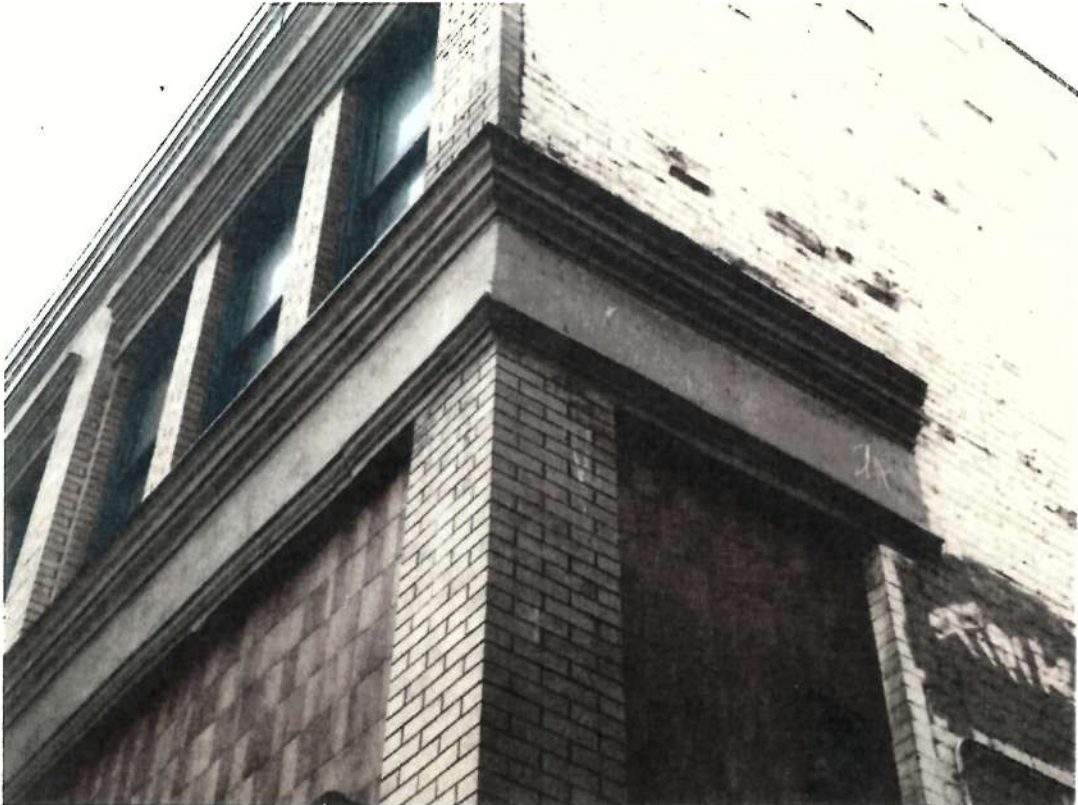
Upper Cornice Return

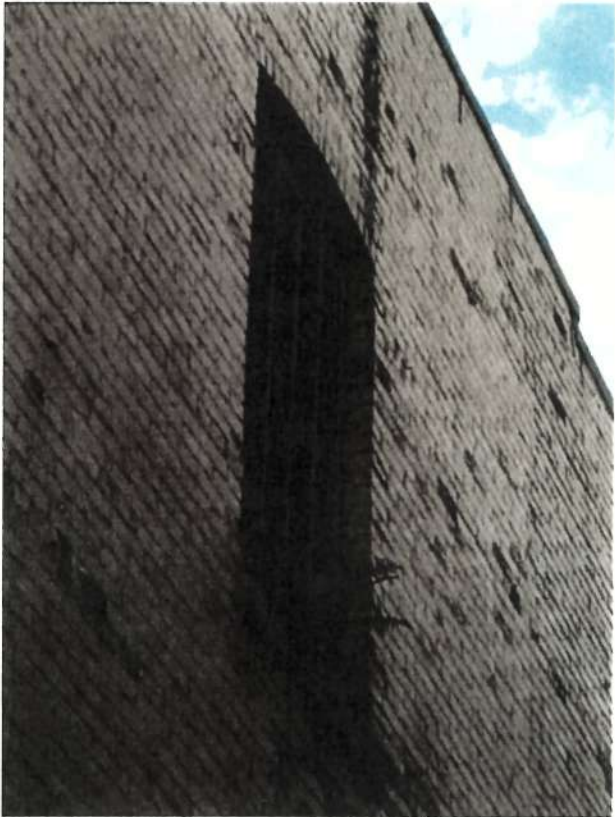
Upper West Wall Semi-Arched Windows

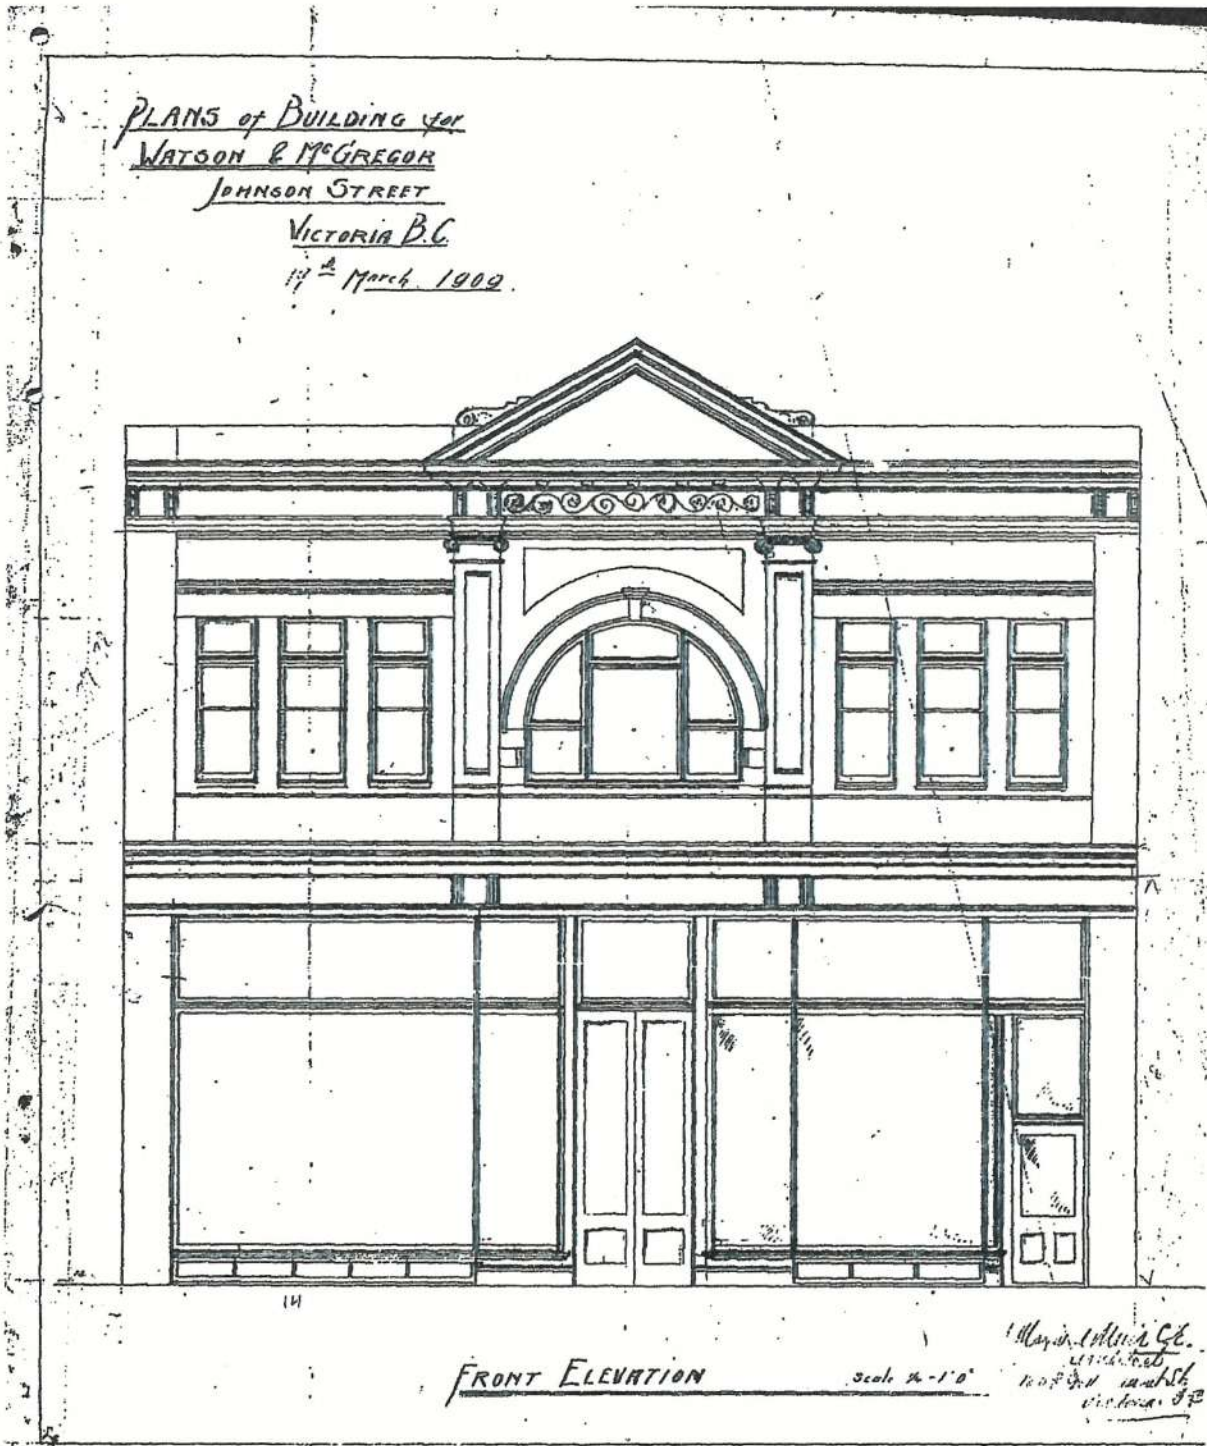
Proposed Watson and McGregor Building, A. Maxwell Muir, architect, 1909. [Preliminary Version]

The building was designed by local architect Alexander Maxwell Muir (1860-1922). Muir's original 1909 scheme shows a far more elaborate façade than was actually built.

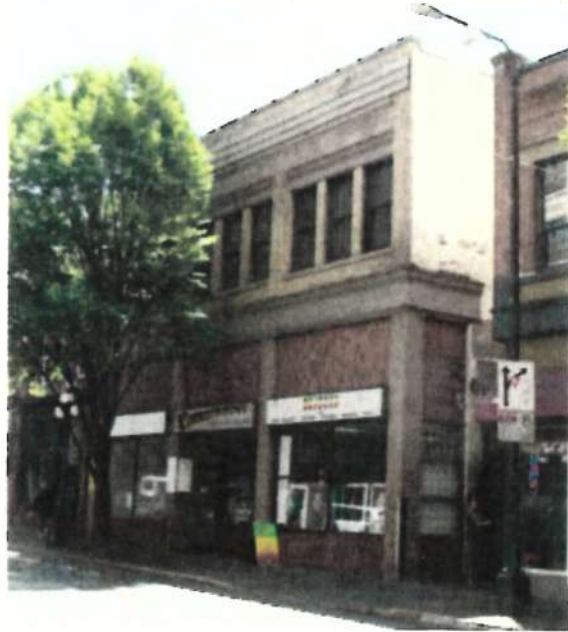
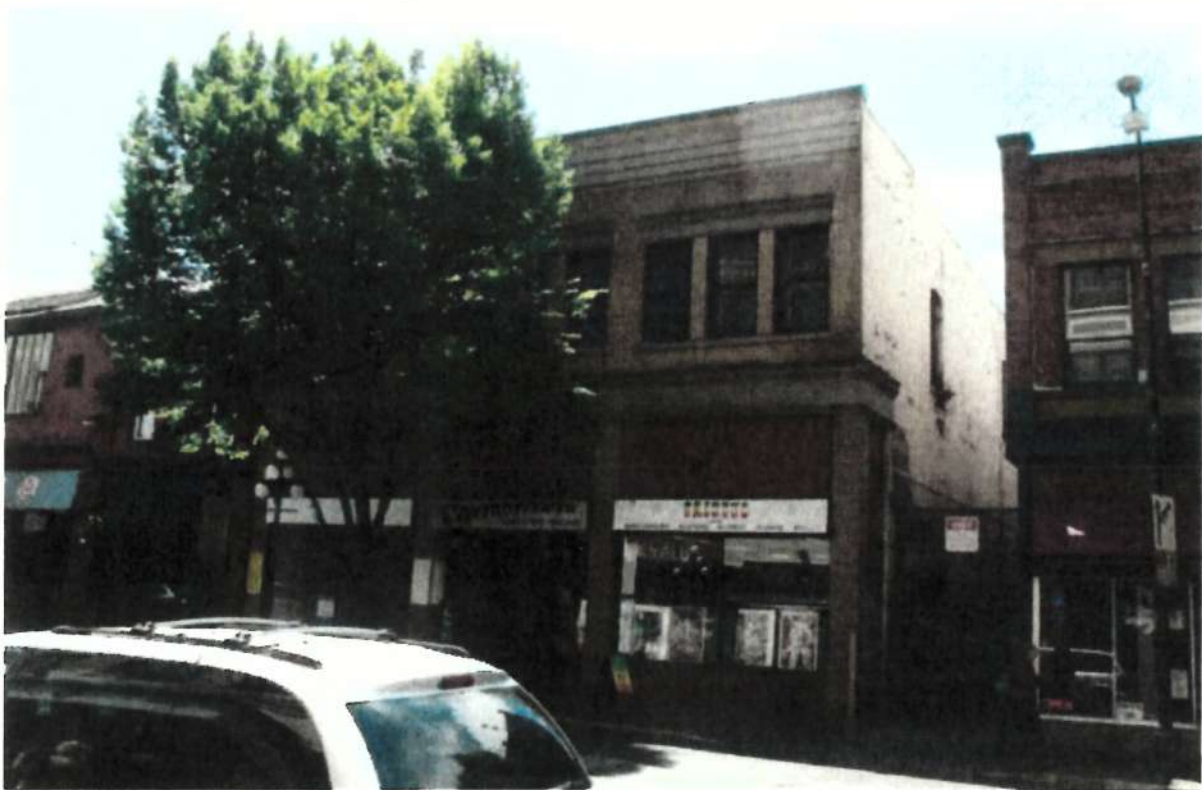
Top (right) and bottom: Photos showing partial front and side (laneway) elevations, as viewed from Johnson Street.

Along the historic front facade, the tan bricks appear to be in fair condition, with signs of weathering caused by water ingress and moisture saturation, as evidenced by efflorescence, staining and discolouration, organic growth, and brick spalling. Other notable signs of deterioration include stepped cracking and mortar loss in localized areas.

Similar deteriorating conditions were noted along the side elevation to the west, in addition to peeling of paint. Further assessment is required to determine the feasibility of removing the existing paint finish, which may include abatement of hazardous materials, without causing significant damage to the brick face underneath.

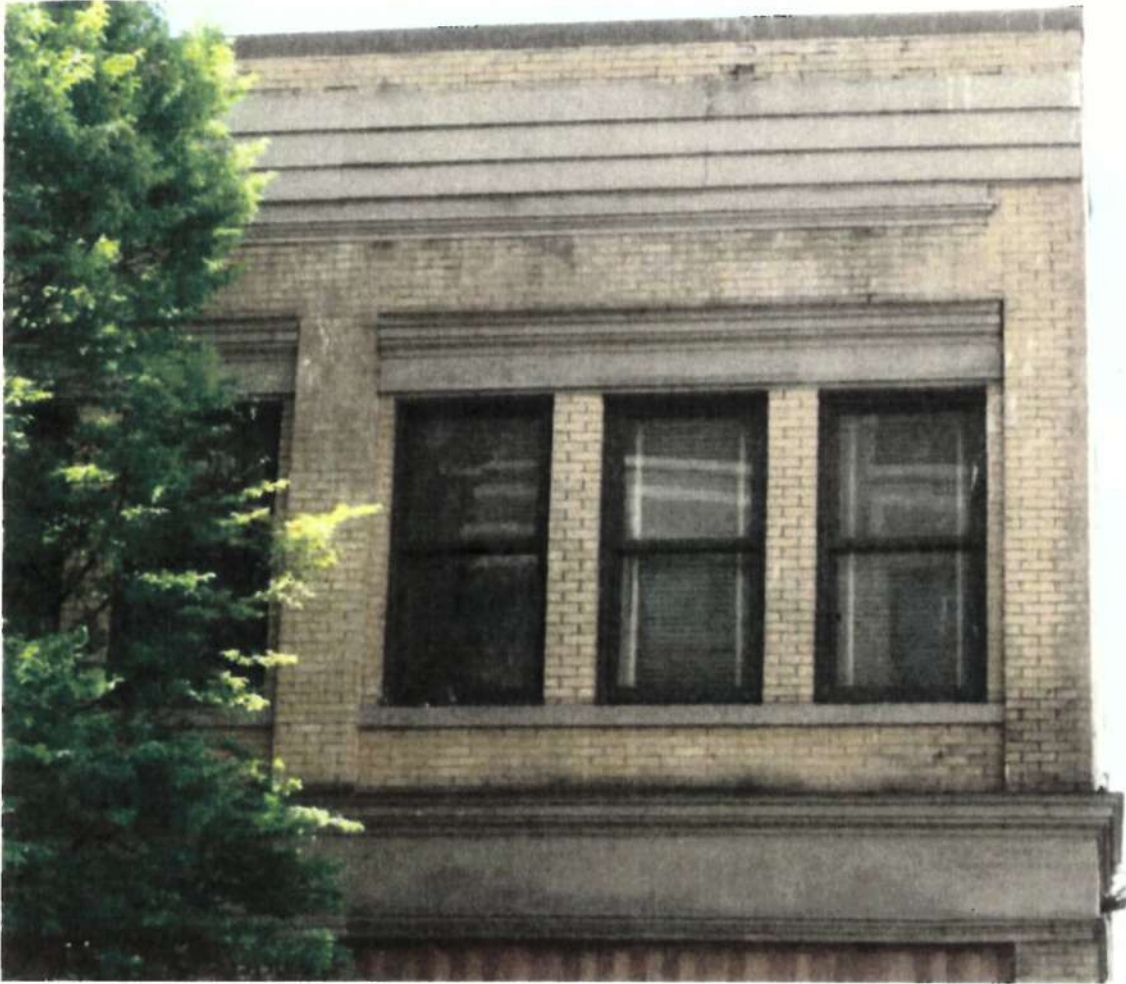
Photo showing partial exterior masonry wall above the storefront. Note typical deterioration of masonry wall.

- Preserve the brick whenever possible, and replace in kind brickwork that is too deteriorated for safe use.
- Undertake complete condition survey of condition of all brick surfaces.

- Repoint the brickwork by raking out loose mortar material to a uniform depth. Take care that the rises of the brick are not damaged. Work should only be undertaken by skilled masons. Do not use power tools to cut or grind joints; hand-held grinders may be used for the initial raking of horizontal joints after test samples have been undertaken and only if approved by the Heritage Consultant. Repoint mortar joints with new mortar that matches existing in consistency, composition, strength, colour and pointing profile; note the finely tooled profile of the original mortar joints.

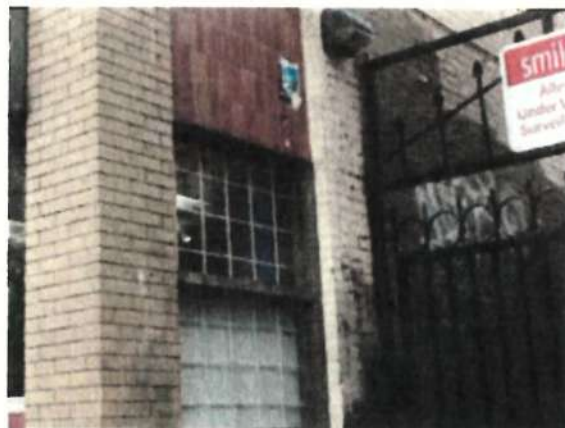
Photo showing storefront return, and partial masonry wall along the laneway elevation to the east; note tilework at the storefront transom that are not original and should be removed.

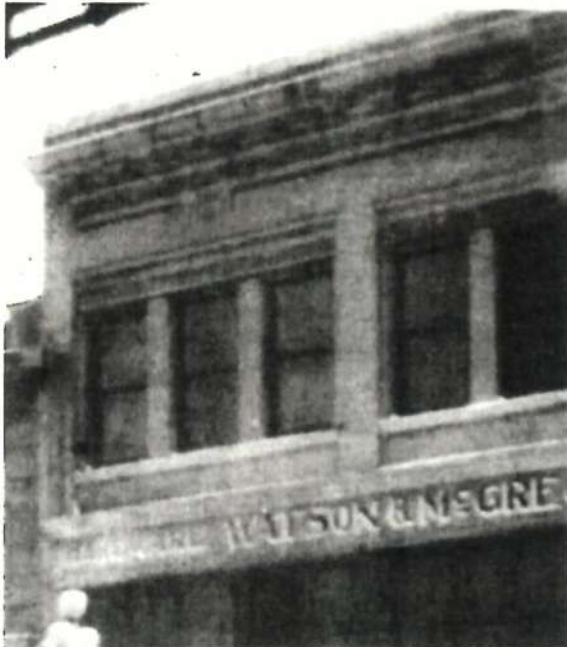
Detail photo showing project metal cornice at parapet level, and the storefront cornice with signband at the lower street facade, circa 1913 [Collection Nancy Davis; Hallmark Society Files]

The Watson & McGregor Building originally featured a large, projecting metal cornice along the parapet level of the historic front facade, with partial return along the laneway elevation to the west. The original parapet cornice is no longer extant, and has been subsequently replaced with overlapping horizontal bands of unsympathetic flat, metal flashing that does not contribute to the historic character of the building.

The lower street facade features a modest storefront cornice with a continuous signband, similarly including a partial return along the laneway elevation to the west. All efforts should be made to restore the missing cornices and storefront signband based on archival photos.

- Remove unsympathetic cornice replacements, and restore missing metal cornices with historically appropriate profile based on archival photos, as possible.

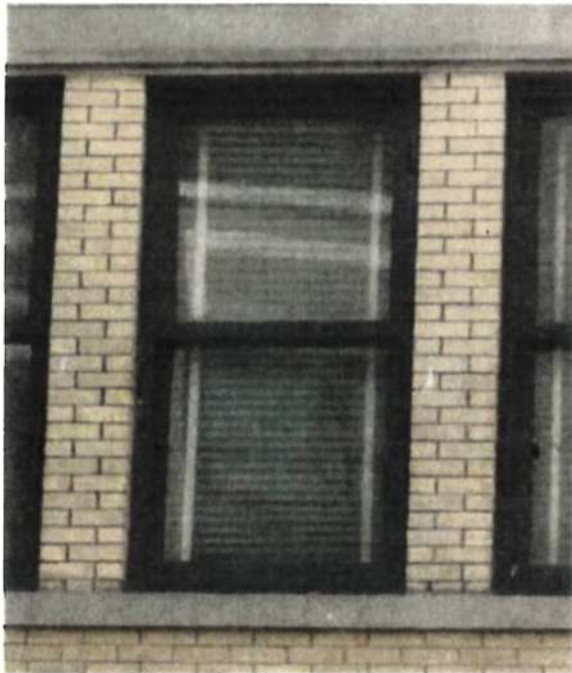
Typical existing condition of double-hung wood sash window at upper level.

Based on the initial visual review from the ground level, the existing wood windows appear to be intact and in good to fair condition that show varying degrees of deterioration. Further review and assessment are required to confirm the existing condition of each assemblies, and to determine the appropriate extent of conservation work required.

- Inspect for condition and complete detailed inventory to determine extent of recommended repair or replacement.
- Retain existing window sashes; repair as required; install replacement matching sashes where missing or beyond repair.
- Preserve and repair as required, using in kind repair techniques where feasible.
- Overhaul, tighten/reinforce joints. Repair frame, trim and counterbalances.
- Each window should be made weather tight by re-puttying and weather-stripping as necessary.
- Retain historic glass, where possible. Where broken glass exists in historic wood-sash windows, the broken glass should be replaced.

When removing broken glass, the exterior putty should be carefully chipped off with a chisel and the glazier's points should be removed. The wood where the new glass will be rested on should be scraped and cleaned well, and given a coat of linseed oil to prevent the wood from absorbing the oil from the new putty. The new glass should be cut 1/16-1/8th smaller than the opening to allow for expansion and irregularities in the opening, to ensure the glazing does not crack due to natural forces. Window repairs should be undertaken by a contractor skilled in heritage restoration.

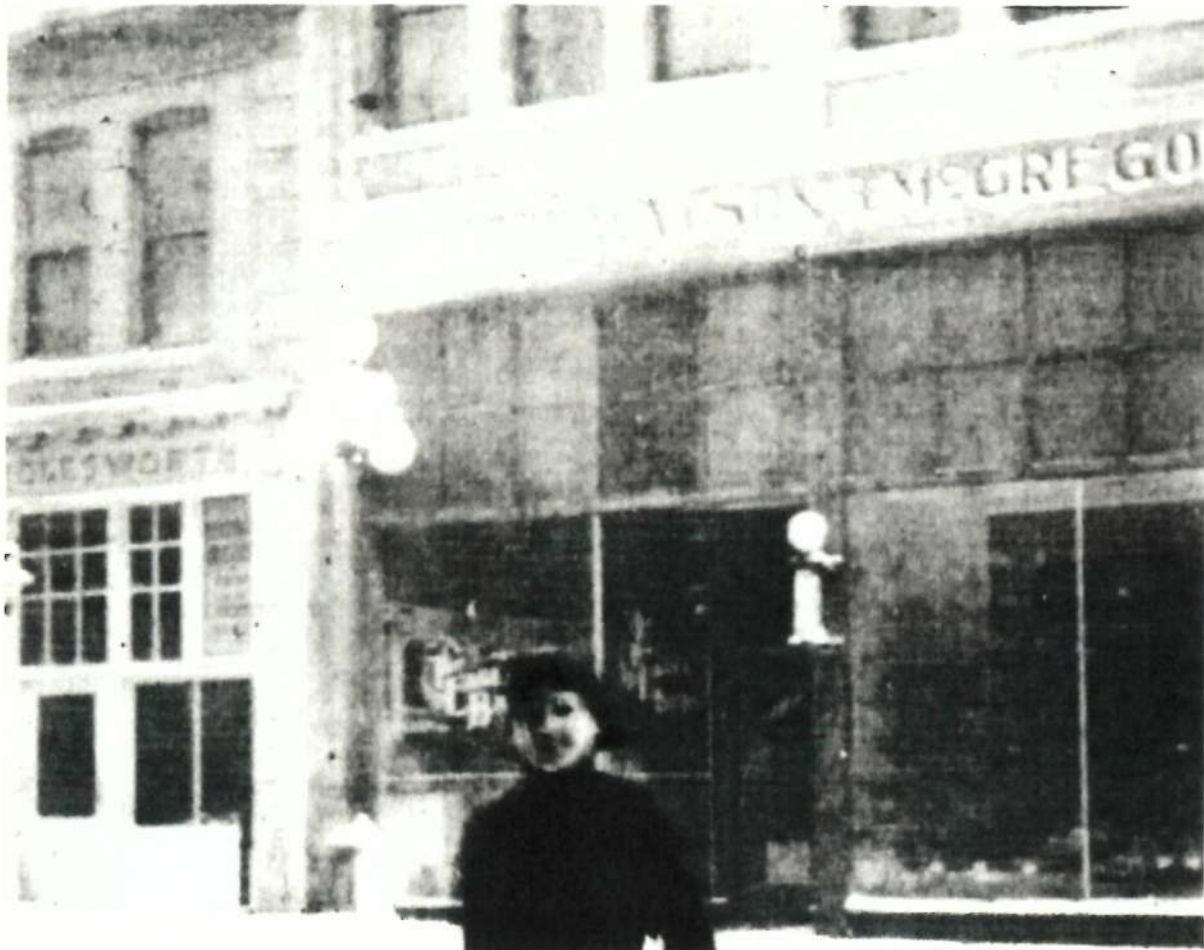
Detail photo showing original storefront configuration, circa 1913. [Collection Nancy Davis; Hallmark Society Files]

- Reinstall a rehabilitated wooden storefront system. Reference the historic design as noted in archival images and original architectural drawings. The design of the rehabilitated storefronts should resemble the original historic precedents.
- Integrate commercial signs and new lighting systems as required.
- Provide new accessible entryways for the ground floor, as required.
