825 FORT STREET, VICTORIA, BC

## CONSERVATION PLAN

DECEMBER 2017

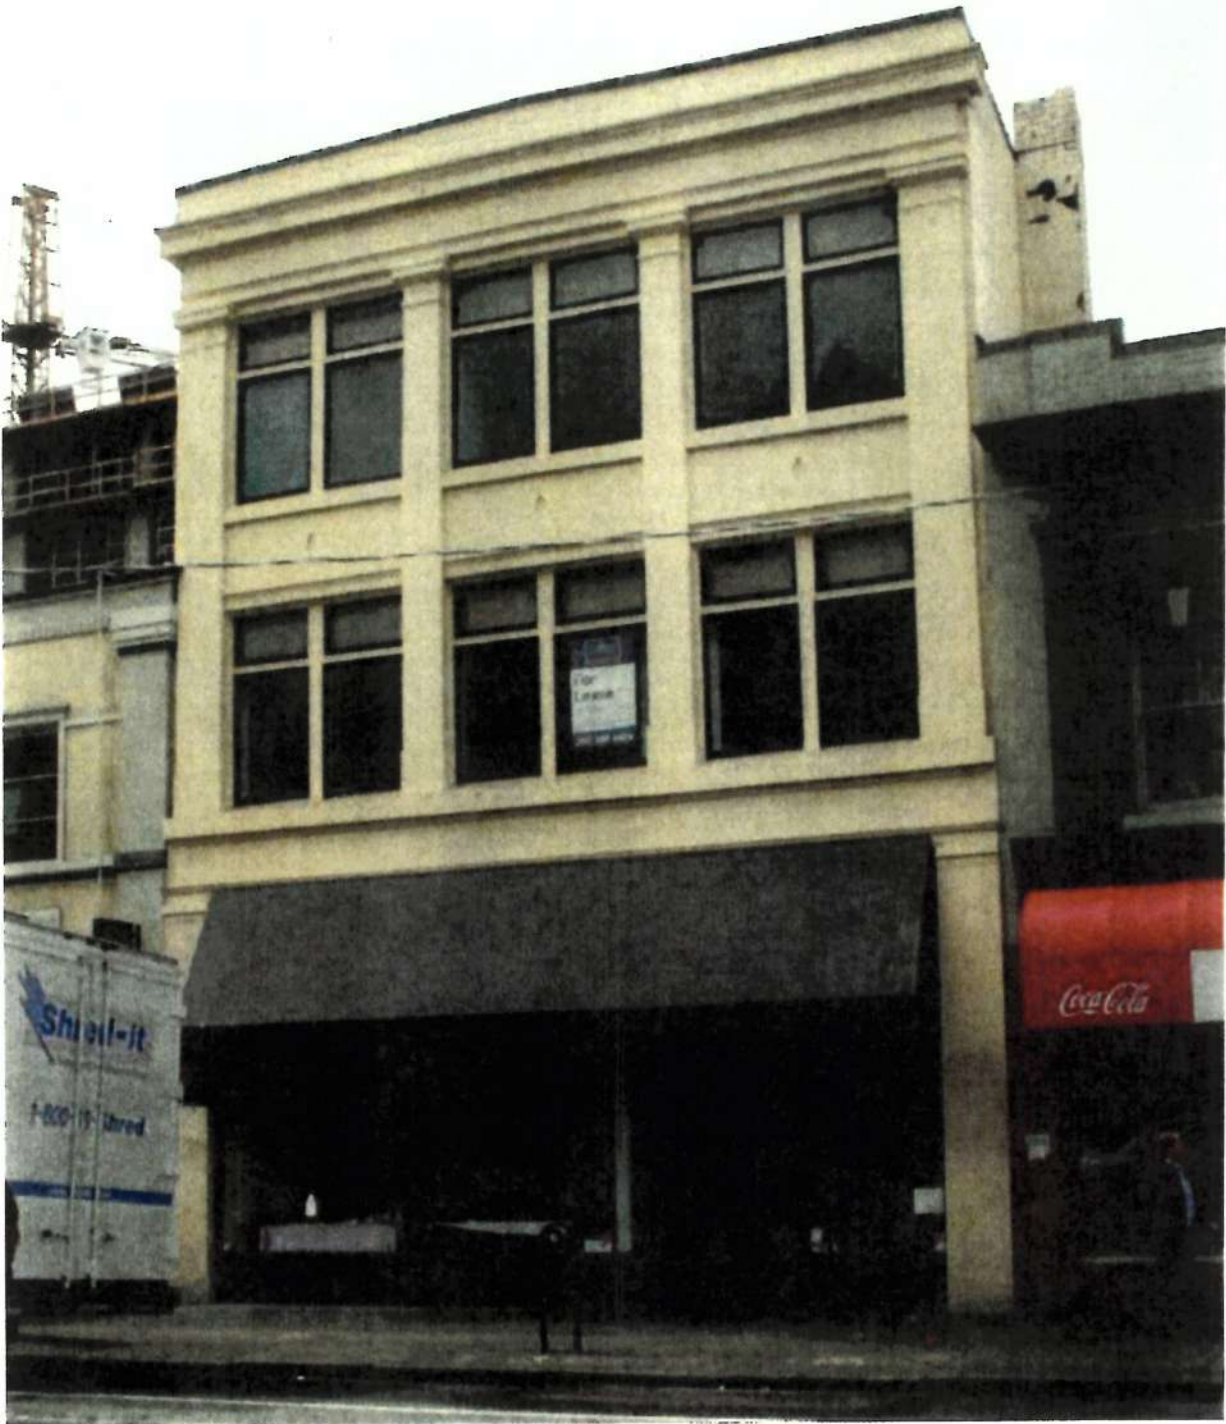
*Historic front facade of B.C. Hardware Company Building, addressed at 825 Fort Street. 2017*

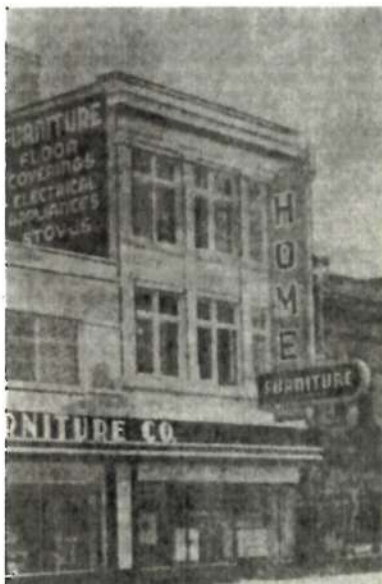
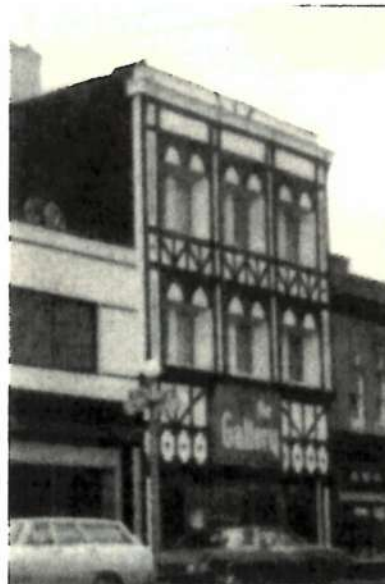
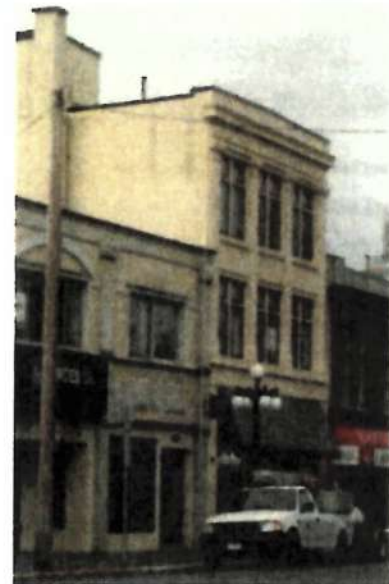
The overall façade has been parged, and additional paint has been applied over time, resulting to the removal of the striking pattern and finish colours that defined key features at the bottom and top of each floor, as found in archival images. At grade, the columns appear to be intact; however, the capitals have been removed and replaced with a

paired back profile. The original storefront has been replaced subsequently, and the original decorative panels on the bulkhead are no longer intact.

Detail photos showing the historic front facade in 1940s (left), 1960s (middle), and its existing condition in 2017 (right).

- Preserve the overall form, scale and massing of the front facade. Please refer to the historical reference materials for more detail.
- The storefront may be rehabilitated in a manner is sympathetic to the historic appearance of the building, based on archival images.

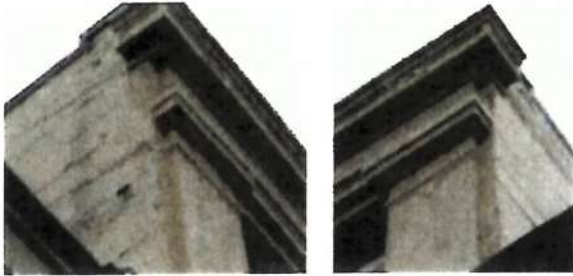
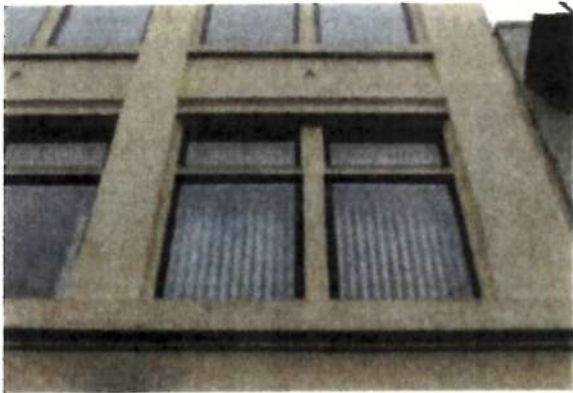
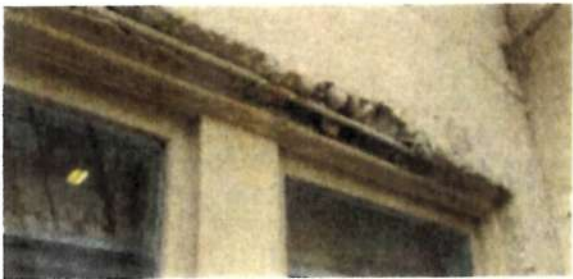
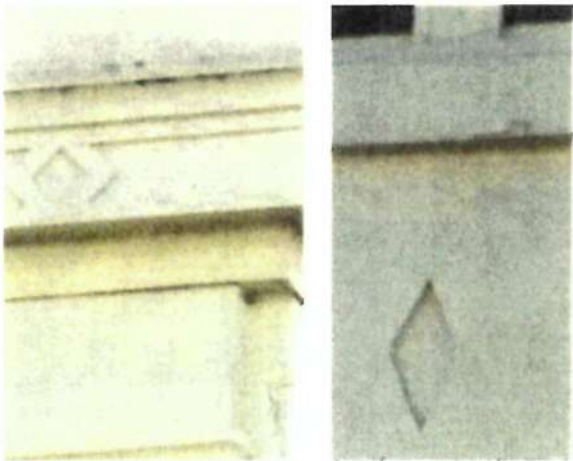
*Photos showing typical deterioration of the exterior walls.*

The exterior walls of B.C. Hardware Company Building feature cast-in-place concrete elements, with the exception of the multiple-wythe brick parapet wall with cement coping at the historic front facade. In general, the exterior walls appear to be in good condition, with notable signs of weathering and deterioration in localized areas, as evident by minor discolouration, organic buildup, bird deposits, unsympathetic patchwork, material loss, and some missing components, particularly on the storefront level. Further investigation is required to determine if any original elements are intact underneath the later parging, in addition to identifying other later unsympathetic interventions that should be replaced with historically appropriate detailing.

- Preserve the front (north) facade, and repair in-kind as required.
- Undertake complete condition survey of condition of all exterior surfaces.
- The exterior may require cleaning. Cleaning should be done in the gentlest means possible, ideally with low-pressure water and scrub brushes. Harsh chemical cleaners or any abrasive cleaning methods should be avoided to ensure the exterior walls are not damaged.

- All redundant metal inserts and services mounted on the exterior should be removed or reconfigured.
- Small hairline cracks are often not a serious concern, and should be remediated by sacking, as required. All repair work should be finished with a coat of paint, consistent with the paint schedule devised by the Heritage Consultant.

- Caulking compounds should not be used for patching hairline cracks, and are an unsuitable repair method. The physical and aesthetic characteristics of caulking compounds are incompatible with concrete, and will weather differently and attract more dirt.

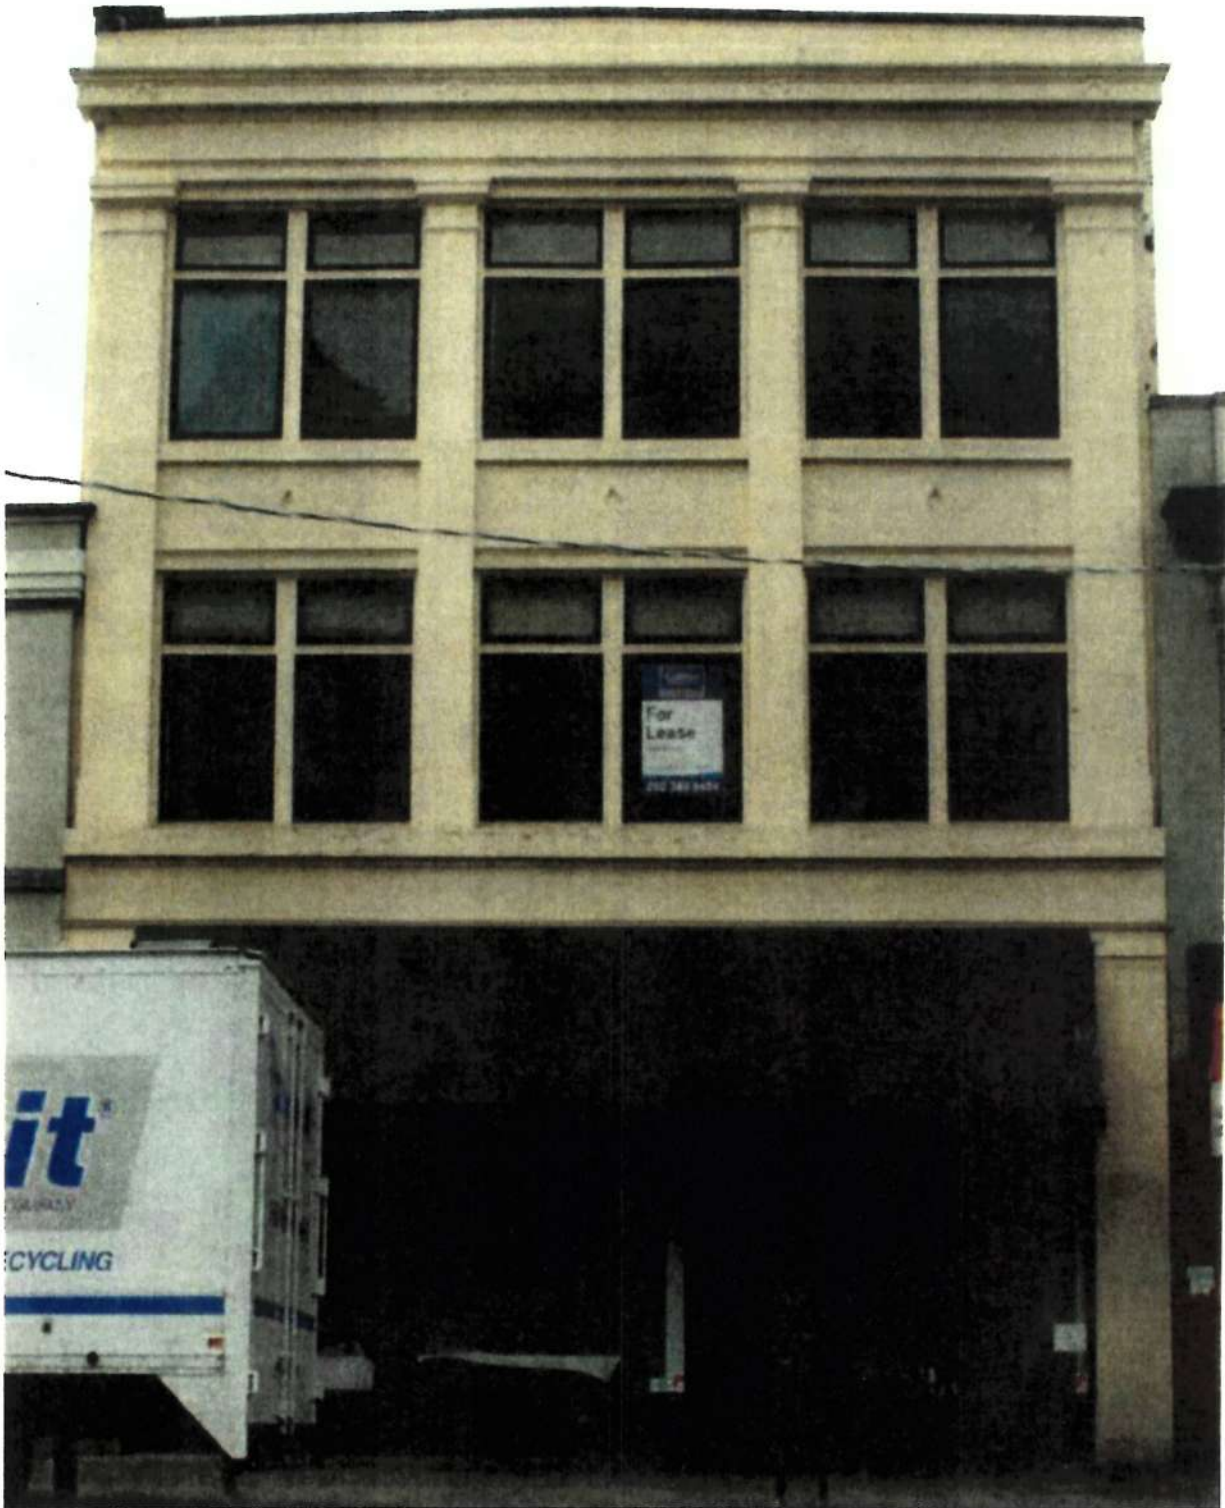
*Existing condition of the historic front facade (north elevation) along Fort Street.*
