# TURKISH BATH HOUSE

819-823 FORT STREET, VICTORIA, BC

## CONSERVATION PLAN

MARCH 2018

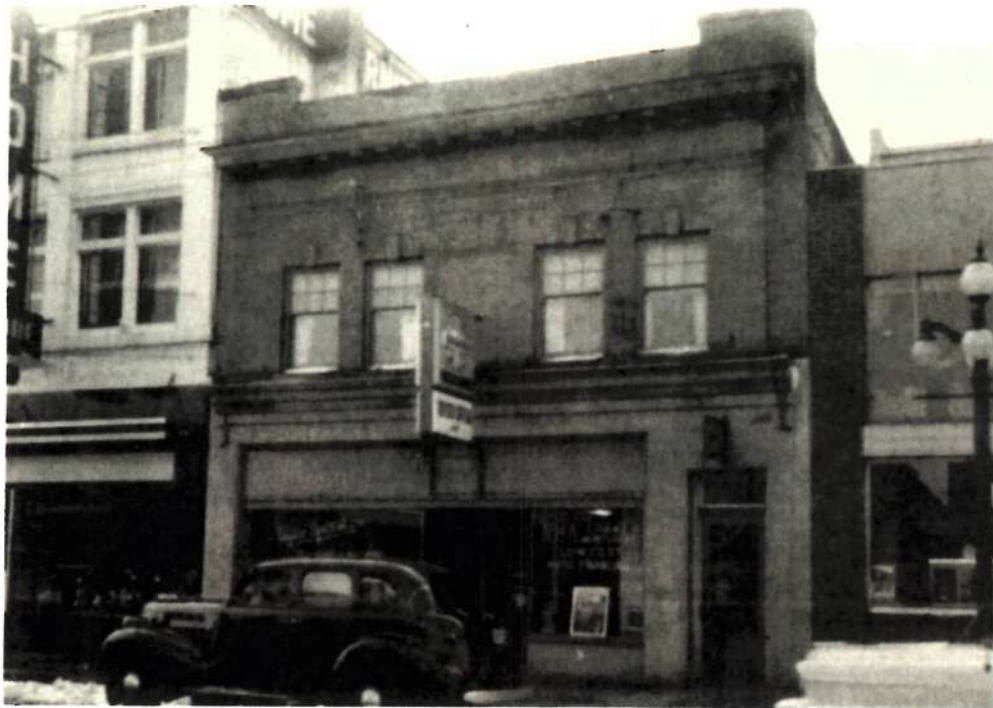
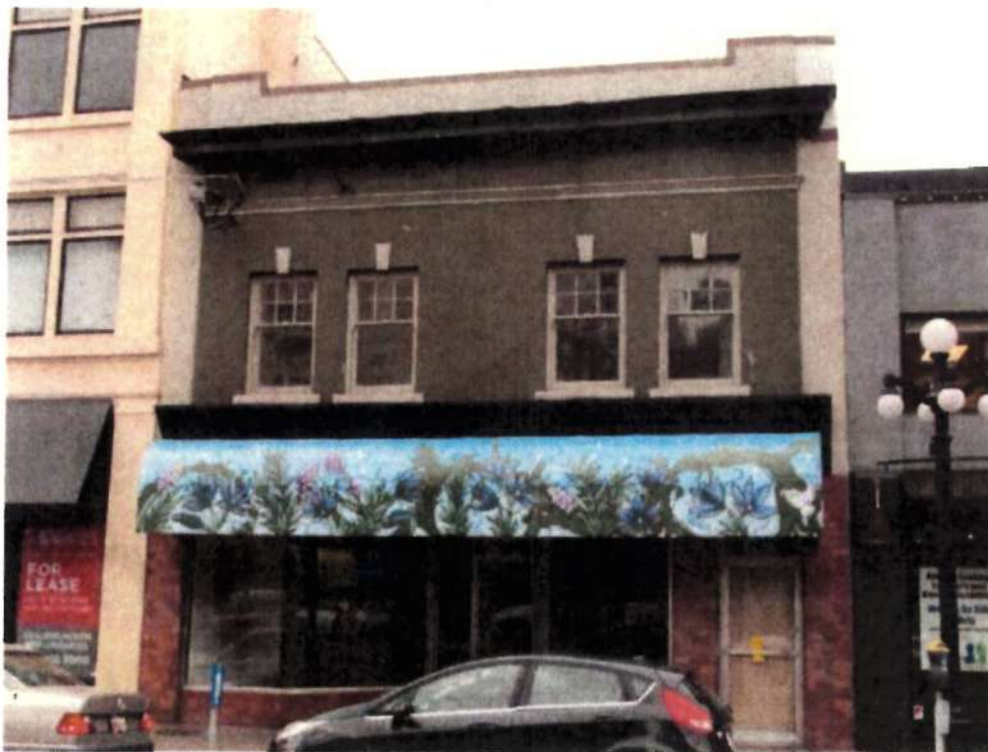
Top: Historic building at 819-823 Fort Street, 1960, (City of Victoria Archives M03921\_141)  
Bottom: Existing condition of the historic building, 2017

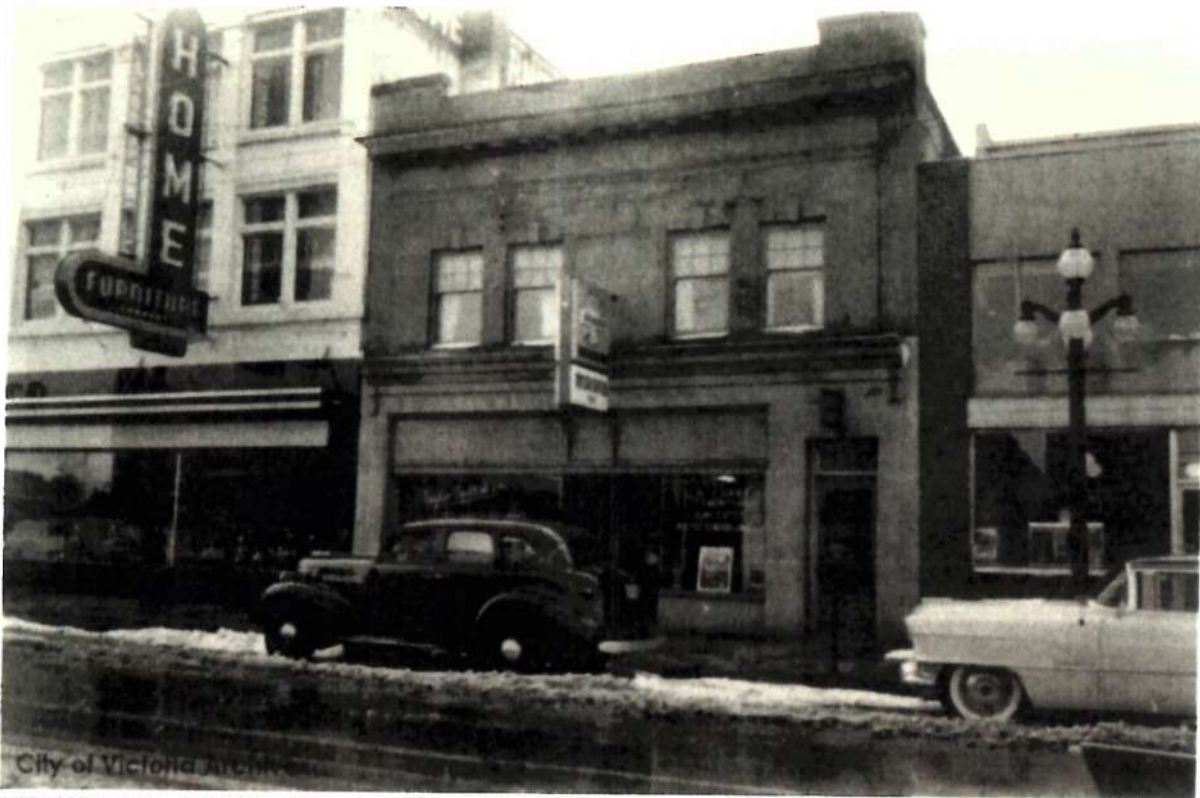
819-823 Fort Street, 1960, [City of Victoria Archives M03921\_141]

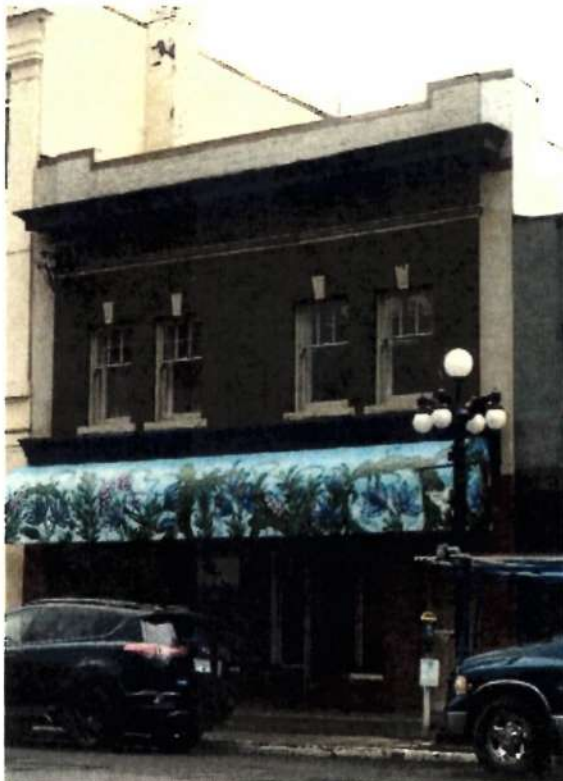
*Front (north) elevation, 2017*

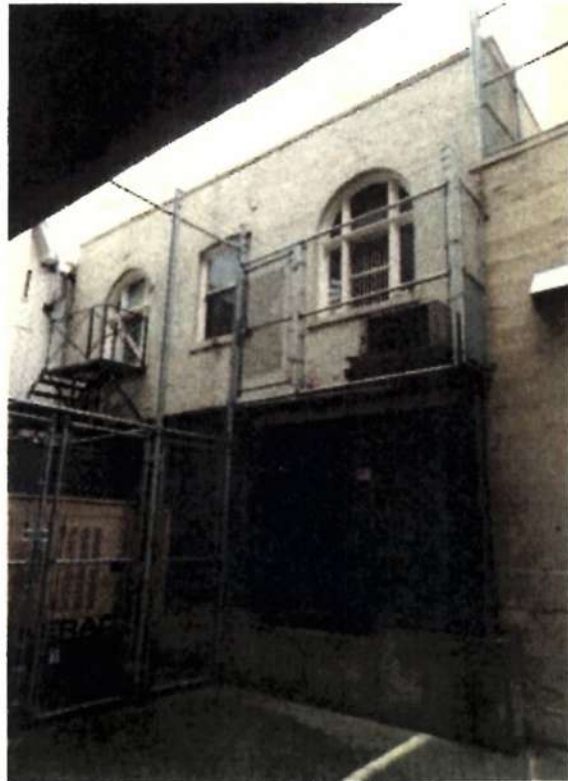
*Rear (south) elevation, 2018*

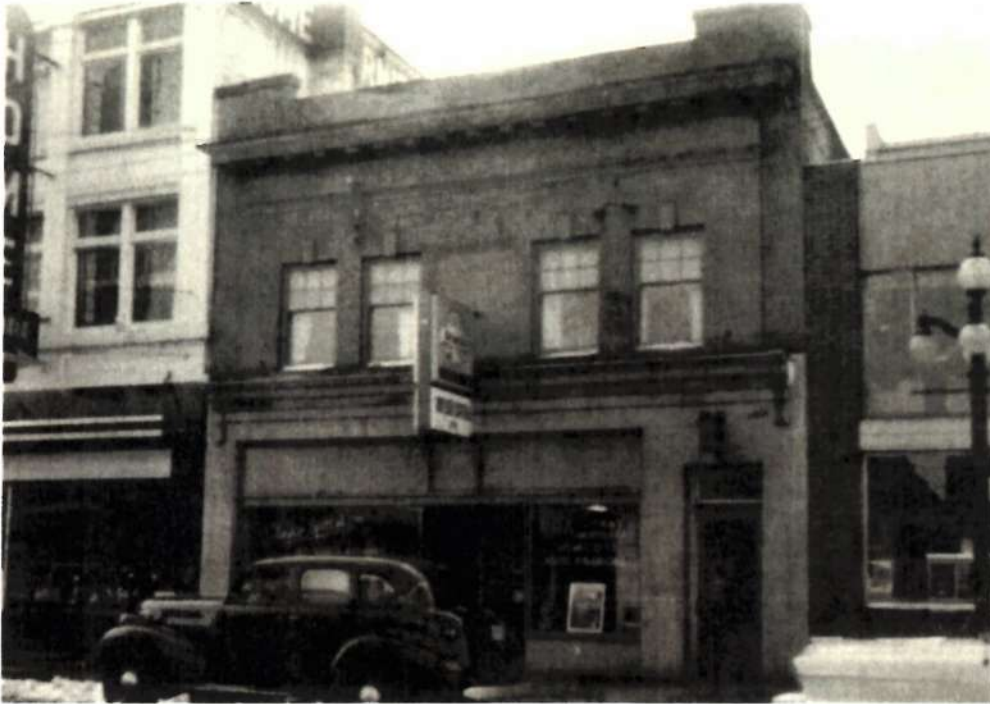
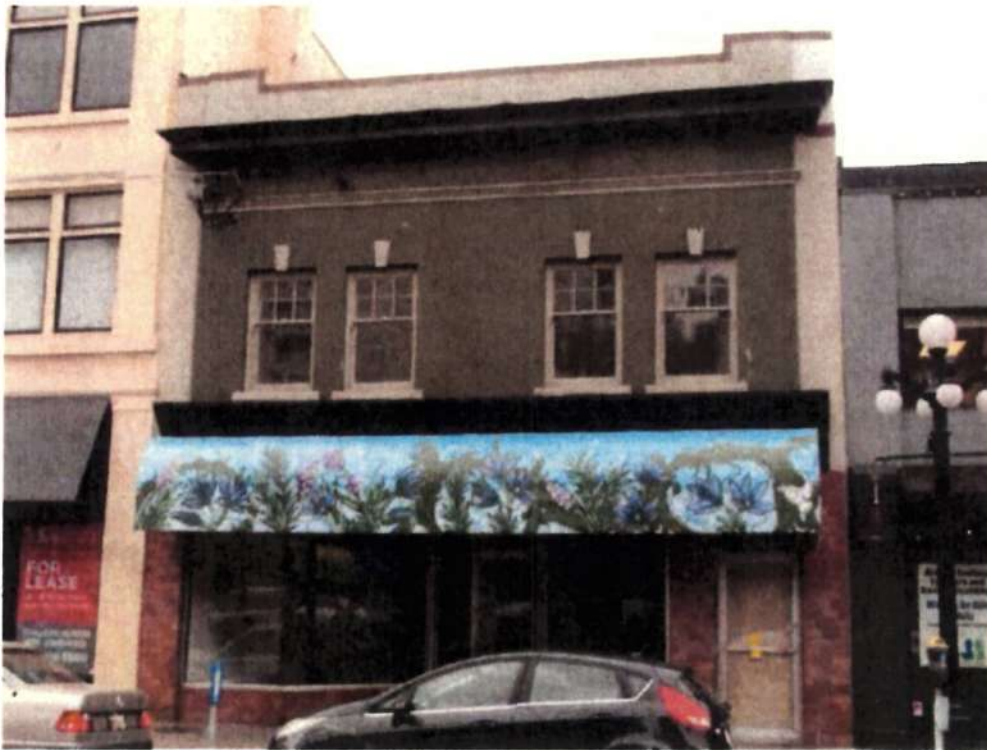
Top: Historic building at 819-823 Fort Street, 1960, (City of Victoria Archives M03921\_141)  
Bottom: Existing condition of the historic building, 2017

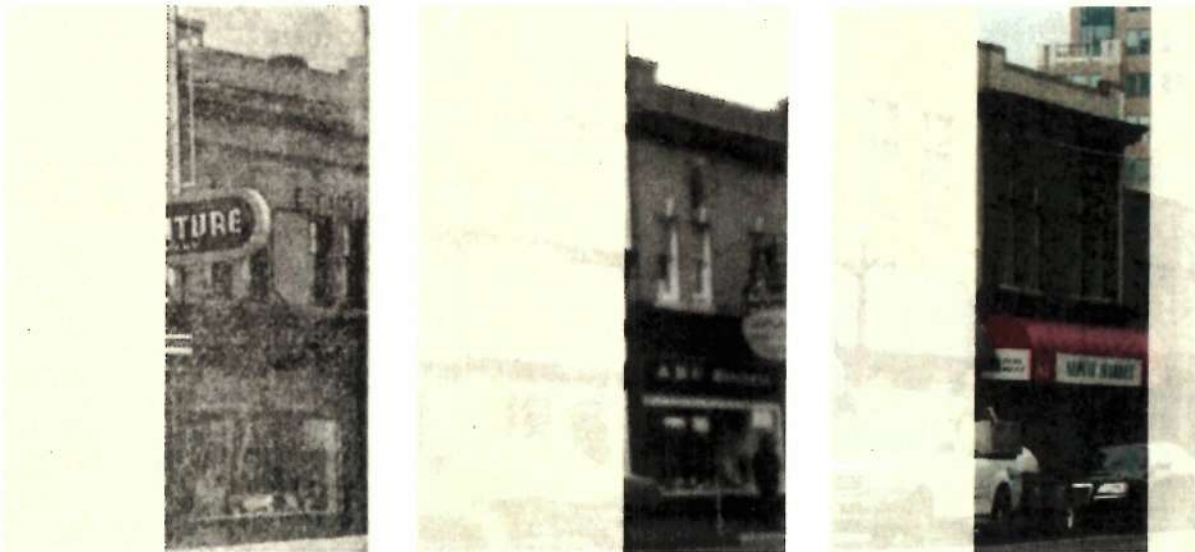
The original one-storey brick masonry building was constructed in 1908, with the second storey added around 1913 to accommodate new furnished suites on the upper levels. The early addition was delineated from the original structure by using brick masonry units in different colour, and slight projection of the upper wall that is further articulated by a large projecting architectural cornice along the parapet level.

*Detail photos showing the historic front facade in 1940s (left), 1960s (middle), and its existing condition in 2017 (right).*

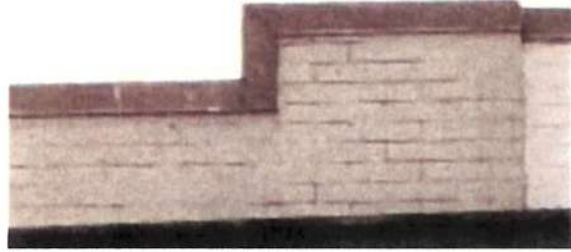
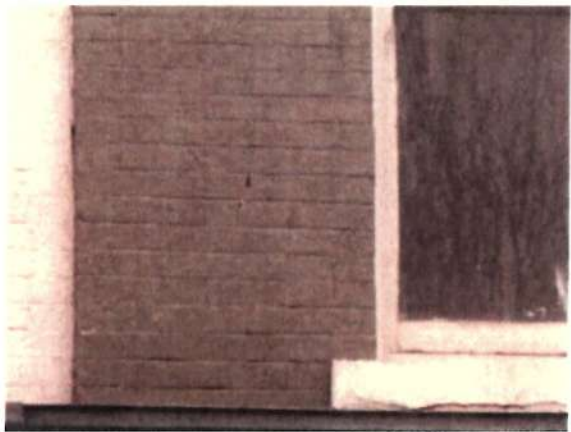
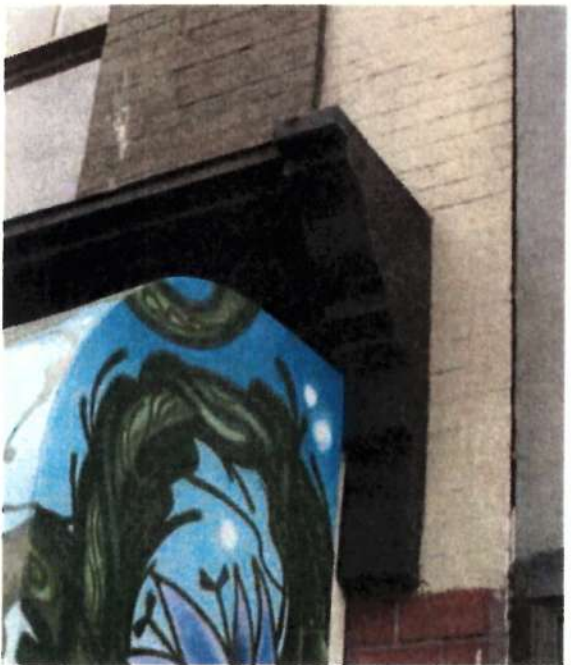
In general, the historic front facade appears to be in good to fair condition, with visible deterioration in localized areas. It is noted that there are a few bricks with repair patches; holes in mortar joints from previous fastenings; redundant metal inserts; discolouration and staining; deteriorated mortar; spalling; and signs of stepped cracking.

*Photos showing typical condition of brickwork on the historic front facade, facing Fort Street.*

- Preserve the masonry elements on the historic front facade of the building, and repair only as necessary. Missing masonry elements should be replaced to match existing.

- Determine whether or not it is feasible to remove the paint and expose the original masonry elements. When working with the existing painted surface, be aware of the risk of existing lead paint, which is a hazardous material. Undertake test samples for paint removal in an inconspicuous area using only approved restoration products. If paint removal is determined to be feasible, prepare removal specification.

- Cleaning, repair, and repointing specifications to be reviewed by Heritage Consultant.
- Repoint masonry only as necessary. If required, repoint the brickwork by raking out loose mortar material to a uniform depth. Work should only be undertaken by skilled masons. Do not use power tools to cut or grind joints; hand-held grinders may be used for the initial raking of horizontal joints after test samples

- Any holes in the brick should be filled or replaced to match existing. Use restoration mortar that matches the brick colour to prevent moisture ingress.
- All redundant metal inserts and services mounted on the exterior walls should be removed or reconfigured.
- Overall cleaning and paint removal of the masonry elements on the exterior front facade should be carried out as feasible/required. Do not use any abrasive methods that may damage the fireskin surfaces. Use a soft natural bristle brush and mild water rinse. Only approved chemical restoration cleaners may be used. Sandblasting or any other abrasive cleaning method of any kind is not permitted.
- Retain sound exterior masonry or deteriorated exterior masonry that can be repaired.
- Seismic reinforcement will be coordinated with structural.

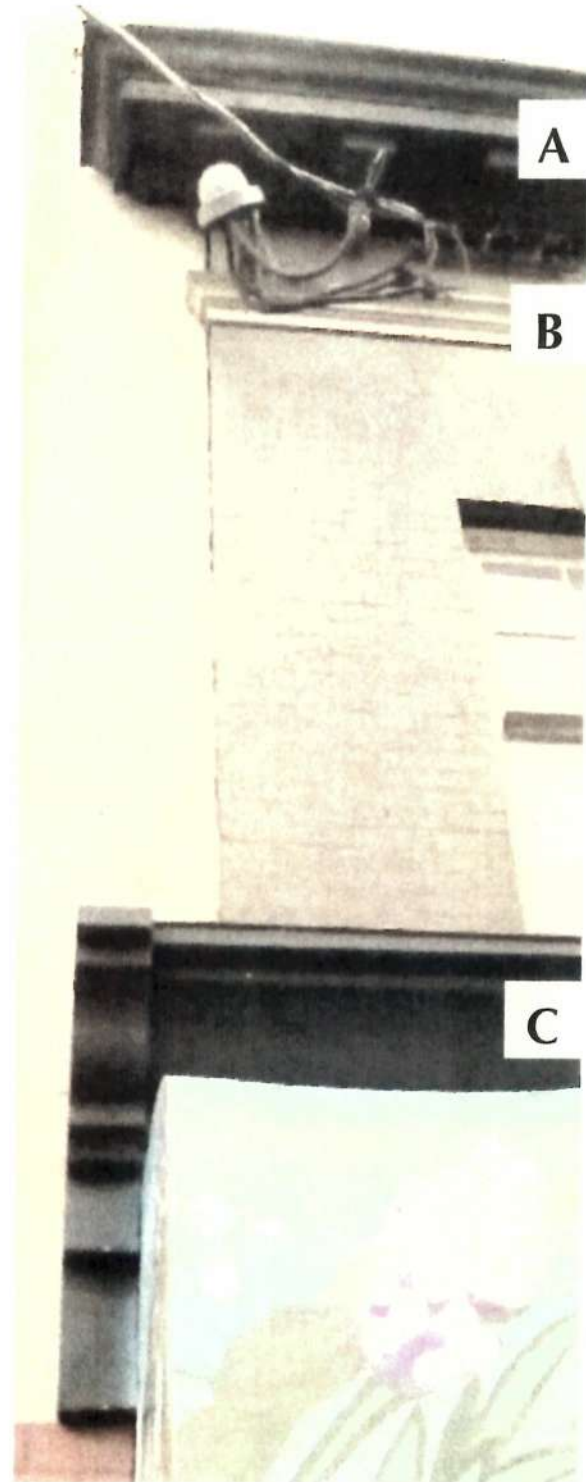
The historic front facade of the Turkish Bath House is characterized by architectural metalworks that include: a large, projecting cornice, with dentils along the parapet level (A); a midline crown metal profile at the upper level (B); and a storefront cornice with brackets on both ends (C). The keystone on each of the window lintels also appear to be pressed metal, but further investigation is required to confirm its materiality.

Further investigation is required to confirm if all intact architectural metalworks are original, as the existing elements appear to be consistent with the historic character of the building, based on existing archival photographs. In general, they appear to be in good condition, and should be preserved, and repaired in-kind only as required.

*Existing architectural metalworks.*

- Evaluate the overall condition of all existing architectural metalworks to determine whether more than protection, maintenance and limited repair or replacement in-kind is necessary.
- The current attachment of the architectural metalworks should be inspected, and should be re-anchored appropriately, if required.
- Repair and stabilize deteriorated architectural elements by structural reinforcement or correction of unsafe conditions, as required, until any additional work is undertaken. Repairs should be physically and visually compatible.

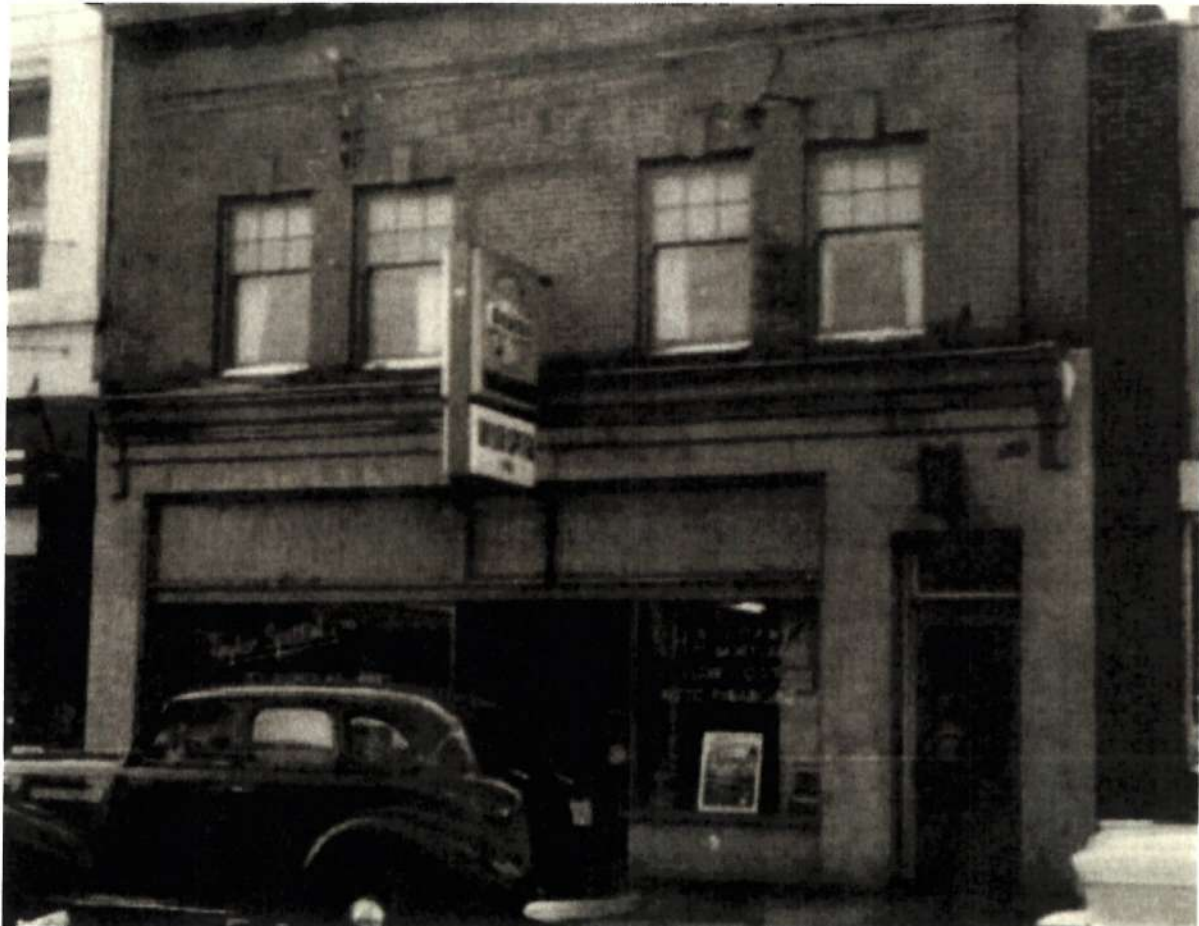
Detail photo showing original storefront at ground level, and double-hung wood windows at upper level.  
(City of Victoria Archives M03921\_141)

The current storefront of the Turkish Bath House has been rehabilitated in an unsympathetic manner at some point in time, including, but not limited to, the following: installation of inappropriate storefront canopy; installation of veneer/faux brick, in orange tone, at storefront level; and the replacement of original wood storefront assembly, including the removal of the leaded transom in true-divided lights.

- Remove later added brick veneer on first floor front facade to reveal materials and condition of underlying original historic materials. Depending on condition of exposed materials, rehabilitate and/or restore to reflect original design and configuration of storefront.
- Rehabilitate the storefront windows, recessed entry, transom windows, and upper floor entry on front facade using archival documents for the overall design and configuration.
- Integrate new commercial signs and lighting systems as required.
- Prime and repaint elements as required in appropriate colour, based on colour schedule devised by Heritage Consultant.

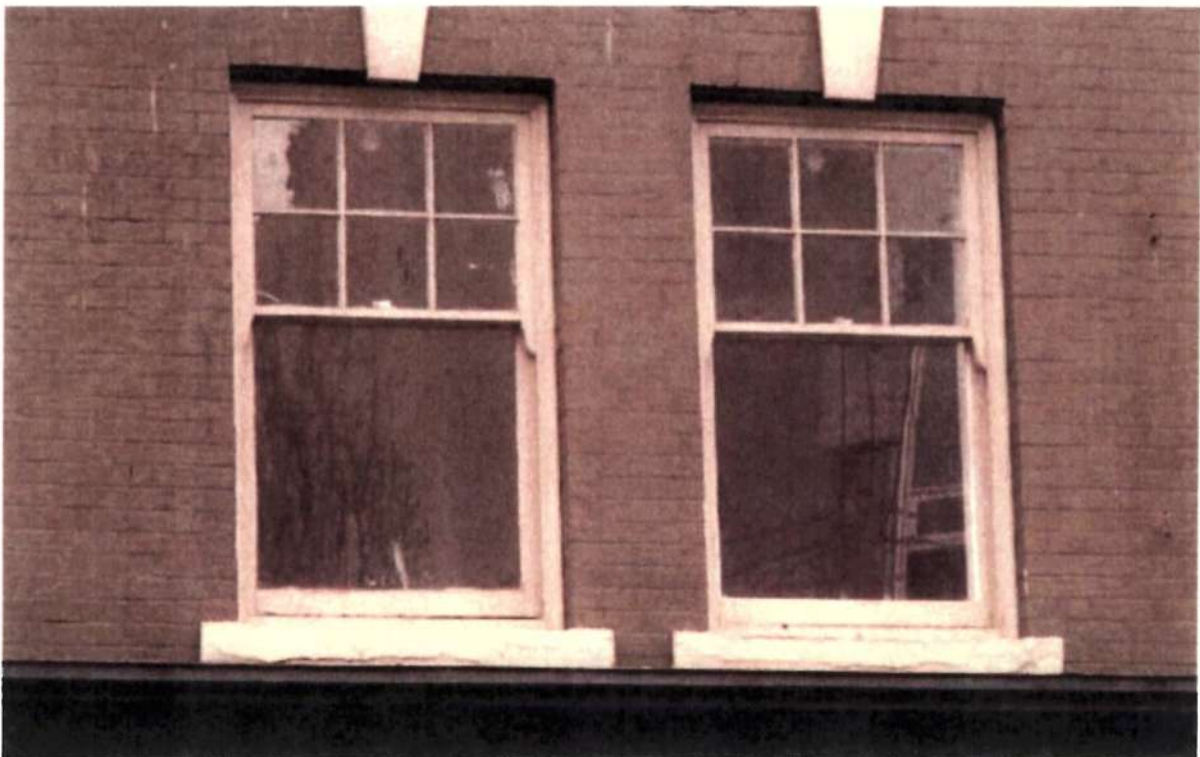
*Two of the four surviving original double-hung wood sash windows at the upper level of the historic front facade. Note multi-pane upper sashes in true divided lights, with true integral sash horns.*

hung wood window assemblies, including upper sashes with true integral sash horns and multi-panes in true divided lights. Initial visual review from the exterior ground level indicate that they are in good condition, with signs of natural weathering and deterioration.

The original wood window assemblies of the Turkish Bath House contribute to the historic character of the building, and should be preserved in place, and repaired in-kind only as necessary. Further assessment is required to confirm their condition, and to determine the extent of repair that is required for each assembly.

- Inspect for condition and complete detailed inventory to determine extent of recommended rehabilitation for windows on the front facade of the building. Shop drawings to be reviewed by Heritage Consultant.
- Preserve and repair as required, using in-kind repair techniques where feasible.
- Overhaul, tighten/reinforce joints. Repair frame, trim and counterbalances.
- Each window should be made weather tight by re-puttying and weather-stripping as necessary.
- Retain historic glass, where possible. Where broken glass exists in historic wood-sash windows, the broken glass should be replaced. When removing broken glass, the exterior putty should be carefully chipped off with a chisel and the glazier's points should be removed. The wood where the new glass will be rested on should be scraped and cleaned

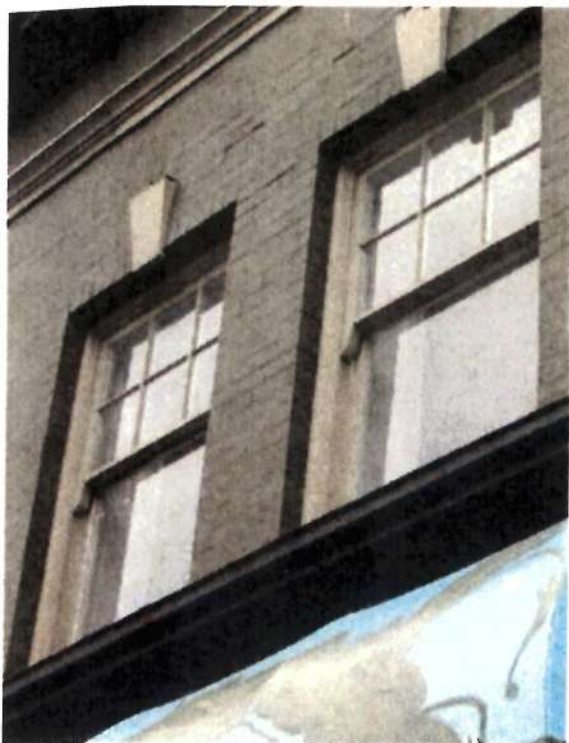
*Detail photo of original double-hung wood sash windows at the upper level of the historic front facade.*

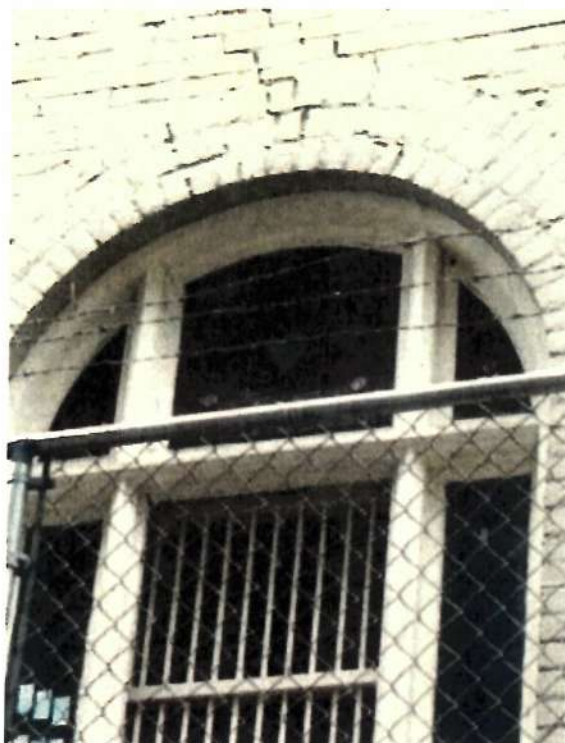
*Detail photo showing tripartite wood window assembly. Note semi-circular arched transom with surviving original multi-pane leaded wood sashes in true divided lights.*

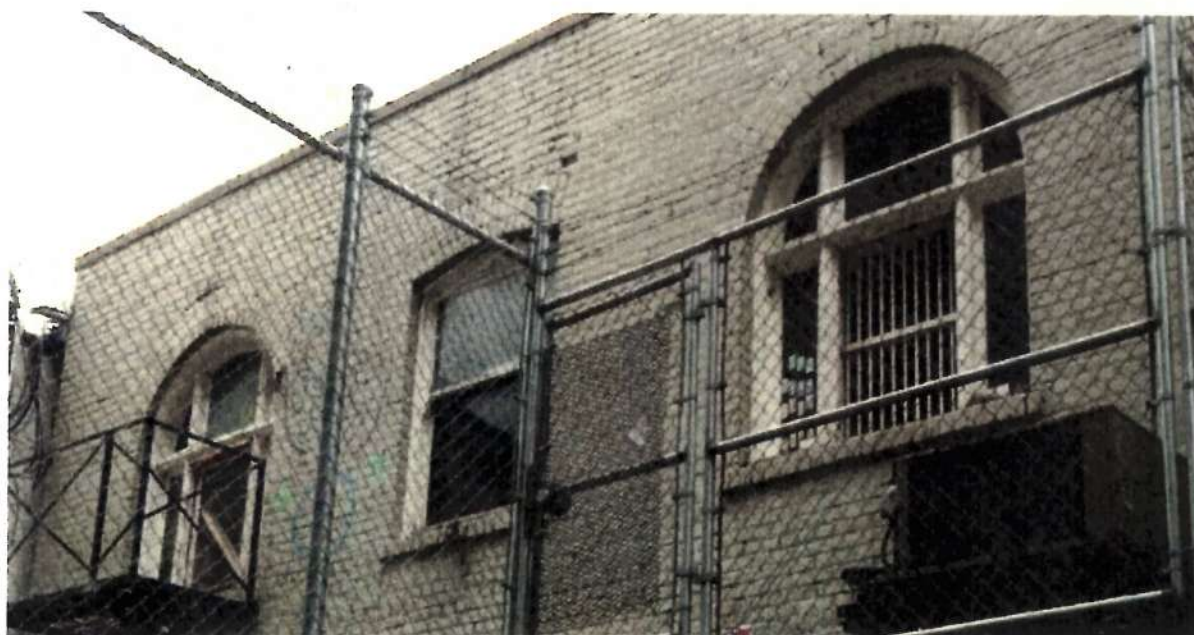
*Upper level of the rear (south) elevation, showing three original window openings.*

- Replacement glass to be single glazing, and visually and physically compatible with existing.
- Prime and repaint as required in appropriate colour, based on colour schedule devised by Heritage Consultant.
- Salvage window frames, sashes, and intact historic glazing of all windows on upper floor of rear facade. Rehabilitate windows as required for their repurposing elsewhere in the building.

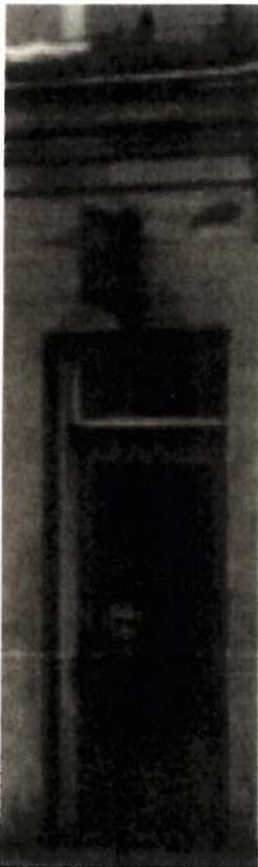
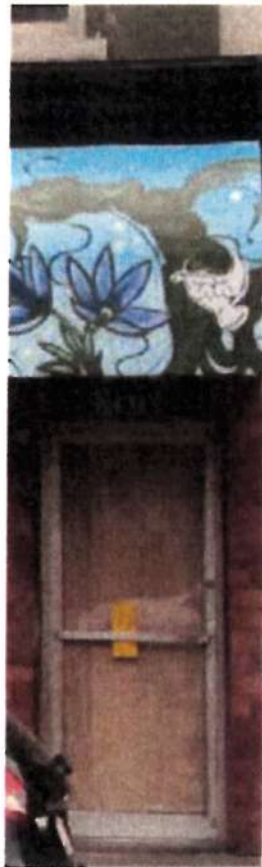
The historic front facade features original door opening, with a later, replacement, narrow-stile aluminum door assembly that does not contribute to the historic character of the Turkish Bath House. The existing, unsympathetic door assembly, which include the transom, should be replaced with a historically appropriate assembly based on archival photograph.

Left: Archival photo showing original side-entry door assembly.  
Right: Existing unsympathetic narrow-stile aluminum door assembly.

- Retain the door openings in their original locations, and rehabilitate to reflect original door assembly based on archival photograph.
- New doors should be visually compatible with the historic character of the building.
