Construction Impact Assessment &

Tree Preservation Plan

Jobsite Property: 931 Redfern St, Victoria

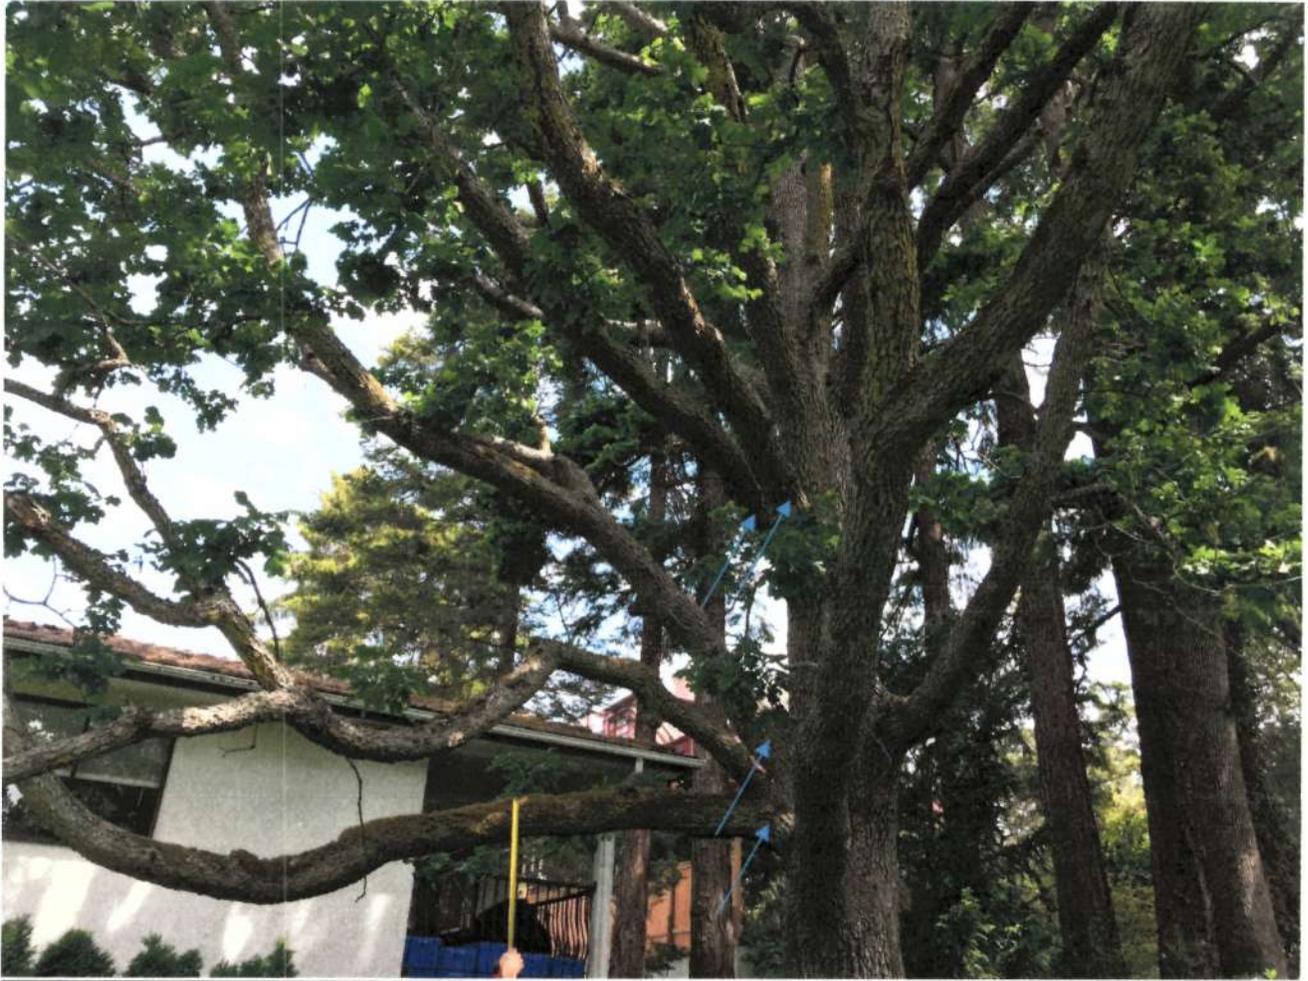
Four large limbs (approximately 25cm, 20cm, 20cm, and 15cm in diameter), in addition to smaller lateral branches will have to be pruned for building clearance (*Image 1*). We recommend pruning the large limbs back to small lateral branches where available to avoid creating pruning wounds near the trunk of the tree, which will minimize the chance of introducing infection into the main stem.

Image 1. Four limbs, approximately 15-25cm in diameter, in addition to smaller branches will have to be pruned for building clearance.

- **Garry Oak #200:** Excavation for construction of the new house may have a significant impact on the health of this tree. If working room be limited to 1m outside the building footprint, excavation will occur approximately 3m from the base of the tree. We anticipate large roots will be encountered at this distance and recommend the retention status of the tree be determined at the time of excavation.

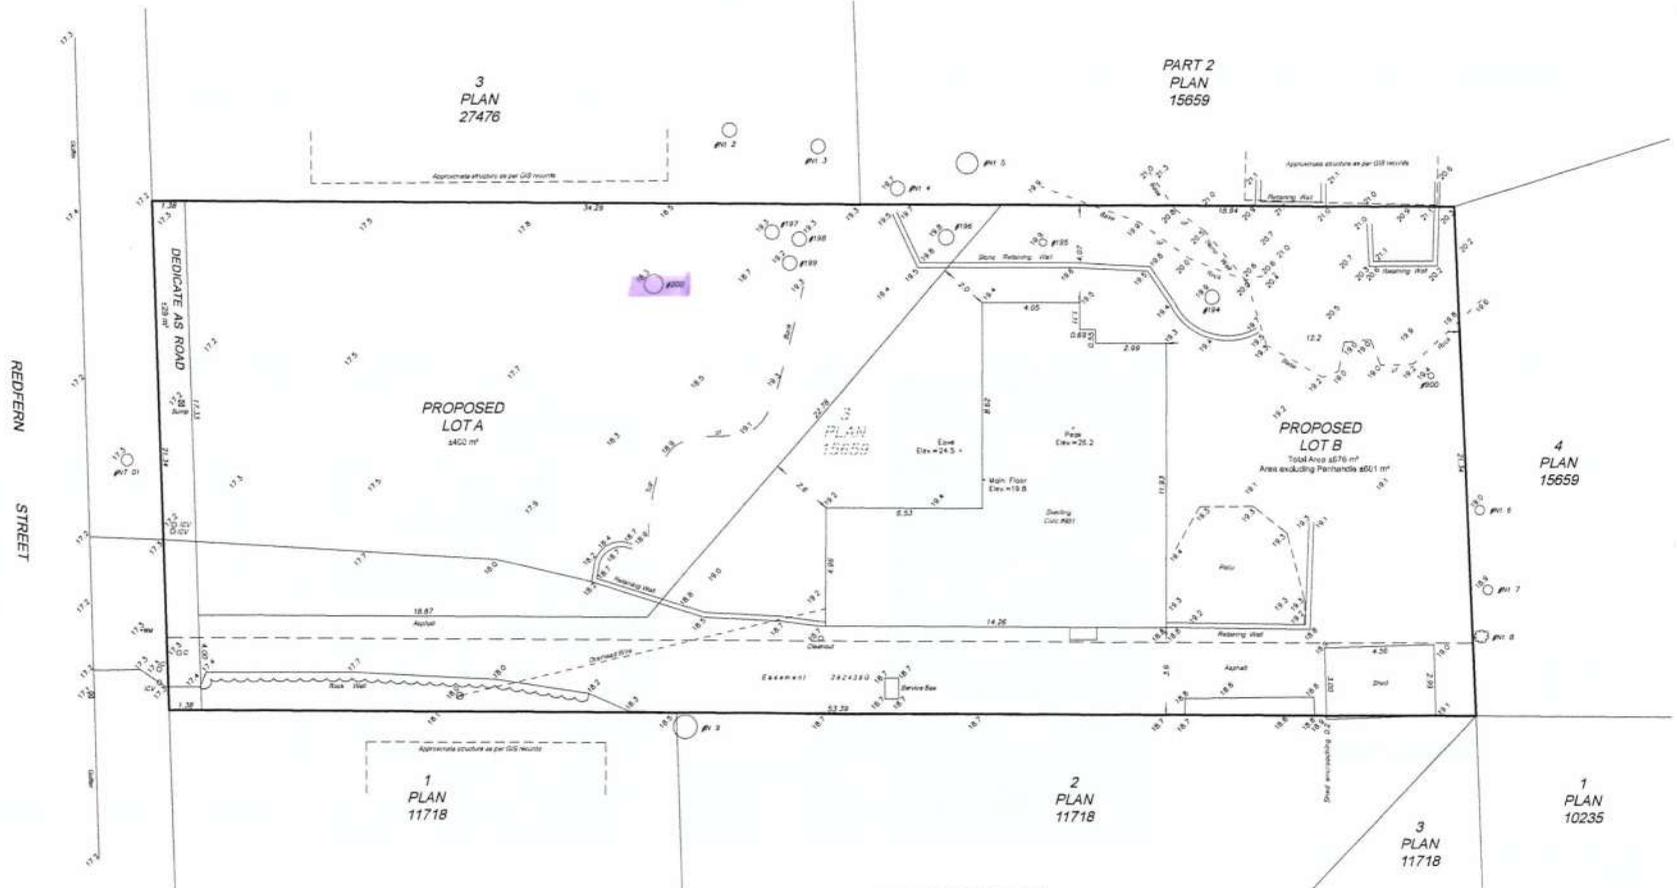
**PROPOSED SUBDIVISION PLAN OF LOT 3, SECTION 68,
VICTORIA DISTRICT, PLAN 15659.**

Field survey dated April 6, 2018.
 The parcel is subject to Easement 2824383.
 Total site area ±1162 m².

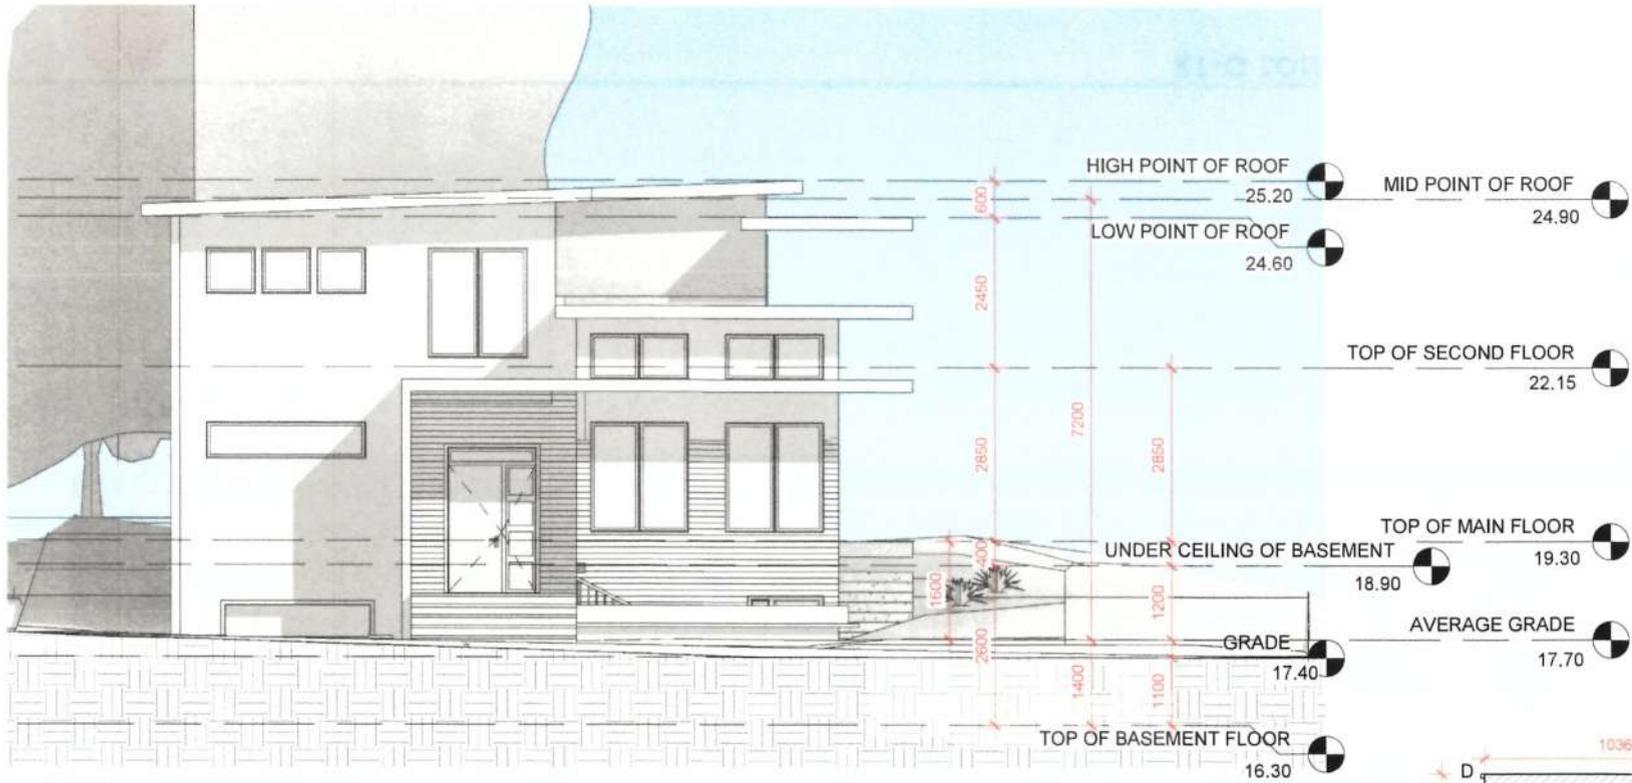
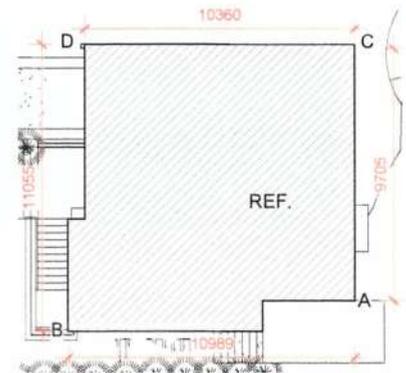
GRADE POINTS

GRADE POINT A : 18.1
 GRADE POINT B : 17.5
 GRADE POINT C : 18.1
 GRADE POINT D : 17.35

$745.72 / 42.11\text{M (PERIMETER OF THE BUILDING)} = 17.70$

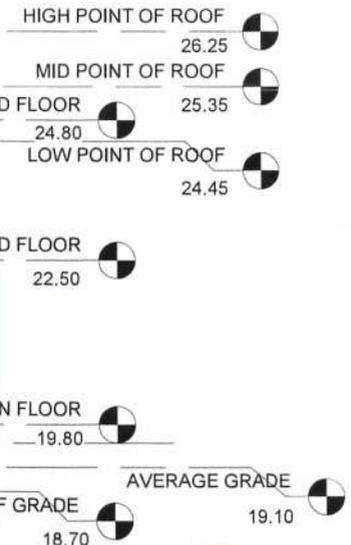
GRADE POINTS	GRADE POINTS	AVERAGE OF POINTS	DIST. BETWEEN GRADE POINTS	TOTALS
GRADE POINT A = 19.2	POINTS A & B	$((19.2 + 18.7) / 2)$	X 4.96	93.99
GRADE POINT B = 18.7	POINTS B & C	$((18.7 + 18.8) / 2)$	X 14.26	267.38
GRADE POINT C = 18.8	POINTS C & D	$((18.8 + 19.3) / 2)$	X 11.93	227.27
GRADE POINT D = 19.3	POINTS D & E	$((19.3 + 19.4) / 2)$	X 2.99	57.86
GRADE POINT E = 19.4	POINTS E & F	$((19.4 + 19.5) / 2)$	X 0.69	13.42
GRADE POINT F = 19.5	POINTS F & G	$((19.5 + 19.4) / 2)$	X 4.05	78.77
GRADE POINT G = 19.4	POINTS G & H	$((19.4 + 19.4) / 2)$	X 8.62	167.23
GRADE POINT H = 19.4	POINTS H & A	$((19.4 + 19.2) / 2)$	X 6.53	126.03
				1,031.95

$1031.95 / 54.03M$ (PERIMETER OF THE BUILDING) = 19.10

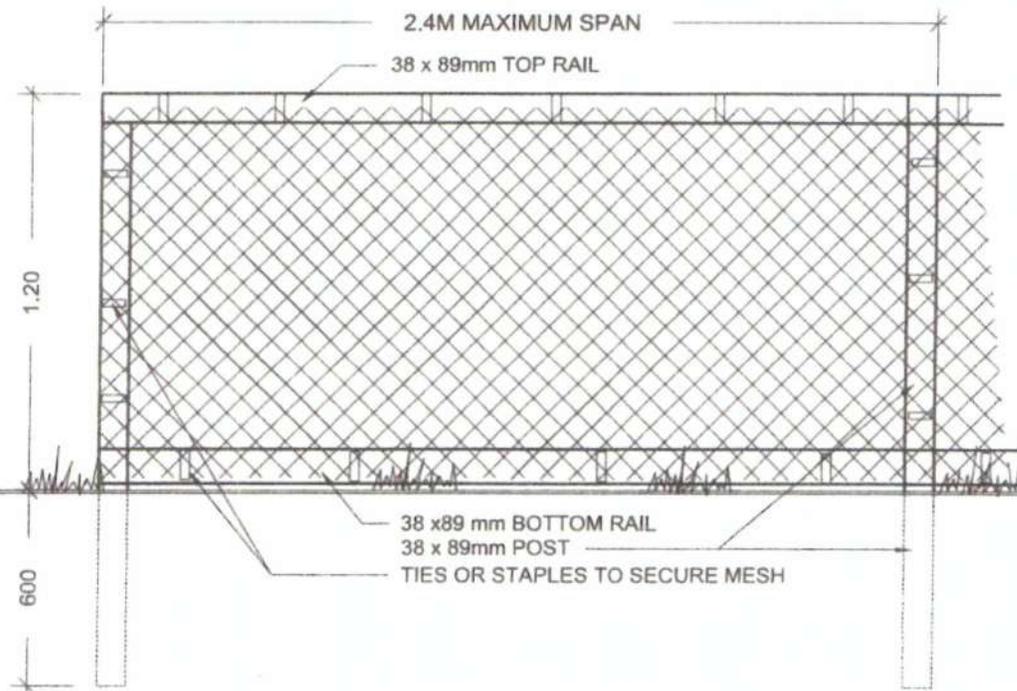
TREE PROTECTION FENCING
 FENCE WILL BE CONTRUCTED USING
 38 X 89 mm (2"X4") WOOD FRAME:
 TOP, BOTTOM AND POSTS. *
 USE ORANGE SNOW-FENCING MESH AND
 SECURE TO THE WOOD FRAME WITH
 "ZIP" TIES OR GALVANZIED STAPLES

* IN ROCKY AREAS, METAL POSTS (T-BAR
 OR REBAR) DRILLED INTO ROCK WILL BE
 ACCEPTED

be erected at the perimeter of the critical root zones. The barrier fencing must be a minimum of 4 feet in height, of solid frame construction that is attached to wooden or metal posts. A solid board or rail must run between the posts at the top and the bottom of the fencing. This solid frame can then be covered with plywood, or flexible snow fencing. The fencing must be erected prior to the start of any construction activity on site (i.e. demolition, excavation, construction), and remain in place through completion of the project. Signs should be posted around the protection zone to declare it off limits to all construction related activity. The project arborist must be consulted before this fencing is removed or moved for any purpose.
