I.1.a.b 819-823, 825 and 827 Fort Street - Rezoning Application No. 00621, Heritage Alteration Permit Application with Variances No. 00009, and Heritage Designation Application No. 000176 (Fairfield)

The purpose of this report is to provide Council with information, analysis and recommendations for a Heritage Alteration Permit Application with Variances for the property located at 819-823, 825 and 827 Fort Street. The proposal is for a ten-storey mixed-use development containing approximately 100 rental units and ground floor commercial at a density of 6.17:1 FSR. The proposal would retain and rehabilitate the façade of the heritage-designated building located at 825 Fort Street and designate and rehabilitate the façade of the building located at 819-823 Fort Street. The property at 825 Fort Street is consolidated with 827 Fort Street; however, the building at 827 Fort Street is not identified as a character-defining element as part of the existing designation of 825 Fort Street as little heritage value remains in the altered 1947 two-storey façade, nor was 827 Fort Street ever heritage-registered or designated. The building would not be retained.

CONSERVATION PLAN

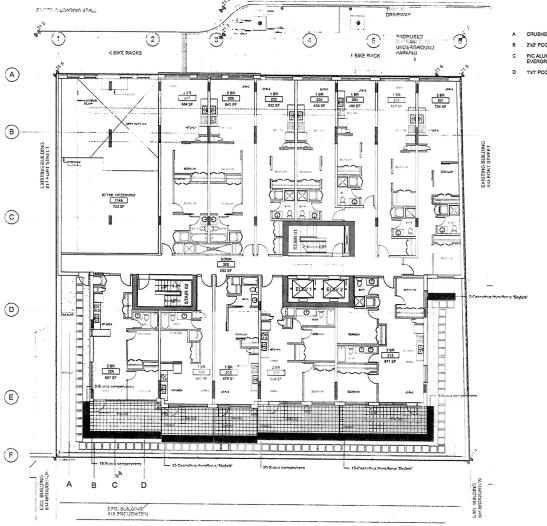
- CRUSHED ANGULAR WHITE GRAVEL
- 2'x2' PCC WHITE PAVER
- P/C ALUMINIUM PLANTER MIN 2" PLANTING DEPTH / EVERGREEN LOW HEDGE EG. BUXUS
- D 1'x1' PCC PAVER ON PEDESTALS

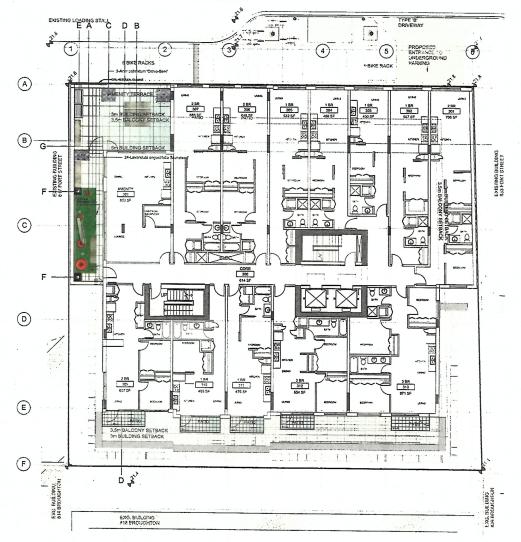
- A DOG RUN AREA WITH LOGS/ FAKE HYDRANTS. SURFACE TO BE WASHABLE PET FRIENDLY SYNETHIC GRASS. SPRINKLER SYSTEM TO BE INSTALLED FOR MAINTENANCE, HOSE BIB ALSO PROVIDED.
- B TABLES AND BENCHES SPECIFICATION TBC.
- C P/C ALUMINIUM PLANTER MIN 4' PLANTING DEPTH / SMALL TREE - SP. ACER AND LAVANDER SHRUBS.
- 1'x1' PCC PAVER
- PRO ARFA
- F DOG WASTE RECIPTICLES AND DOG WASTE BAG DISPENSER.
- G DOG RUN ENCLOSED WITH SELF LATCHING 6' HIGH GATE TO MATCH GUARD DETAIL. SEE ARCHITECTURAL

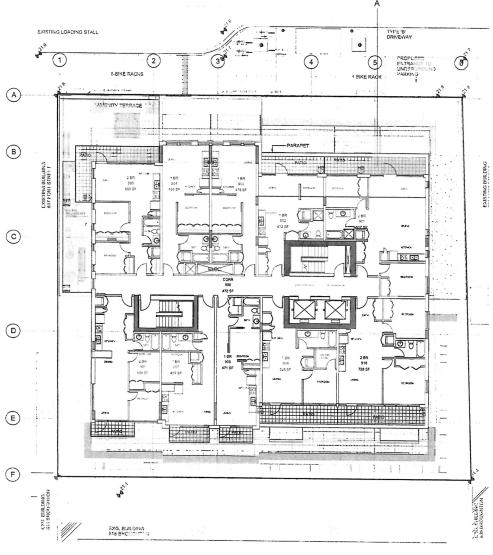
1 9TH FLOOR GENERAL ARRANGEMENT
L9_L1 1:100 METRIC

A 1'x1' PCC PAVER ONTO PEDESTALS

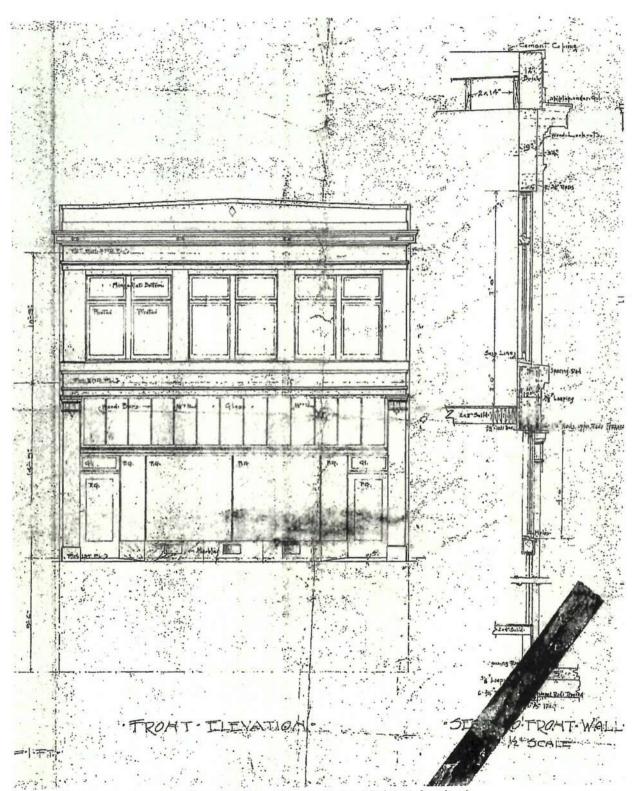
Detail of original architectural drawing, showing elevation and cross-section of the historic front facade.

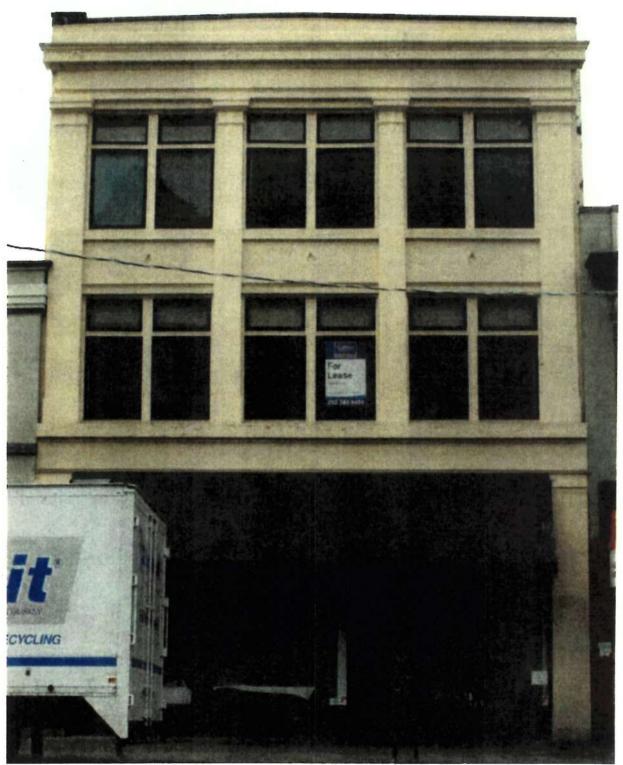
Existing condition of the historic front facade (north elevation) along Fort Street.

The overall condition of the main elevations appear to be good with some decay and damage visible, most notably the missing capitals on the ground floor columns of 825 Fort Street. The windows on both buildings are intact and in good condition, and the main painted brick elevation of 819-823 Fort Street also appears to be in good condition.

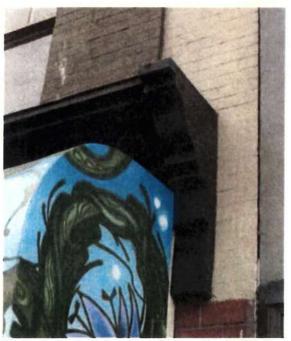
Photos showing typical condition of brickwork on the historic front facade, facing Fort Street.

have been undertaken and only if approved by the Heritage Consultant. Repoint mortar joints with new mortar that matches existing in consistency, composition, strength, colour and pointing profile; note the finely tooled profile of the original mortar joints.

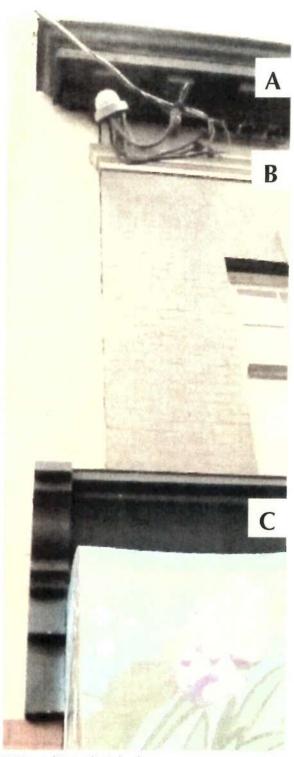
Further investigation is required to confirm if all intact architectural metalworks are original, as the existing elements appear to be consistent with the historic character of the building, based on existing archival photographs. In general, they appear to be in good condition, and should be preserved, and repaired in-kind only as required.

Existing architectural metalworks.

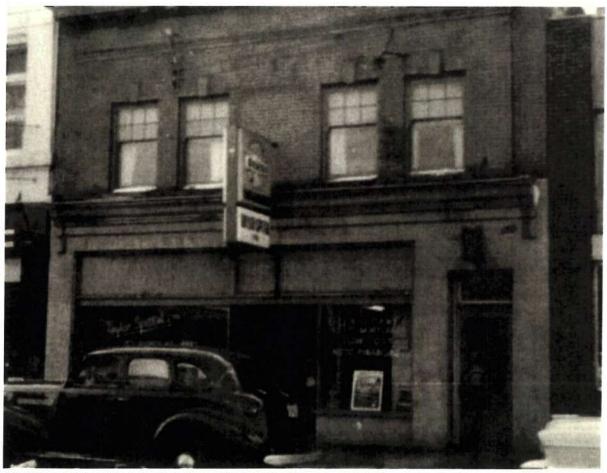
Detail photo showing original storefront at ground level, and double-hung wood windows at upper level. (City of Victoria Archives M03921_141)

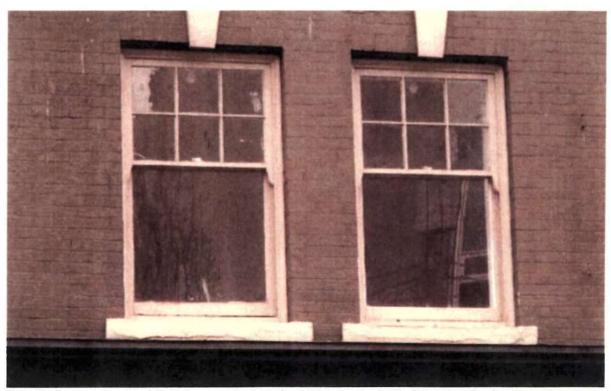
Two of the four surviving original double-hung wood sash windows at the upper level of the historic front facade. Note multi-pane upper sashes in true divided lights, with true integral sash horns.

hung wood window assemblies, including upper sashes with true integral sash horns and multi-panes in true divided lights. Initial visual review from the exterior ground level indicate that they are in good condition, with signs of natural weathering and deterioration.

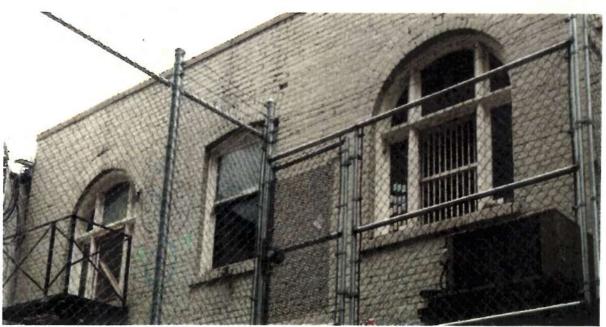
Upper level of the rear (south) elevation, showing three original window openings.

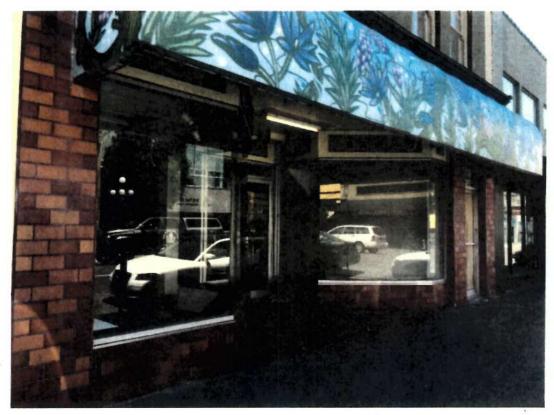
Traditional Raked Storefront of 819-823 Fort Street

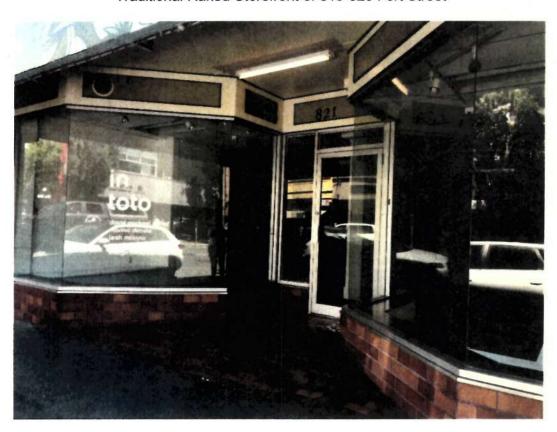
Traditional Raked Storefront of 819-823 Fort Street

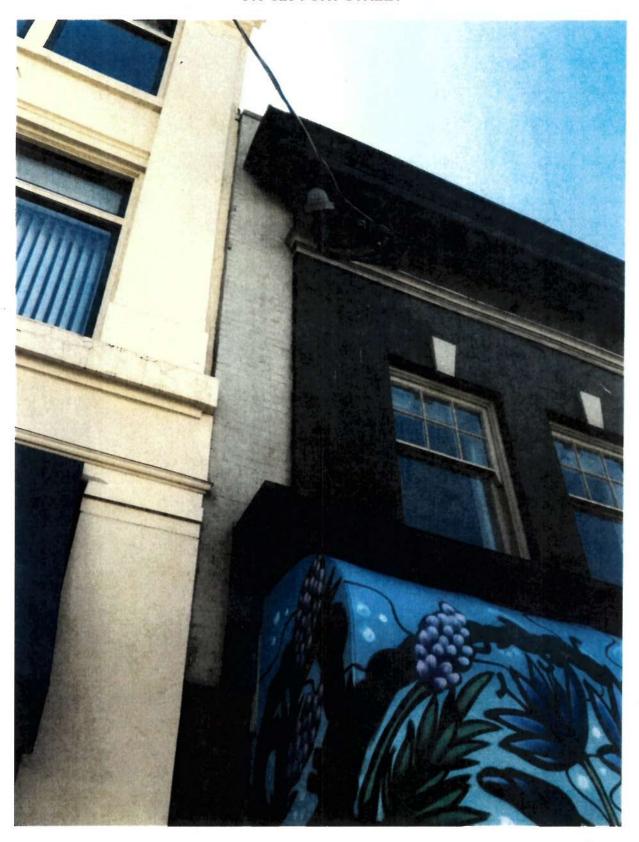
Upper and Lower Cornice and Original Six-Over-One Double-Hung Windows
