1314-1324 BROAD STREET, VICTORIA, BC

# CONSERVATION PLAN

NOVEMBER 2019

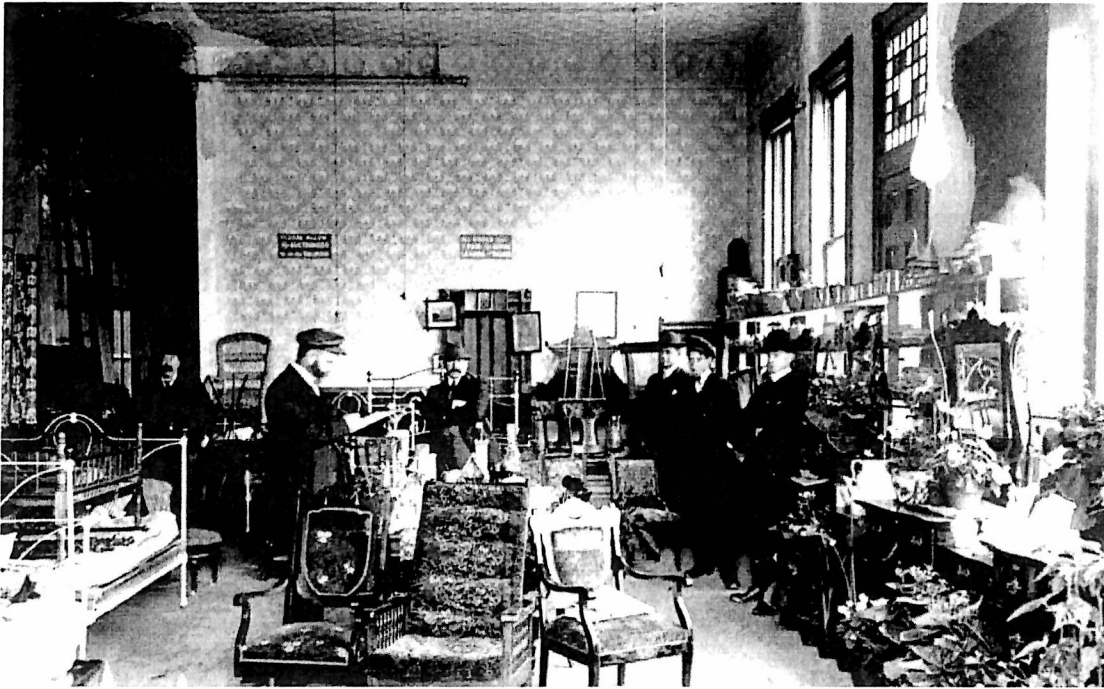
Top: Maynard's Auction Room at 1318 Broad Street, Victoria, circa 1908. [BCA C-05946]

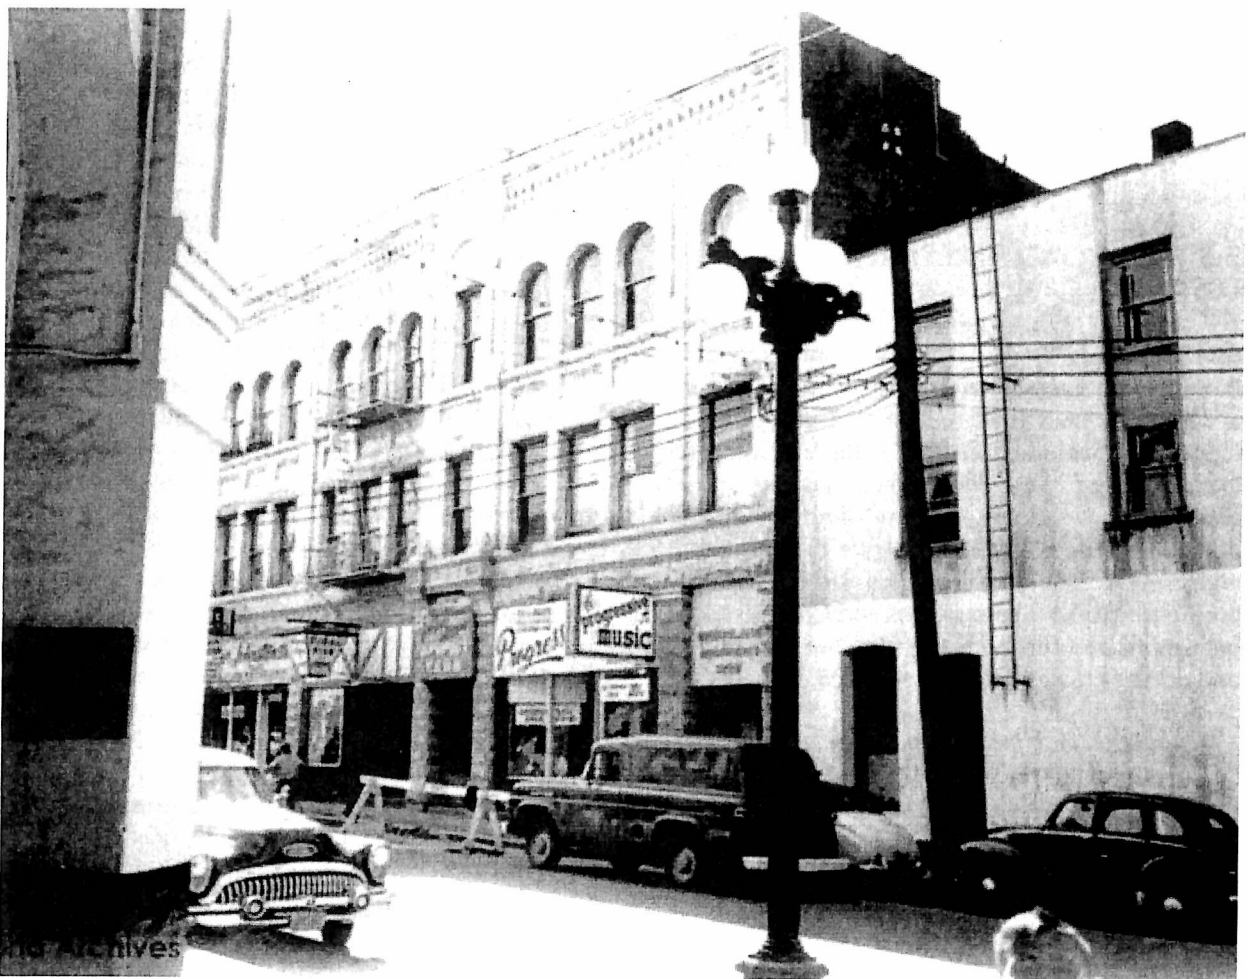
The Duck Block, 1960. [City of Victoria Archives M-03288]
