615-625 JOHNSON STREET, VICTORIA, BC

CONSERVATION PLAN

NOVEMBER 2019

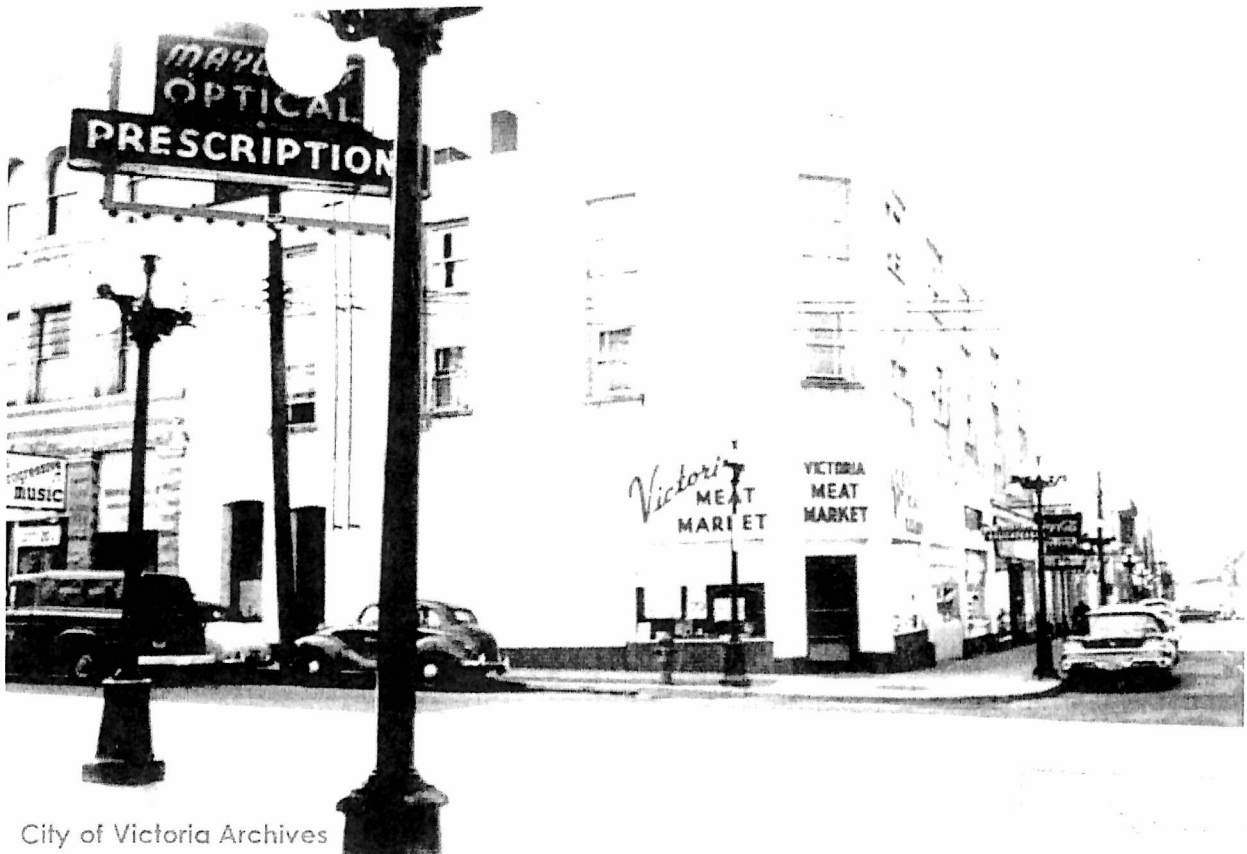
City of Victoria Archives
Victoria Meat Market, 623 Johnson Street, April 1960. [CVA M00431]

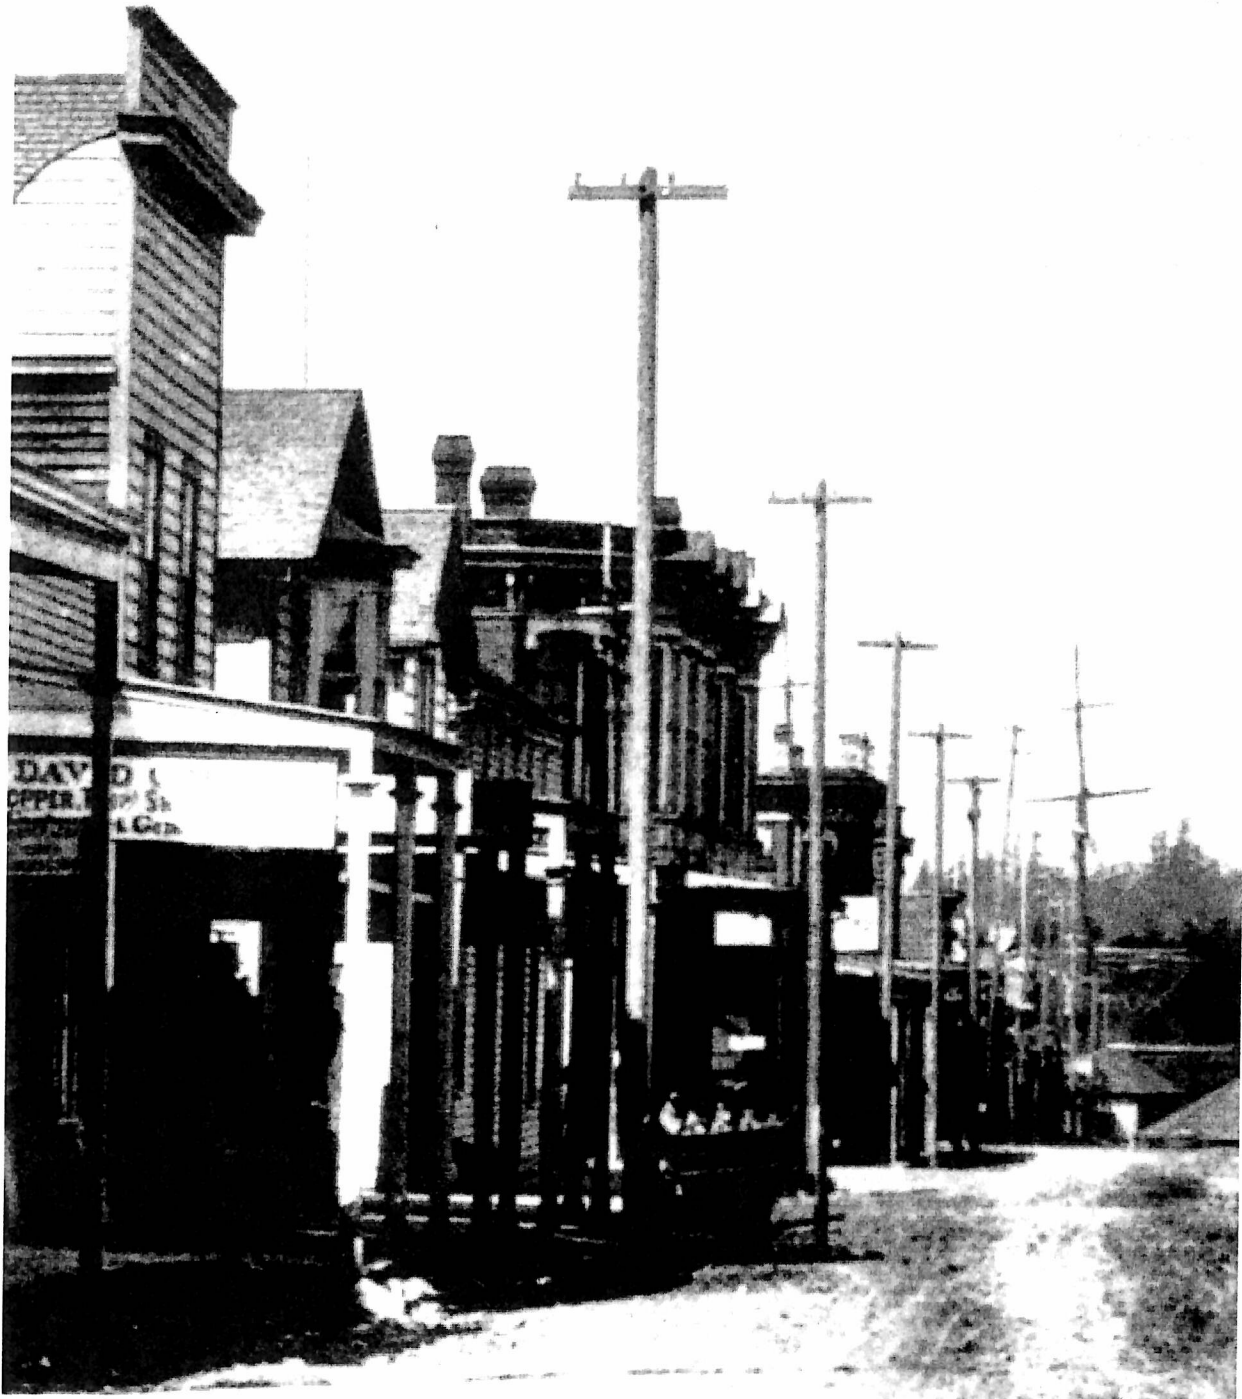
Johnson Street, 1877. First Duck's Carriage Factory, with chimneys and arcade, can be seen at centre; the two westernmost bays can be seen to be different in appearance. [City of Victoria Archives M06538]

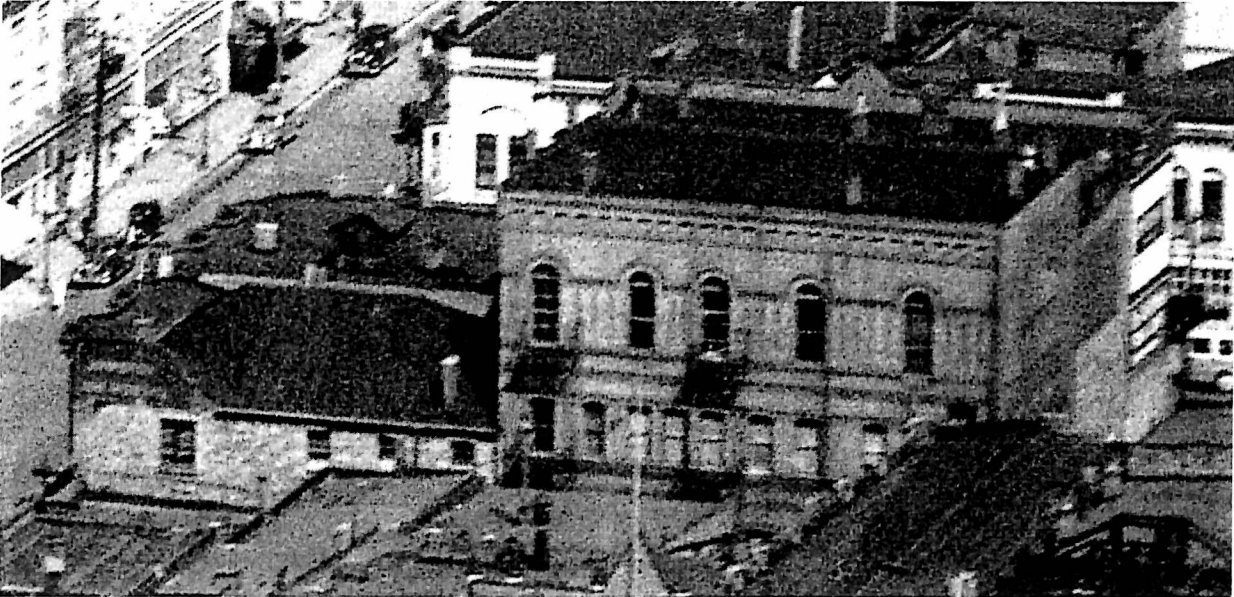
Victoria 1947 BO-47-1455 detail showing alley elevation. Note that the hipped roof of the Carriage Factory is still visible. It was later raised and flattened to match the roofline of the First Duck's Carriage Factory, and the stone wall extended upward in brick.
