Rezoning and Heritage Alteration Application with Variances

1306-1331 Broad Street, 615-625
Johnson Street and parts of 622 and
630 Yates Street

Heritage Alteration Application with Variances

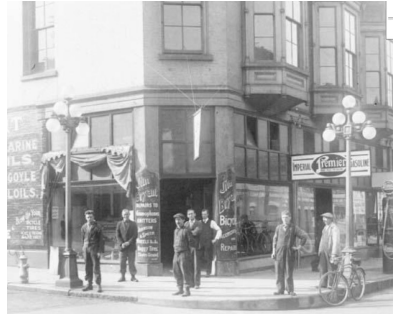
25

1324 Broad Street (the "Canada Hotel")-
Heritage Register status

- Scale altered
- Stucco cladding covers original finishes, which may or may not exist underneath
- Storefronts altered and reconfigured
- Cornices removed
- Restoration would require substantial interior/exterior reconstruction based on guesswork and partial photographs

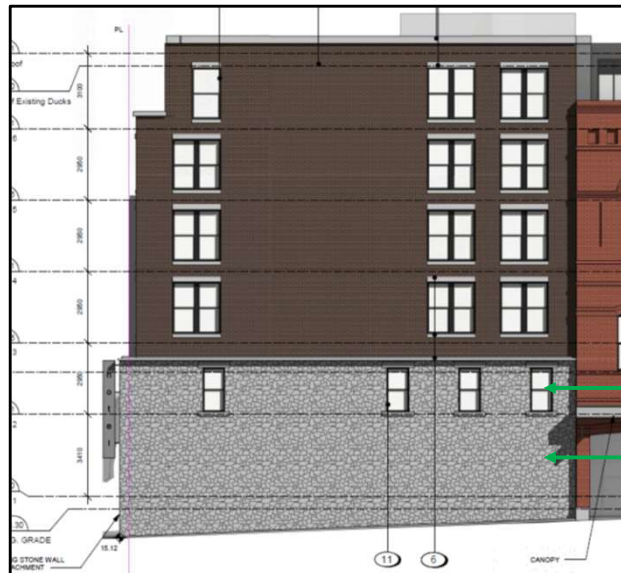
29

Conservation- the Rubble Wall

Windows rehabilitated
and openings retained

Mortar repointing and
stone repair

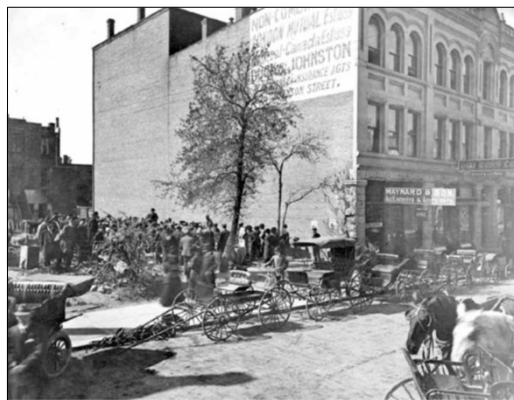
35

Heritage Significance- Duck's building

- Heritage register status
- Built in 1892 for Simeon Duck, an entrepreneur, MLA and former Minister of Finance for BC
- Heritage value for aesthetic qualities including bold decoration and detailing and dominant presence on Broad Street's narrow streetscape, and associations

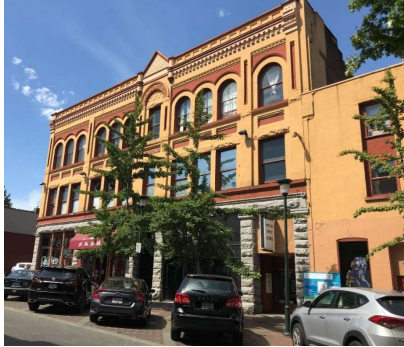
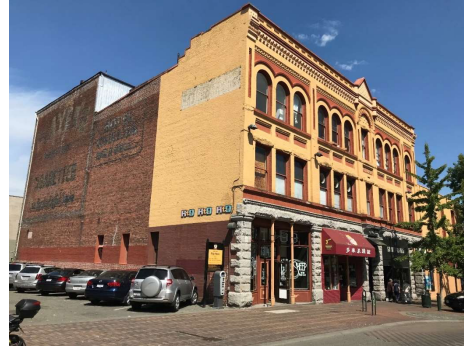
36

Front (east) and side (south) elevations of the Duck's Building

Building has been unsympathetically painted, concealing contrasts between materials such as the rusticated stone lintels against the brickwork

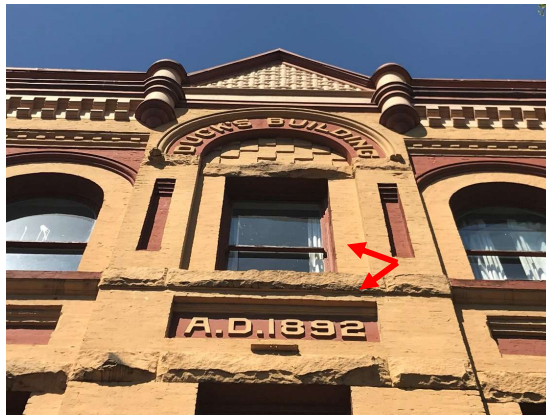
Paint hides different materials

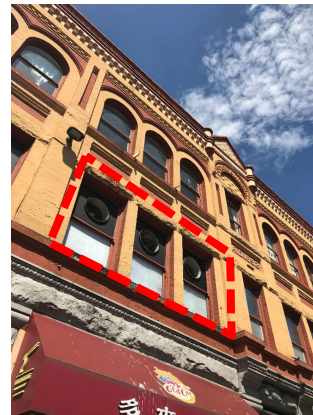
Blocked windows

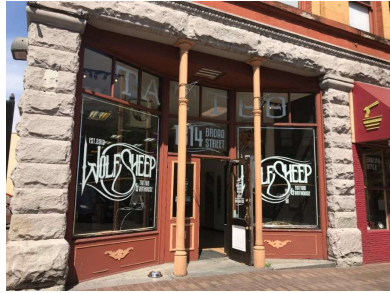
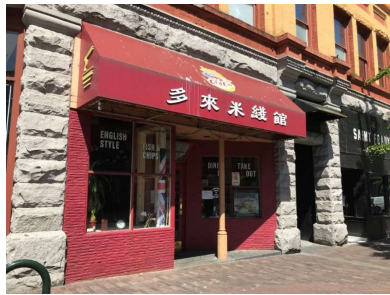
38

Retail unit frontages are inconsistent and not historically accurate

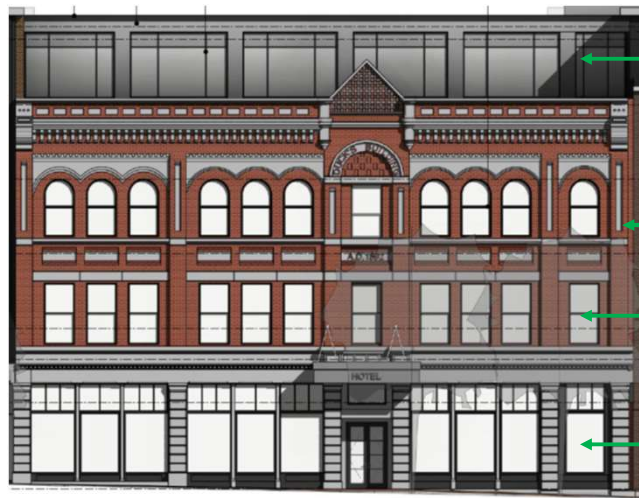
44

Proposal Ground Floor Plan

Addition set back 7m, making it invisible from Broad Street

Paint removal from facade

Rehabilitation of wood windows

Rehabilitation of storefront in wood, reintroduction of transom windows

Entire façade braced and restrained, with new construction behind ensuring a life safety standard under upcoming 2022 building code

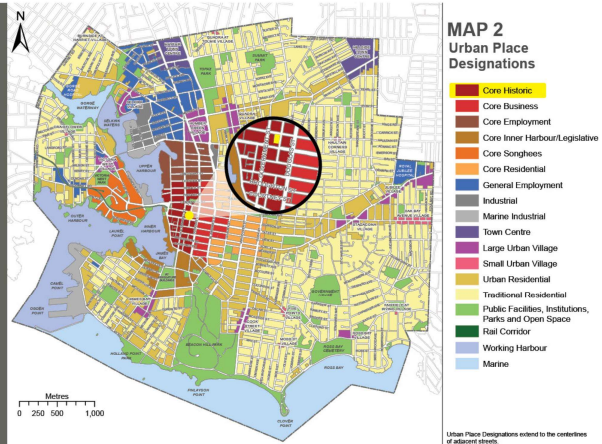
52

OCP Map

SUBJECT SITE - LAND USE

Subject site is located in the core historic area.

CURRENT ZONING
• OTD-1

OCP ALLOWED
• Density - 3.0 FSR
• Height - 15 metres
• '...approximately 5-storesy...'
