# **1224 Richardson St, Victoria**

## **Construction Impact Assessment &**

## **Tree Preservation Plan**

Date of Issuance: May 13, 2019  
Updated August 19, 2019

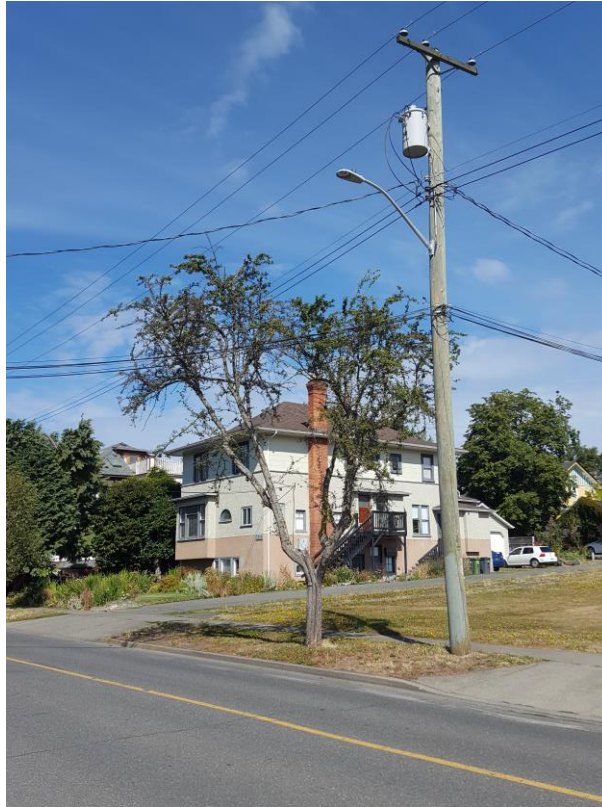
Municipal Hawthorn #1 (31cm DBH below union).

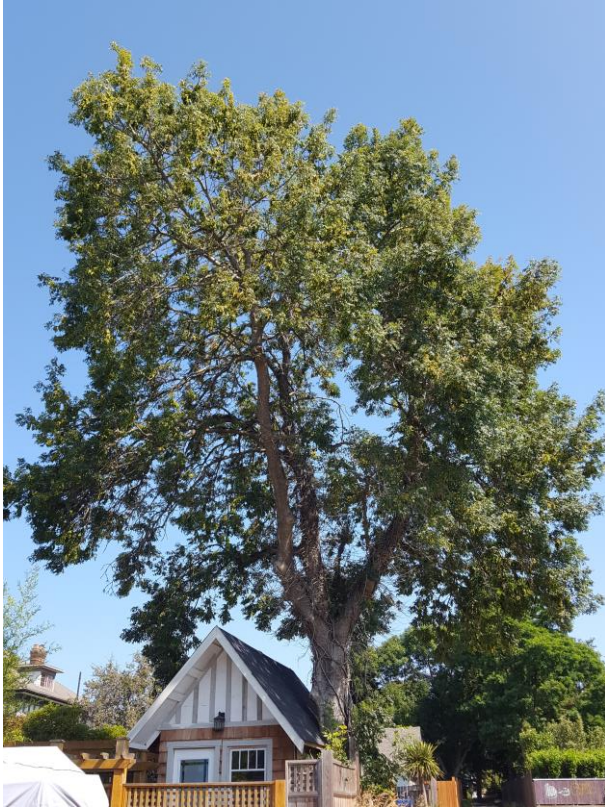
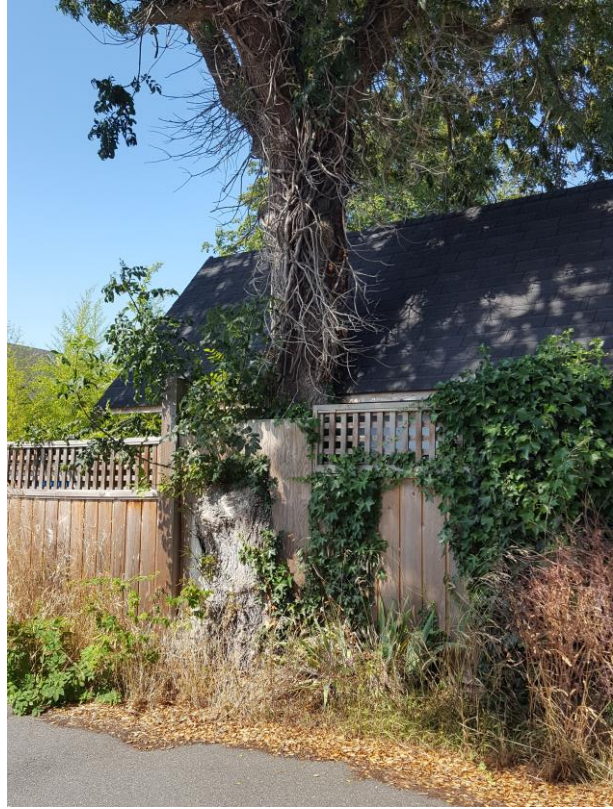
Ash #2 (~75cm DBH). We could not measure this tree's DBH as it is growing through the neighbour's fence.

- **Ash #2** (~75cm DBH) is located across the driveway west of the subject property and is approximately 5.5m from the northwest corner of the retaining wall surrounding building B. Less than one-quarter of this tree's CRZ will be impacted and we do not anticipate its health will be impacted. We recommend the project arborist prune any roots encountered back to sound tissue at the edge of excavation. We were unable to measure this tree as there it is growing through a neighbour's fence and is conflicting with a garage roof. It may be by-law protected (80cm DBH or greater).

of the property. If underground services are run down the west side of the property, excavation will likely be required within the CRZ of Ash #2, potentially resulting in significant impacts if roots are damaged or severed. If they are aligned on the east side of the property, excavation may occur within the CRZ of municipal Hawthorn #1. Alternative excavation techniques (e.g. hydro-vac, air-spade, or a combination of machine and hand-digging) would likely be recommended in each case. We recommend the project arborist review the site servicing plan once it becomes available to evaluate the potential impacts to trees to be retained and recommend mitigation measures.

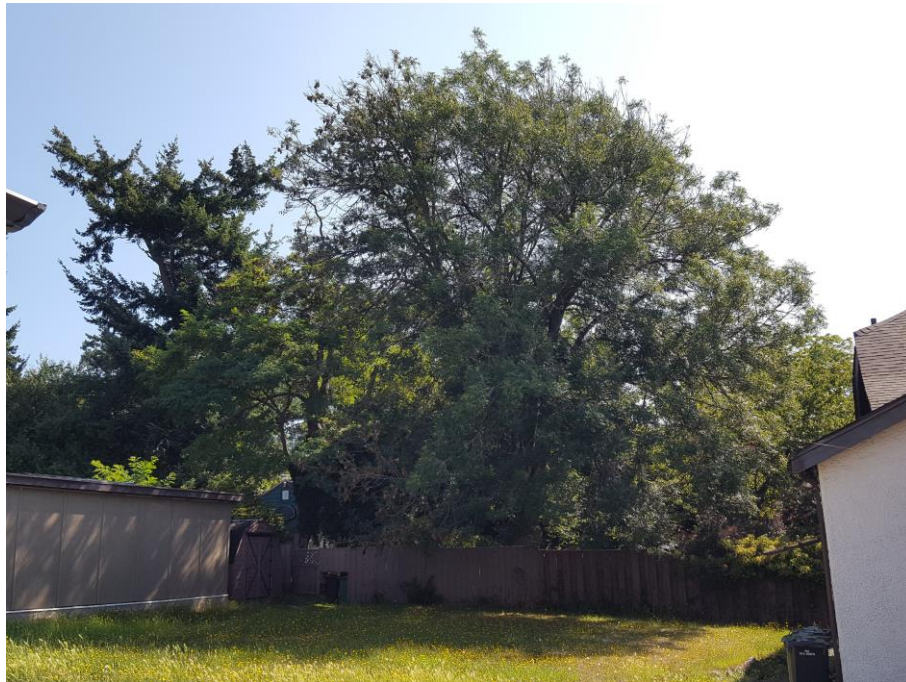
Black Locust #3 (left, ~60cm DBH) and Ash #4 (right, 81cm DBH). These trees are both growing within 1m of the fence. We did not measure the DBH of #3 as it is located on the neighbour's property. The DBH of #4 was provided by City of Victoria Parks.

**Trees to be Removed:** We anticipate one tree, **Ash #4** (81cm DBH), will require removal as a result of the excavation to construct building C. The lower floor of the building, which will be constructed below the existing grade, and the surrounding retaining wall will likely require excavation to the east property line. The tree is approximately 0.5m from the fence. We anticipate large, structural roots will be encountered, resulting in significant health and structural impacts. In addition, about half of the tree's crown would have to be pruned for building clearance and would likely require entire limbs to be removed. Therefore, we recommend the tree be removed prior to construction. If the neighbour wishes to retain this tree, we anticipate the risk associated with whole tree failure will increase considerably. The neighbour should be notified of the proposed impacts to their tree. This tree is bylaw protected.

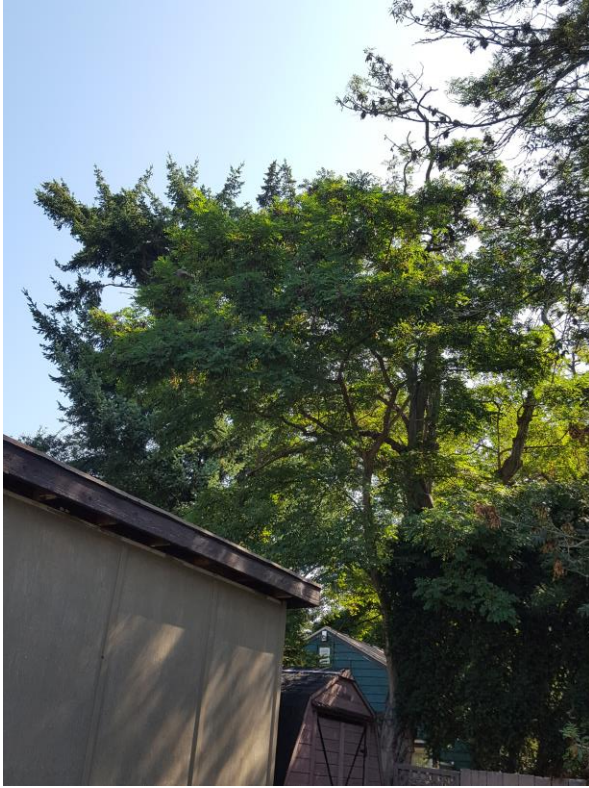
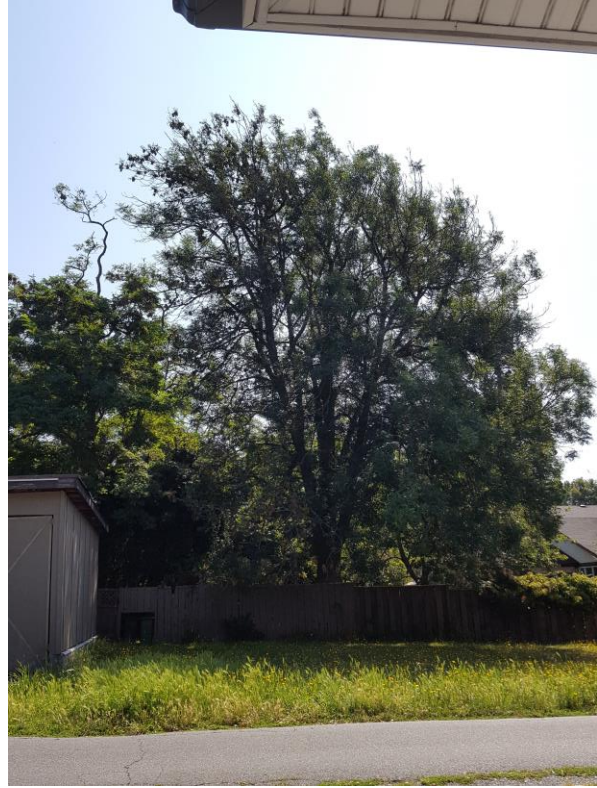
Black Locust #3 (left) had some dieback and large deadwood but is in fair health. The existing garage on the subject property is located within this tree's CRZ. Ash #4 has some dieback and is in fair health.

- **Black Locust #3** (~60cm DBH) is also located next to the east fence line but is approximately 3m from the northeast building corner. To minimize root loss, we recommend limiting the extent of excavation at the northwest corner of building C. If excavation occurs 1m outside the building footprint, we anticipate less than one-quarter of this tree's CRZ will be impacted. Large roots (>3cm in diameter) will likely be encountered, which may exacerbate this tree's already declining health condition. We recommend the project arborist supervise all excavation within this tree's CRZ and prune any roots encountered back to sound tissue at the edge of excavation.

Crown pruning will also be required to attain building clearance. This tree is growing asymmetrically away from the adjacent ash tree, which limits the number of conflicting limbs. There appear to be suitable laterals to prune back to, and we anticipate the largest branches that will have to be removed are about 4cm in diameter. It should be noted that this tree is already in fair to poor health condition. Depending on the number and size of roots encountered, the root loss and crown pruning may expedite this tree's decline. It may be prudent to remove this tree and plant young, well-structured replacement trees. The neighbour should be notified of the proposed impacts to their tree. This tree is not by-law protected.

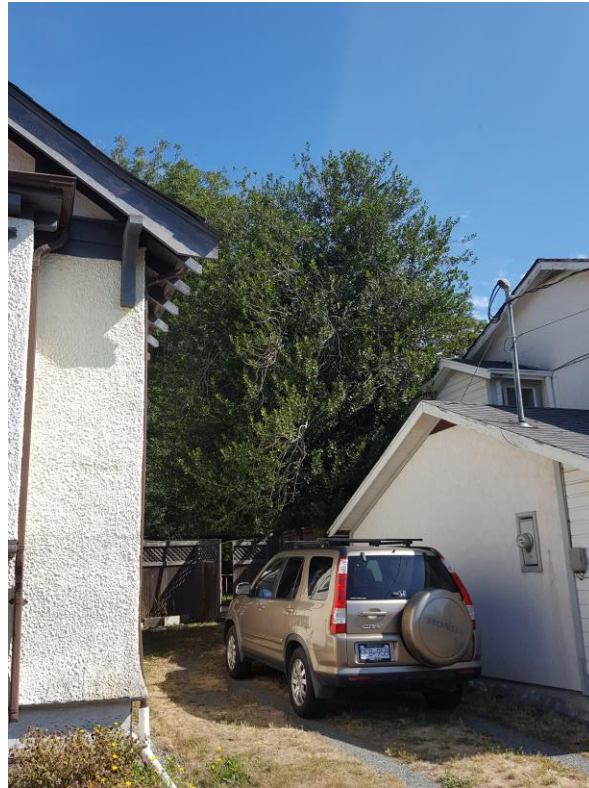
Holly #5 (~40cm DBH). We did not measure the DBH of this tree as it is located on the neighbour's property.

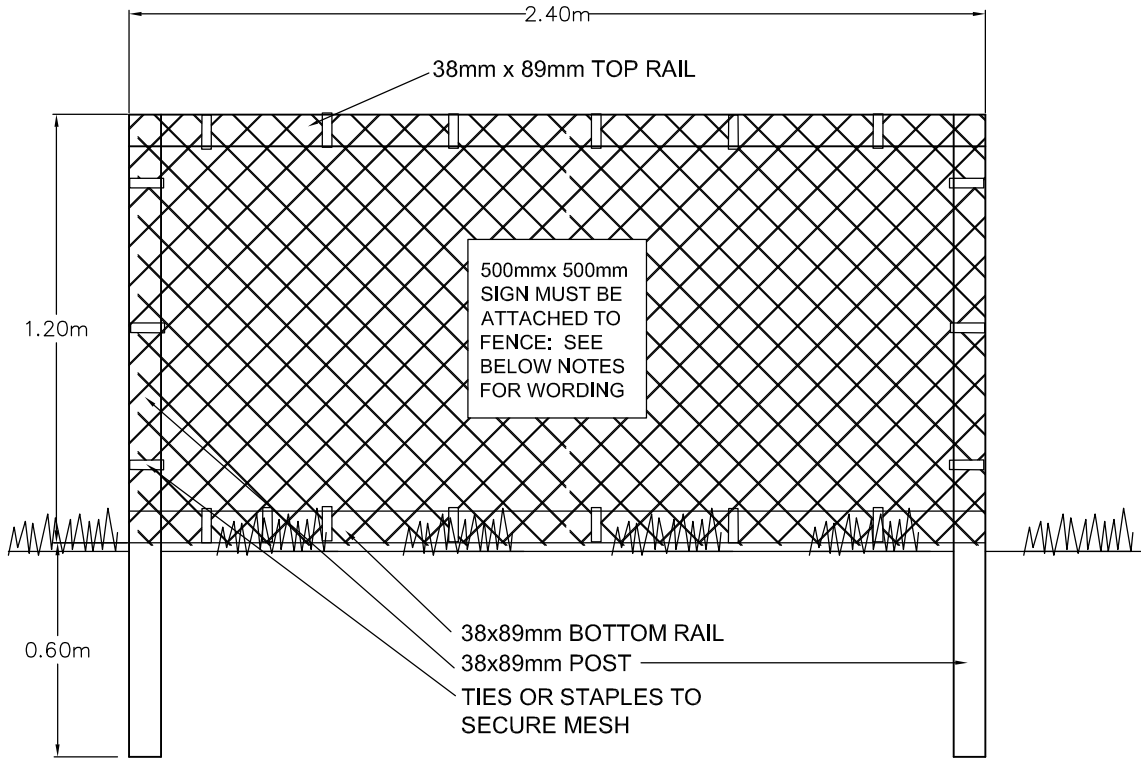
**TREE PROTECTION FENCING**

1. FENCE WILL BE CONSTRUCTED USING 38 mm X 89mm WOOD FRAME: TOP, BOTTOM AND POSTS \* USE ORANGE SNOW-FENCING MESH AND SECURE THE WOOD FRAME WITH "ZIP" TIES OR GALVANIZED STAPLES.
  2. ATTACH A 500mm X 500mm SIGN WITH THE FOLLOWING WORDING: WARNING- TREE PROTECTION AREA. THIS SIGN MUST BE AFFIXED ON EVERY FENCE OR AT LEAST EVERY 10 LINEAR METERS.
- \* IN ROCKY AREAS, METAL POSTS (T-BAR OR REBAR) DRILLED INTO ROCK WILL BE ACCEPTED
