CAIRE & GRANCINI WAREHOUSE

1314 WHARF STREET, VICTORIA, BC

CONSERVATION PLAN

DONALD LUXTON
AND ASSOCIATES INC

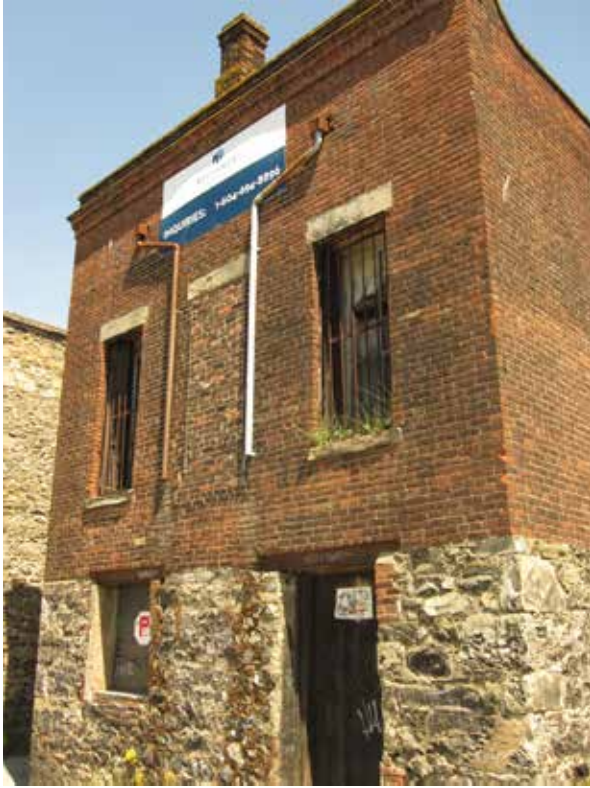
The exterior walls are a mixture of rubble stone, found at the base on the bottom storey at the rear of the building. Red brick is used on the main floor of the building. The window and door openings are framed by inset sandstone headers and sills. In some locations the openings were bricked in during later interventions to the building.

Current rear elevation of the Caire & Grancini Warehouse

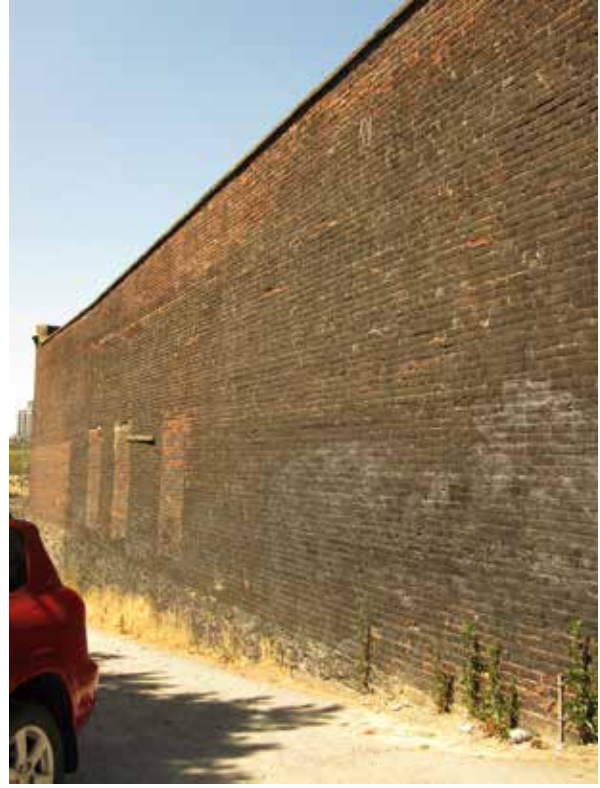
Current south Elevation of the Caire & Grancini Warehouse

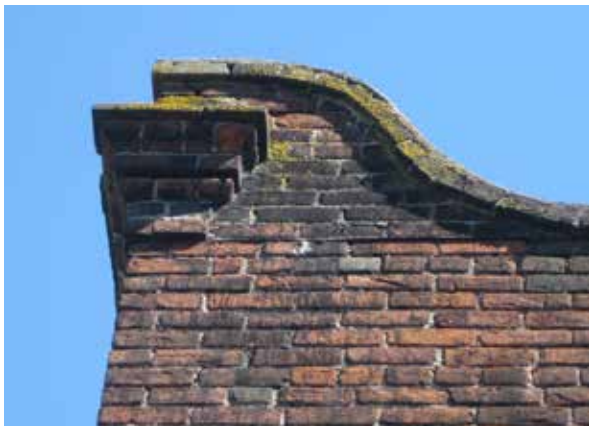
The cap flashings on the Caire & Grancini Warehouse are limited and only visible on the front façade. Other parapet locations, and chimney do not indicate that flashing have been installed to shed water and protect the masonry façade. The existing cap flashings on the front elevation are oversized, are not sympathetic to the existing building, and are in a significant state of decay and should be replaced. In locations where the flashings are absent, new flashings should be installed to protect the brickwork.

The roof and parapet were not safely accessible for close review and were evaluated from the ground. Further investigation is required to identify the conditions and associated repairs required including appropriate profiles and finishes to be used for the rehabilitation. A mock-up of the flashing should be provided to the heritage consultant for review in situ.

Parapet at rear of Building - no cap flashing noted

- Evaluate the overall condition of the parapet cap flashing to determine whether more protection is required, or replacement in kind is required.
- Repair or replace deteriorated flashing, as required. Repairs should be physically and visually compatible.
- If new flashings are installed, ensure that the colour is compatible with the overall colour scheme.
