Cummer Heritage Consulting

Heritage Assessment and Evaluation

3080 Washington Avenue, Victoria, BC

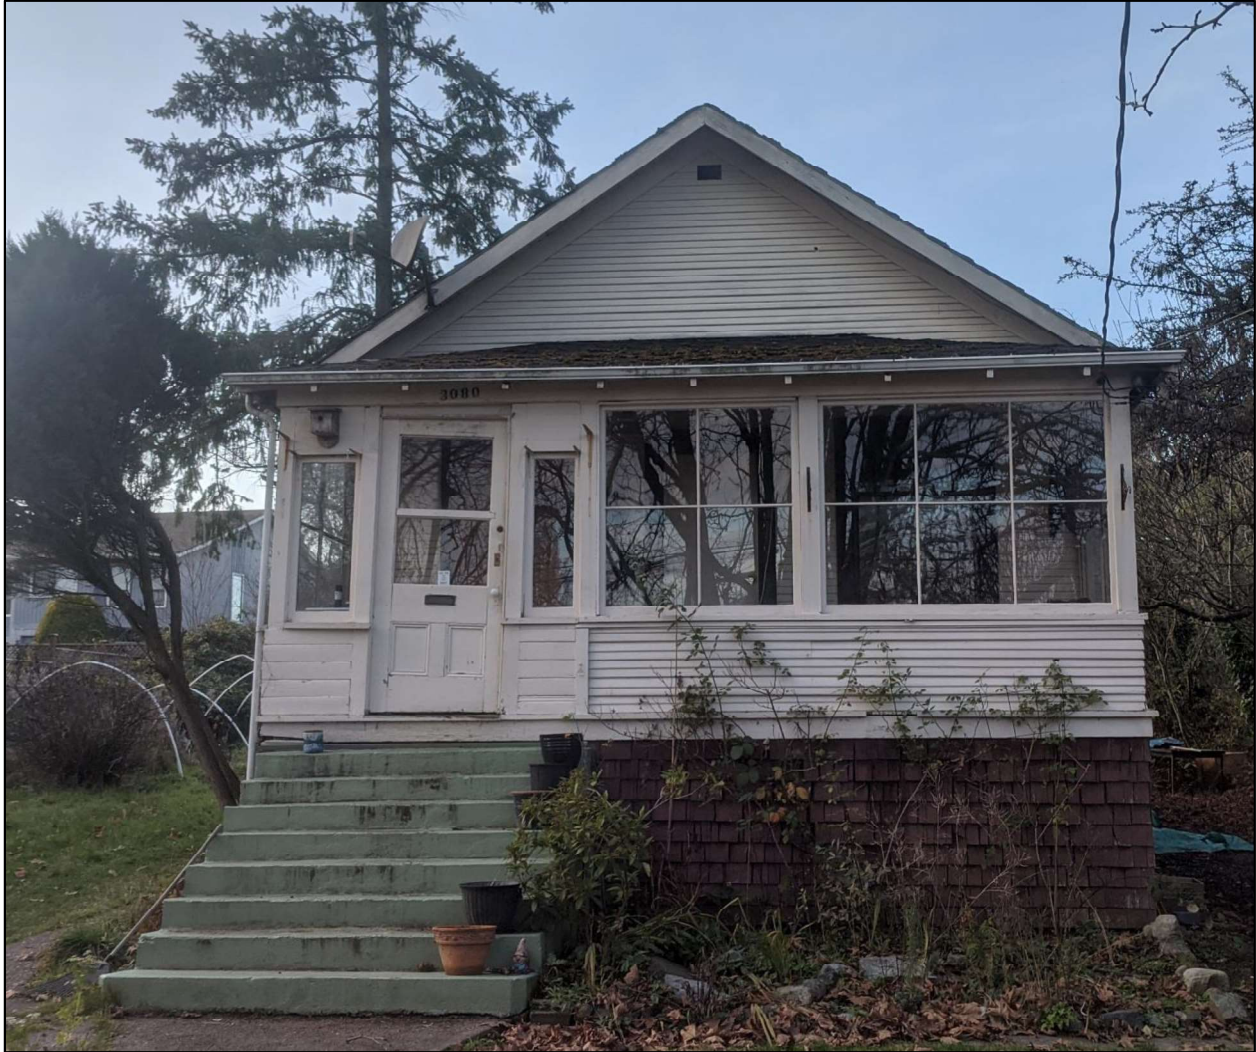
The structure located at 3080 Washington Avenue is a modest, early 20th century, rectangular structure built in 1909. It is a slightly raised one-storey, front gabled house, with bevelled horizontal wood siding on the upper portions of the house and simple cedar shingles along the bottom portions (Figs. 2 to 4). While not of any distinct style, its simplicity is reminiscent of pioneer houses, which “were simple cottages or cabins, often only one room deep with the door set in the middle, usually with a full-width hipped roof front porch” (VHF). The front porch (visible in Fig. 2 below) was not closed in originally, as discernible from the 1913 Fire Insurance Plan of the area (Fig. 5b below).

Fig. 2: Front view of 3080 Washington Avenue. (Source: Cummer, 2019)

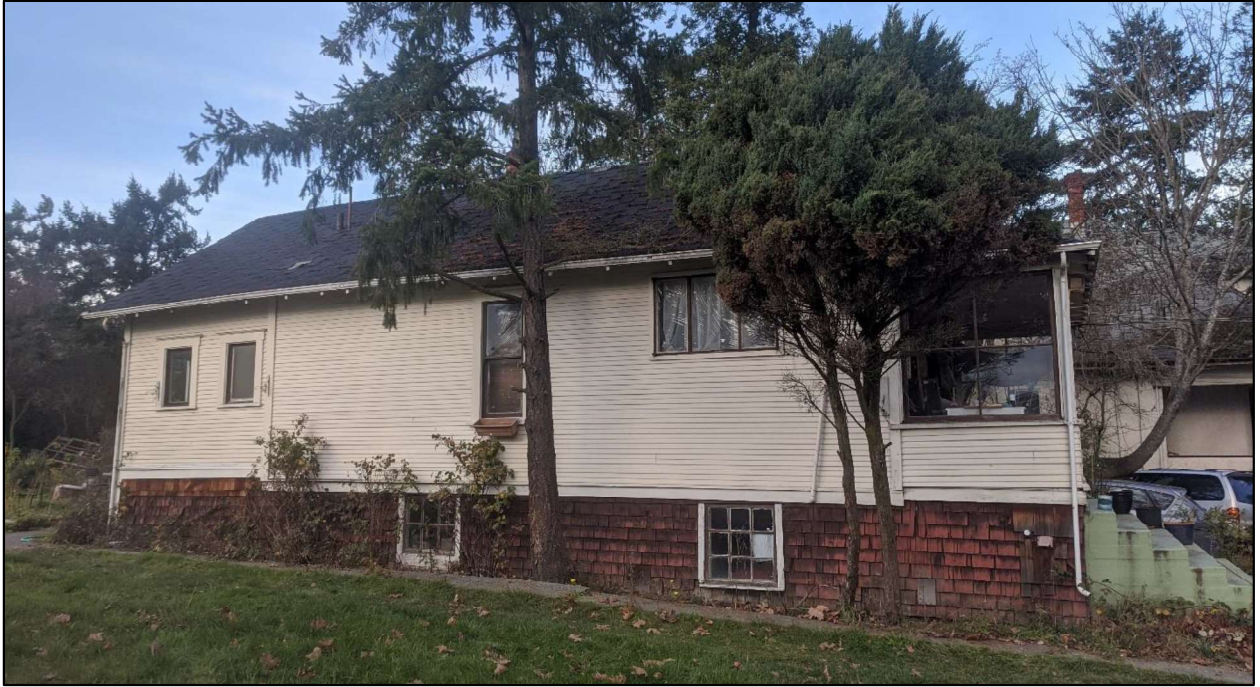
Fig. 3: Southern side view of 3080 Washington Avenue. (Source: Cummer, 2019)

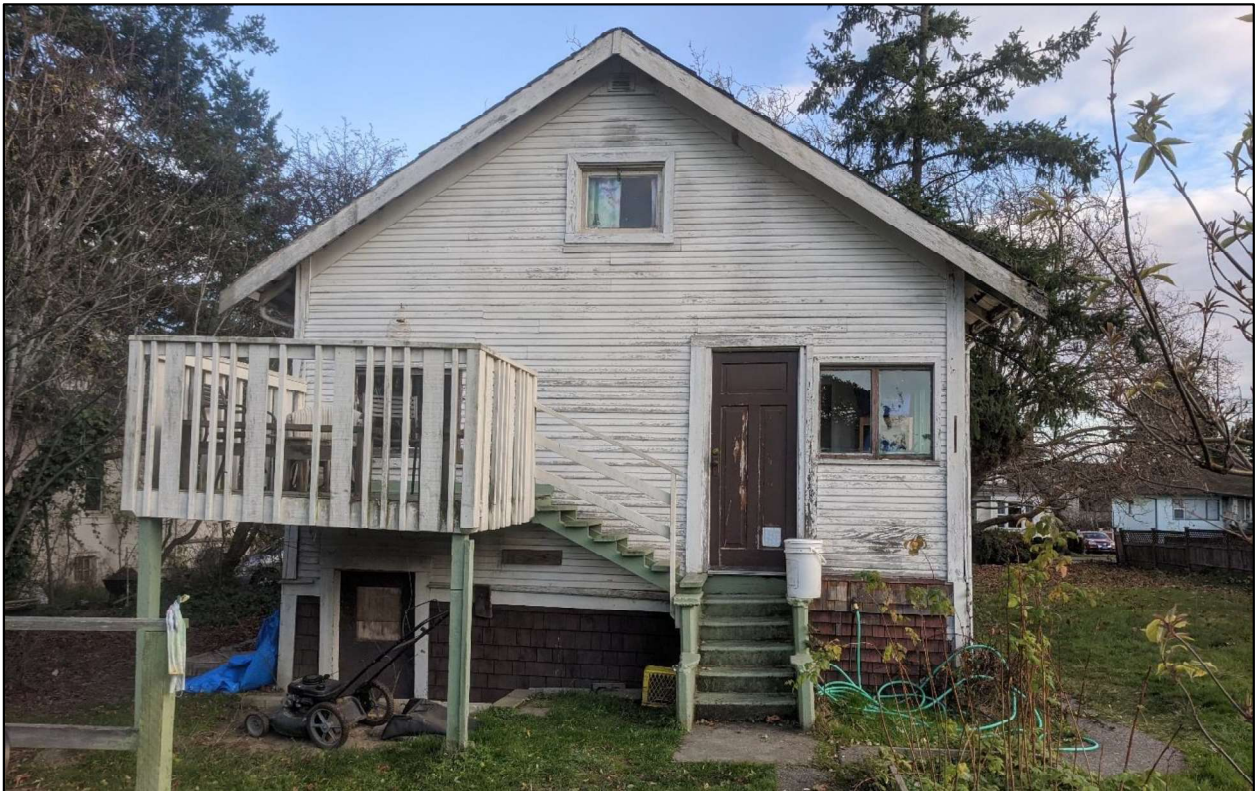
Fig. 4: Back view of 3080 Washington Avenue. (Source: Cummer, 2019)

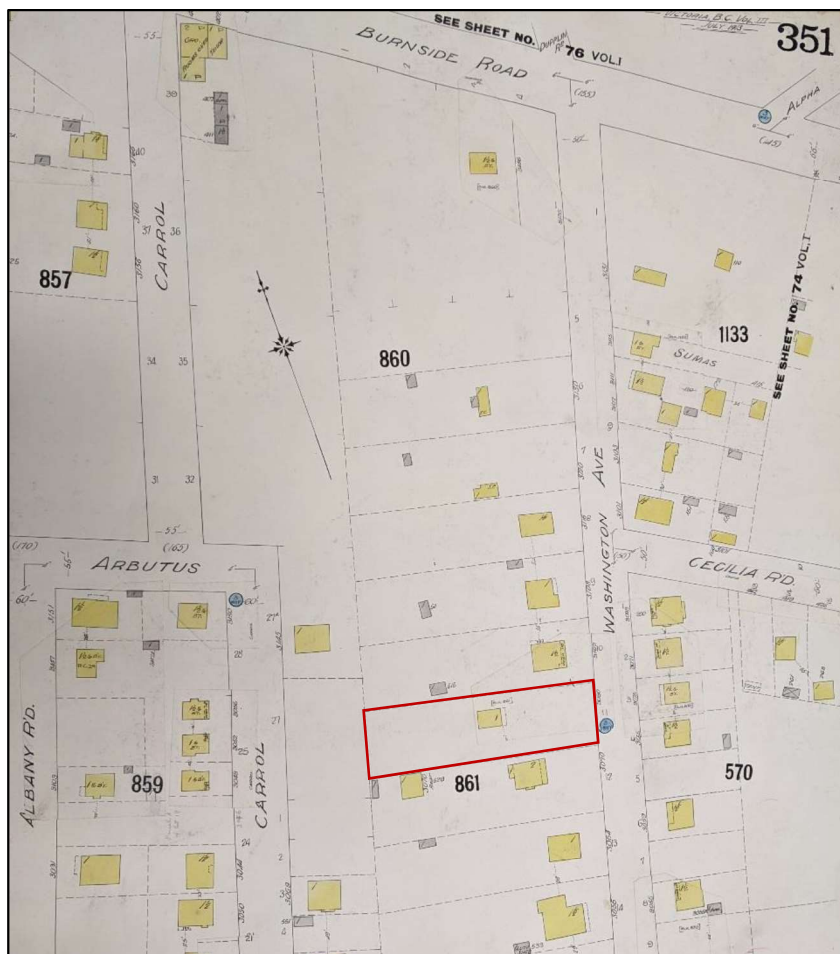
Fig. 5a: Fire Insurance Plan of Victoria, 1913. The lot of 3080 Washington Avenue is outlined in red. (Source: City of Victoria Archives, 1913 Volume III, Sheet 351)

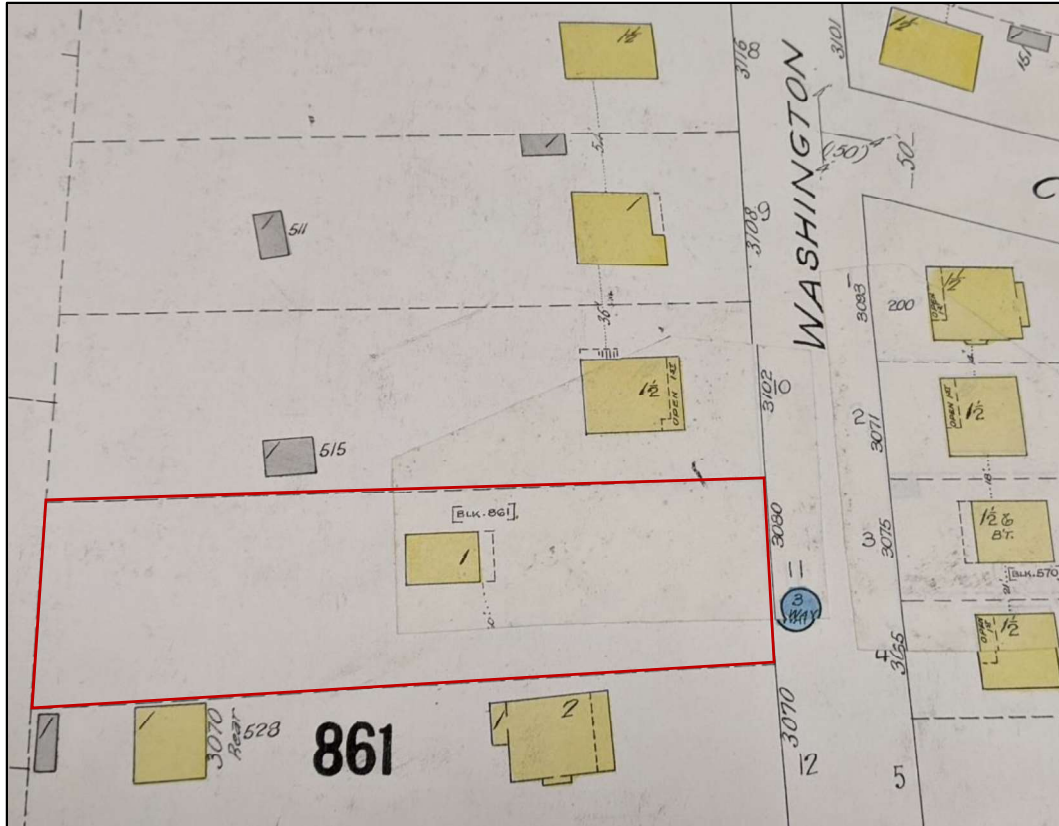
Fig. 5b: Detail of Victoria Fire Insurance Plan, 1913. The modest scale of 3080 Washington Avenue, outlined in red, is visible, as is the originally open porch. (Source: City of Victoria Archives, 1913 Volume III, Sheet 351)

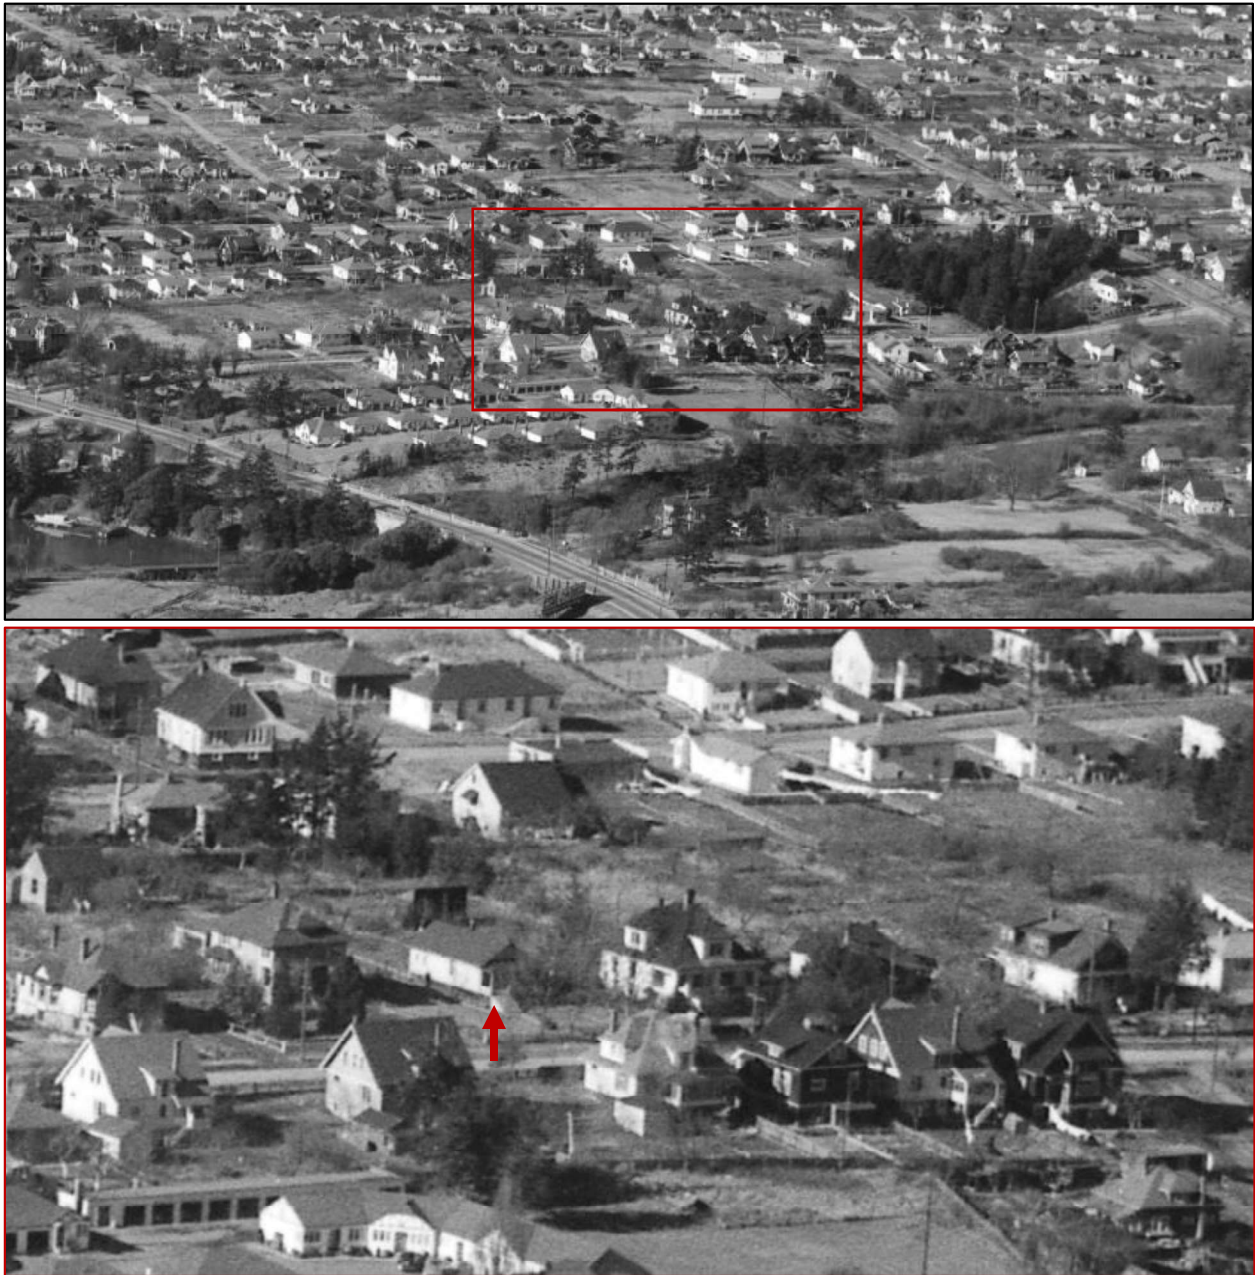
Figs. 7a and 7b: Above (Fig. 7a) is an aerial photograph of the Burnside neighbourhood, 1951, with the rough location of 3080 Washington Avenue outlined in red. Below (Fig. 7b) is a closer view of 3080 Washington Avenue and its surrounding houses, with its front steps pinpointed with a red arrow. (Source: Vintage Air, 1-79)

The neighbourhood of 3080 Washington Avenue is largely residential with surrounding houses in a range of types, scales and ages. This is distinctly visible in a 1951 aerial photograph of the area (Figs. 7a and 7b), a 2019 aerial view (Fig. 8) and a modern-day map (Fig. 9) with corresponding table (Table 2), providing the various construction dates of the surviving houses along the street.

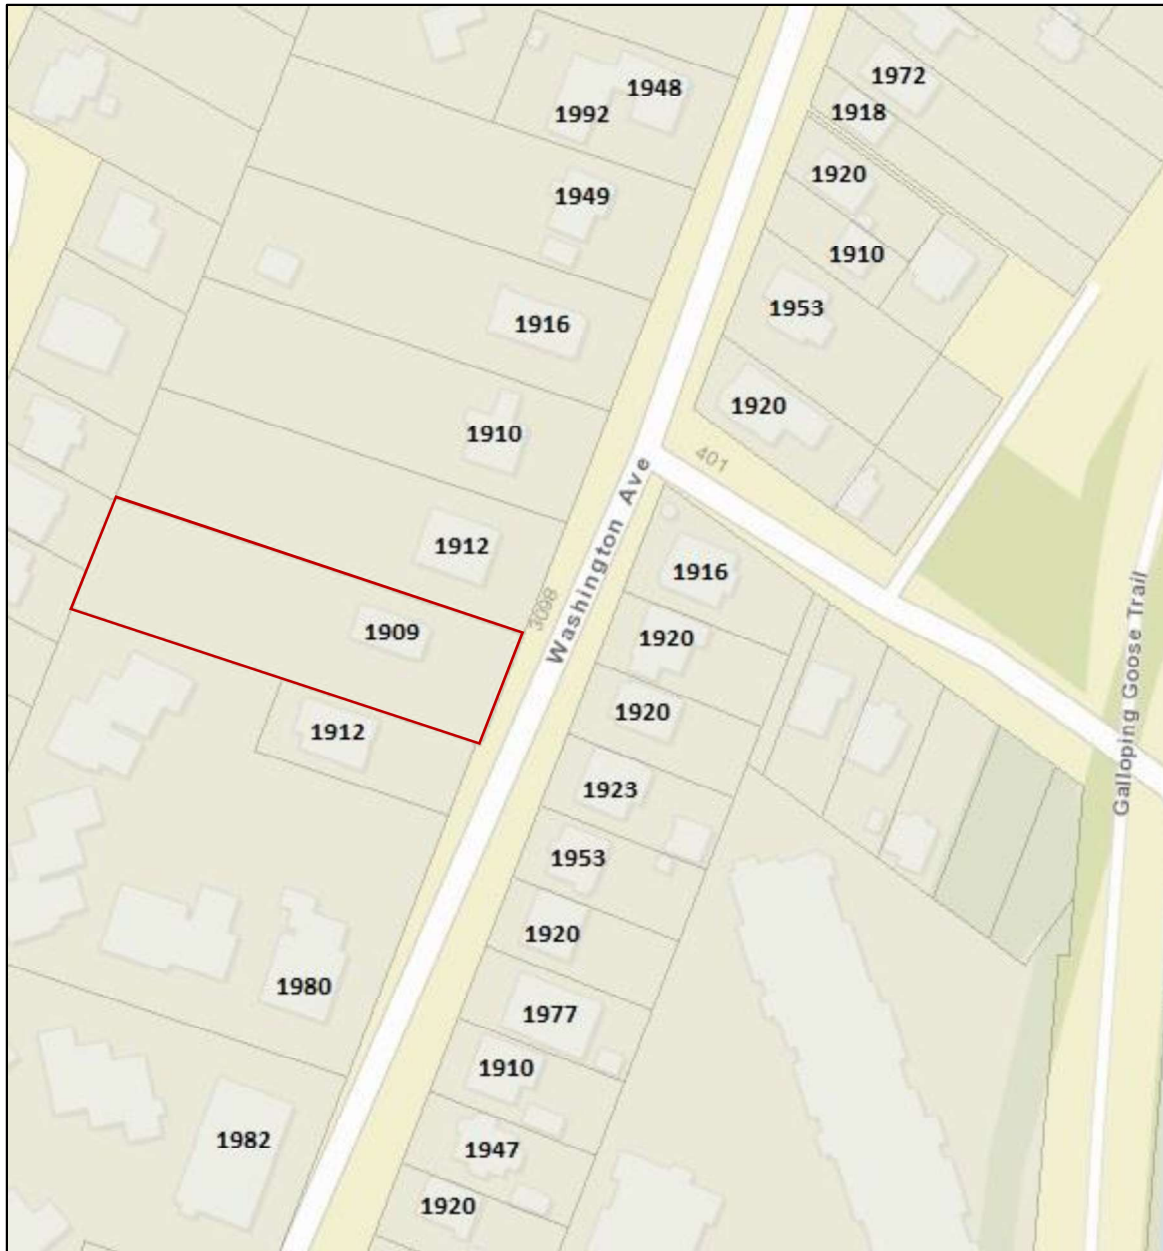
Fig. 9: Map of part of Washington Avenue, specifically the properties surrounding 3080 Washington Avenue, outlined in red, with the construction years listed for the buildings in the immediate vicinity of the study site. Note the range of years. (Source: BC Assessment with author updates)

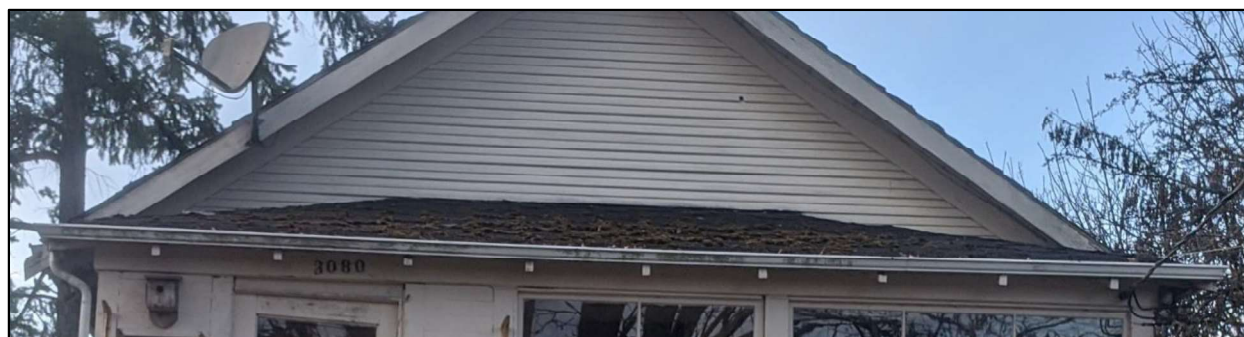
The current condition of the house at 3080 Washington Avenue is good in areas, but overall largely fair, with a few key areas in need of attention. Certain areas of the roof, such as over the closed-in porch, are in need of maintenance (Fig. 10). Most of the horizontal wood siding is in good condition (Fig. 11), particularly along the sides, with areas at the back simply in need of cleaning (Fig. 12). However, the cedar shingles along the lower portion of the house are cracked and warped in many places (Fig. 13) and it is difficult to know the state of the building beneath this deterioration. Without an interior inspection, it is hard to say the condition of the structure, overall, particularly with no view to its foundation. As for the windows, most are in good condition and appear to be the original double-hung, horned wood windows (Figs. 14 and 15). Other areas in need of attention are largely cosmetic, such as the front steps (Fig. 16). Lastly, the landscaping on site, particularly along the southern side, is potentially damaging the house in touching the wood siding and roof, as well as possibly impacting the foundation, with roots growing too close (as also visible in Fig. 11 below).

Fig. 10: Front porch roof of 3080 Washington Avenue, highlighting its need for maintenance. (Source: Cummer, 2019)
Katie Cummer, PhD CAHP – Cummer Heritage Consulting (CHC)

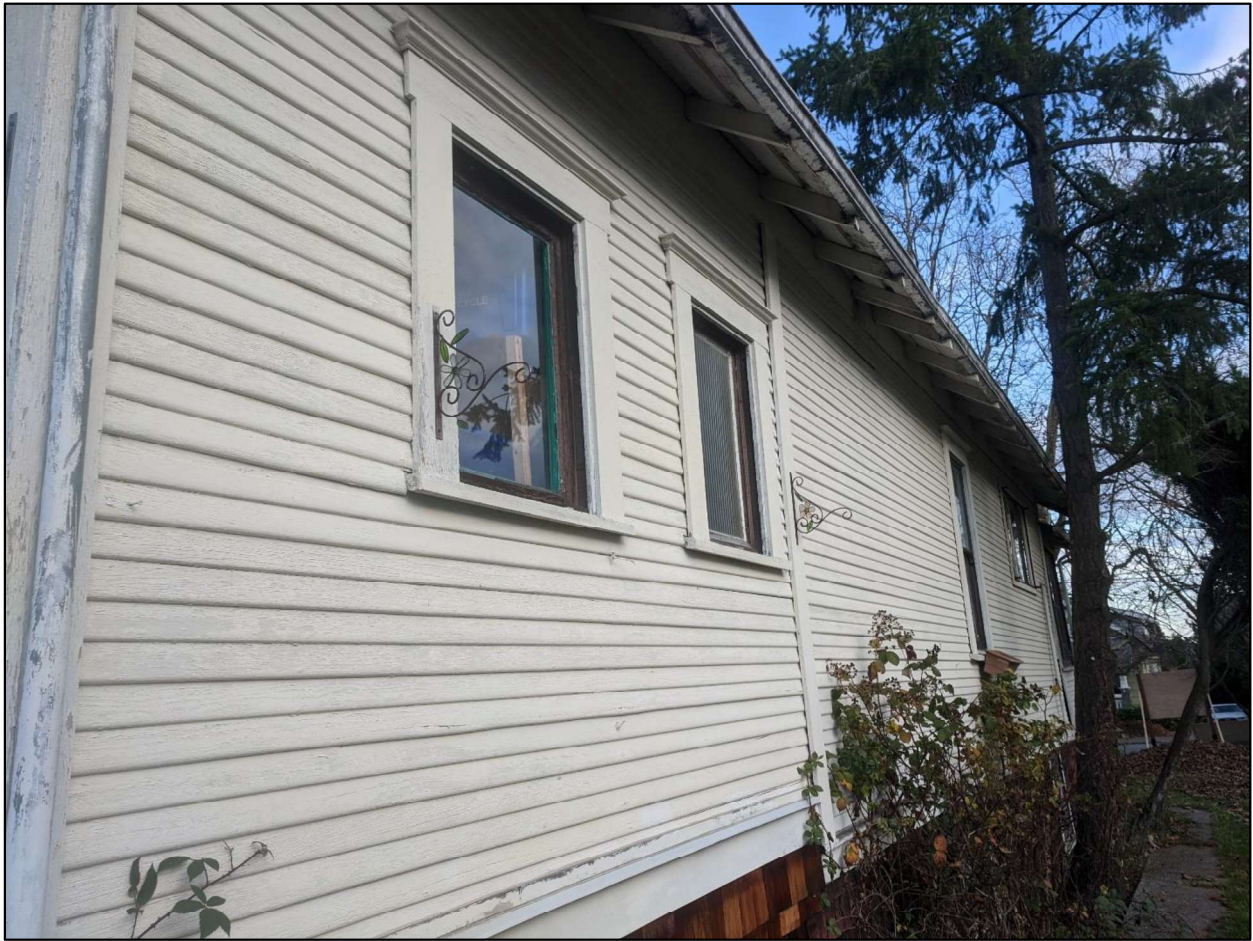
Fig. 11: Southern side view of 3080 Washington Avenue, highlighting the largely good condition of the horizontal wood siding. Please note the landscaping growth very close to the house and the floral window detailing, also visible at the front of the house. (Source: Cummer, 2019)

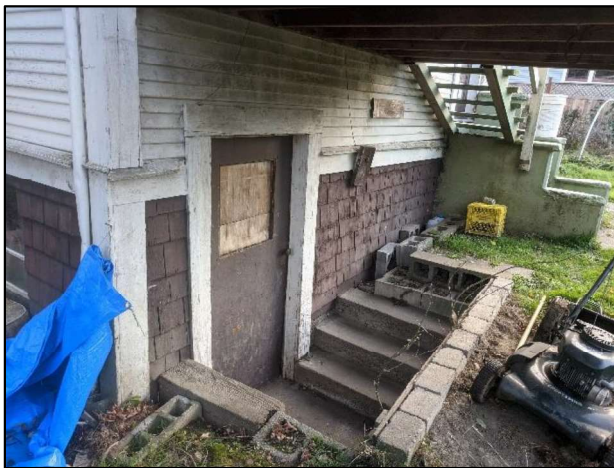
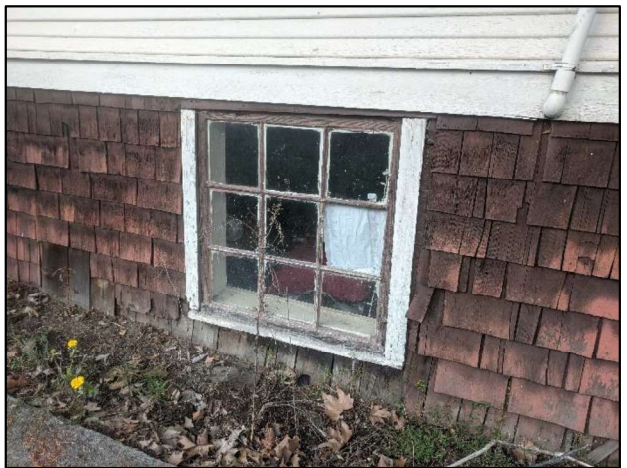
Figs. 12 and 13: Left (Fig. 12) illustrates the back of 3080 Washington Avenue, showing the horizontal wood siding in need of cleaning. Right (Fig. 13) shows the lower portion cedar shingles of 3080 Washington Avenue that are in poor condition (cracked and warped). (Sources: Cummer, 2019)

There appear to have been some minor alterations to the property carried out on the house over time, such as the closing in of the original open porch, however, nothing too major. As for its condition, certain areas of the house are in quite good condition (such as the horizontal wood siding and many of the original double-hung horned wood windows), with others simply in fair condition (such as the deteriorating cedar shingles along the lower portion of the building).

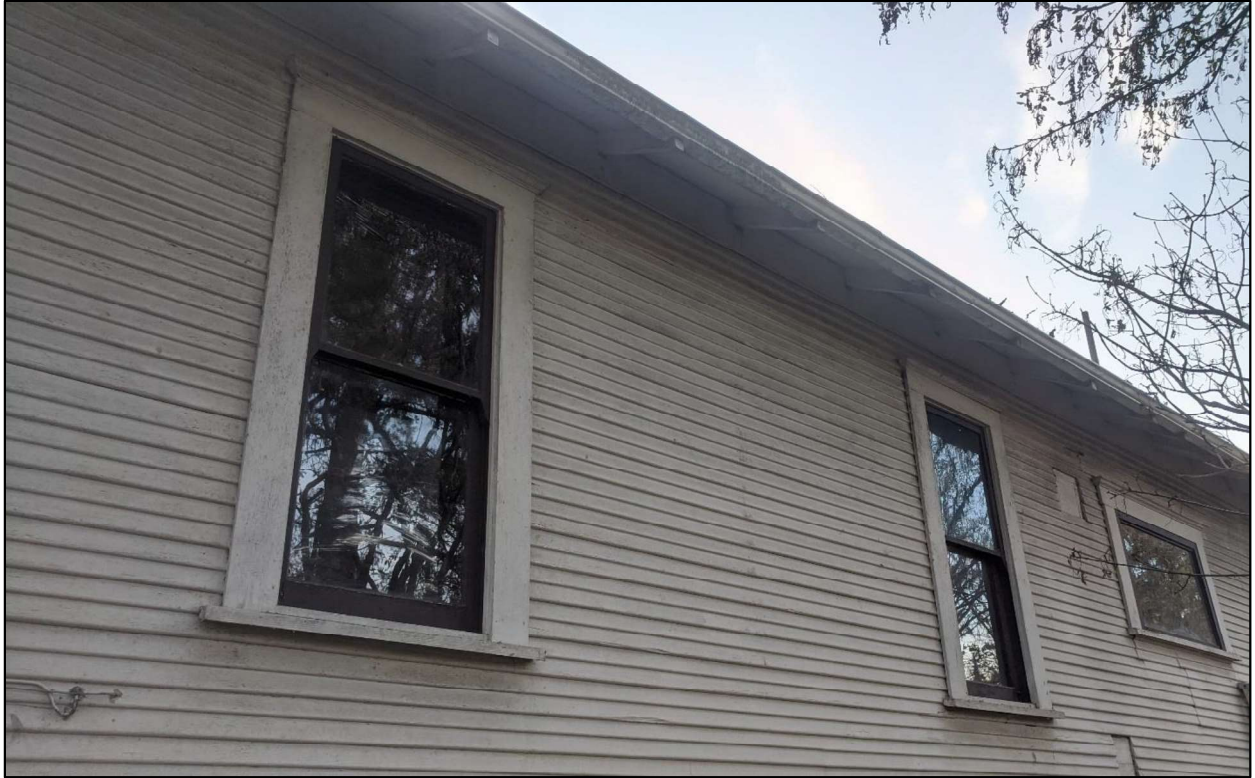
Fig. 14: Northern side view of 3080 Washington Avenue, highlighting the largely good condition of the double-hung, horned wood windows. (Source: Cummer, 2019)

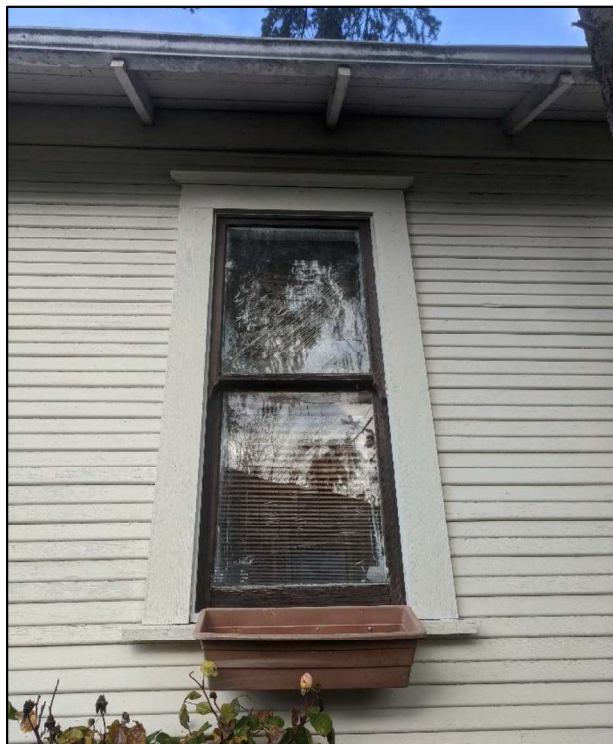
Fig. 15: Southern side view of 3080 Washington Avenue, highlighting another good condition double-hung, horned wood window. (Source: Cummer, 2019)

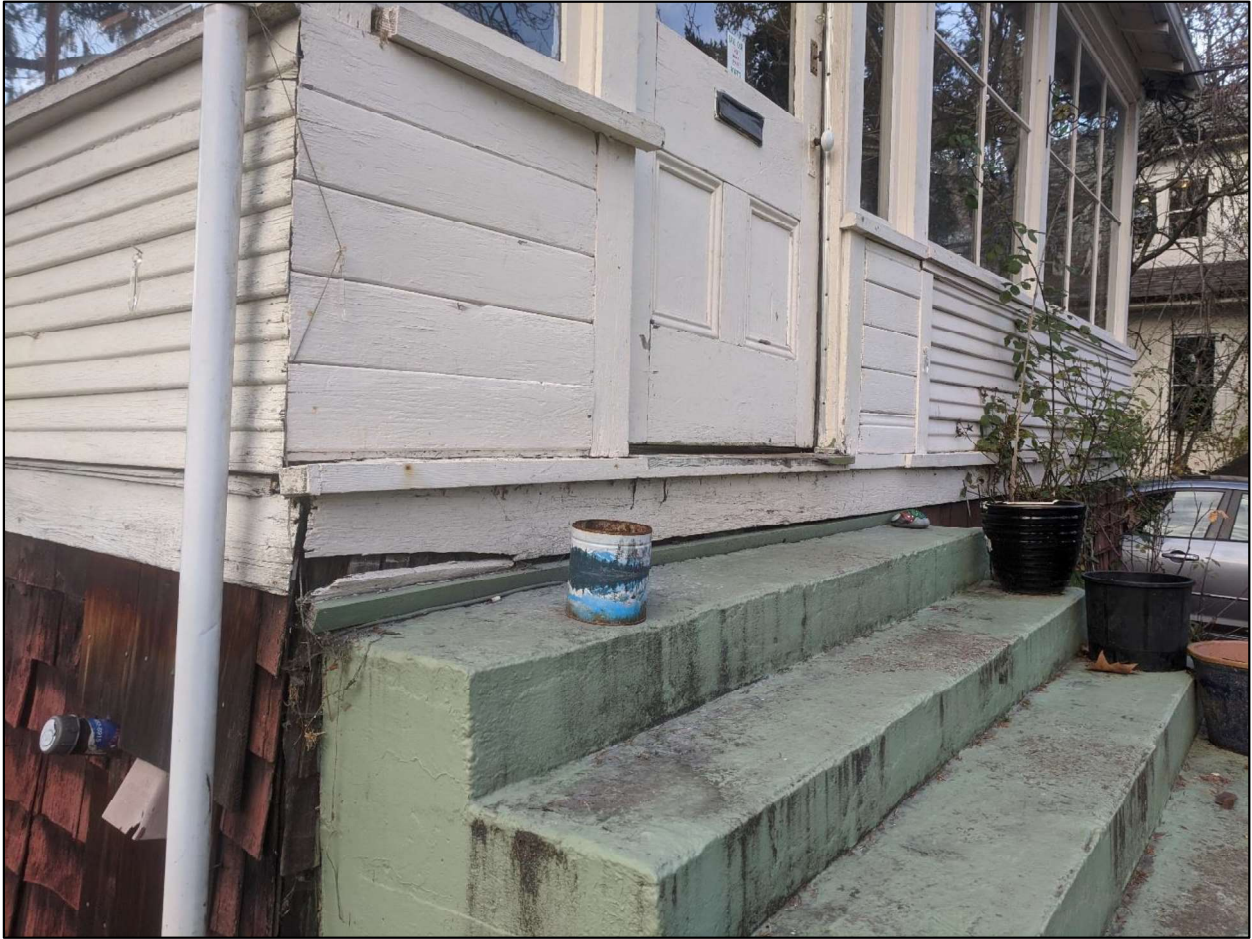
Fig. 16: Front view of 3080 Washington Avenue, highlighting some of the cosmetic work that could be done (cleaning, painting, patching, etc.). (Source: Cummer, 2019)

Based on the above, it is this professional's assessment that the house located at 3080 Washington Avenue does not have much heritage significance. That being said, if it is to be demolished, I strongly encourage materials be salvaged (such as its original double-hung, horned wood windows), as there are elements in good condition and of value that could be given a new lease of life elsewhere.

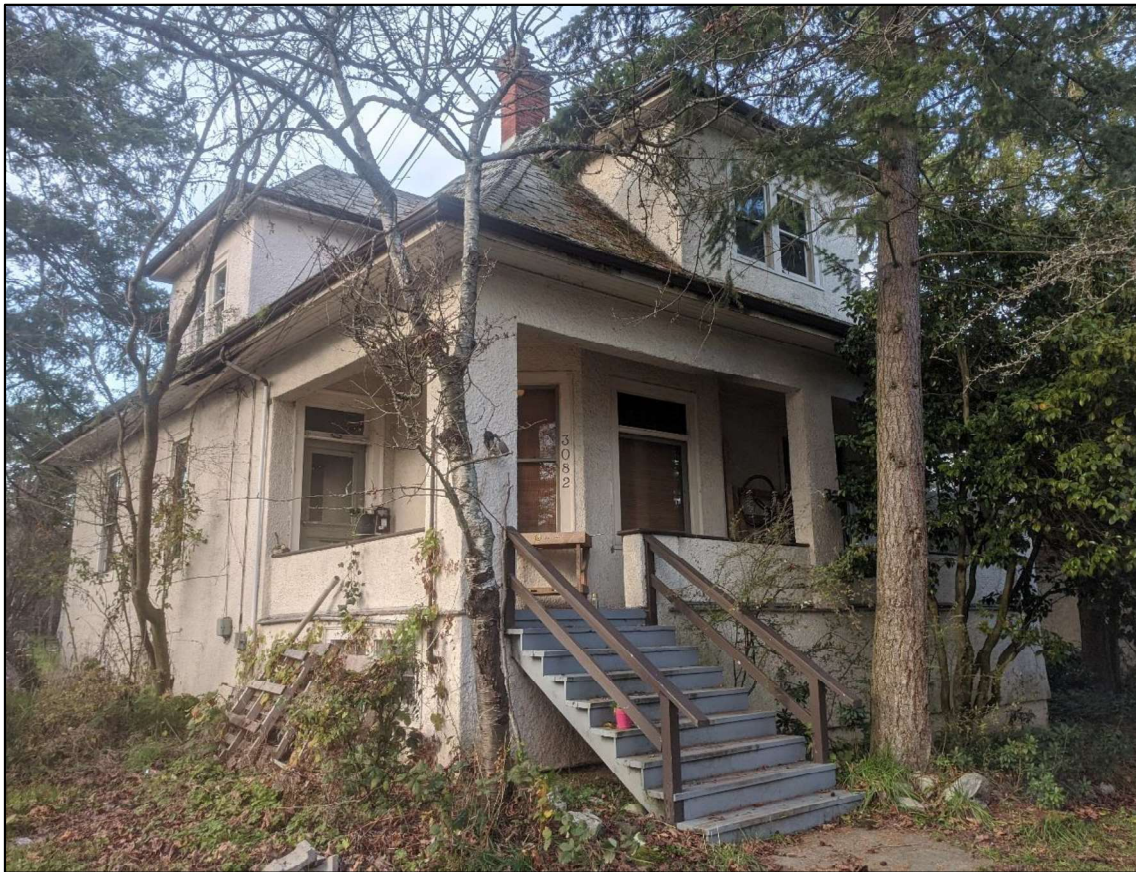
This cottage largely fits this description. Its front door is more offset than is typical, being on the far left of the front façade, with a bay window to the right of this, protruding into the middle of the front porch (Fig. 2). The house has three dormers: One at the front in the middle, with one on each side. It also has the bell-cast flare roofline, distinctly visible from the back of the property (Fig. 3). It boasts many original double-hung, horned wood windows throughout (Fig. 4), as well as a panel window (possibly stained glass) in the middle of the front bay window (Fig. 5).

Fig. 2: Front view of 3082 Washington Avenue. Note the offset front door on the left of the front façade, the bay window in the middle, the front middle dormer and the southern side dormer visible as well. (Source: Cummer, 2019)

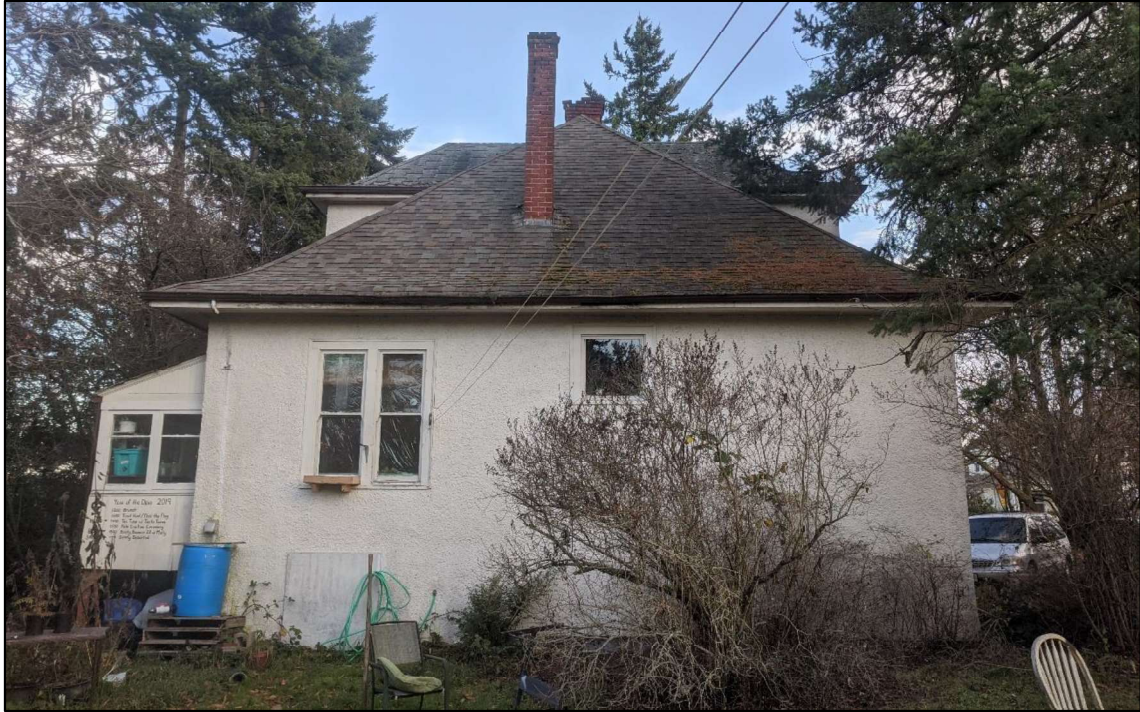
Fig. 3: Back view of 3082 Washington Avenue. Note the flared roofline and the two side dormers distinctly visible. (Source: Cummer, 2019)

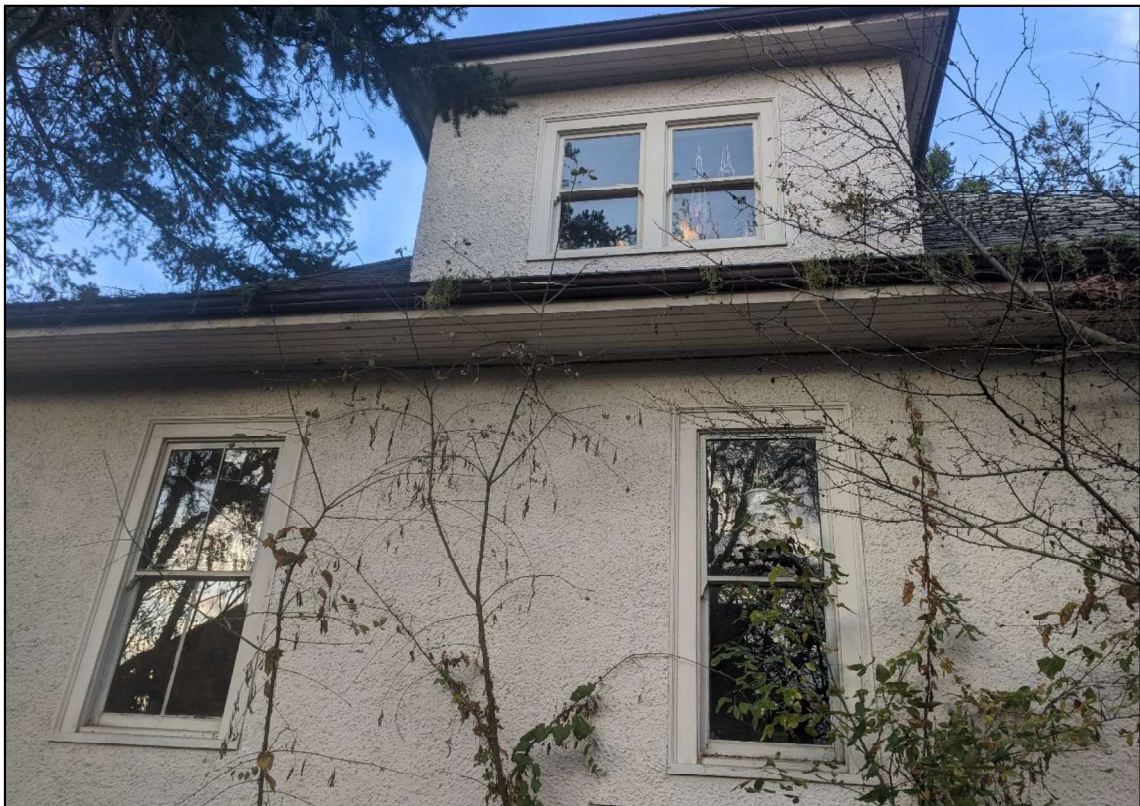
Fig. 4: Southern side view of 3082 Washington Avenue. Note four double-hung, horned wood windows. (Source: Cummer, 2019)

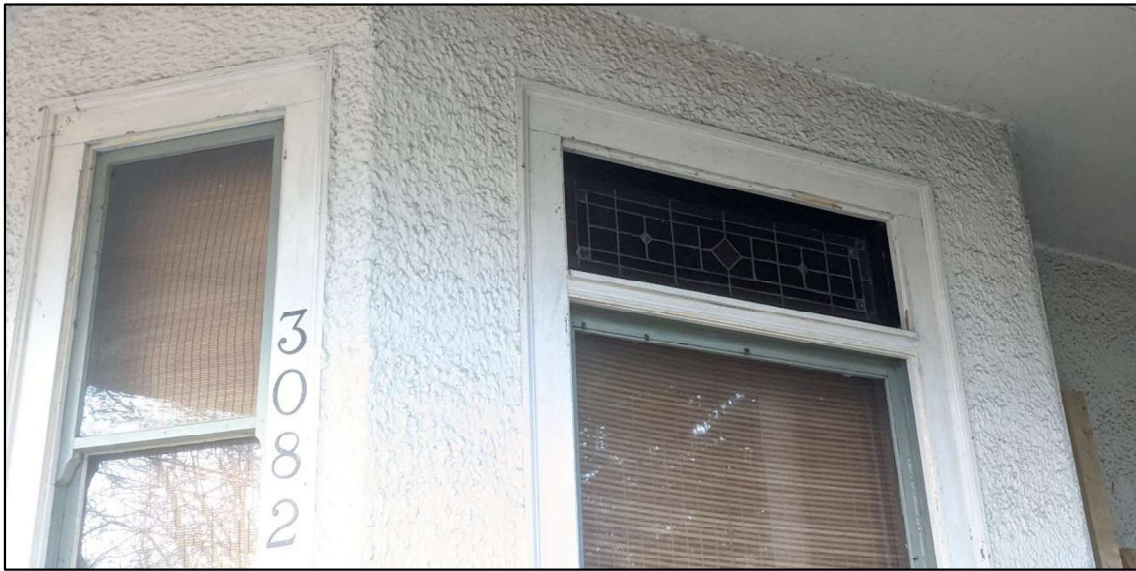
Fig. 5: Front view of 3082 Washington Avenue, showing the horizontal window panel (possibly stained glass) above the middle of the bay window. Note another double-hung, horned wood window on the left. (Source: Cummer, 2019)

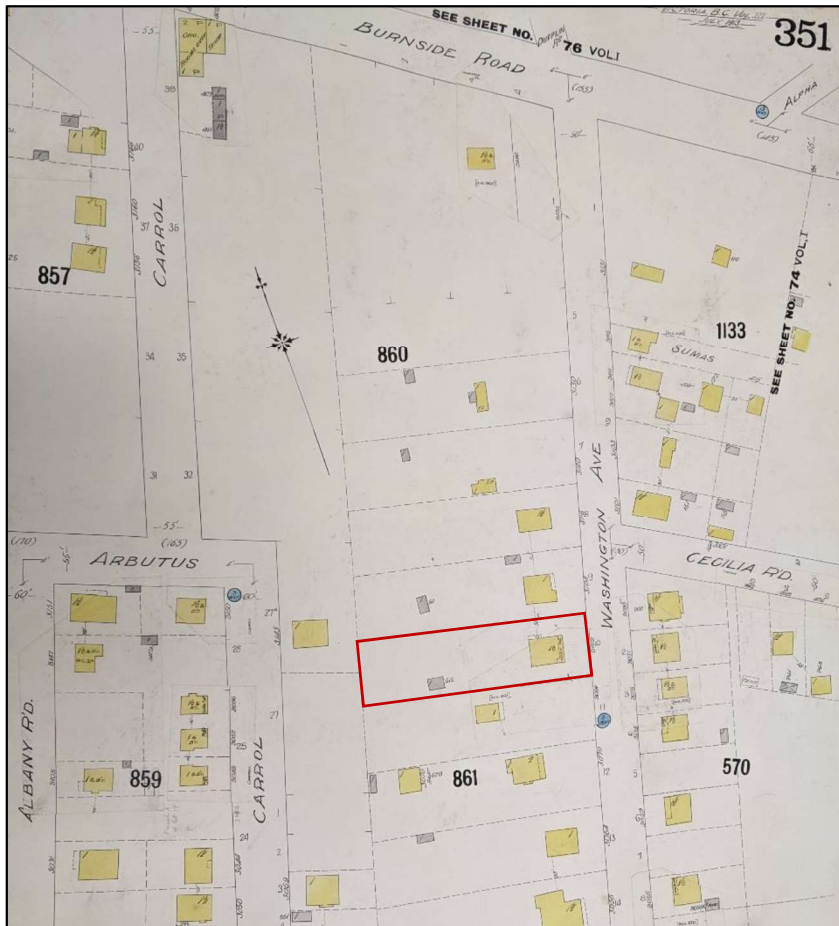
Fig. 6a: Fire Insurance Plan of Victoria, 1913. The lot of 3082 Washington Avenue is outlined in red. (Source: City of Victoria Archives, 1913 Volume III, Sheet 351)

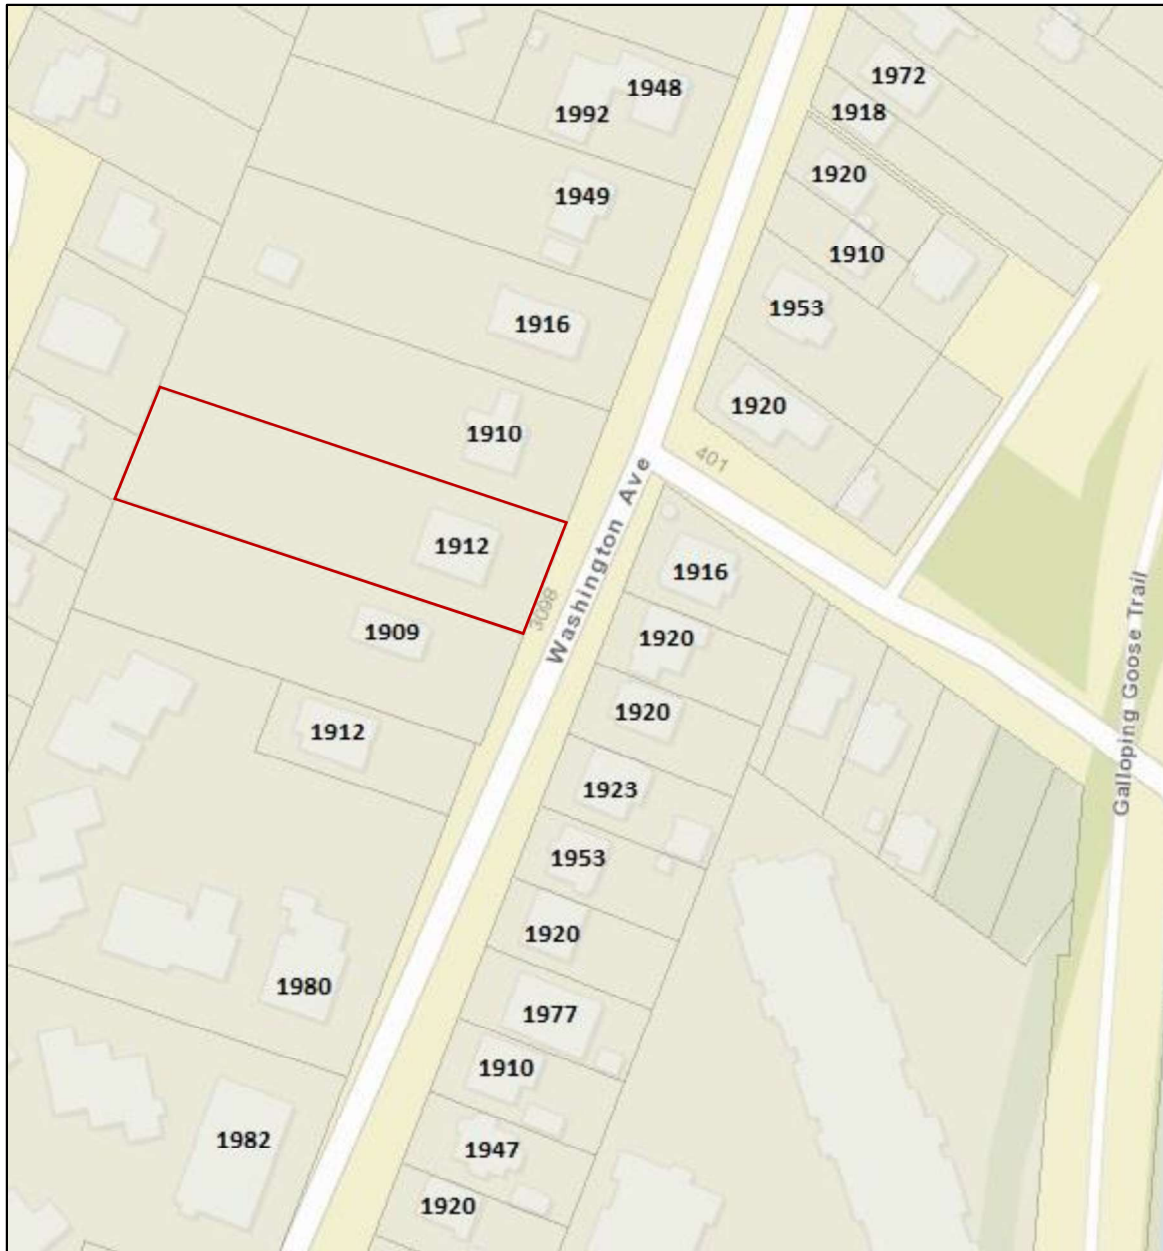
Fig. 11: Map of part of Washington Avenue, specifically the properties surrounding 3082 Washington Avenue, outlined in red, with the construction years listed for the buildings in the immediate vicinity of the study site. Note the range of years. (Source: BC Assessment with author updates)

The neighbourhood of 3082 Washington Avenue is largely residential with surrounding houses in a range of types, scales and ages. This is distinctly visible in a 1951 aerial photograph of the area (Figs. 9a and 9b), a 2019 aerial view (Fig. 10) and a modern-day map (Fig. 11) with corresponding table (Table 2), providing the various construction dates of the surviving houses along the street.

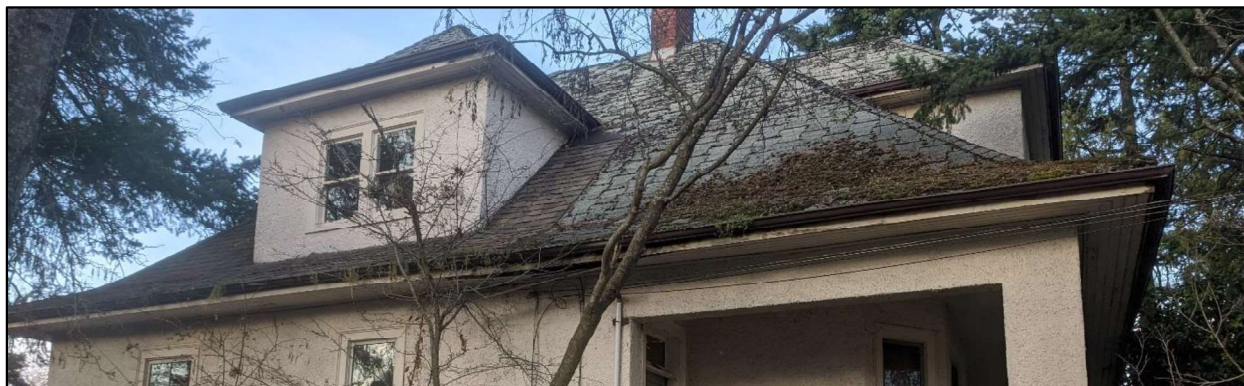
The current condition of the house at 3082 Washington Avenue is good in areas, but overall largely fair, with some key areas in need of attention. Many parts of the roof, both at the front and back, are in need of maintenance (Fig. 12). The concrete foundation also appears to be cracking in places, which could be an indication of larger structural concerns (Fig. 13). There are areas of stucco in need of maintenance as well. As mentioned above in the overview discussion, most of the windows are in good condition and appear to be the original double-hung, horned wood windows. One of the chimneys is in very poor condition with bricks missing, having fallen off (Fig. 14). Lastly, the landscaping on site, on all sides, is potentially damaging the house, touching the sides and roof, as well as possibly impacting the foundation, with roots growing too close (Fig. 15).

Fig. 12: Front roof of 3082 Washington Avenue, highlighting its need for maintenance. (Source: Cummer, 2019)

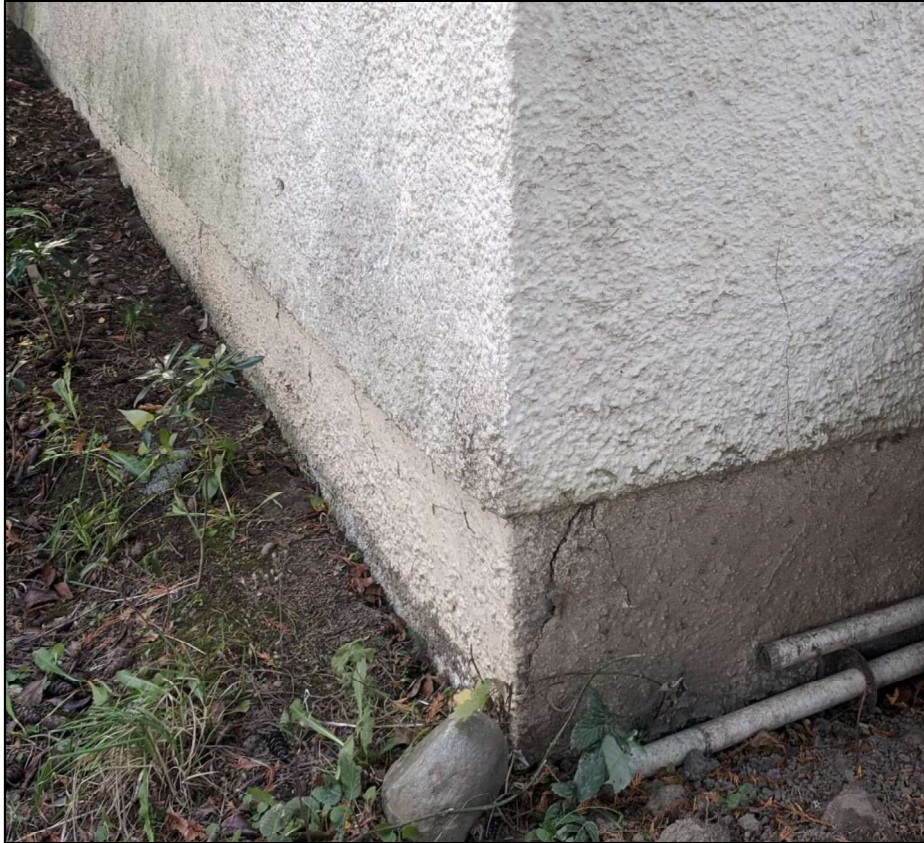
Fig. 13: Northeastern corner view of the concrete foundation of 3082 Washington Avenue, highlighting the cracks appearing and some of the stucco in need of maintenance as well. (Source: Cummer, 2019)

There appear to have been some minor alterations to the property carried out on the house over time, such as a possible back extension, however, nothing too major. As for its condition, certain areas of the house are in quite good condition (such as its double-hung horned wood windows), with others simply in fair condition (such as its roof, front chimney and cracked foundation, which could potentially indicate larger structural concerns).

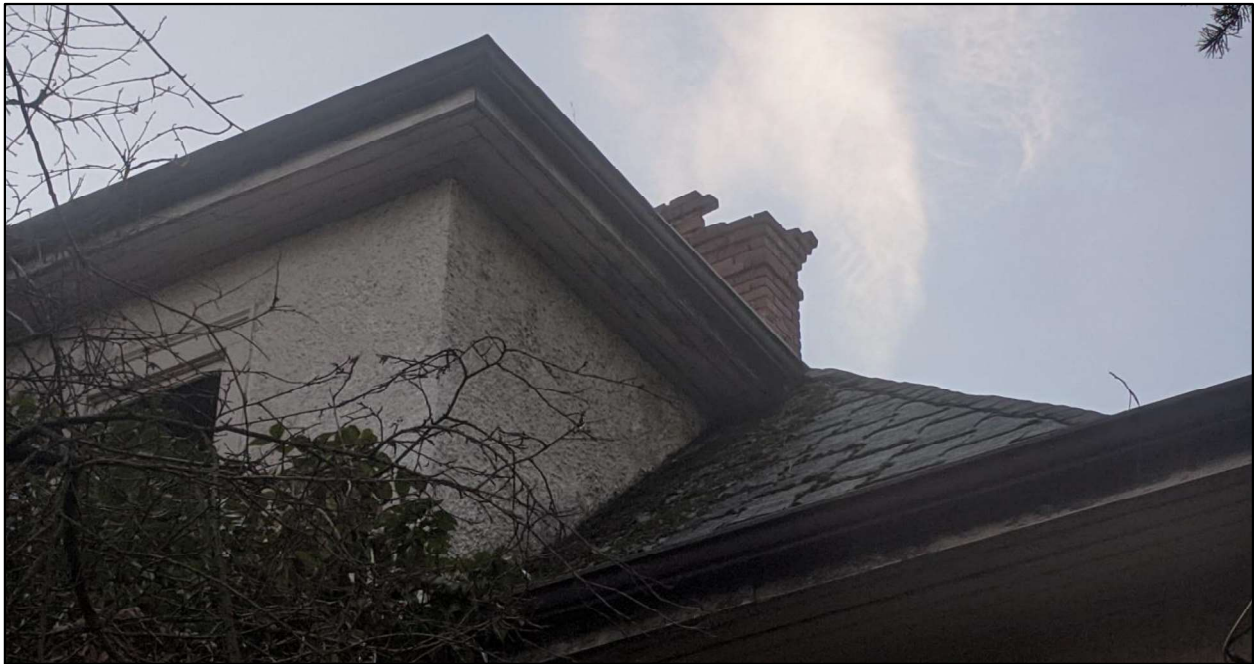
Fig. 14: Northeastern corner view of the front of 3082 Washington Avenue, highlighting the damaged chimney, another patch of mossy roofing and an example of the landscaping encroaching on the house. (Source: Cummer, 2019)
