Cummer Heritage Consulting

Heritage Assessment and Evaluation

3080 Washington Avenue, Victoria, BC

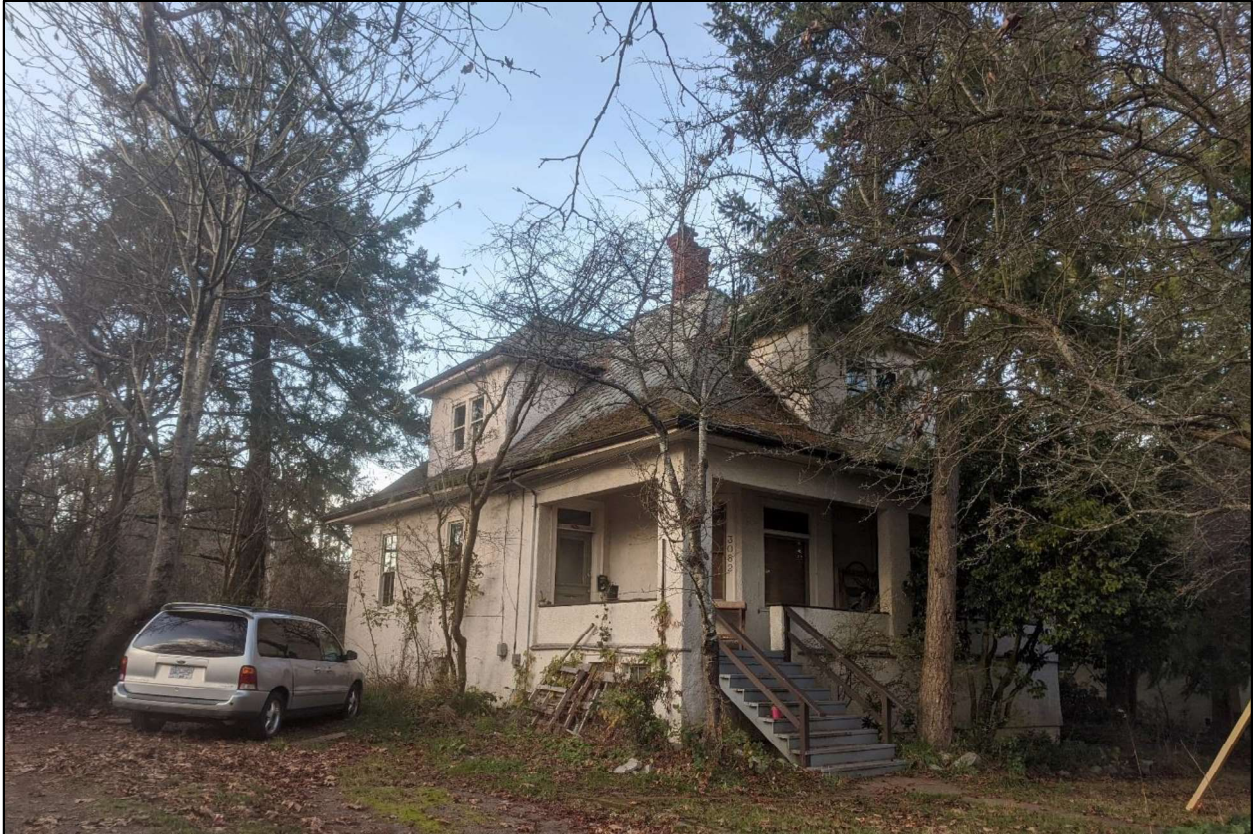
Fig. 15: Front view of 3082 Washington Avenue, highlighting the range of landscaping on site encroaching on the house. (Source: Cummer, 2019)
