Committee of the Whole Report

Subject: Development Permit with Variance Application No. 00129 for 1035 Joan Crescent

Semi-Attached Dwellings Project - DEVELOPMENT VARIANCE PERMIT APPLICATION (REVISED)
6 January 2020

1035 Joan Crescent Exploratory Excavation Photos May 10, 2019

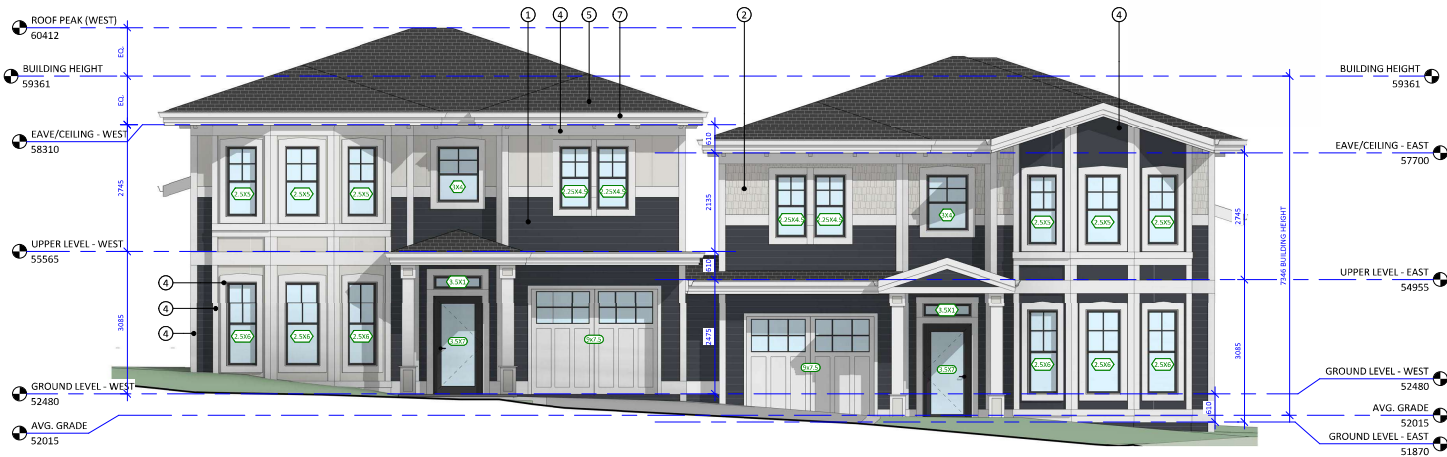
1 BUILDING ELEVATION - SOUTH
1:50

MATERIALS LEGEND	
1	CEMENTITIOUS LAP SIDING, PAINTED
2	CEMENTITIOUS SHINGLE SIDING, PAINTED
3	CEMENTITIOUS BOARD & BATTEN, PAINTED
4	WOOD TRIM, PAINTED
5	ASPHALT/FLYSHALE ROOFING
6	LOW SLOPE ROOFING SYSTEM
7	METAL ROOF GUTTER, PREFINISHED

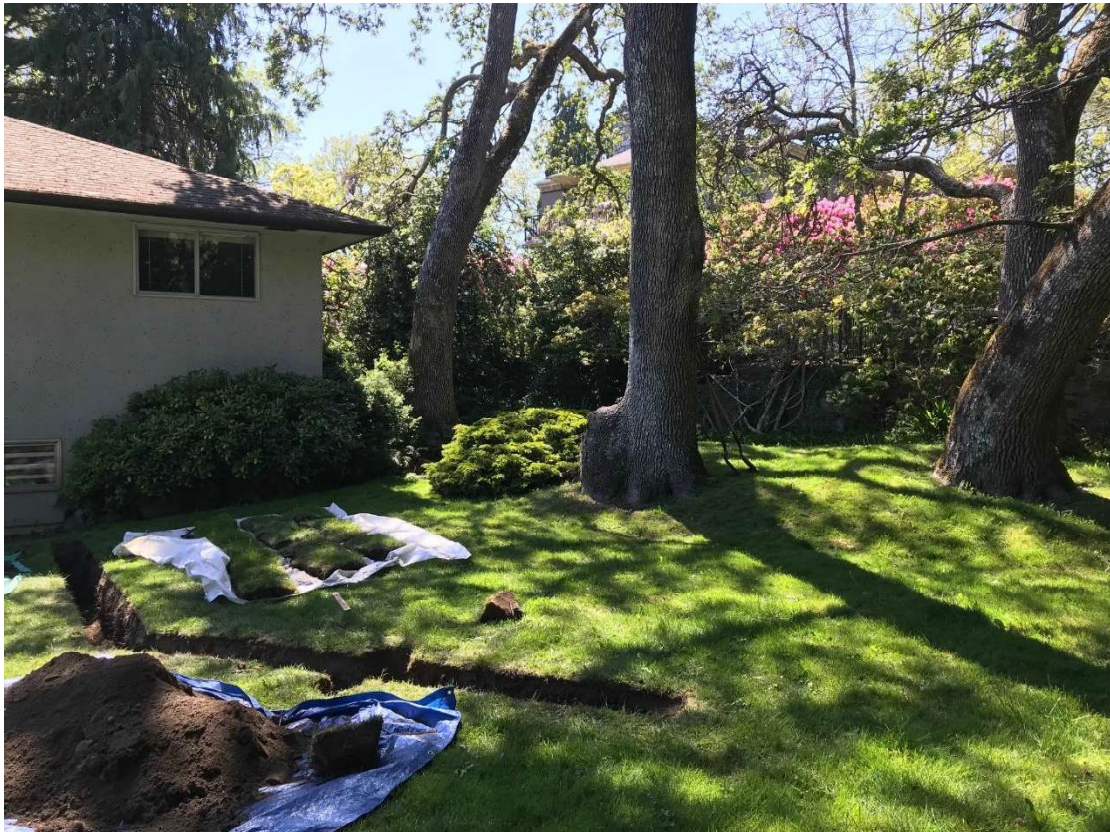
A trench was hand-dug at the approximate location of the proposed foundation excavation, 4.5m from Oak #201.

All roots were damaged by the hand-digging and were pruned back to sound tissue. We anticipate the oak will recover from this root loss with no significant impact on its health or stability. If the excavation required for the foundation is deeper than 40-50cm, there is the possibility of more roots being encountered, but based on observations of root density and depths within the trench, we do not anticipate a significant amount will be encountered below this area.

The lowest limb of the oak will require pruning for building clearance and at most, will require pruning back to the upright lateral ~4m from the trunk; the pruning cut would be approximately ~20cm at most. We recommend part of this pruning take place first at the beginning of construction to raise the canopy of the limb away from potential machinery, and second during the framing stage of the project.

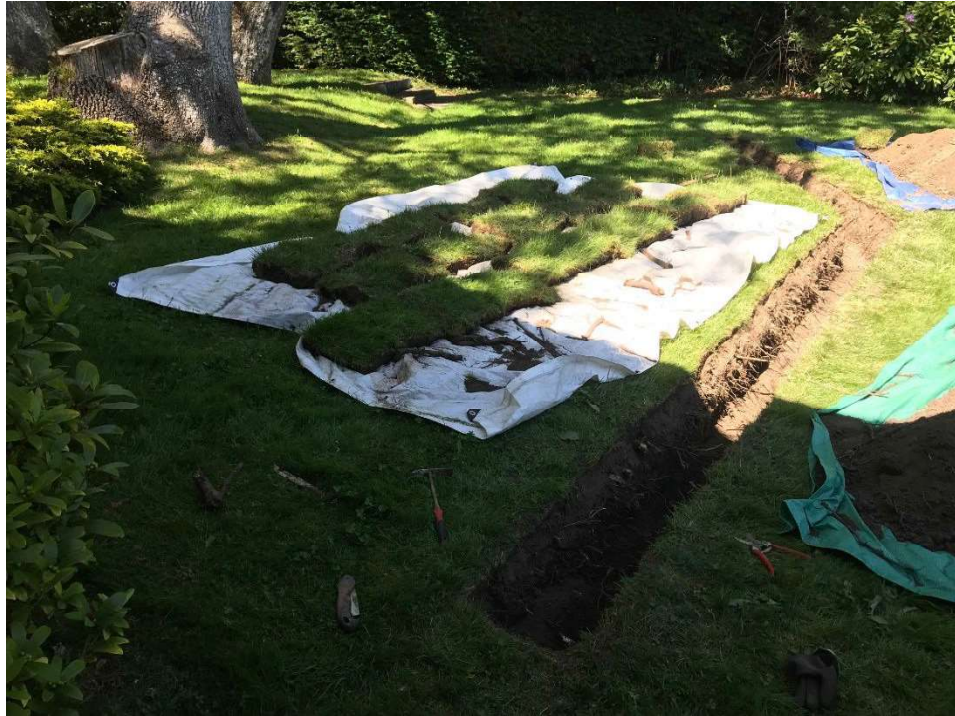
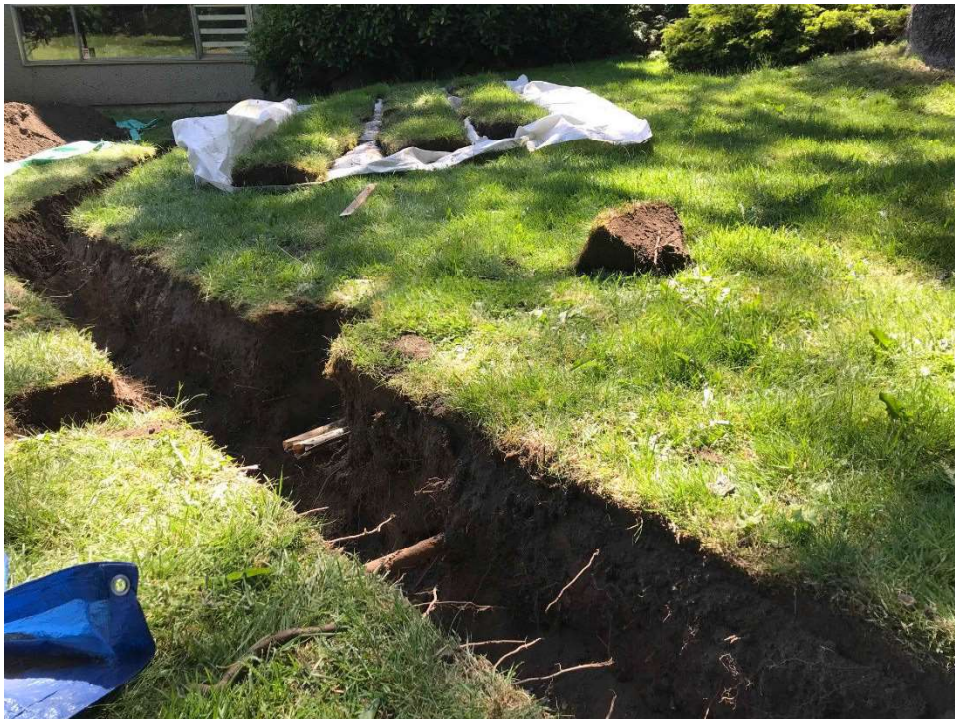
Pruned oak roots damaged or severed during hand-digging

The following roots were observed within the trench:

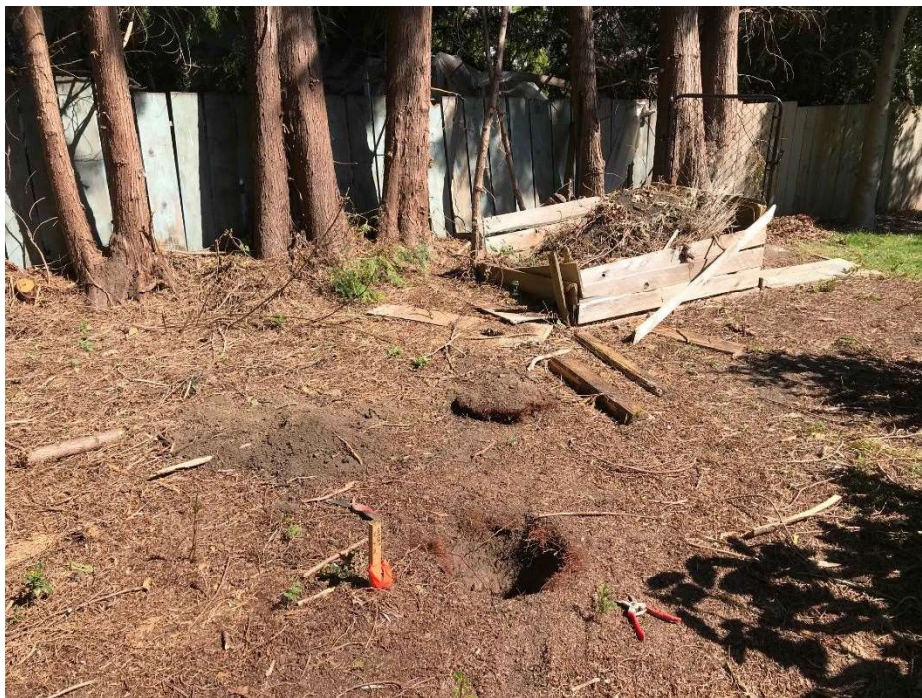
Test hole at patio deck footing location, ~5m from Cedar #207..

Cedar #207 is ~5m from the excavation for the patio footing. Minimal working room is expected for the patio footing and the foundation excavation will be a further 1m away at its closest point to the tree. A small test hole was dug near the footing location, 5m west from the tree. A moderate density of fibrous roots and two 1cm roots were observed.

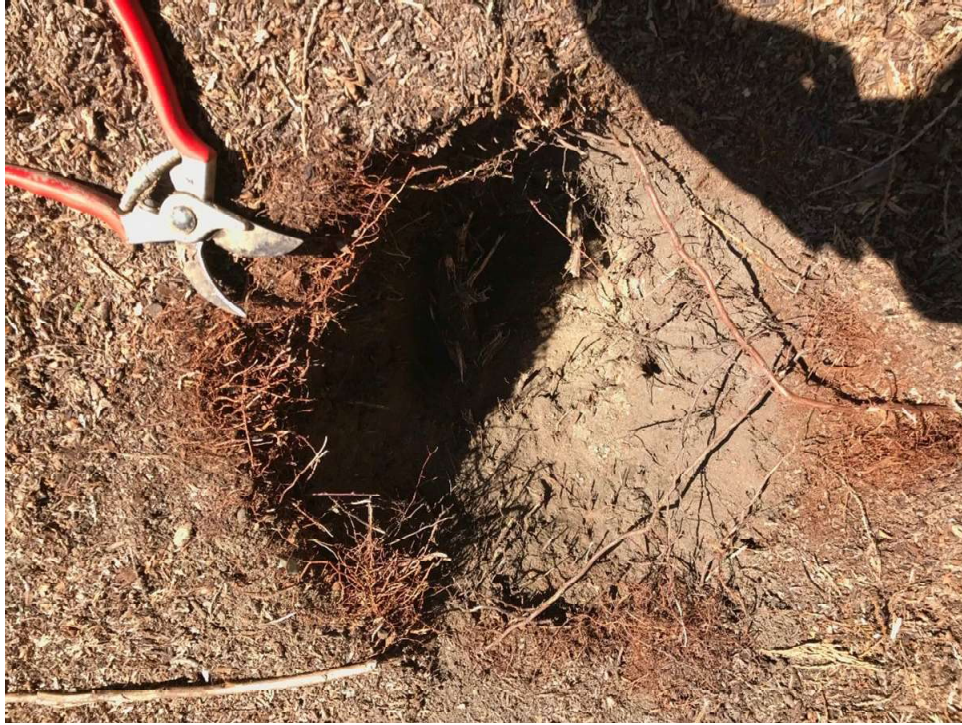
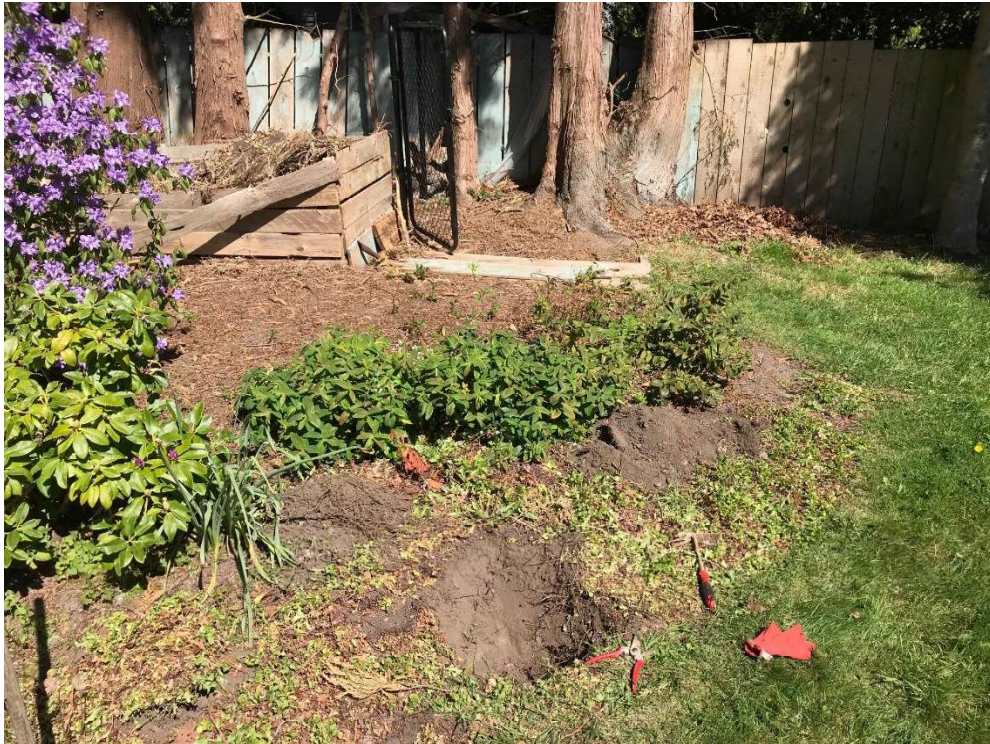
Test hole 4m west from Cedar #208 at approximate location of foundation excavation. One 6cm root was encountered (following picture).

This tree is at the end of the row of trees and is ~4.7m from the proposed house foundation corner (at its closest point). If only 1m of working room is required, the house foundation excavation will extend to 3.7m from the tree. A test hole was dug 4m west from the trunk. One 6cm and a high density of small fibrous roots were observed. Root loss is therefore expected, but considering the remaining protected root zone, we anticipate the tree will recover.

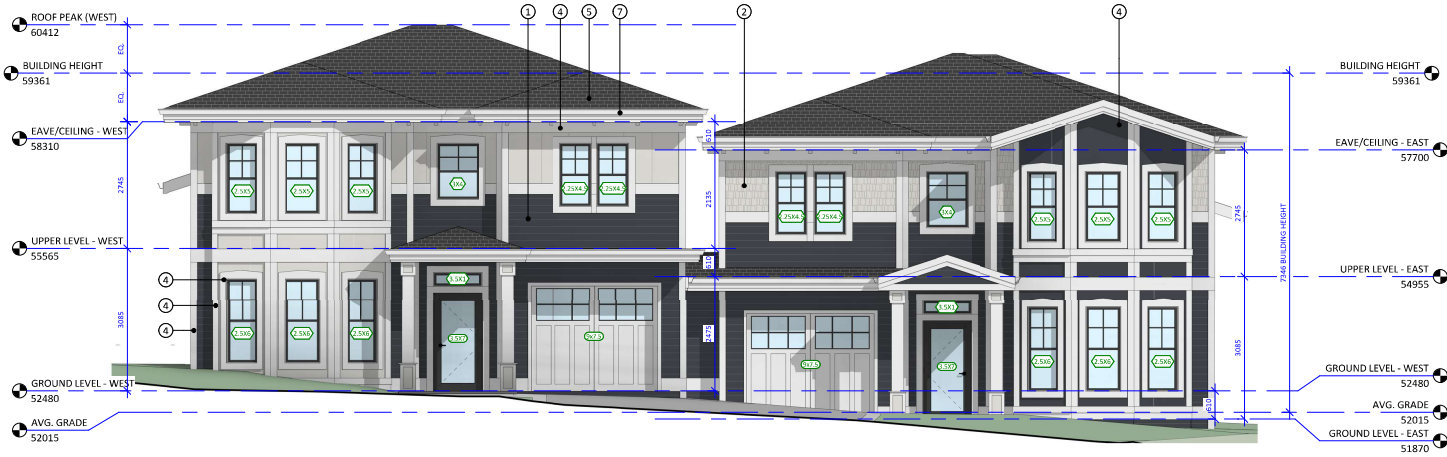
1 BUILDING ELEVATION - SOUTH
1:50

MATERIALS LEGEND	
1	CEMENTITIOUS LAP SIDING, PAINTED
2	CEMENTITIOUS SHINGLE SIDING, PAINTED
3	CEMENTITIOUS BOARD & BATTEN, PAINTED
4	WOOD TRIM, PAINTED
5	ASPHALT/FLYSHINGLE ROOFING
6	LOW SLOPE ROOFING SYSTEM
7	METAL ROOF GUTTER, PREFINISHED

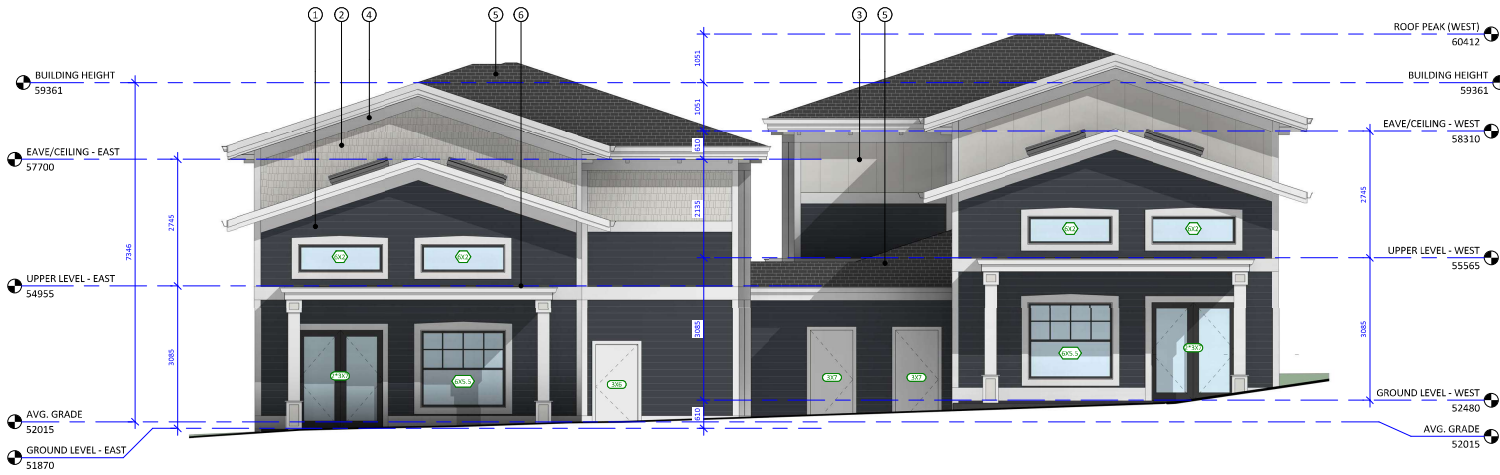
1 BUILDING ELEVATION - NORTH
A1.02 1:50

MATERIALS LEGEND	
1	CEMENTITIOUS LAP SIDING, PAINTED
2	CEMENTITIOUS SHINGLE SIDING, PAINTED
3	CEMENTITIOUS BOARD & BATTEN, PAINTED
4	WOOD TRIM, PAINTED
5	ASPHALT/FLYSHINGLE ROOFING
6	LOW SLOPE ROOFING SYSTEM
7	METAL ROOF GUTTER, PREFINISHED

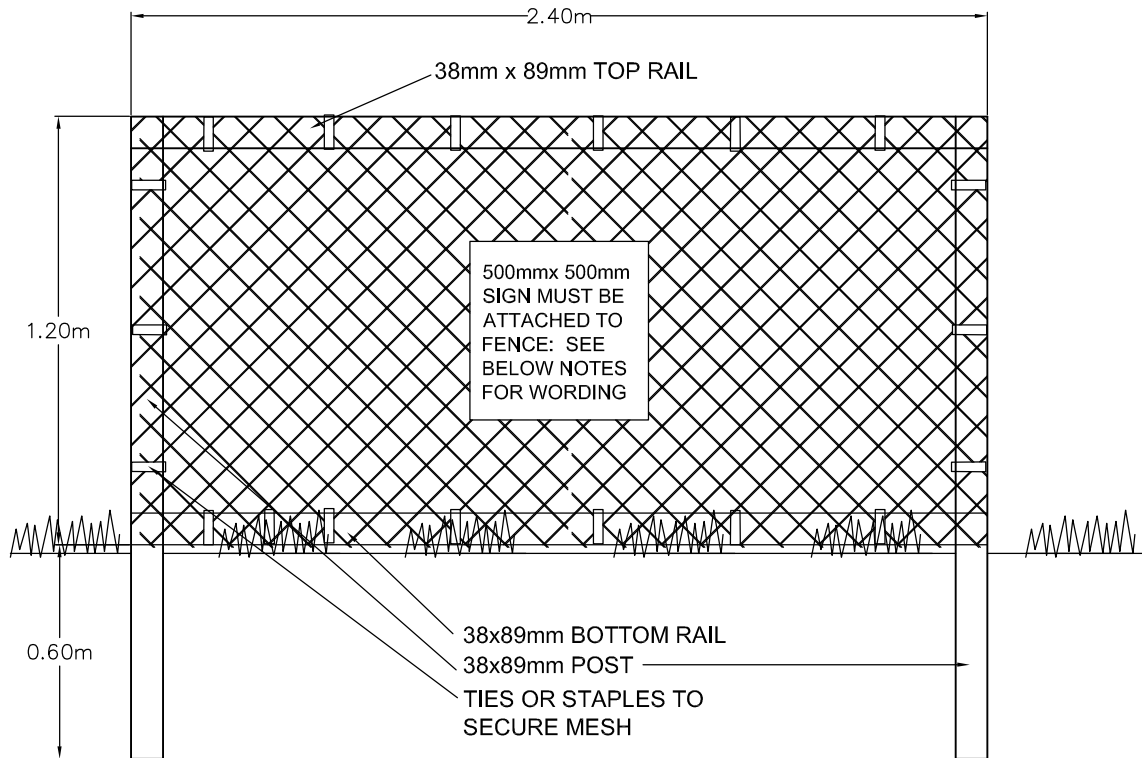
TREE PROTECTION FENCING

1. FENCE WILL BE CONSTRUCTED USING 38 mm X 89mm WOOD FRAME: TOP, BOTTOM AND POSTS * USE ORANGE SNOW-FENCING MESH AND SECURE THE WOOD FRAME WITH "ZIP" TIES OR GALVANIZED STAPLES.
 2. ATTACH A 500mm X 500mm SIGN WITH THE FOLLOWING WORDING: WARNING- TREE PROTECTION AREA. THIS SIGN MUST BE AFFIXED ON EVERY FENCE OR AT LEAST EVERY 10 LINEAR METERS.
- * IN ROCKY AREAS, METAL POSTS (T-BAR OR REBAR) DRILLED INTO ROCK WILL BE ACCEPTED

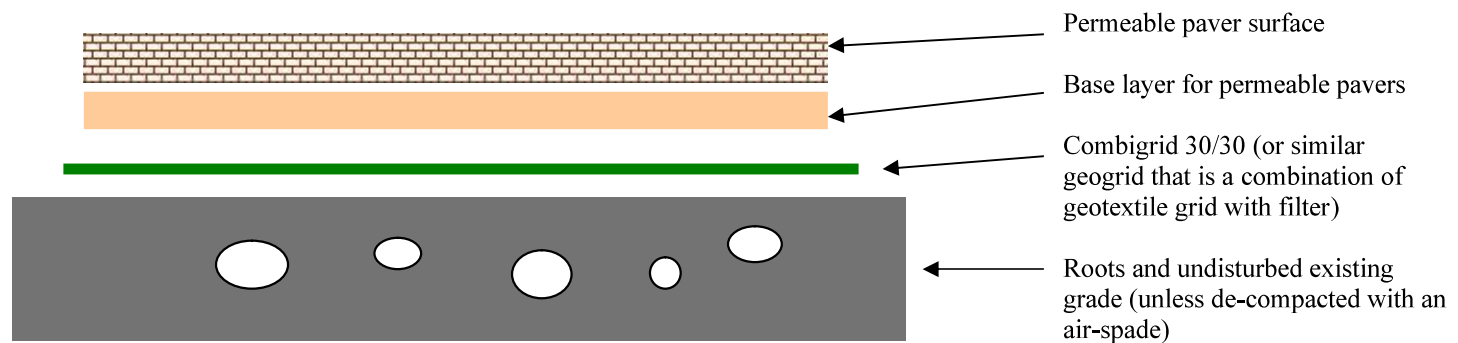
Diagram – Permeable paver surface crossing over Critical Root Zone

Specification #1 for Paved Surfaces Over Critical Root Zones (driveway, parking or walkway areas)

1. Minimal excavation to remove turf and loose soil for the required permeable surface, under the supervision of the project arborist. Root loss to be avoided.
2. A layer of Combigrd 30/30 geotextile is to be installed over the existing grade.
3. Construct base layer of well-draining material and permeable surface over geogrid layer to required grade.

If significant roots are encountered, excavation should be stopped and a geogrid material (such as CombiGrid 30/30 or similar) placed over the area to reduce compaction and to disperse weight over soils high in organics and roots. The base material for the paving should be placed above this material and should be well-draining (filter cloth or geotextile fabric may be recommended to separate coarse and fine layers in order to ensure this layer is well-aerated). Ultimately, a geotechnical engineer should be consulted and, in consultation with the project arborist, may specify their own materials and methods that are specific to the site's grading, soil conditions and requirements, while also avoiding root loss, reducing compaction to the sub-grade and ensuring long-term permeability.

Ideally, to allow water to drain into the root systems below, the project arborist may recommend that the surface be made of a permeable material (instead of conventional asphalt or concrete) such as permeable asphalt, paving stones, or other porous paving materials and designs such as those utilized by Grasspave, Gravelpave, Grasscrete and open-grid systems. The driveway could also be constructed as a "ribbon driveway" with an unpaved area between the two-tracks.
