YATES BLOCK

1244 WHARF STREET, VICTORIA, BC

CONSERVATION PLAN

SEPTEMBER 2020

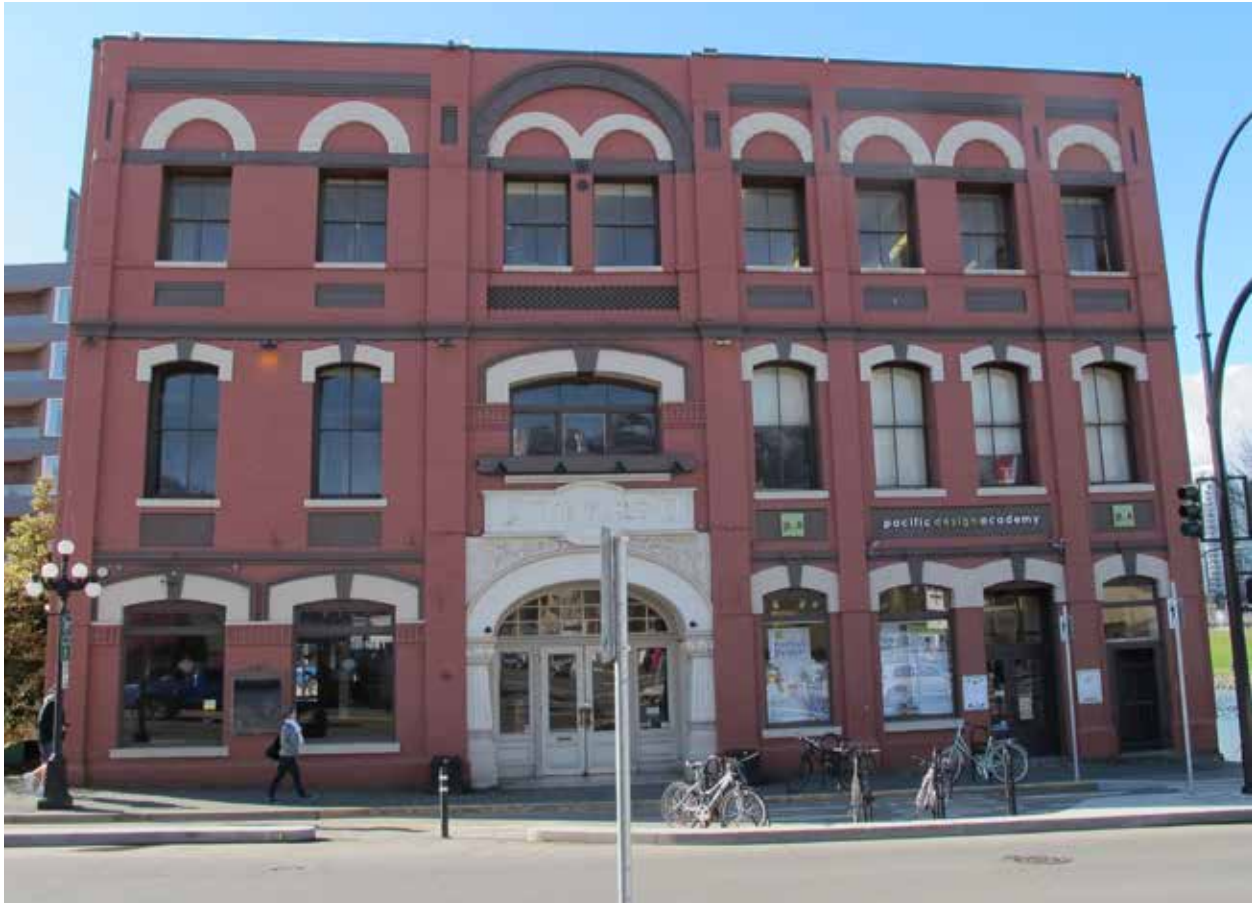
Front elevation of the Yates Block showing multi-wythe brick walls with brick and stone detailing.

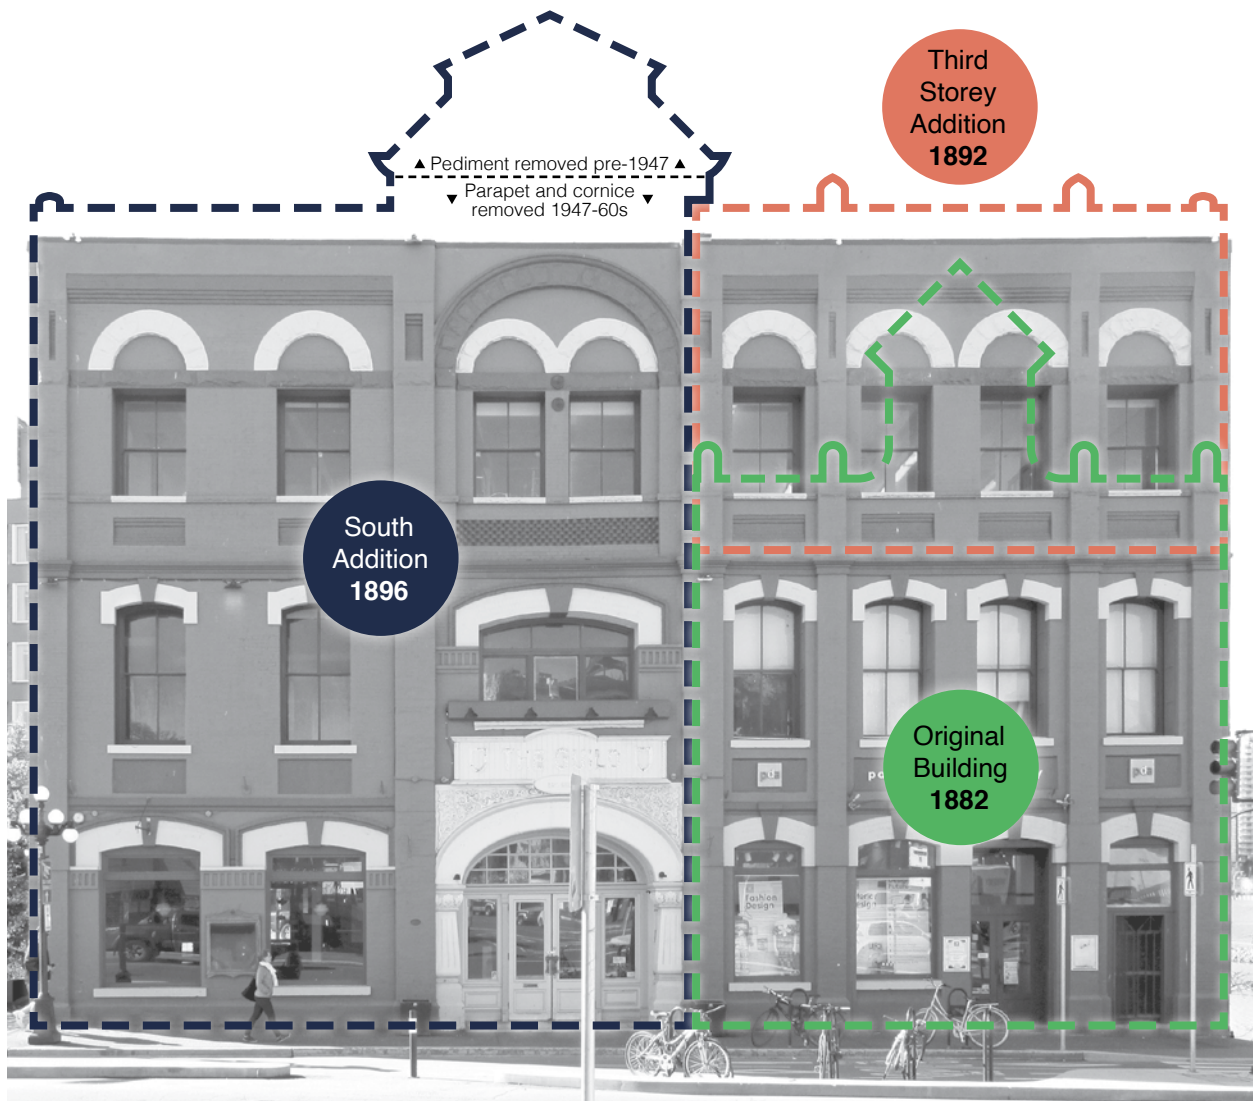
1882 and was two-storeys at the street elevation and four-storeys at the rear. The block had a rectangle plan with hipped roof behind a parapet with central pediment. The front elevation of the original block was further characterized by its symmetrical fenestration arrangement on the ground and second floors. Of the extant building, the intact 1882 portion is the ground and second floors at the north end of the building. A decade later, 1892, a third storey was added to the building. As a result of this addition, the original roof, parapet, and pediment were demolished. The materials, detailing, and symmetry of the 1892 addition are reflective of the original

1882 portion of the block. Four years later, 1896, the third stage of the building was constructed, a three-storey addition at the south wall of the block. The materials, detailing, fenestration placement of the 1896 addition were designed to match the architecture of the 1882 and 1892 portion of the block. The 1896 addition altered the symmetry of the front elevation of the building changing it to an asymmetrical facade with off-centre main entry. Also as part of the 1896 construction, a parapet and substantial metal cornice with off-centre pediment were constructed.

The three primary construction stages of the Yates Block. The pediment and parapet were removed at separate times.

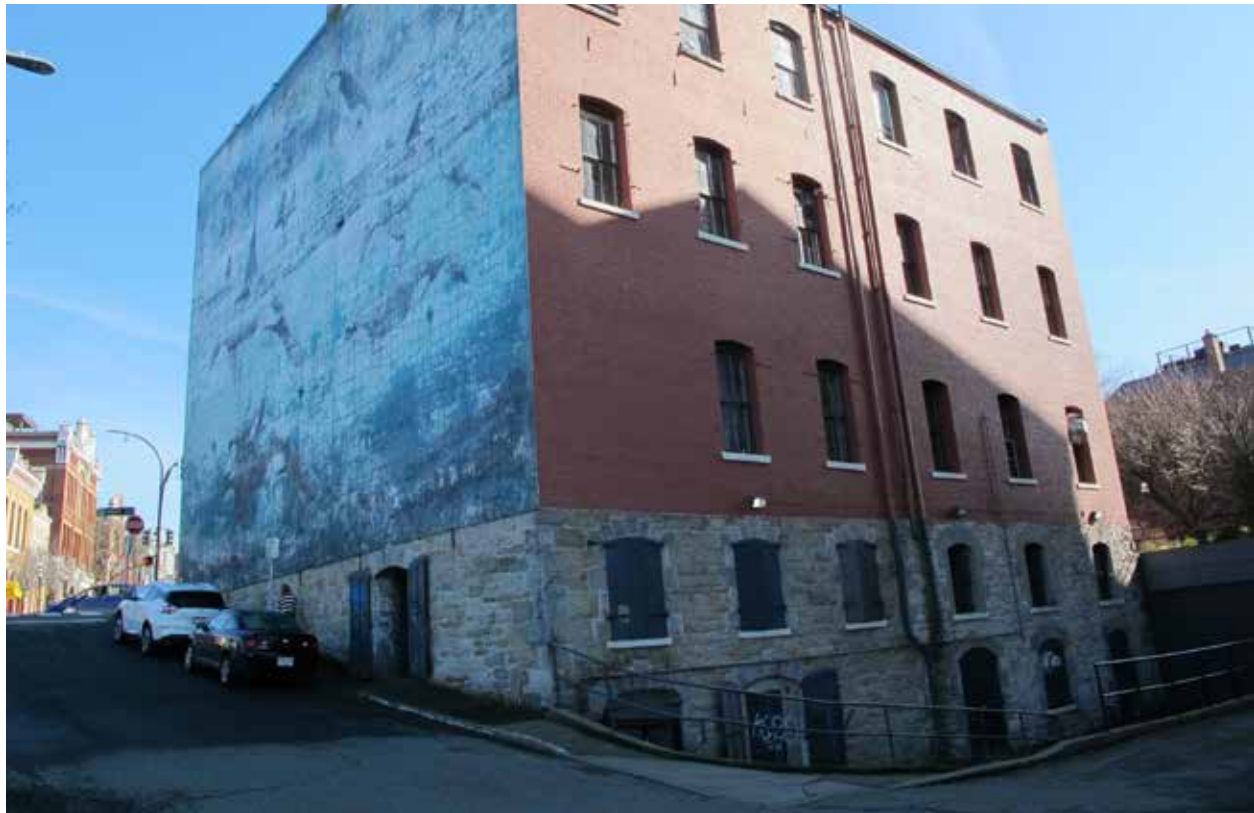
Rear (right) and north (left) elevations of the Yates Block showing painted brick on rear elevation and painted mural installation on north elevation

have been painted which obscures the condition of the stone, brick, and mortar of those elevations. On the north elevation, a mural has been installed in front of the brick which also prevents review of the condition of the masonry on this elevation. The south elevation is unpainted and has evidence of ghost lettering from past painted signage. The unpainted south elevation possesses areas of mortar loss. The front (east) elevation also possesses redundant anchors, a signband installed over the entry, and lighting all of which have been anchored to the masonry. At some point between 1947-60s, the masonry parapet was altered likely when the metal cornice was removed. As part of the proposed redevelopment scheme, the four elevations will be preserved. Removal of paint from sandstone elements on the front (east) elevation will be explored.

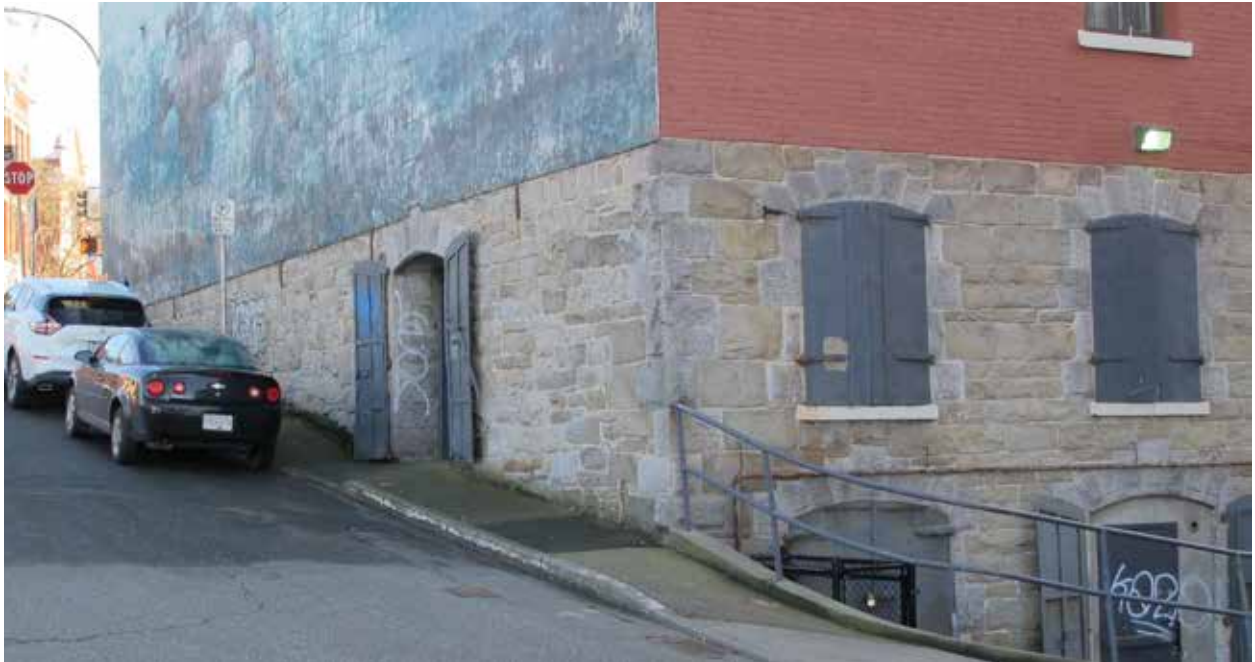
Top: Stone foundation exposed on the north (left) and rear (right) elevations. Stone is laid in a random ashlar pattern on north elevation, and random coursed ashlar on the rear elevation.

Bottom: Rear elevation of the Yates Block with transition (noted with arrow) between original 1882 (left) and 1896 (right) foundations evident.

of the block are granite fenestration surrounds and quioning. On the lower levels of the rear elevation the transition between the 1882 foundation and 1896 addition is evident. The foundation of the 1896 addition is limestone with parged fenestration surrounds. Overall, the foundation is intact and in good condition. There are localized areas of deterioration such as chips to the stone, staining (below exhaust fan), moisture issues resulting in organic deposits (e.g. behind downspouts), rust staining, and localized mortar loss.

The extant stone foundation will be preserved as part of the proposed redevelopment. Seismic improvements may be required as part of the redevelopment. These improvements should not be evident on the exterior of the building. Measures should be taken throughout the project to ensure that no damage occurs to the masonry walls above grade during any interventions throughout the course of the project.

- Existing foundations to be preserved.
- Extant foundations should be reviewed by a Structural Engineer to determine their condition. Once condition is assessed,

conservation recommendations can be provided, if required.

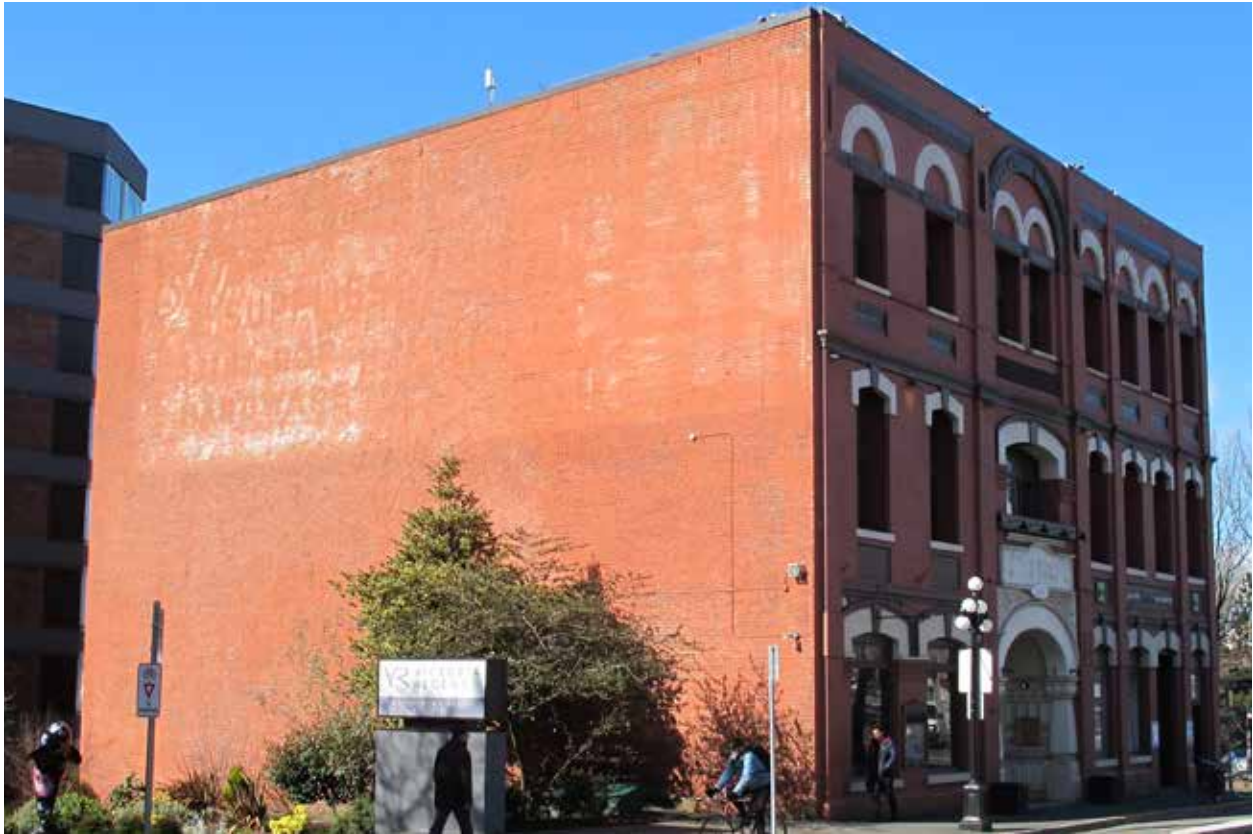
South elevation (left) of the Yates Block with ghost lettering of past painted signage.

Based on preliminary visual condition assessment, the brick and stone appears to be in good to fair condition; however, later interventions significantly limit the ability to review the masonry exterior of the block. The front (east) and rear (west) elevations

- Preserve the original structure of the historic building.
- Preserve original exterior masonry walls.
- Design structural or seismic upgrades, if required, so as to minimize the impact to the character-defining elements.
- Undertake complete condition survey of condition of all masonry (brick and stone).
- Retain sound exterior masonry or deteriorated exterior masonry that can be repaired. Replace in-kind brick and stone that is missing or too deteriorated to retain.
- Cleaning (including paint removal), repair and repointing specifications to be reviewed by Heritage Consultant.
- All redundant metal inserts and services mounted on the exterior walls should be removed or reconfigured.
- Any holes in the brick and stone should be filled or units replaced to match existing.

- If overall cleaning of the elevations is carried out. Do not use any abrasive methods that may damage the brick or stone surfaces. Use a soft natural bristle brush and mild water rinse. Only approved chemical restoration cleaners may be used. Sandblasting or any other abrasive cleaning method of any kind is not permitted.
- If repointing occurs, repoint by raking out loose mortar material to a uniform depth. Take care that the brick and stone are not damaged. Work should only be undertaken by skilled masons. Repoint mortar joints with new mortar that matches existing in consistency, composition, strength, colour and pointing profile. Consider integrating repointing program as part of maintenance schedule.

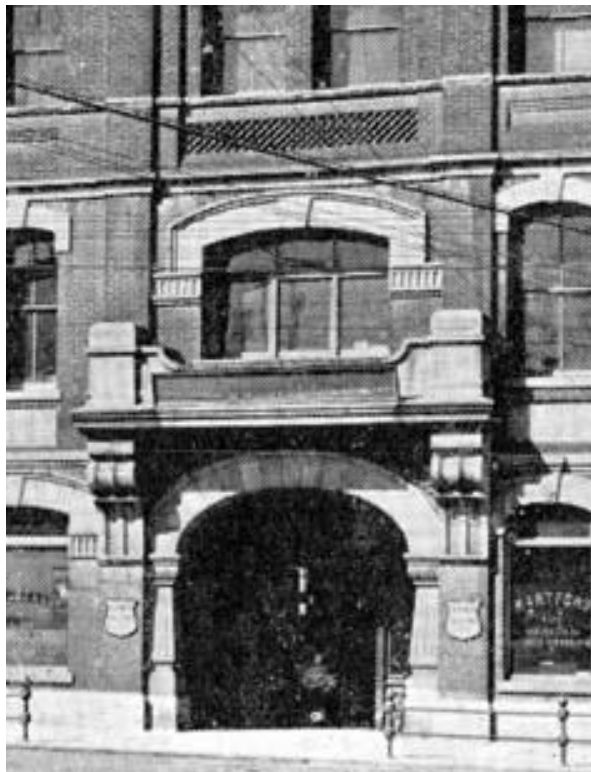
Main entry of the Yates Block following the 1896 addition with balcony supported by large scroll-like brackets.

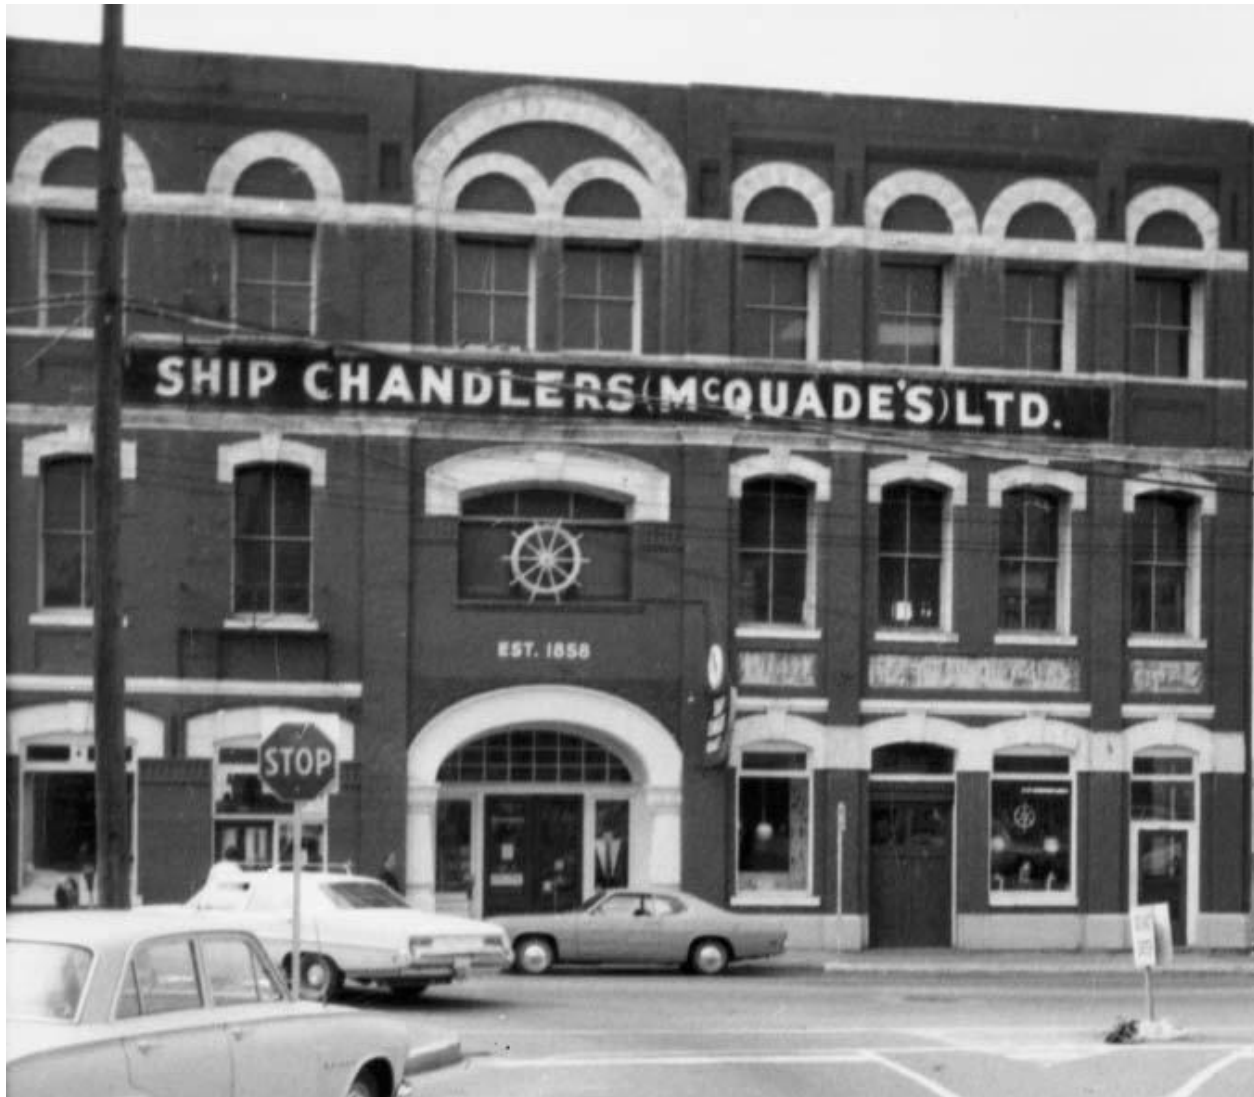
Yates Block, c.1972, with metal cornice and entry canopy removed and masonry parapet altered.

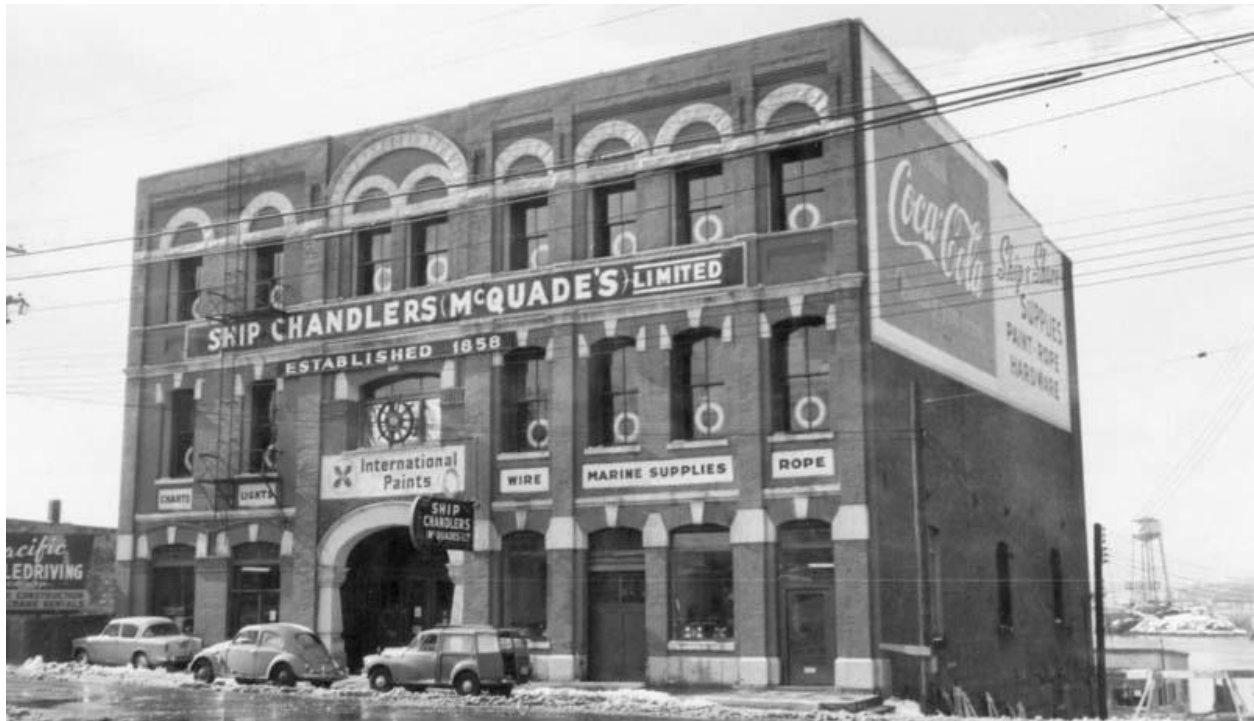
The Yates Block as it appeared in the 1960s with north elevation windows evident. (City of Victoria Archives M01147)

The north and west elevations of the block possess entries which provided access to the lower warehouse levels of the building. The west elevation has four doors which provided access to the lowest level and the north elevation has a single entry that provided access to the second lowest warehouse level. All the doors are recessed and have metal fire doors. The doors of the 1882 portion of the block having granite surrounds, while the doors of the 1896 addition have parged door surrounds.

Through the redevelopment, the doors of the lowest level of the rear elevation will be preserved. The north elevation entry will be rehabilitated to suit

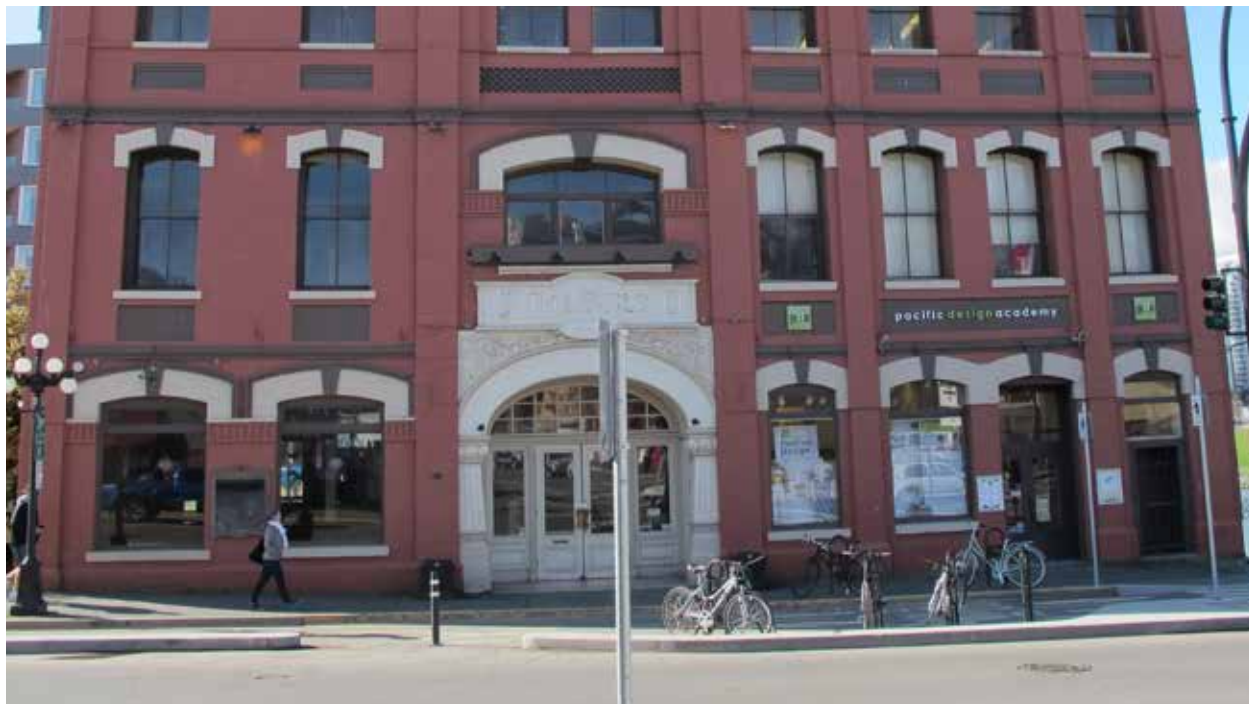
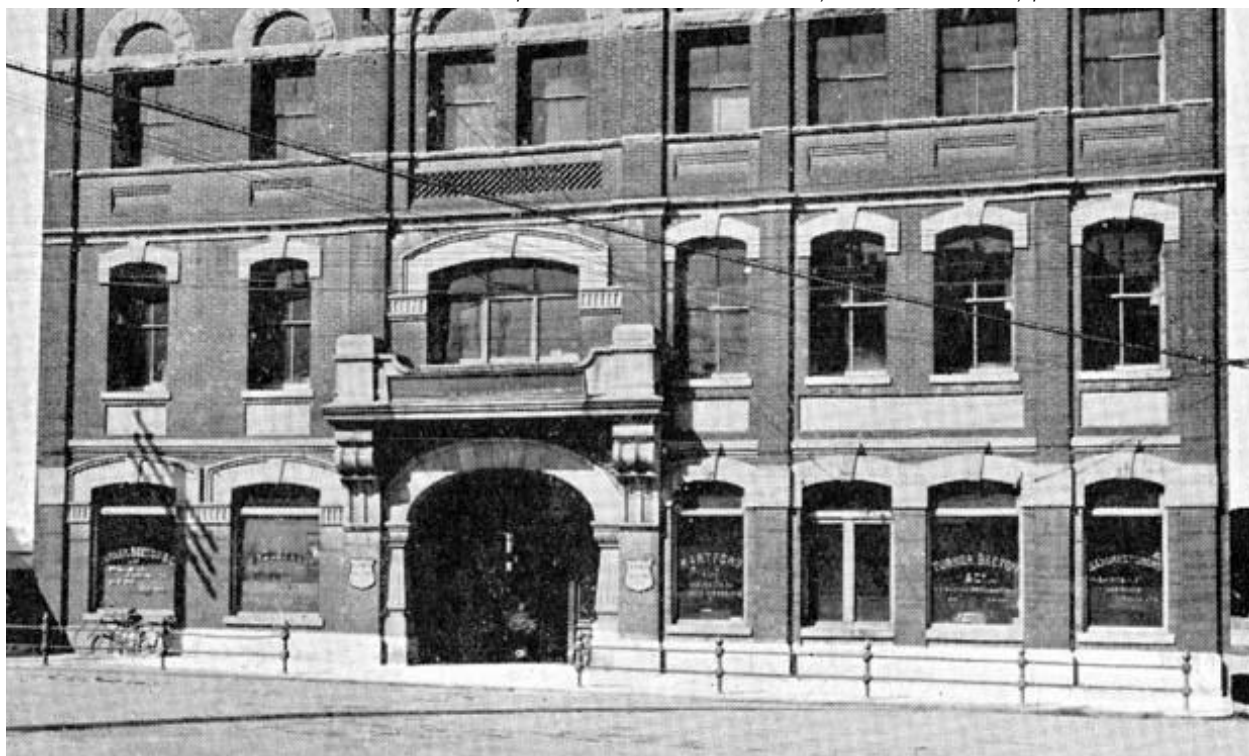
Above: Contemporary view of the Yates Block storefront with off-centre main entry and two secondary entries.

Below: Yates Blocks storefront after completion of 1896 addition with only off-centre main entry present.

- Preserve the location of the windows, recessed main entry, and southern most secondary entry of the storefront level.
- Preserve intact wood window assemblies and main entry door assembly, entryway (walls, soffit, floor), engaged stone columns supporting stone arch, and decorative wall panel with floral motif. Complete in-kind repairs as required.
- Restore the location of one of the secondary entries to its original 1882 position.
- Rehabilitate assemblies of secondary entries in 1882 portion of block.
- Integrate commercial signs and new lighting systems as required.
- Finish the storefront level in finish schedule devised in consultation with Heritage Consultant.

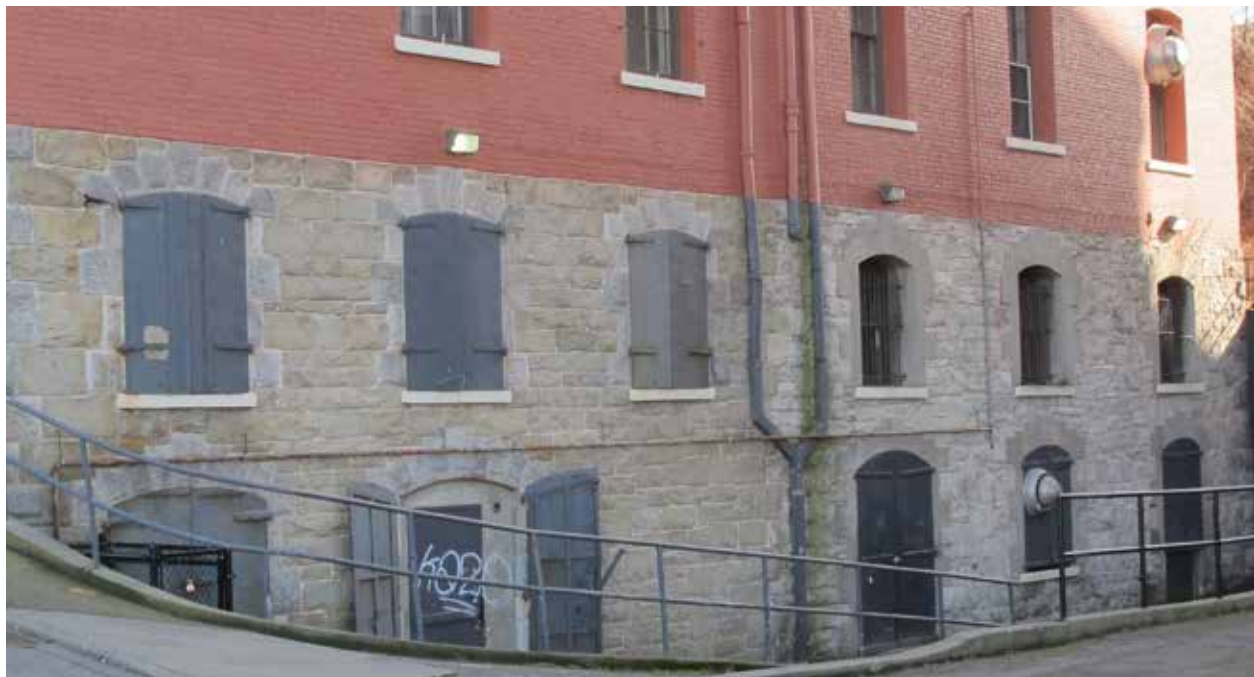
Rear elevation of the Yates Block with four doors providing access to the building's lowest level.

- Retain the recessed door openings of the north and west elevations in their original locations.
- If possible, preserve and repair any original door assemblies.
- Rehabilitate the north elevation entry to suit the new interior use of the building.
- Where new doors are installed, they should be visually and materially compatible with the historic character of the building.
- Finish doors based on finish schedule devised in consultation with Heritage Consultant.

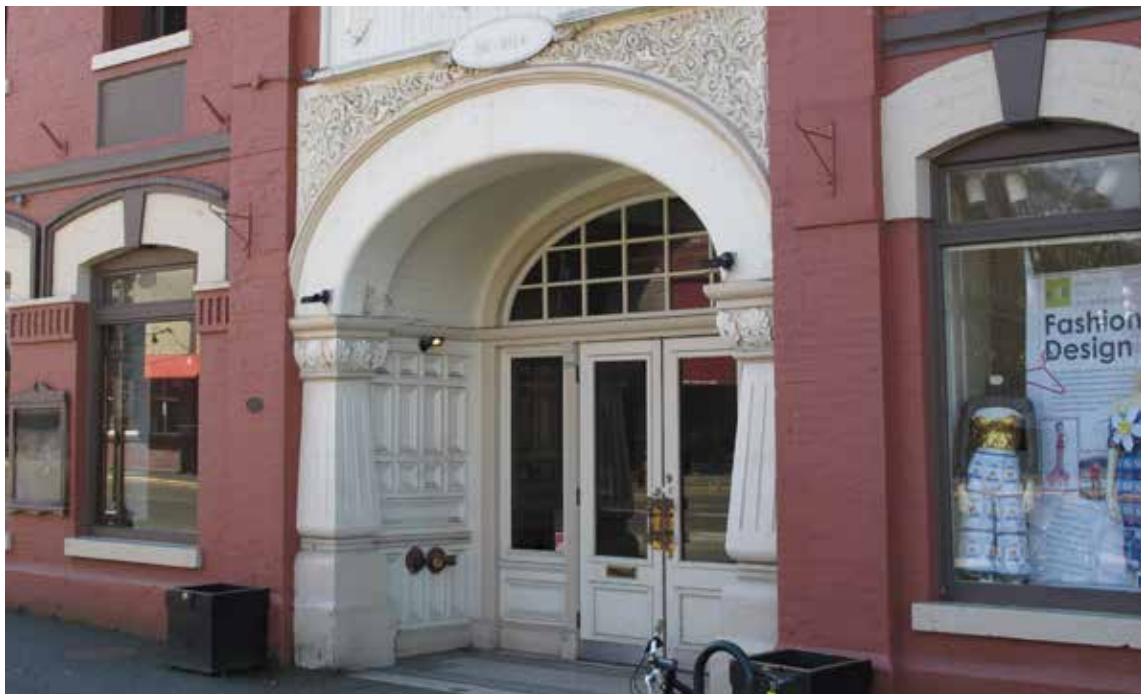
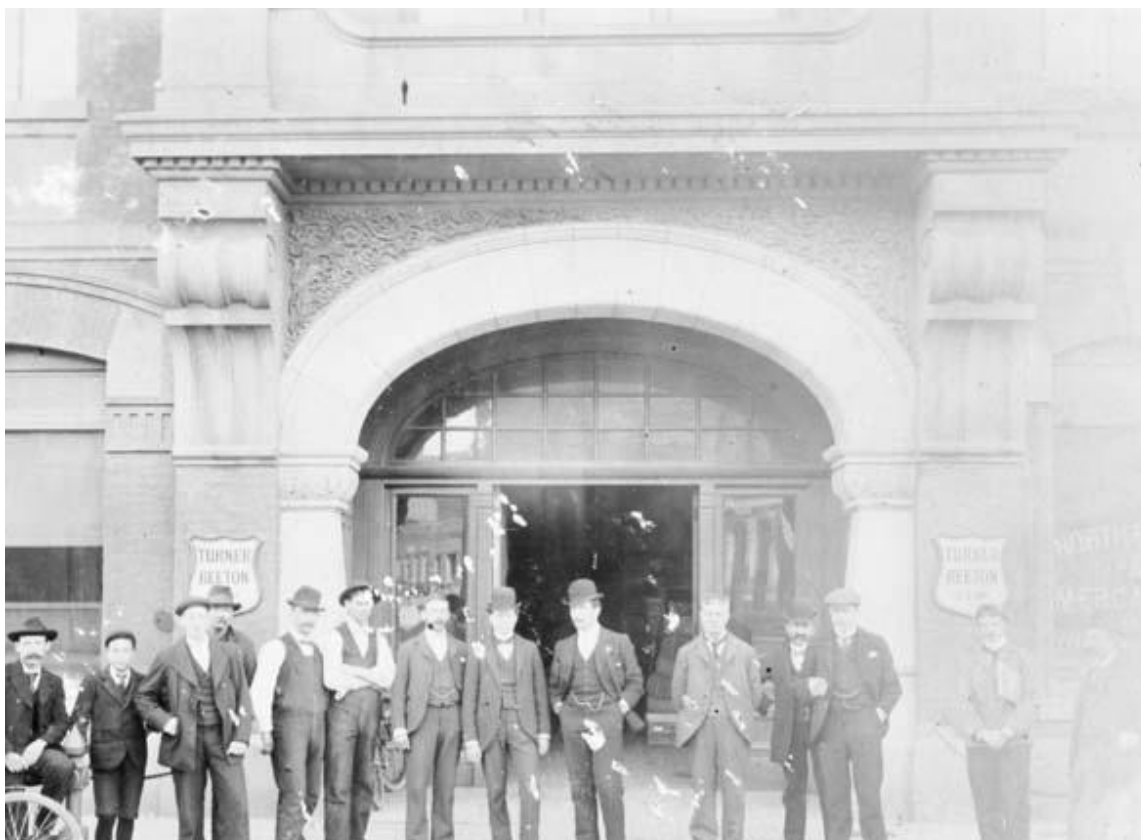
Top: Current main entry of the Yates Block.

Bottom: Detail of the main entry of the Yates Block following completion of 1896 addition with decorative balcony over the main entry in place.

The extant off-centre main entry is associated with the third stage of construction of the Yates Block which was completed in 1896. The detailing, materials, and ornamentation of this entry projects a sense of wealth and is reflective of the architectural aesthetic of the building. The entry is recessed under a stone arch supported by two engaged stone columns with roughly square bases, fluted tapered shafts, and capitals with a leaf motif. Above the arch's drip mould is a decorative panel in a floral motif. The entry is further characterised by wood coffered walls and tongue and groove soffit. The floor of the entry is mosaic tile with a geometric perimeter band. The doors, sidelights, and transom are a wood and glass assembly consisting of: double doors with large upper glass panels and recessed lower wood panel; sidelights with upper glass pane (matching the size of the glass panel in the doors) and recessed panel with trim; full-width arched multi-lite glass transom;

and wood trim. The double doors also have unique 'key-shaped' door pulls. It's not known if the pulls are original. Overall, the main entry is highly intact and in good condition. Localized areas of wear and deterioration are present on the floor, engaged column bases, and lower portion of the walls, doors, and sidelights. One significant alteration to the main entry is the absence of the original decorative balcony and its supporting brackets (see section 5.5) that was removed prior to 1972.

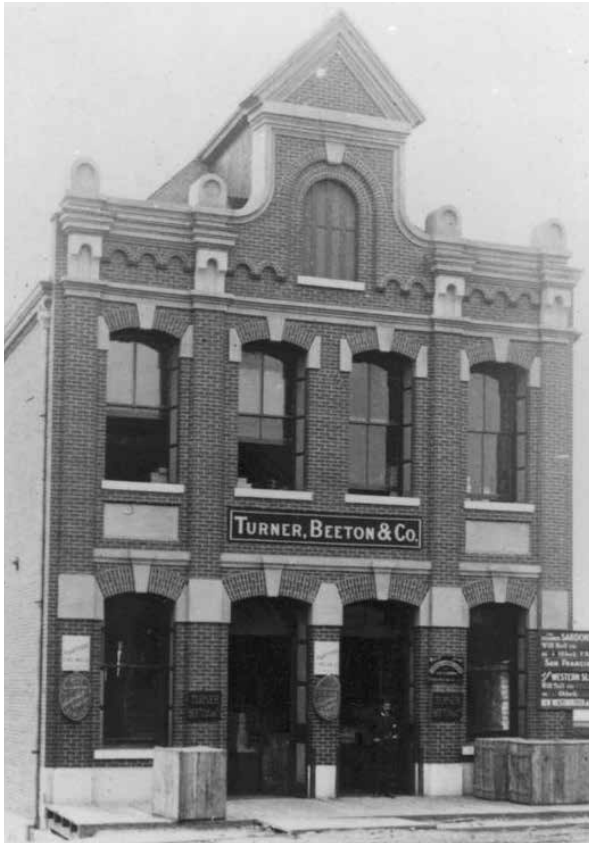
Yates Block with two entries in central bays, flanked by single windows in each structural bays
