## **Lime Bay Park Beach Restoration: Project Proposal**

# The Victoria International Marina, Pocket Beach Nourishment Project

Restoration Report Prepared by:

Kyle Armstrong MSc, Restoration Coordinator,  
Peninsula Streams Society  
July 15<sup>th</sup>, 2021

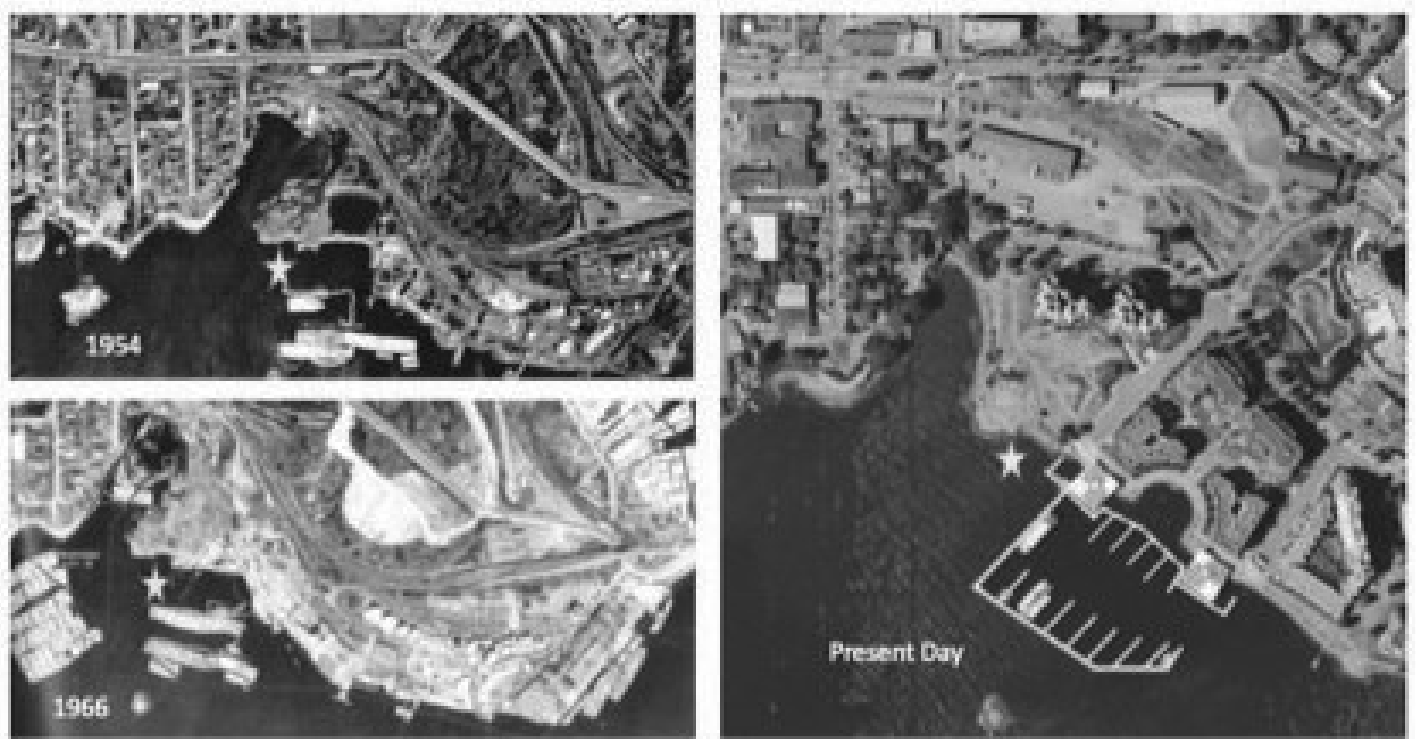
Figure 2.) Infilling and development of Lime and Mud Bays from 1954 (top left), 1966 (bottom left), to present-day (right) demonstrates the complete and partial filling of Mud and Lime Bays respectively. Star denotes the approximate location of the project site foreshore across time.

Since the 1930s, large portions of Lime Bay and all of what was known as Mud Bay to its east were filled to facilitate harbour development and industries. Today, the site exists as a highly modified remnant of what was historically a much larger beach complex of cultural and ecological significance. The sand and gravel beaches of this complex, used by the Lekwungen people, visiting nations, and likely spawning forage fish, now lay buried below condominiums, grassed lawn, and engineered riprap, providing minimal value for people and nature (Figure 2).

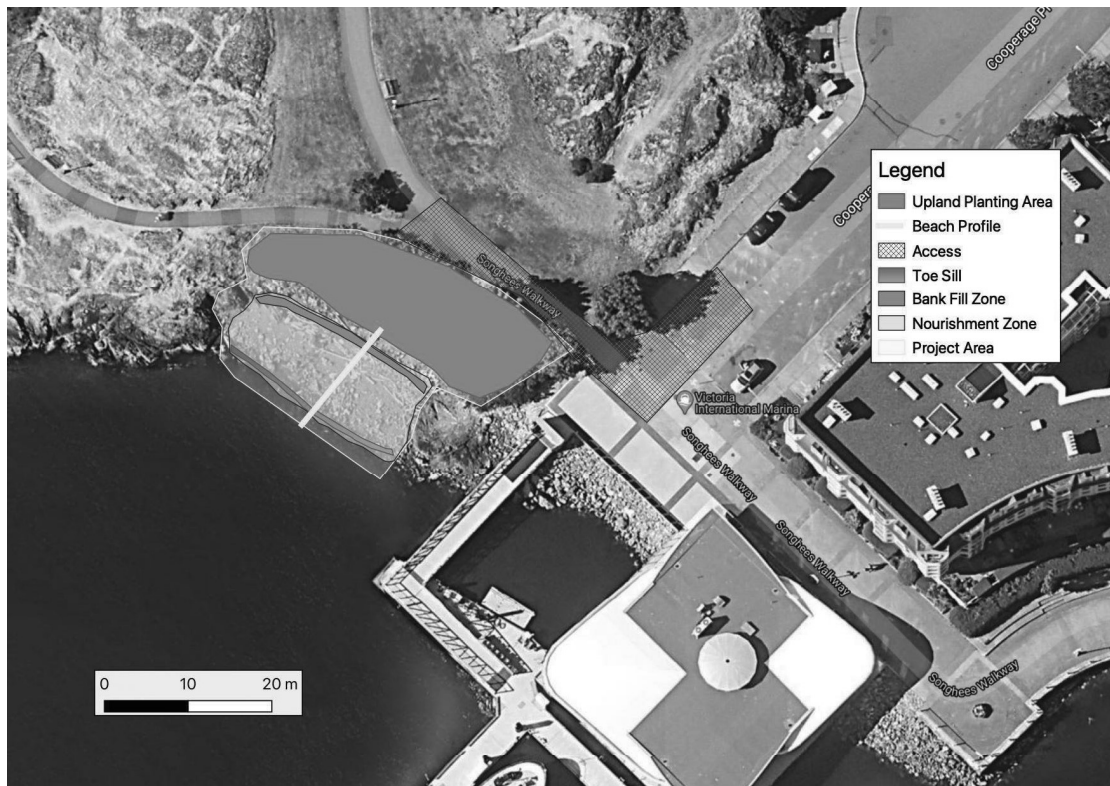
Figure 3.) Proposed Project layout including backshore planting and beach nourishment areas.

The approximate 150 m<sup>3</sup> of nourishment sediment will be composed of a mix of cleaned coarse sand to fine gravel. Approximately 45% will consist of sediment in the 0.15-5 mm range and approximately 55% will consist of heavier sand, pea gravel, and pebbles ranging from

approximately 13-38 mm. Based on availability, crushed oyster shells may also be introduced along with the benefits of this medium in intertidal ecosystems. Coarser material would be included to both mimic natural beach conditions in this area and to aid in the longevity of sediment in the project area. Large wood will be sourced and repurposed from other areas in the harbour where it is a nuisance and where it can be donated and delivered from other projects.

The proposed project will be accomplished in the following stages:

- Access to the beach will be established through the Songhees Walkway at the terminal end of Cooperage St. and an alternative detour and exclusion zone established for the public (CoV)
- Boulders and cobbles for the bank and toe sills will be sourced from the site and constructed using an excavator with biodegradable hydraulic and engine oil (PSS)

- Rock armour debris from the nourishment project area will be removed or strategically placed along with large woody debris, while asphalt, metal, and cement debris will be removed from the beach (PSS)
- Gravel sand mix will be delivered to the beach using a dump truck (PSS)
- Sediments will be distributed using excavator an excavator using opportunistic low tides for intertidal works (PSS)
- Restore access route areas to original conditions, including upland native beach riparian plantings (CoV)
- Install pest deterrents to help protect plantings and vegetation recovery (CoV)
- Pole raising and naming ceremony for beach
- Perform as-built topographic survey and ongoing project monitoring including forage fish surveys

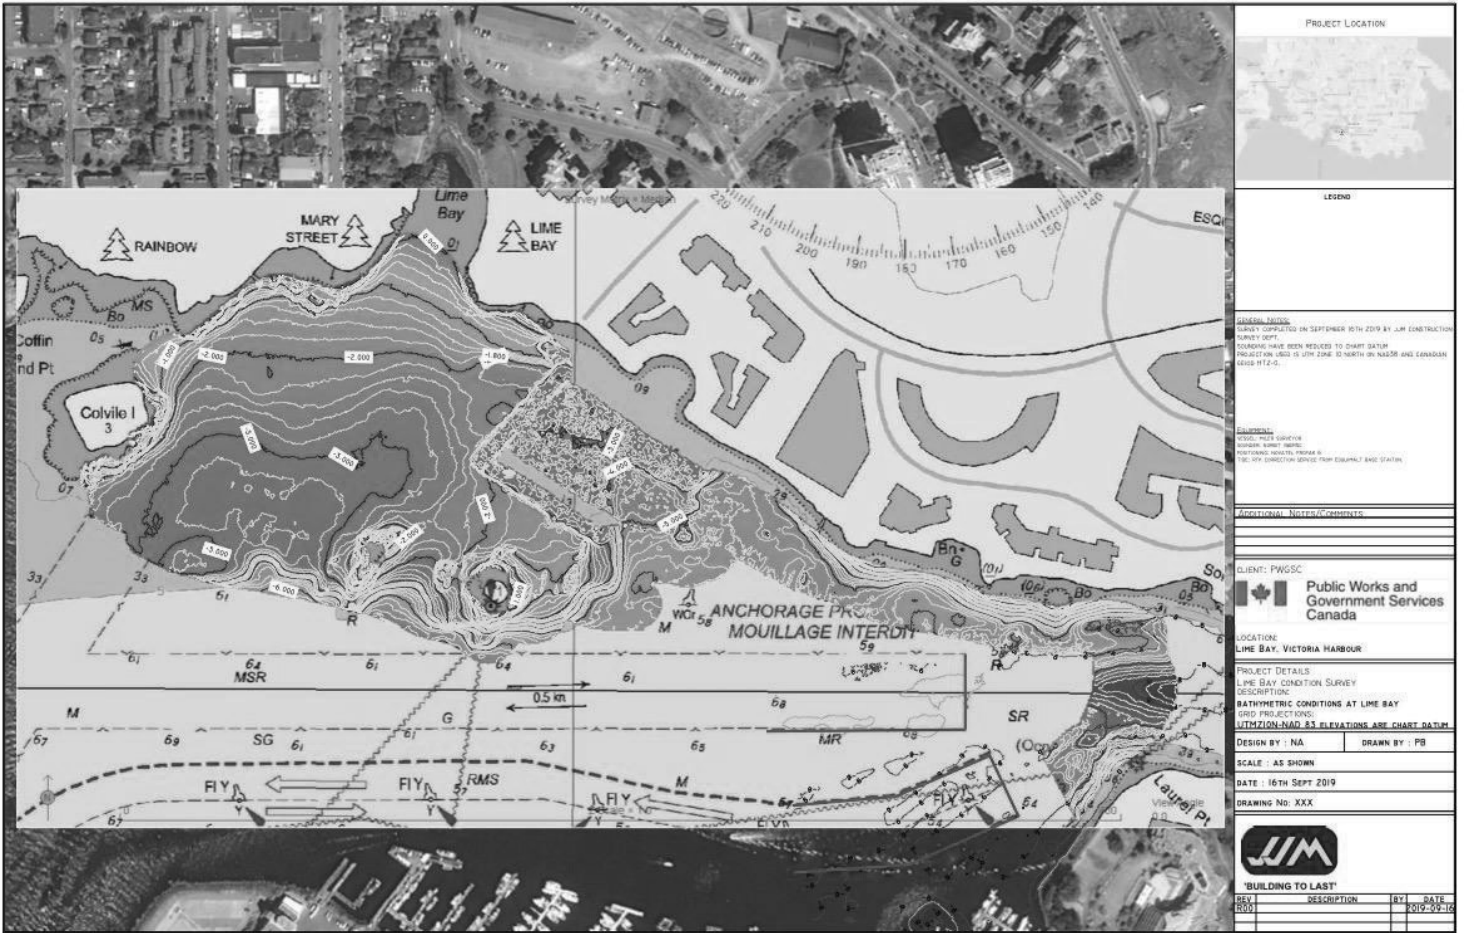
# A3 Site Bathymetry

**GENERAL NOTES:**  
 SURVEY COMPLETED ON SEPTEMBER 10TH 2019 BY JRM CONSTRUCTION SURVEY DEPT.  
 SOUNDINGS HAVE BEEN REDUCED TO CHART DATUM  
 PROJECTION USED IS UTM ZONE 18 NORTH ON NAD83 AND CANADIAN GEOD HT 2.0.

**PROJECT DETAILS:**  
 LIME BAY CONDITION SURVEY  
 DESCRIPTION:  
 BATHYMETRIC CONDITIONS AT LIME BAY  
 GRID PROJECTIONS:  
 UTM ZONE 18 NORTH  
 ELEVATIONS ARE CHART DATUM

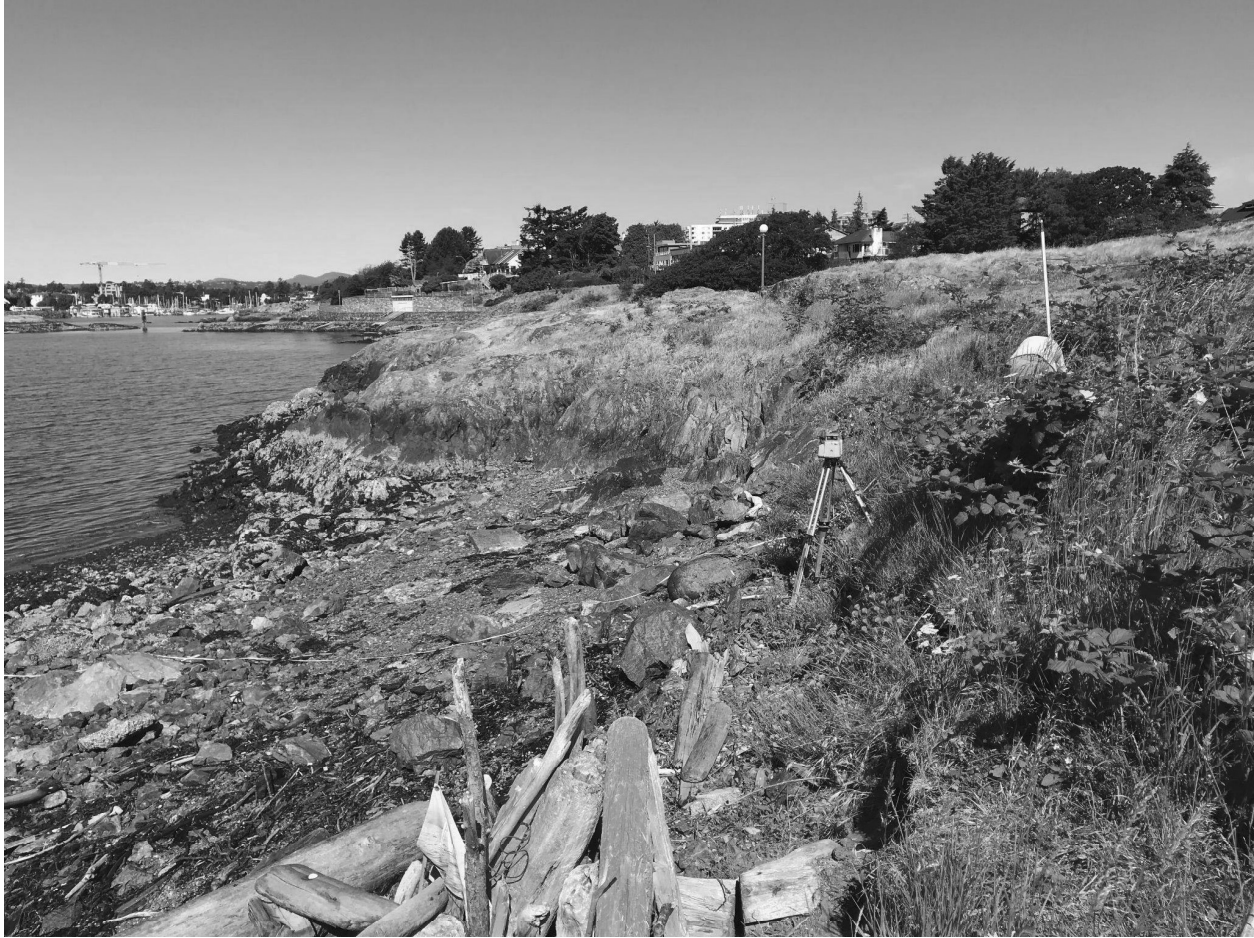
**A8 Backshore West**

The observed backshore is a combination of grassed lawn topping anthropogenic fill of unknown depth and native bedrock. The bedrock shore extends ~10m from the western end towards the center of the beach while anthropogenic fill backs the beach for the remaining ~15 m. The backshore ecological value is rated low in regional inventories, with invasive species such as Himalayan blackberry (*Rubus armeniacus*), bindweed (*Convolvulus arvensis*), and English ivy (*Hedera helix*). Native species observed onsite include gumweed (*Grindelia stricta*), snowberry (*Symphoricarpos albus*), and Nootka rose (*Rosa nutkana*). The steep upland bank (~90 degrees) is collapsing due to erosive forces from combined forces of anthropogenic disturbance, Sea Level Rise, and increased storm surge. At the current rates of erosion, upland infrastructure including the Songhees Walkway is at risk. Public removal of boulders to create rock structures on the beach is further exacerbating erosion of this area and the hazard of collapse. Recent tree and brush removal works were carried out by the City of Victoria in preparation for the pole raising ceremony. This vegetation removal has likely worked to further destabilize the already mass wasting bank and City action is imminent. There is informal access to the beach via a rock pathway. While one tree remains onsite, very little vegetation serving cultural, physical, or ecological functions exists.
