Arborist Report for Development Purposes  
Re: Proposed Rezoning and Redevelopment

Site Location: 450 Dallas Rd., Victoria BC  
Darryl Clark PN-6253A TRAQ Qualified  
November 15, 2021

November 15, 2021  
For Reliance Properties  
111 Water St Suite 305, Vancouver, BC V6B 1A7  
Attn. Juan Piera  
Re. 450 Dallas Rd.- Proposed Rezoning and Redevelopment

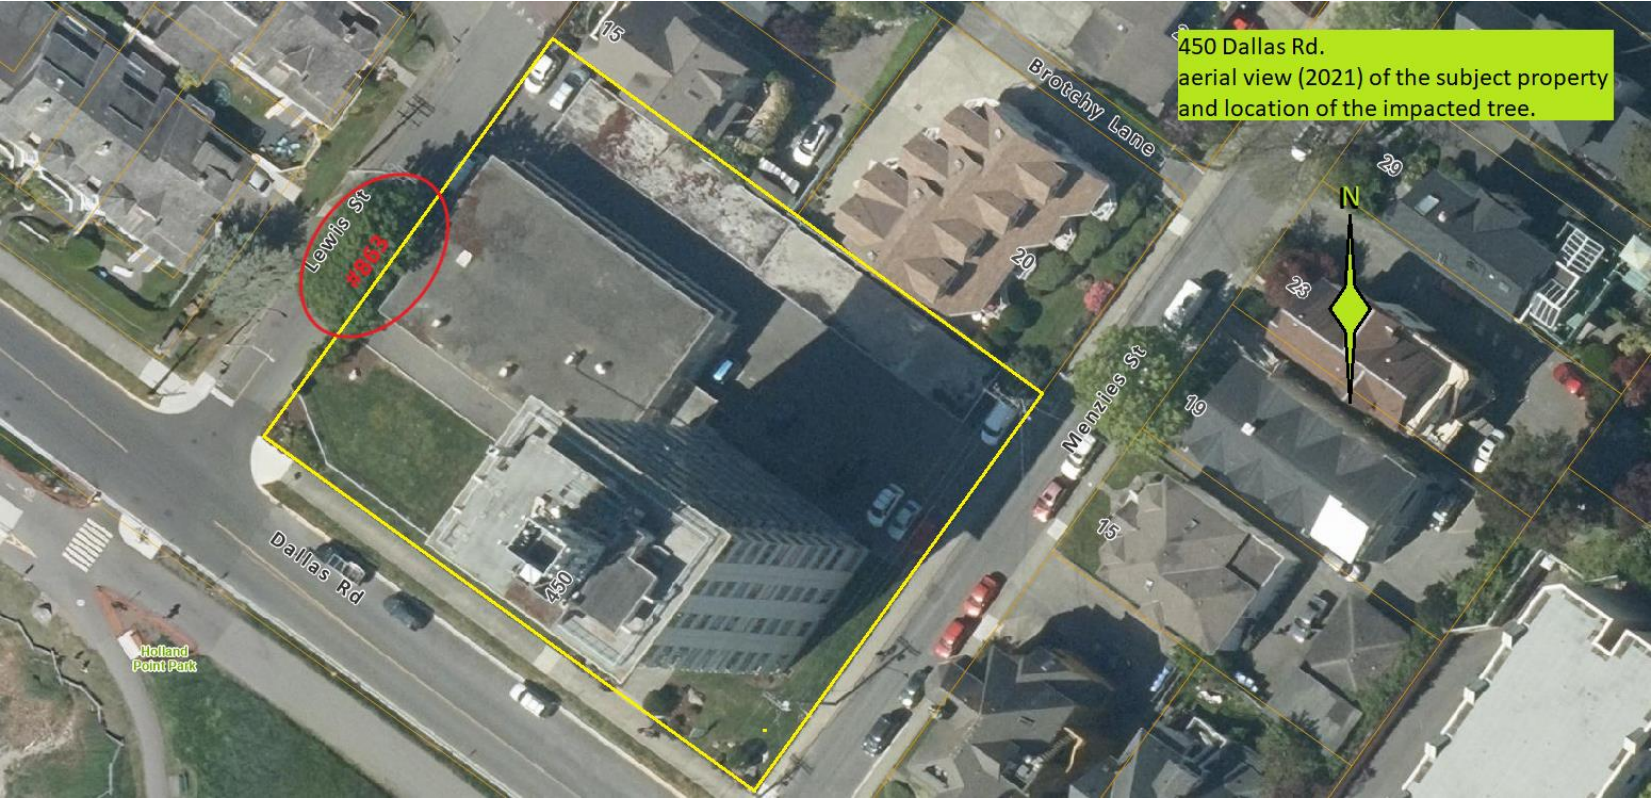
- An aerial site map was marked indicating tree location.
- visual inspection of (1) protected tree on the property and notes were collected on health and structural condition.
- An existing tree tag (#863) was utilized as the identifier for the tree
- Tree measurements (DBH) were calculated as per the bylaw at the time of development submissions (2019)
- The tree's protected rootzone (PRZ) and a critical rootzone (CRZ) are defined in the inventory.
- Photos were taken to document the site and affected on-property.
- Tree height was estimated to the nearest metre.
- A scaled survey map provided by the landscape design team is included with tree canopy and protected root zone overlaid for reference.

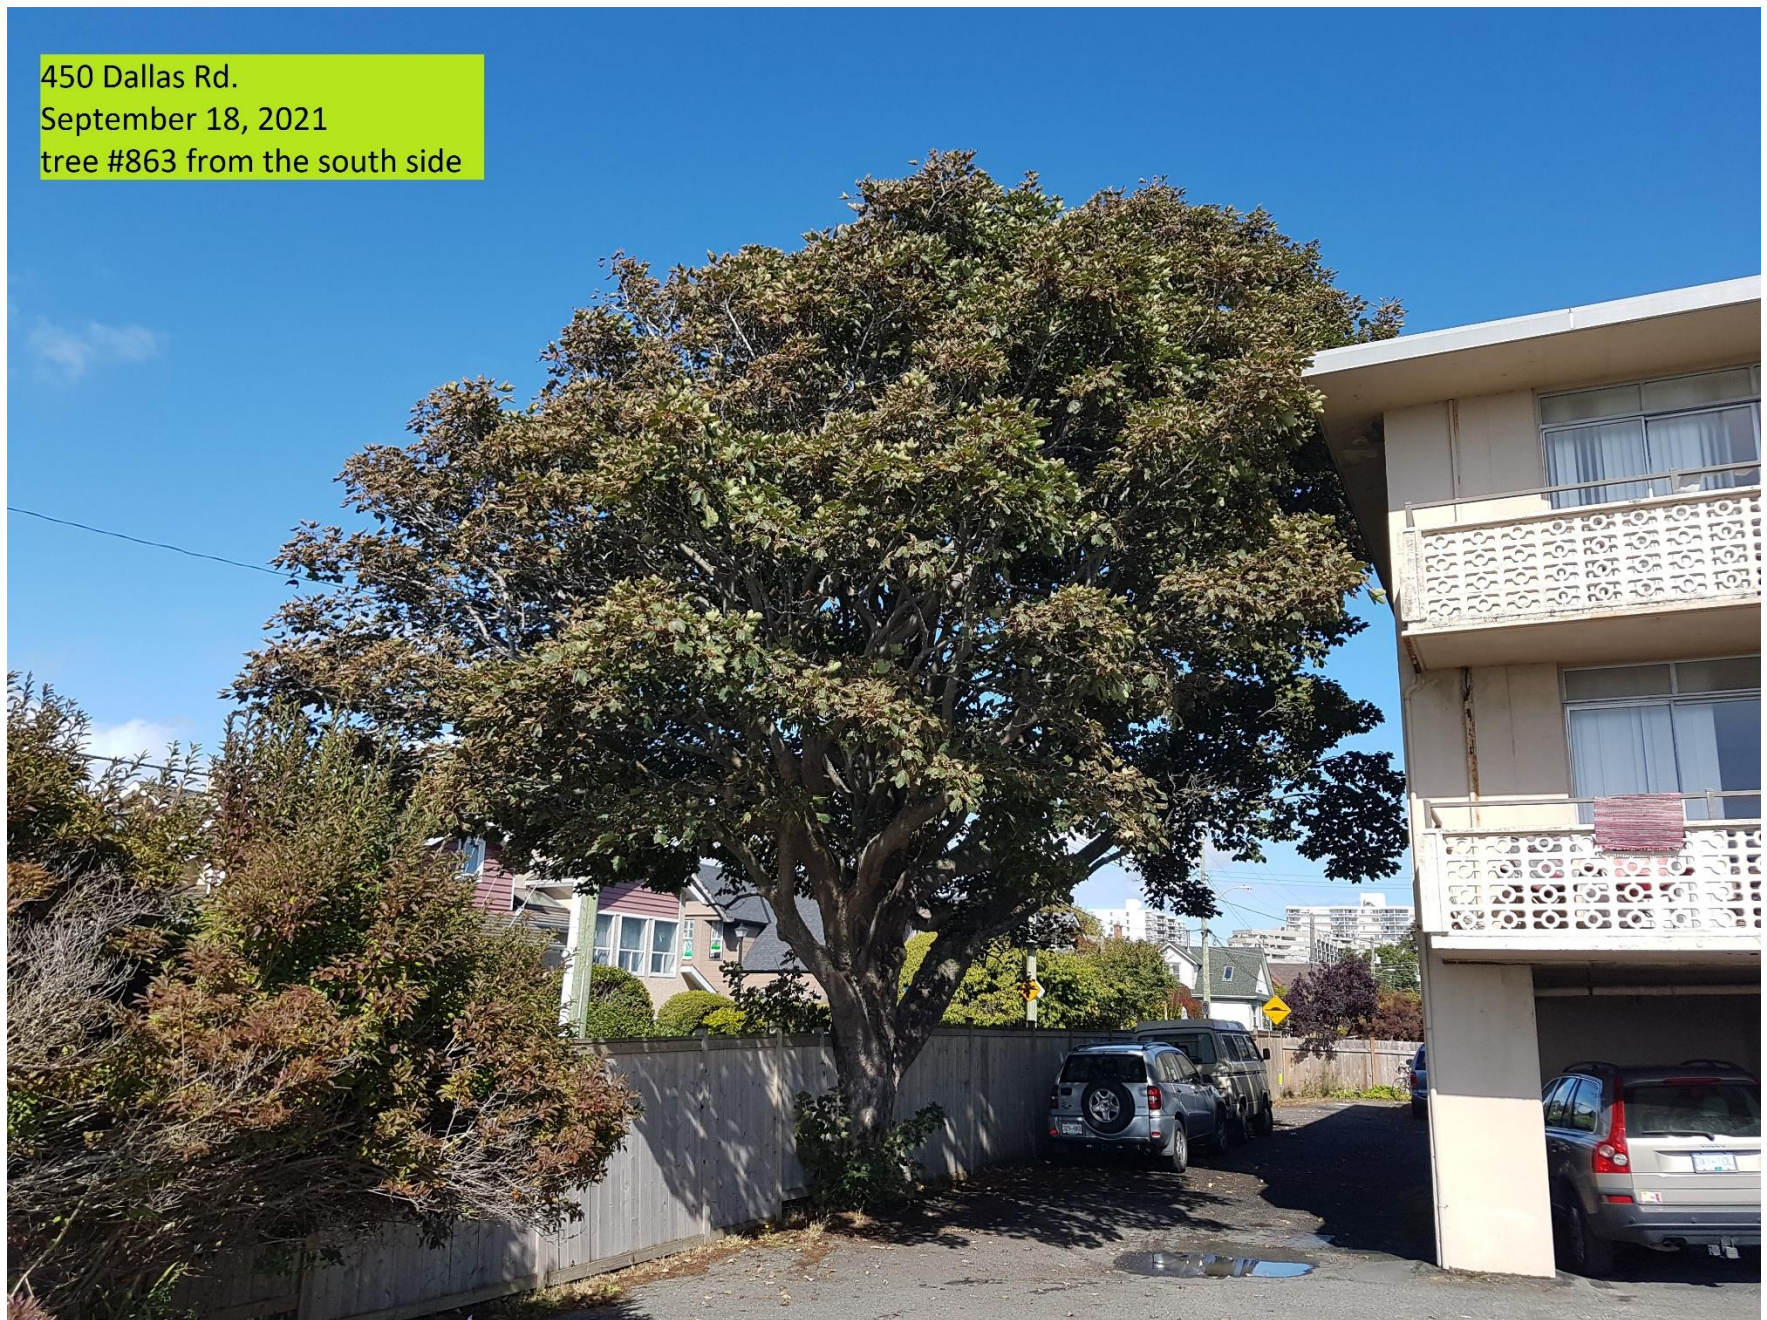
450 Dallas Rd.  
September 18, 2021  
tree #863 from the south side

Tree #863 will require removal prior to demolition and construction.

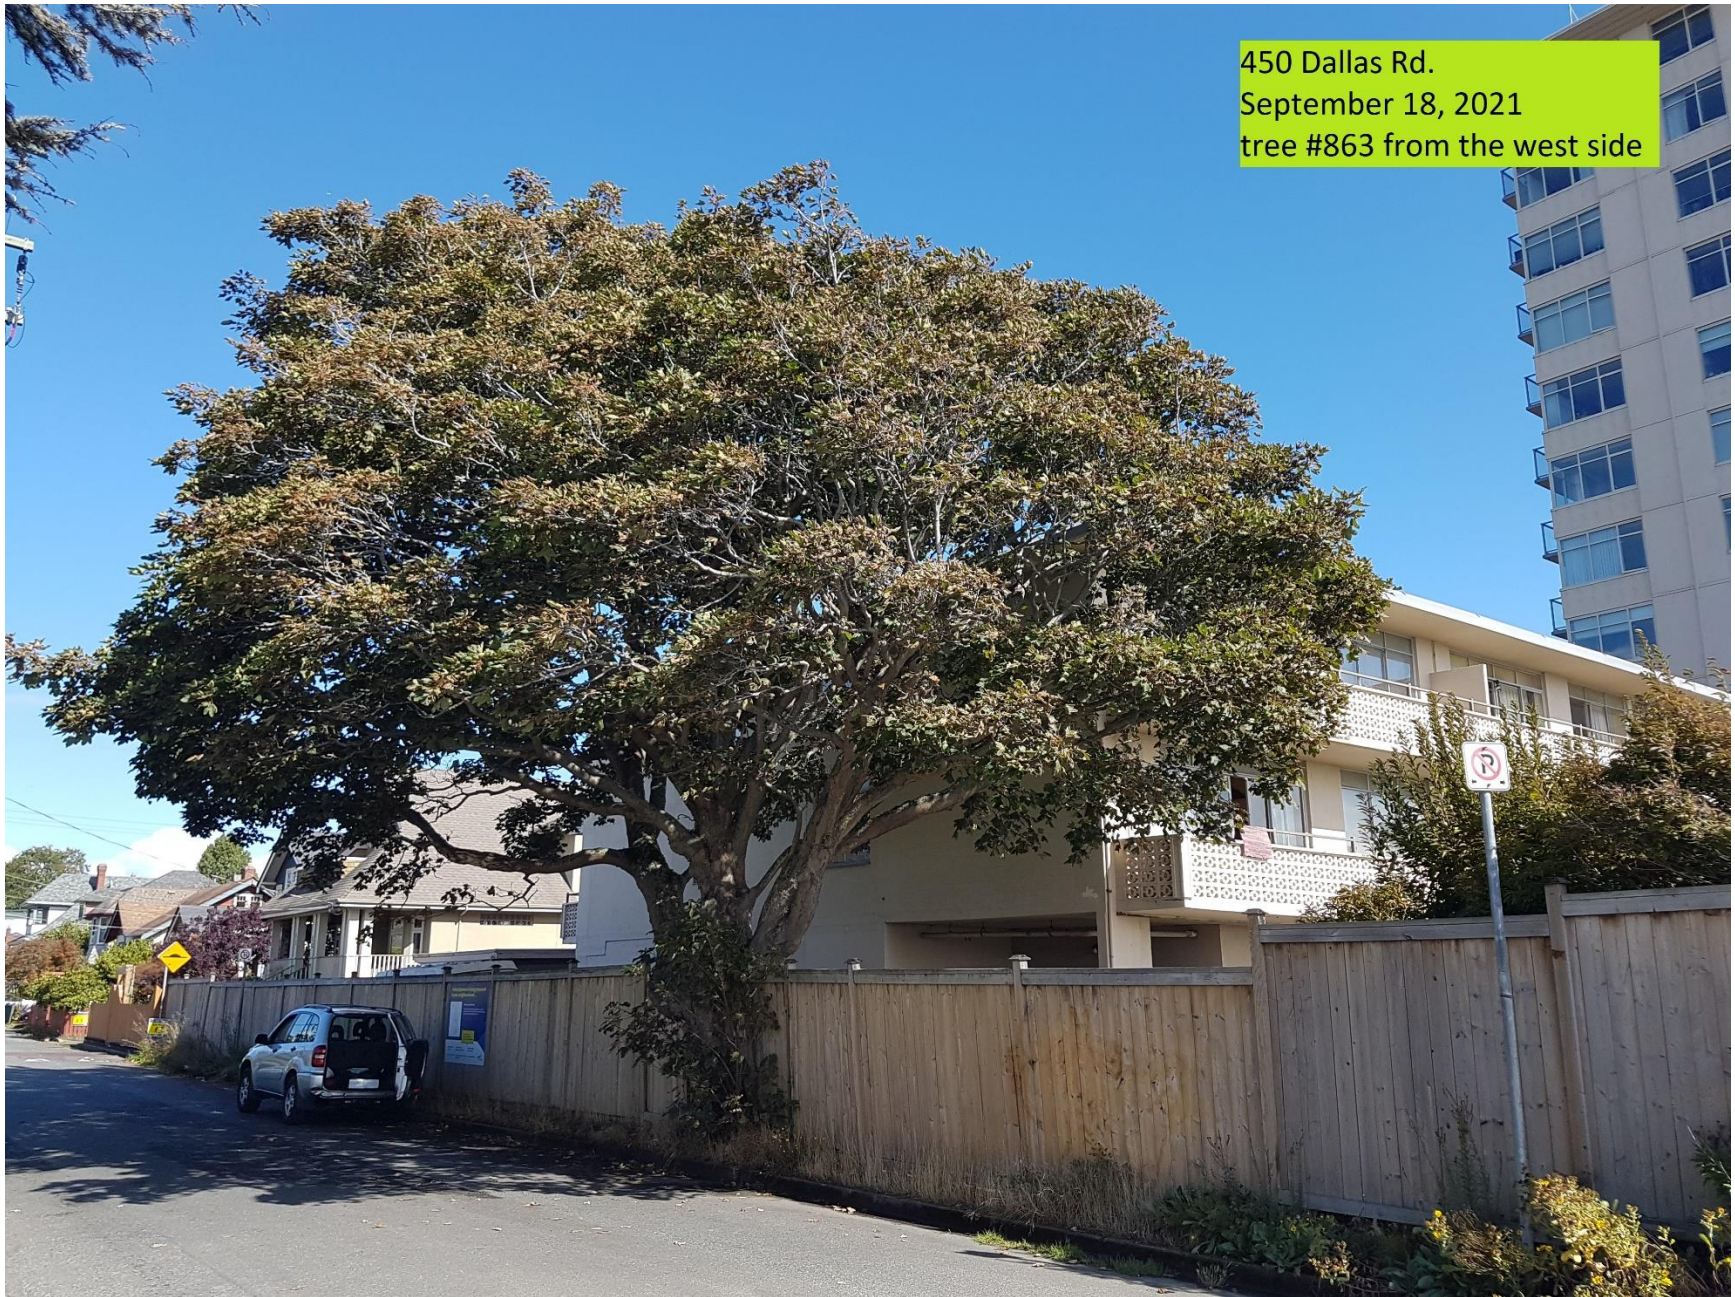
450 Dallas Rd.  
September 18, 2021  
tree #863 from the west side
