Appendix A 'Rooting Analysis'

722 & 726 Discovery St, Victoria, BC V8T 1H2

December 15, 2022

ScanPlus Root Investigation

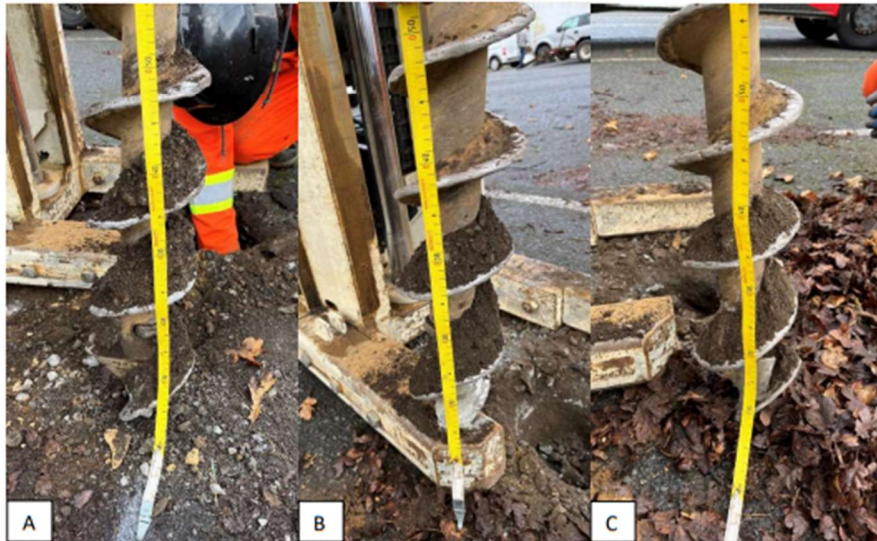
Borehole test pits were drilled approximately 10m North of the southern property line. Every borehole location was cleared by ScanPlus Ltd. to ensure that no utilities or significant roots were encountered. Three different bore holes were drilled for tree 151, two (2) were limited at 40cm and the last hole was limited at 30cm. This indicates that the soil in this area is either quite shallow or contains large rocks or concrete slabs that the drilling rig could not move aside or destroy. Soil from these holes was composed of sandy loam with some organics.

Figure 2. Tree 151 Test holes.

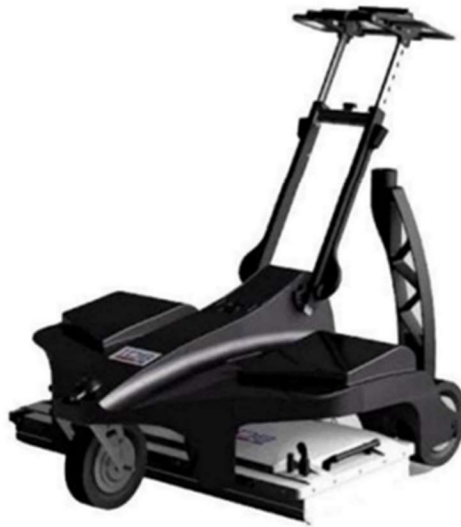
Data collection was performed by ScanPlus using an IDS Stream C, a multichannel device with 30 active antennas, all with 600 MHz as their central bandwidth size. The tight antenna spacing and high frequency of the antennas, which are oriented in both directions of travel (cross-polarized) allow the creation of highly detailed tomography. This equipment was chosen for its quality of output, to allow for the highest resolution of subsurface features at the site location, while still typically penetrating about 2m below surface.

Figure 2: An Example of the Stream C multichannel device.

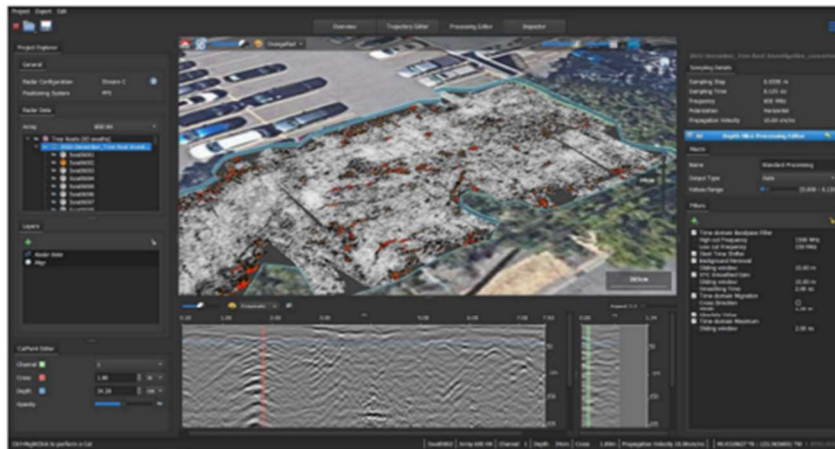
The software program used to process data was IQ maps, a proprietary software package made by IDS specifically for their multichannel devices.

Figure 3: The three-dimensional computer modeling of the subsurface environment in IQ maps.
