Tree Management Plan for the Development Proposed at  
448 Wilson Street and 422 Edward Street, Victoria, B.C.

October 9, 2023

## Background

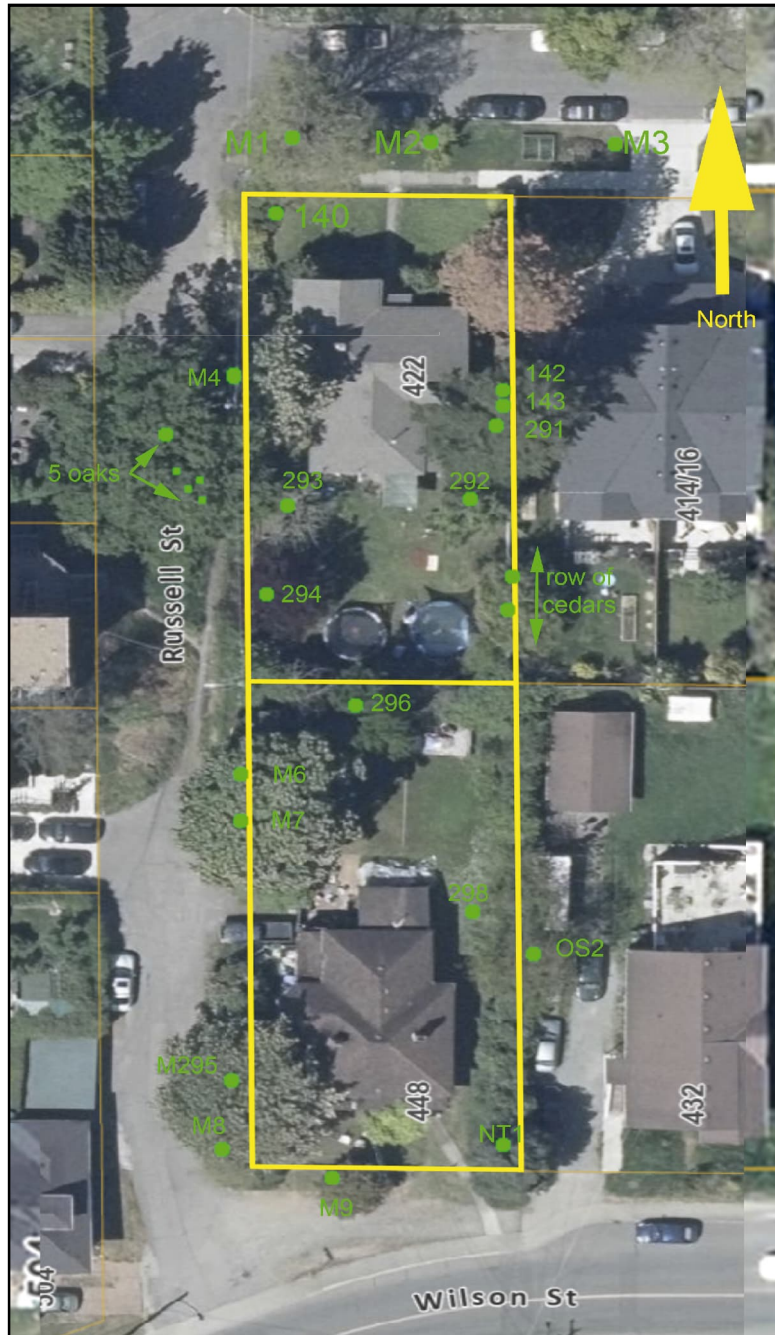
Two properties at 448 Wilson Street and 442 Edward Street are proposed for consolidation and redevelopment into higher density use. The location of the trees on the properties is shown in Figure 1.

Figure 1. Location of the two properties at Wilson and Edward.

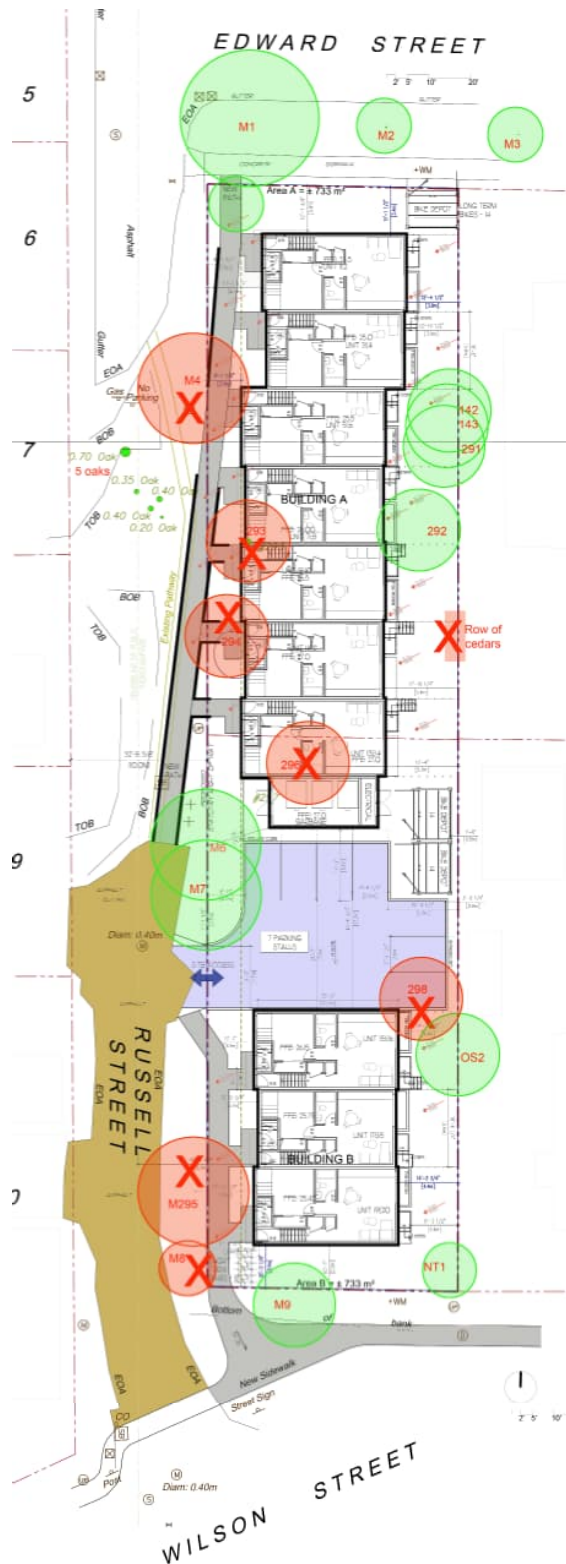
Figure 2. The proposed development.

Figure 2 shows the planned development footprint and the trees to be retained (green) or removed (red), as well as the new connecting footpath between Edward Street and Wilson Street, and the access and parking on the new site. The specific details of how each area is to be managed is laid out in the next section.

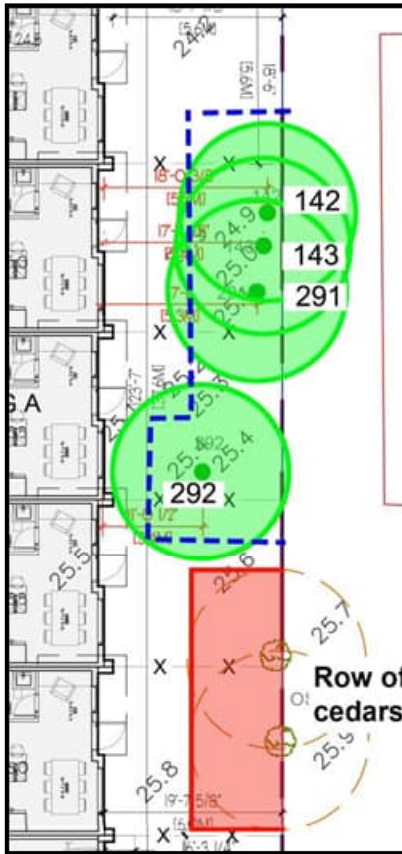
Trees 142 to 292 along the north east boundary require special attention. The existing house wall is located about 3 metres from the base of the Douglas-fir trees. The tree protection fence shall start 3 metres to the north from the base of tree 142, and then placed not more than 0.5 metres away from the existing house wall. It shall extend southwards to a distance of not less than 3 metres from the south of the base of tree 291. From there it shall jog west to form a line that is 2.0 metres (north south) from the base of the pear tree 292, and to a point 2 metres south of the base of that tree. It shall then head east back to the property line. General concept shown in Figure 4.

Figure 4. Fencing around trees 142, 143, 291, 292.

The house demolition can start at the west or south wall and must move all materials into the existing footprint with zero disturbance beyond the east house wall. All foundation materials underground are to be pulled into the footprint. The fence is 0.50 metres away so all of that should be feasible with a skilled operator.

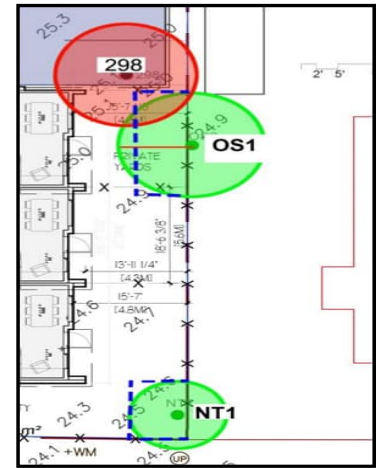
**TREES OS1 AND NT1 - Figure 5.**

For tree OS 1, start fence on boundary 3 metres to the north, extend it 2.5 metres west, 6 metres south and return to boundary.

For Tree NT 1, start fence on boundary 2.5 metres north of tree, extend it 2.5 metres west, then south to property line and back to boundary line.

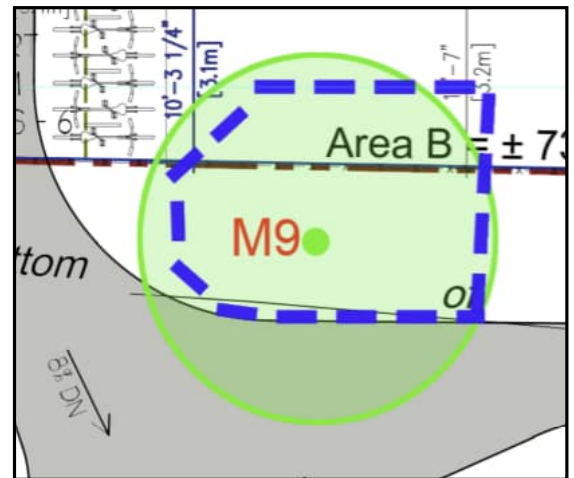
Figure 6. Tree M9.

The protection fence around M9 shall be placed at a radial distance of 3 metres, which may be reduced by 0.3 metres away from the edges of the new path and sidewalk.

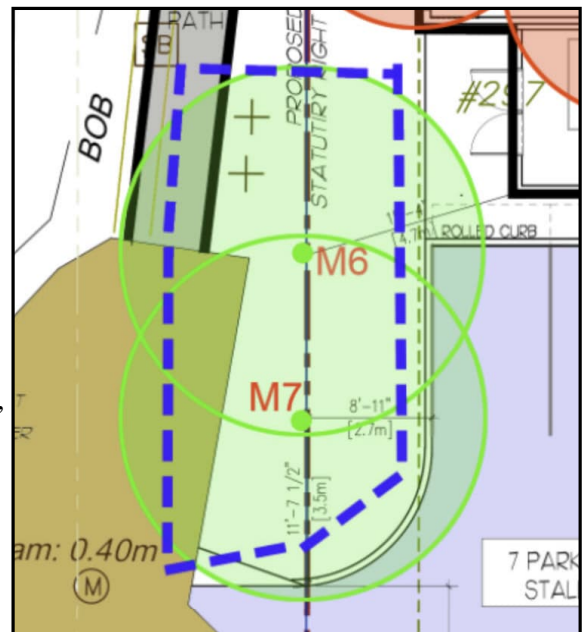
The fence shall start 4 metre to the north of M6 and extend to the edge of the planned pathway, continuing south to the edge of the new road access, and then back north to the starting point

Figure 7. Trees M6 and M7.

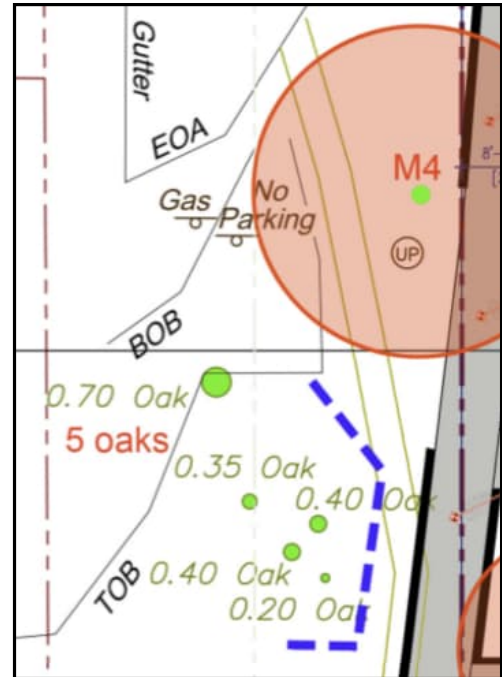
By the untagged trees west of the new path, place a fence 0.5 m beyond the west edge of the new path, starting 2 metres south of the south tree and extend it northwards as shown, to be at least 3 metres beyond the small trees and then uphill for 2 metres

Figure 8. Oak trees west of existing pathway.
