# FRASER WAREHOUSE

1316-18 WHARF STREET, VICTORIA, BC

## CONSERVATION PLAN

AUGUST 2019

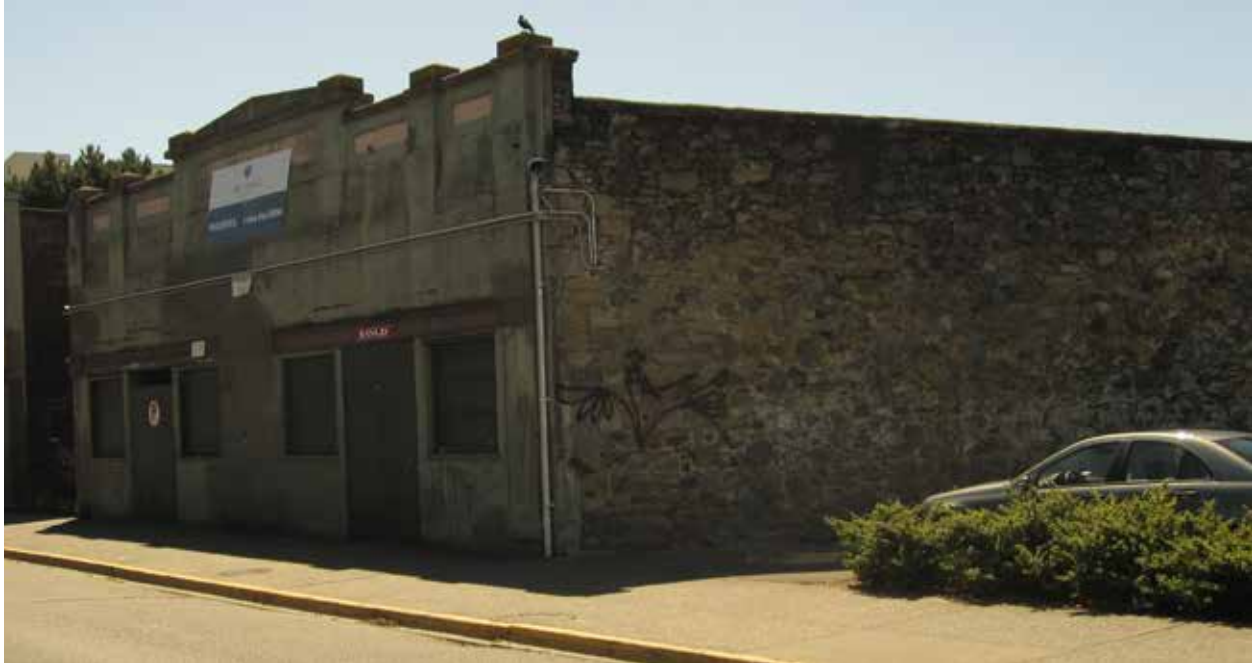
*Current front elevation of Fraser Warehouse with later applied stucco.*

the installation of unsympathetic stucco over the dressed stone and the cornice has been removed. The stucco should be removed, if it can be done safely, to expose the original underlying materials and finishes that may remain. Prior to trying to remove the stucco, test patches should be carried out to see if the stucco and related paint (graffiti, etc) can be removed without causing significant damage to the stone behind.

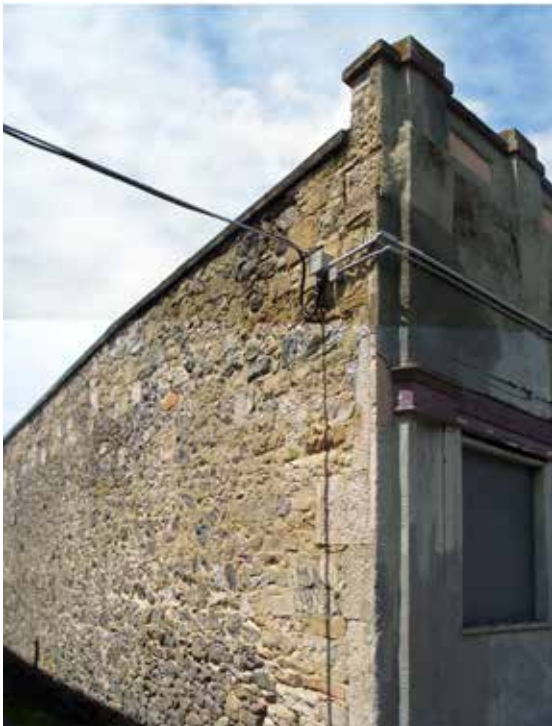
*Current side and front elevations showing the stone construction with quoining on the corner.*

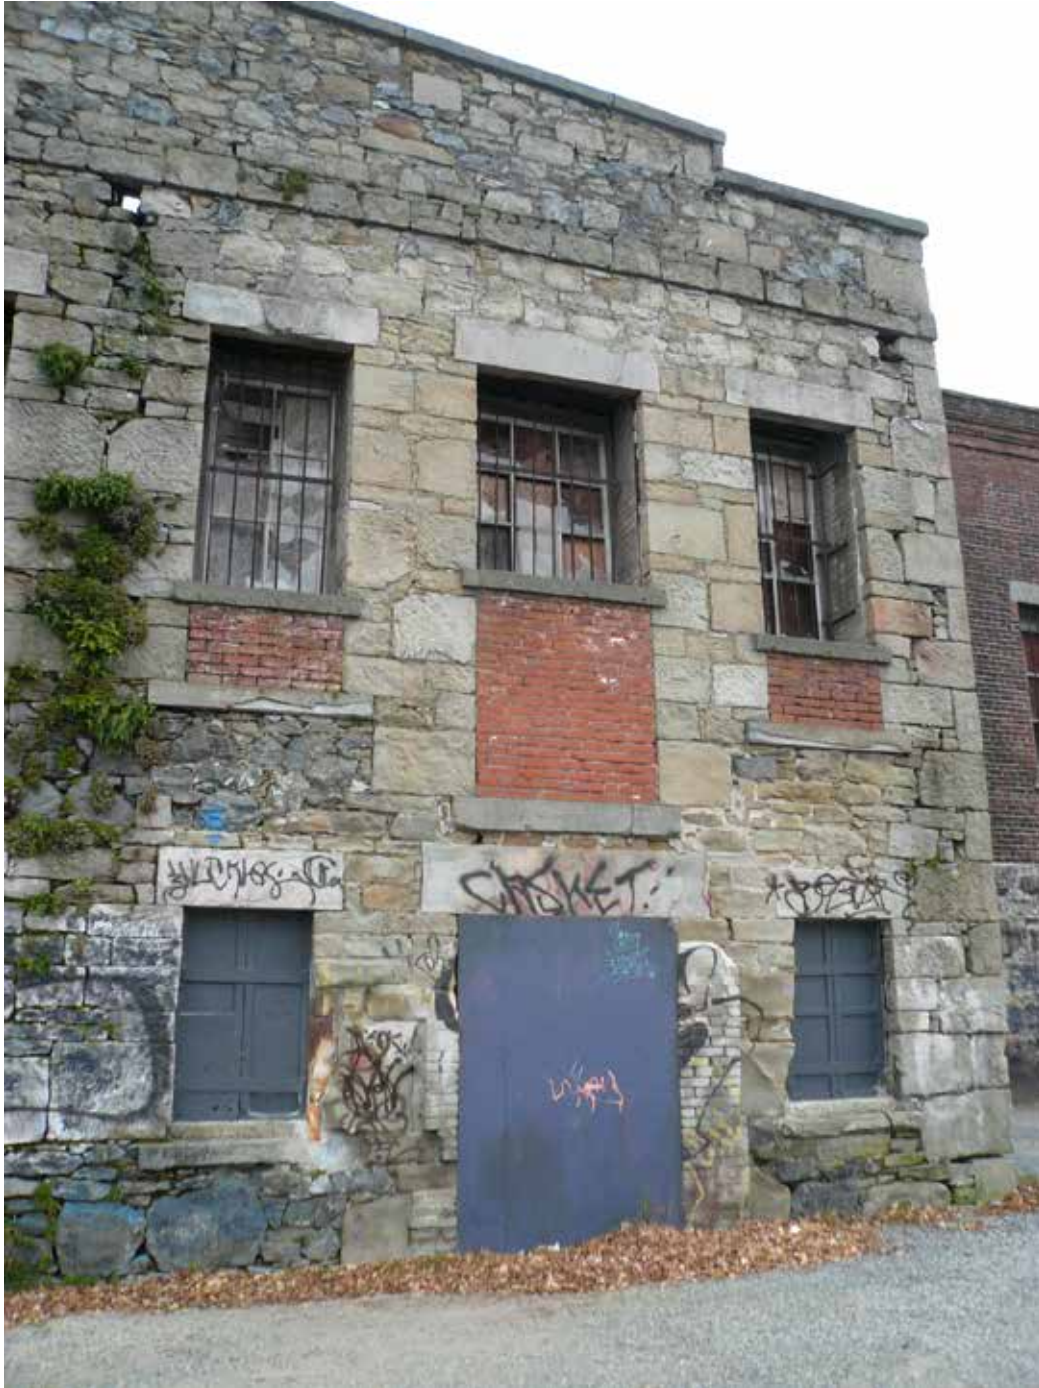
*Rear elevation of the Fraser Warehouse showing openings altered using brick, changes to window assemblies, and general condition of masonry.*

The existing window openings on the rear façade should be reinstated to their original size through the removal of the later added brick removed. Archival photographs of the façade can be used as guides for replacement wood assembly windows. At the front façade, recent interventions will need to be investigated and the later applied stucco removed to clarify what the original design of the front façade was. Contextual photographs of comparable buildings and façades should be used to develop a sympathetic and reasonable front façade that would be in keeping with the historic aesthetic of the building.

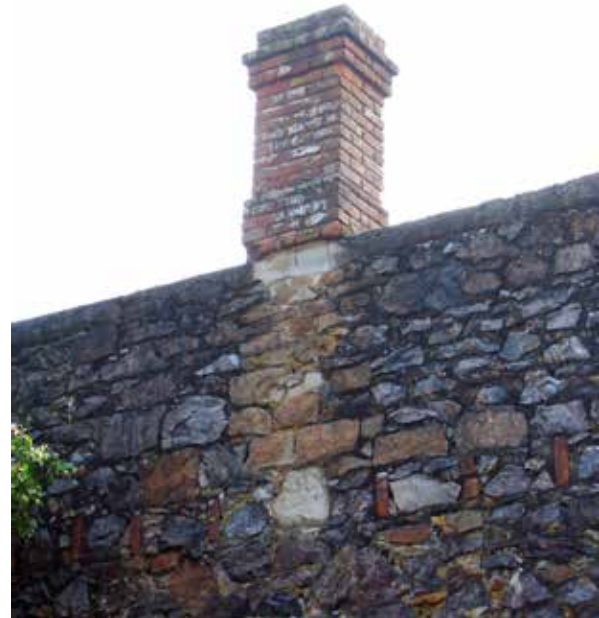
The roof, parapet, and chimneys were not safely accessible for close review and were evaluated from the ground. Those parapet cap flashings visible from ground level on the Fraser Warehouse were limited in their coverage. Absence of flashings to shed water and protect the masonry walls or interface with the roof assembly has contributed to deterioration, organic buildup, mortar loss, and staining. Two brick chimneys are present, as part of the overall redevelopment, these chimneys will not be preserved, but should be documented prior to their demolition.

*Parapet and chimney at rear of building - no flashings present.*

- Evaluate the overall condition of parapet and any intact cap flashing to determine whether more protection is required, or replacement in-kind is required.
- Repair or replace deteriorated flashing, as required. Repairs should be physically and visually compatible.
- If new flashings are installed, ensure that their design and colour is compatible with the historic masonry façades.
