SEISMIC ASSESSMENT AND UPGRADE DESIGN REPORT

NORTHERN JUNK BUILDINGS

1314 - 1318 Wharf Street, Victoria, BC

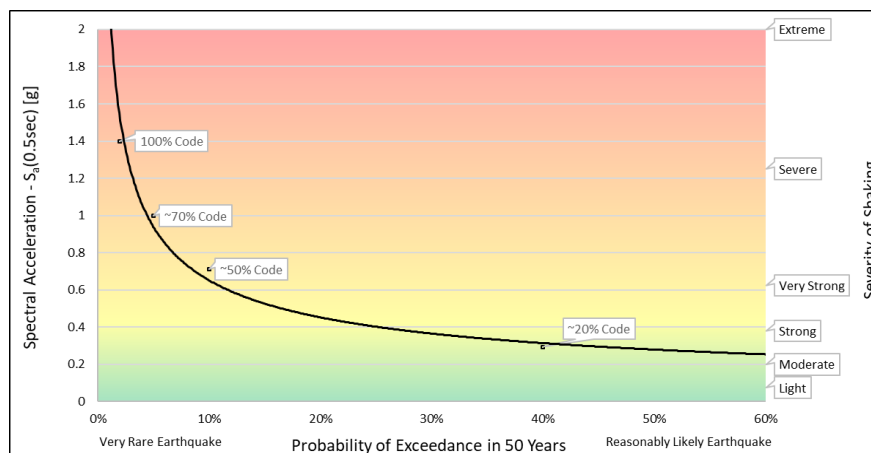
Figure 4 shows an example seismic hazard curve for Victoria. We note that this hazard curve is not directly applicable to the subject building, but is provided to illustrate the nonlinear relationship between “%code” and probability of exceedance (i.e. risk).

Figure 4 - Example Hazard Curve

Typical building codes aim to achieve “Life Safety” performance for the vast majority of buildings (except for example, hospitals, fire stations, etc) under a “very rare” earthquake (see point for “100% Code” in Figure 4). Performance under more frequent (less severe) earthquakes is typically not explicitly considered.

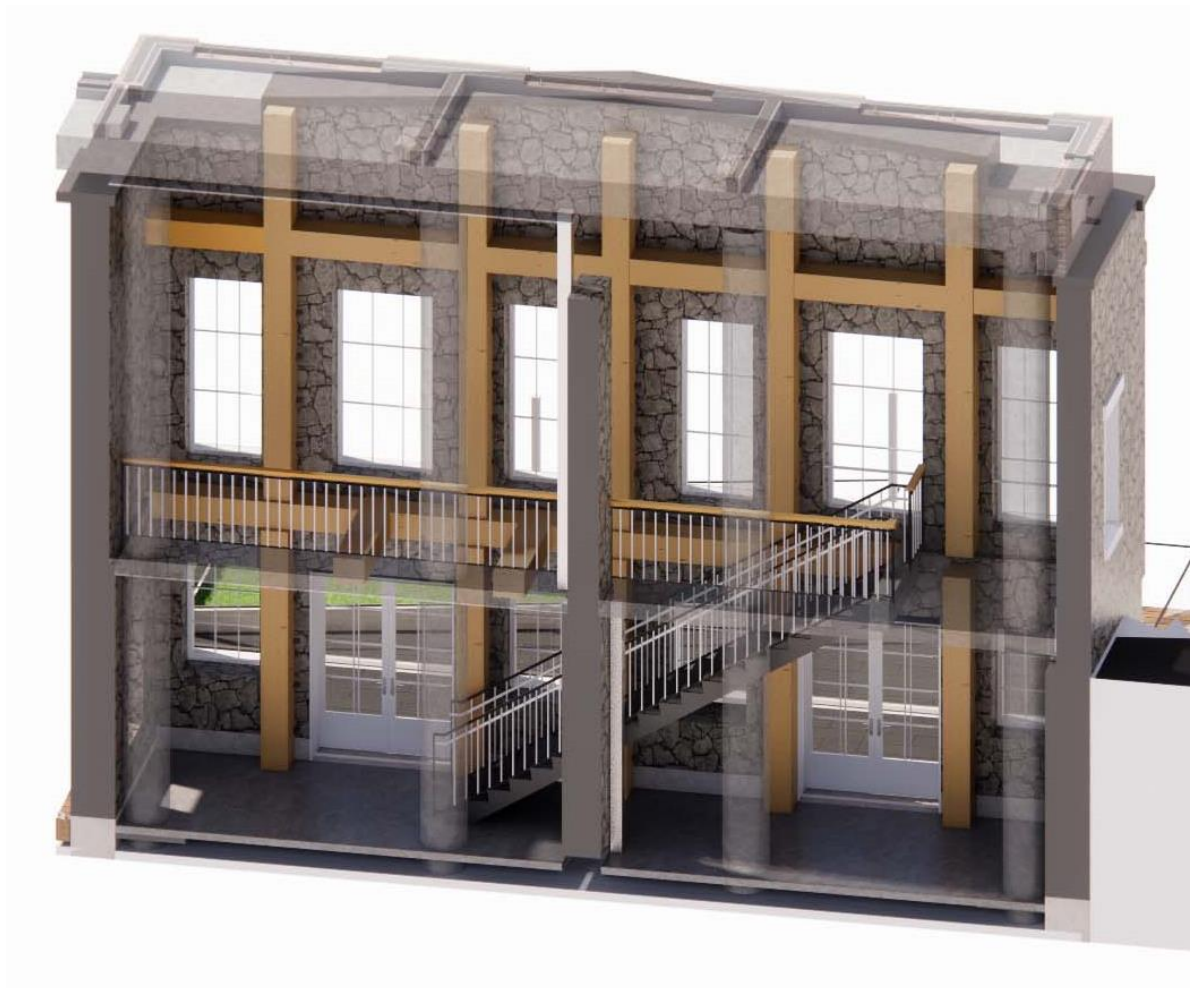
Analysis and design was per ASCE 41-17 using the Linear Dynamic Procedure and Nonlinear Dynamic Procedure. The structure was modelled using ETABS 2018 and/or SAP2000. Elements were modelled as a combination of shell and frame elements. For the nonlinear procedures, concentrated hinges were defined within the frame elements for the masonry piers, the new frame elements and the diaphragms. The use of the nonlinear analysis allowed for the capacity of the existing masonry piers to be combined with new retrofit elements in the most effective manner possible, minimizing the required upgrading. It should be noted that only 1 or 2 spectrally-matched ground motions were used. More ground motions are required for detailed design. The figures below show a 3-D view of the proposed retrofit to west wall of the North Building and the corresponding analysis model.

Figure 6 – Part of Structural Retrofit of Fraser Building West Wall
