December 8, 2023  
223440

**Re: 1314 AND 1316-1318 WHARF STREET HERITAGE BUILDING  
TAX INCENTIVE PROGRAM THIRD-PARTY STRUCTURAL ASSESSMENT**

Glotman Simpson Consulting Engineers are pleased to provide the following Tax Incentive Program third-party structural assessment for the existing 1314 and 1316-1318 Wharf Street heritage structure retention. The building is located at the corner of Wharf Street and Johnson Street in downtown Victoria.

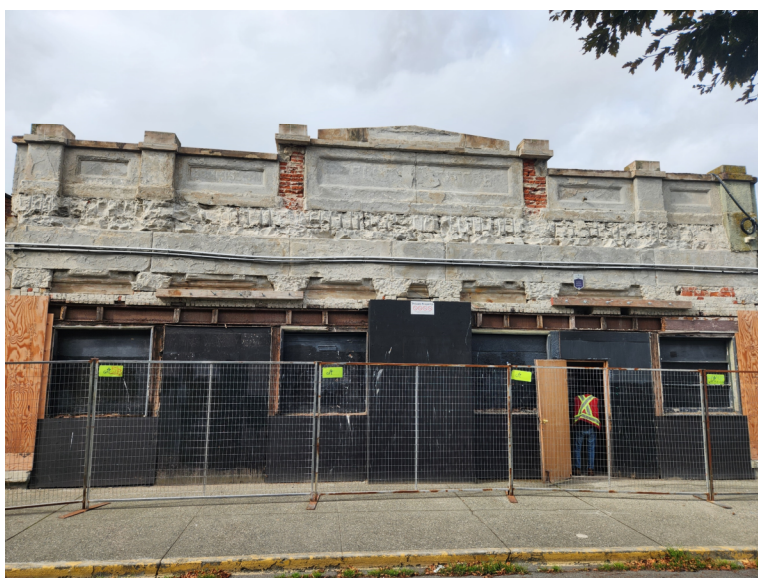
Figure 3 – East Façade along Wharf Street

The existing heritage structure located at 1316-1318 Wharf Street was originally built for commercial and warehouse occupancy and consists of two storeys, one at-grade and one partly below-grade basement. The site slopes from the east along Wharf Street down towards the west to the Gorge waterway. The east side face of the structure provides street-level access to Wharf Street and consists of a mix of stonework and brickwork, with historic stone pilasters at some point during the age of the structure being replaced by steel header beams. The west face of the structure provides access to the Gorge waterway with access directly into the basement of the structure. Refer to Figures 3 and 4 respectively.

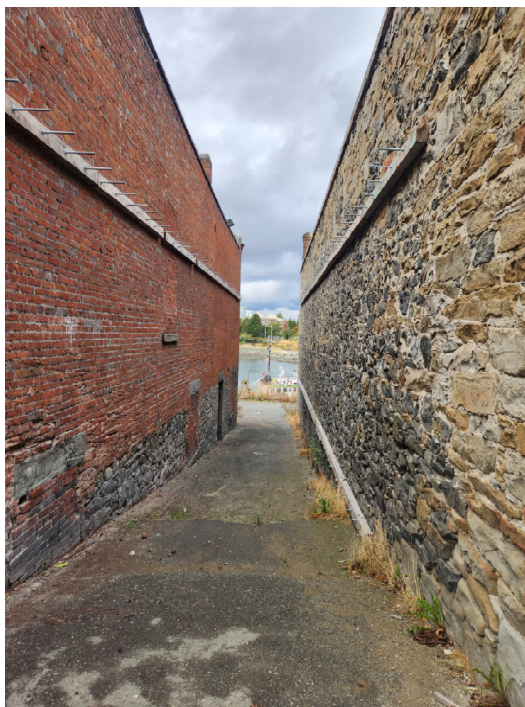
**Figure 5 – Rock South Wall of 1314 Wharf Street / Brick North Wall 1316-1318 Wharf Street**

The north and south elevations consist of stone walls with stacked stone faces complete with mortar and infilled with rock rubble. The rock appears to be a mix of granite (or similar) and sandstone; the sandstone is showing significant weathering with some portions essentially non-existent. The west façade face is similar construction to the north and south sides, with punched window openings framed with a mix of mass stone headers and steel beams.

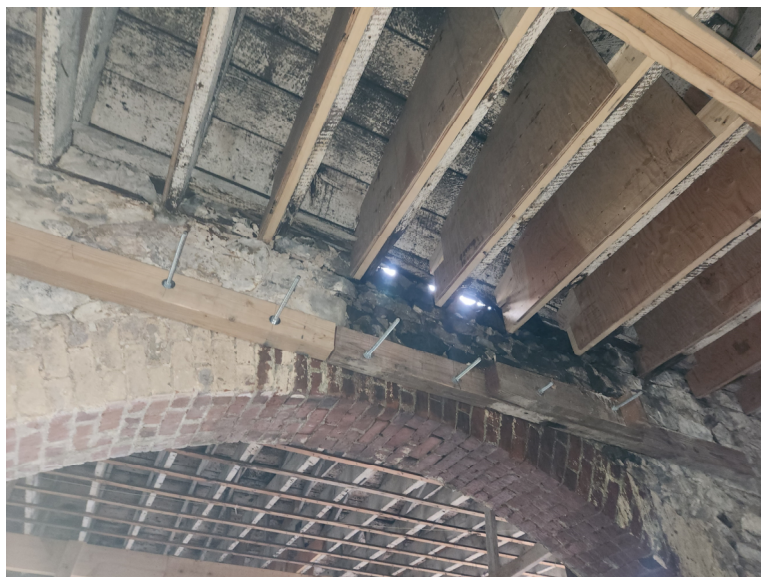
**Figure 7 – Interior Roof Support Condition at Interior Bearing Wall**

The interior structure is delineated into two roughly equal portions with a continuous interior stone-and-mortar partition wall running east-west separating both the upper and lower levels. While it appears that the wall was originally solid, openings through the walls have been added and framed with brick jambs and headers such that the upper level is effectively continuous from one side to the other; the basement levels remain separated. The roof framing consists of wood truss joists spanning north-south from the exterior bearing walls to the interior partition walls. The floor framing appears to have originally consisted of 2x rough joists running north-south and seated within the brick walls, but had at some point been reframed such that the joisting now spans east-west and supported by dropped heavy timber beams and posts. Both the roof and floor framing are sheathed with ship-lap decking.

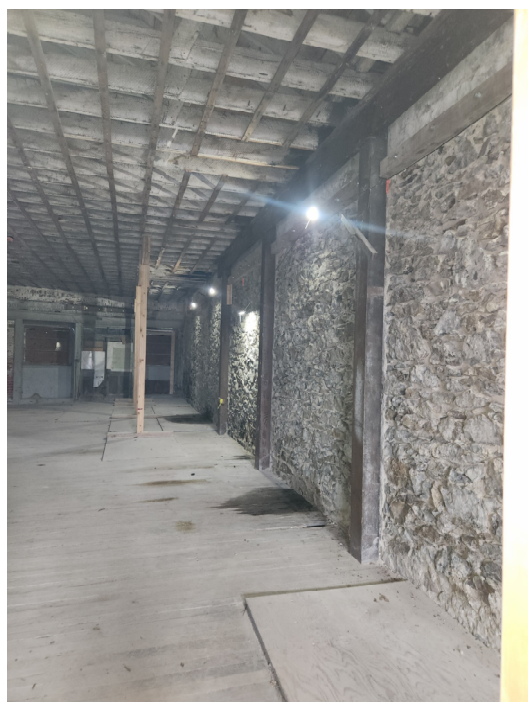
**Figure 9 – South Above-Grade Stone Wall**

Both the roof and floor framing are in extremely deteriorated condition. The existing roof membrane system has, at some point, failed and allowed significant amounts of moisture into the structure and rotted the roof truss joists and floor framing, the former of which has allowed failure and partial collapse of the northern portions of floor framing. The current owner has installed temporary supports to allow for site access, but is not a permanent solution.

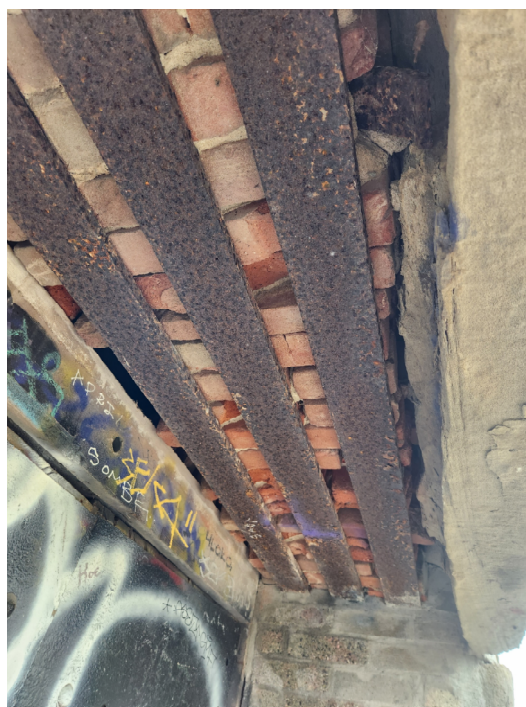
**Figure 15 – Window Header Supports in West Wall**

A field review of the existing site conditions was conducted on September 27, 2023 with representatives from the developer and Glotman Simpson Consulting Engineers. The preceding condition photos were taken as part of this review. In general, the at-grade floor framing and roof framing are in significant weathered condition, with portions having rotted and partially or completely failed. The exterior and interior walls require significant repointing due to significant weathering of the jointing. Additionally, portions of the sandstone have undergone significant weathering and in a few locations have completely weathered through such that there are wide gaps to the exterior.

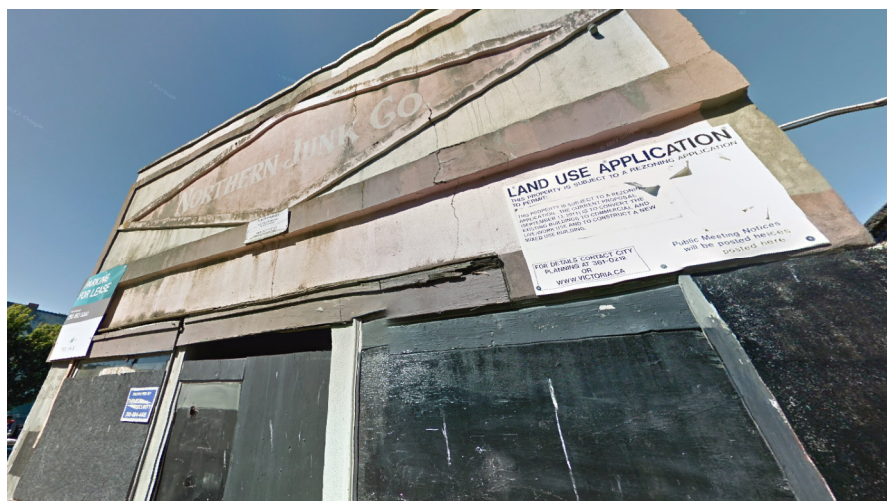
Figure 16 – East Façade along Wharf Street

The existing heritage structure located at 1314 Wharf Street was originally built for commercial and warehouse occupancy and consists of two storeys, one at-grade and one partly below-grade basement. The site slopes from the east along Wharf Street down towards the west to the Gorge waterway. The east side face of the structure provides street-level access to Wharf Street and consists of mass brick brickwork. The west face of the structure provides access to the Gorge waterway with access directly into the basement of the structure. Refer to Figures 16 and 17 respectively. The north and south elevations consist of stone walls with stacked stone faces complete with mortar and infilled with rock rubble for the below-grade portions, and mass brick walls from grade to the parapet level.

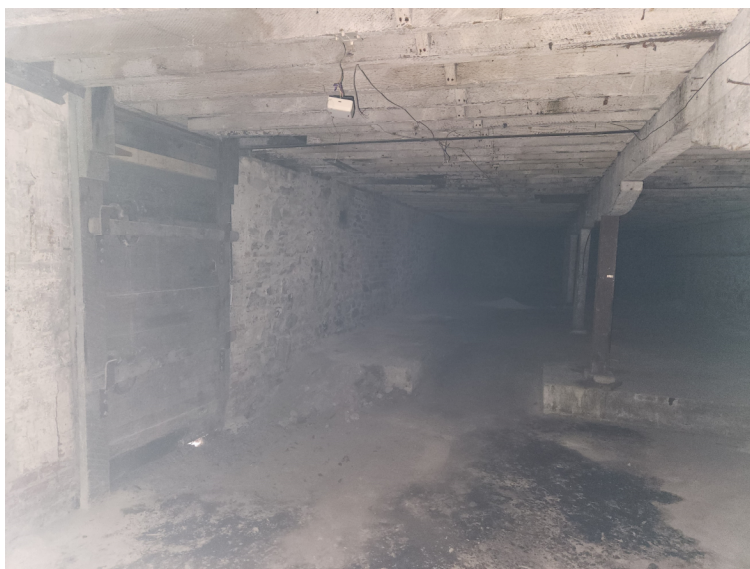
**Figure 20 –North Stone Wall and Floor Framing Above at Basement**

The roof framing consists of wood truss joists spanning north-south between the exterior bearing walls. The floor framing appears to have originally consisted of 2x rough joists running north-south and seated within the brick walls, but had at some point been reframed such that the joisting now spans east-west and supported by dropped heavy timber beams and posts. Both the roof and floor framing are sheathed with ship-lap decking.

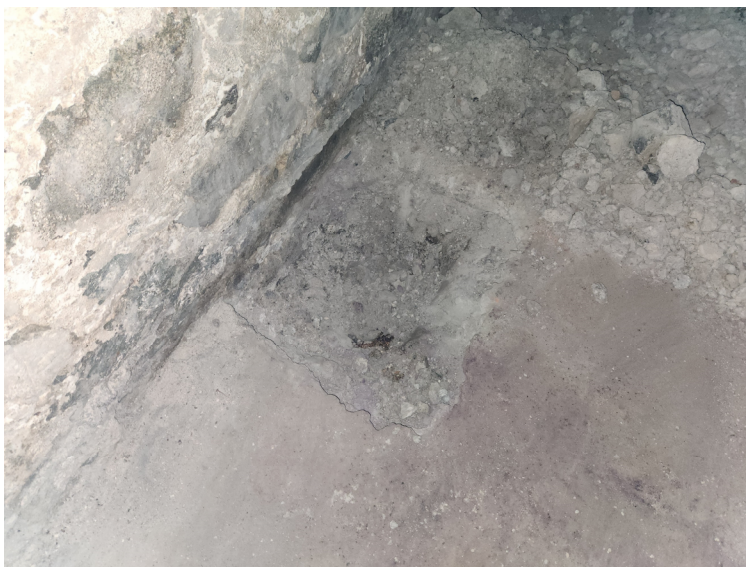
**Figure 23 – Weathered Slab-on-Grade at Basement**

A field review of the existing site conditions was conducted on September 27, 2023 with representatives from the developer and Glotman Simpson Consulting Engineers. The preceding condition photos were taken as part of this review. In general, the at-grade floor framing and roof framing are in fair to weathered condition. The exterior require significant repointing due to significant weathering of the jointing.

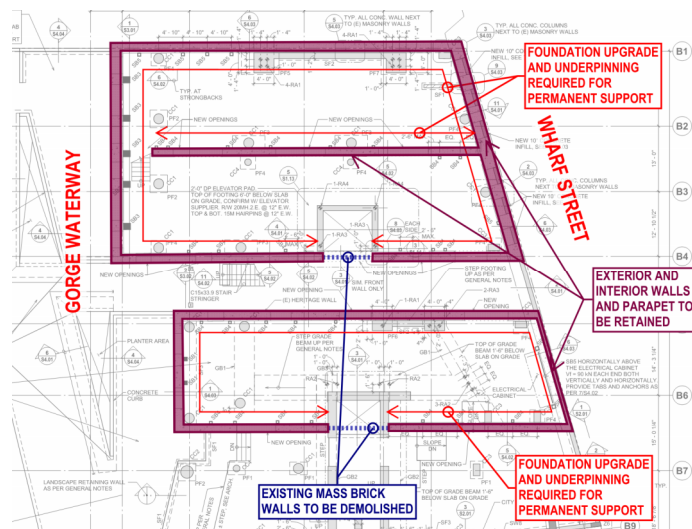
**Figure 24 – Basement Level Heritage Retention Plan (As Proposed by Developer)**

The new development has proposed to retain the following heritage items:

- All exterior façade wall framing for both structures, including parapets and cornices

- Interior bearing wall for 1316-1318 Wharf Street

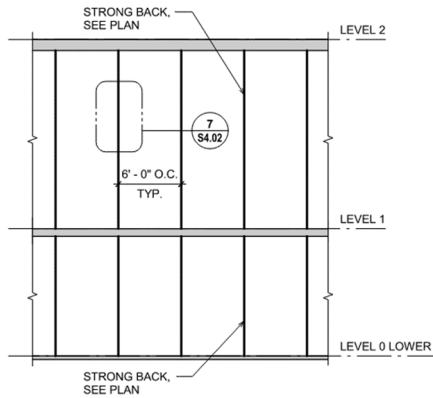
Figure 27 – Typical Wall Strong-Back Framing

The brick and stone wall façades do not have sufficient out-of-plane capacity to resist horizontal lateral movement in a seismic event (i.e. pulling away from the main building) and will require back-up framing. The façades will need to be tied back to the foundation, at-grade and roof level framing with supplemental drilled and epoxy-grout embedded threaded dowels connected to concrete and steel strong-back beams and posts. Refer to Figures 24, 25 and 26 for plan drawing excerpts from the project structural drawings of layout of exterior and interior walls to be retained, as well as Figures 27-30 for typical strong-back layout and connections. These details are typical for the north and south walls for both 1314 and 1316-1318 Wharf Street.

The existing floor and roof framing will be removed and replaced with structural suspended concrete slabs. These slabs will be used to support the strong-back framing, as well as directly supporting the interior stone wall at the floor level by casting the slabs against the wall; the adjacent concrete and steel columns support the vertical loading such that the stone wall does not support any loading beyond its own self-weight.

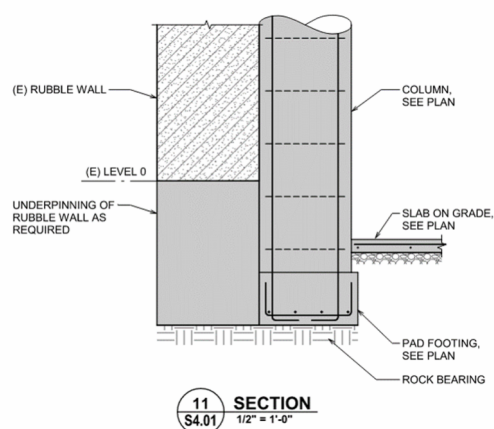
**Figure 34 – Underpinning of Existing Stone Rubble Walls**

The walls for both 1314 and 1316-1318 Wharf Street structures are being supported by stone rubble foundations, which were originally constructed with large, loose cobble-sized stone infilled with smaller stones as well as cement in some locations. These foundations are insufficient to support vertical and lateral loading and require upgrading. The existing walls for both structures will be underpinned, whereby the walls are undermined in short sections and backfilled with new concrete to provide adequate bearing capacity down to the underlying bedrock.

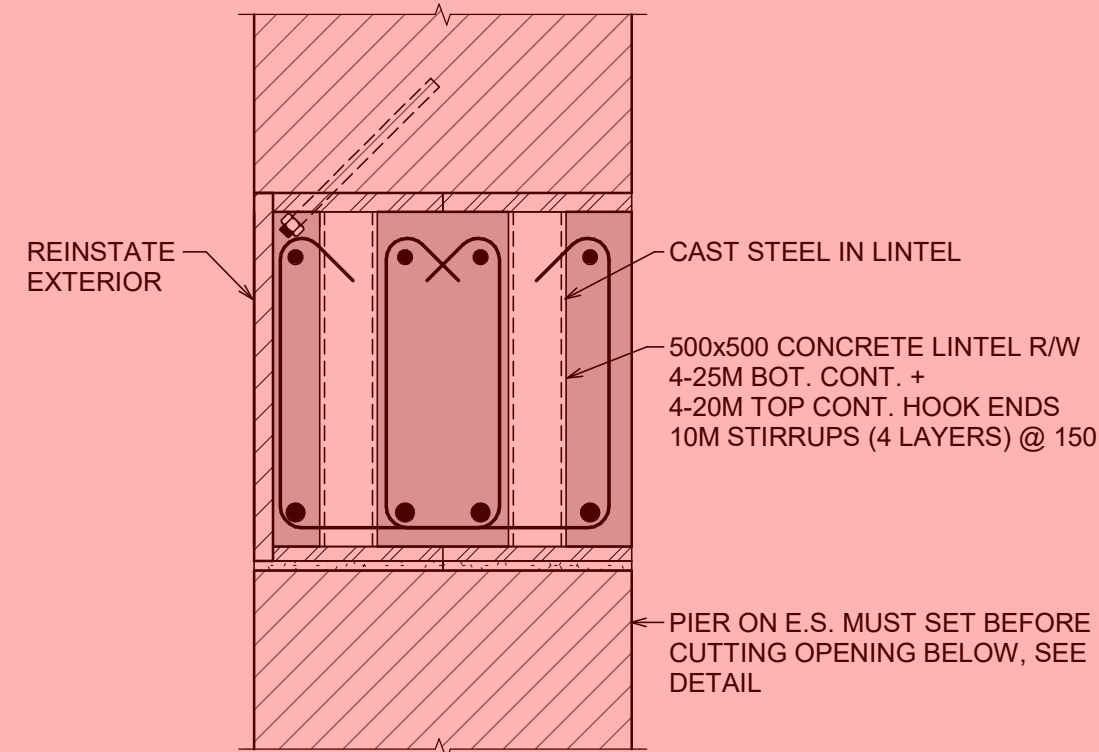
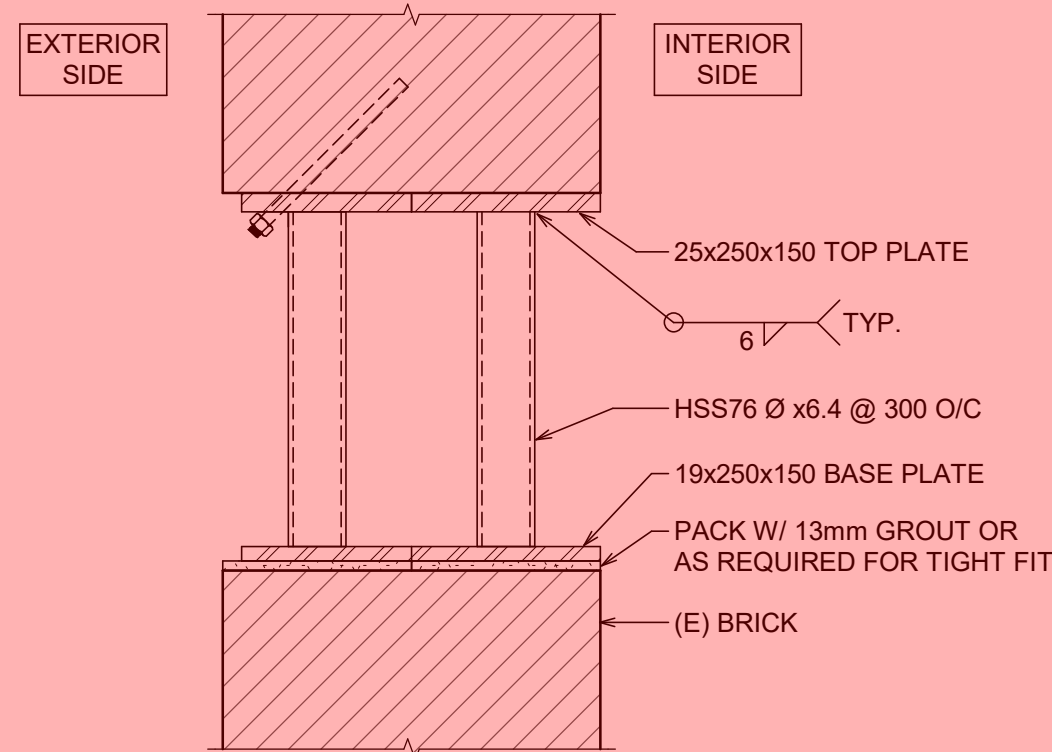
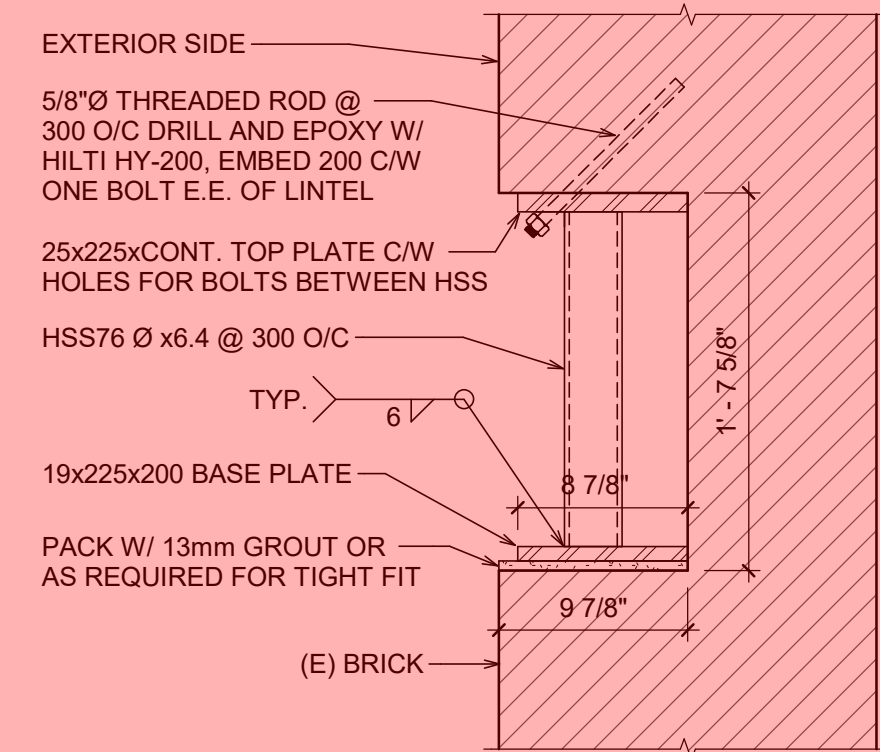
**1**  
**S4.04** CONCRETE LINTEL CONSTRUCTION DETAIL  
1 : 10

**STEP 3**

**STEP 2**

**STEP 1**
