Planning and Land Use Committee Report For the Meeting of January 14, 2015

To: Planning and Land Use Committee **Date:** December 18, 2015
From: Jonathan Tinney, Director, Sustainable Planning and Community Development
Subject: Development Permit Application No. 000445 for 845 Yates Street

REGARDING **The Wave - 845 Yates Street**
Development Permit Application for the Replacement of Tile Mosaic and Thin Stone Cladding

REPLACEMENT OF TILE MOSAIC AND THIN STONE CLADDING

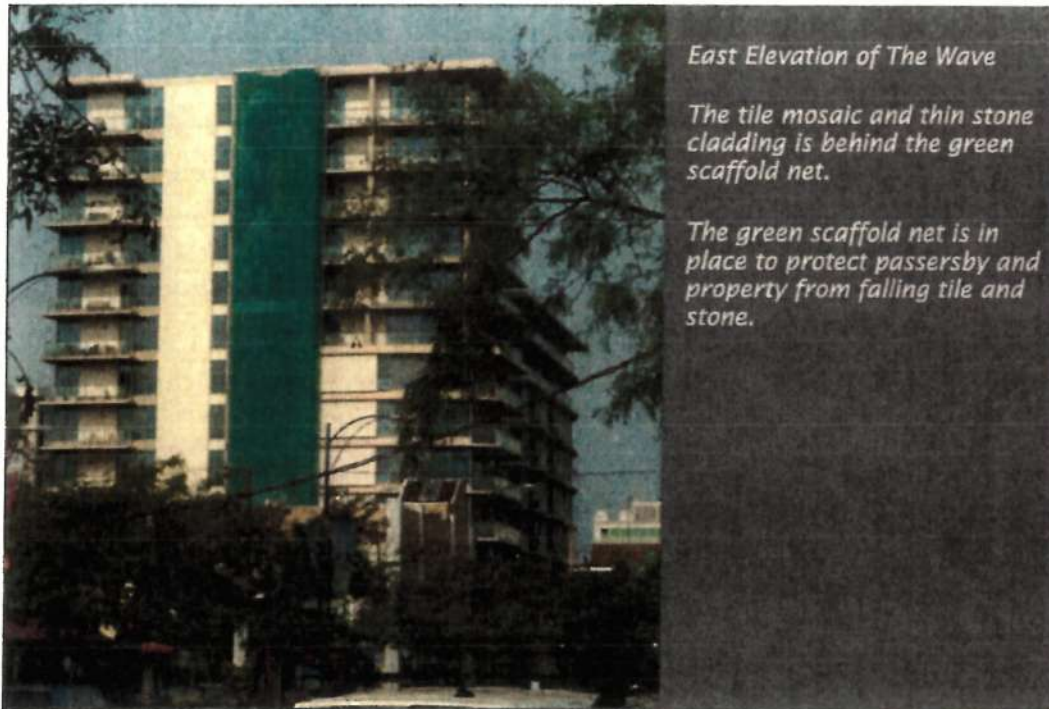
East Elevation of The Wave

The tile mosaic and thin stone cladding is behind the green scaffold net.

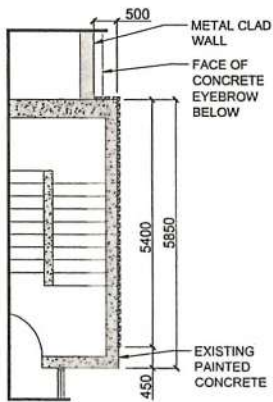
DEMOLITION
floors 2 through 7

- DEMOLISHED CERAMIC TILE
- DEMOLISHED THIN STONE
- EXISTING THIN STONE TO REMAIN
- PAINT TO REPLACE THIN STONE
- PAINTED MURAL

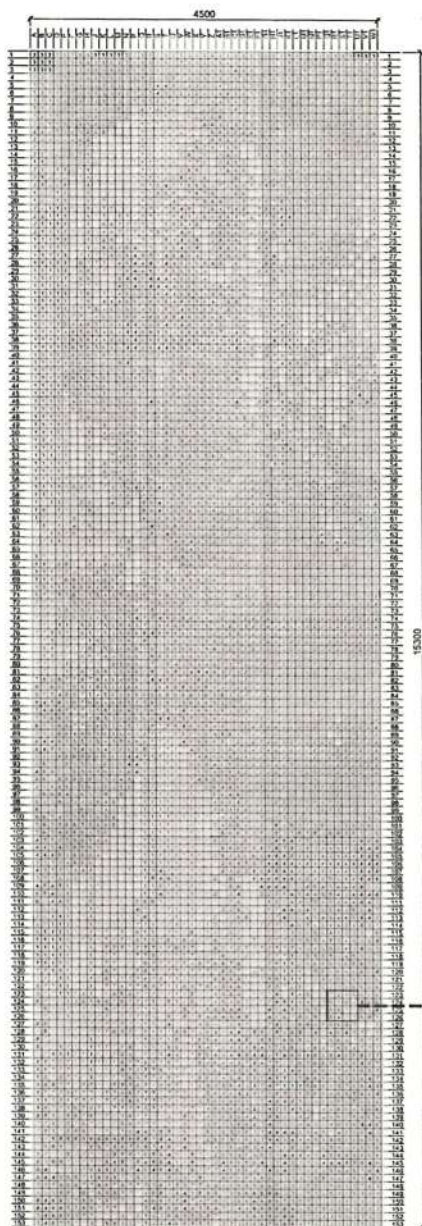
the mural forms a grid of 6885 squares

- The mural is a grid of 6885, 100mm x 100mm squares.
- It is 153 squares high and 45 squares wide.
- A number designates each horizontal row of squares.
- A letter designates each vertical column of squares.
- Each individual square in the grid can be located by row number and column letter [eg. the square at row 23, column S].

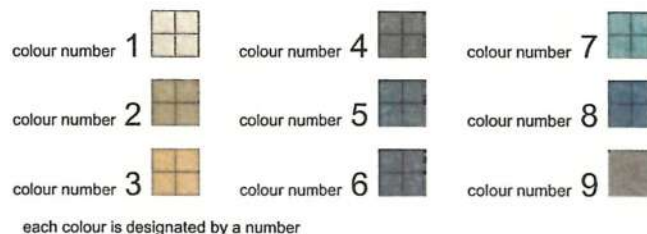
LOCATION

each square is painted in the colour corresponding to its number

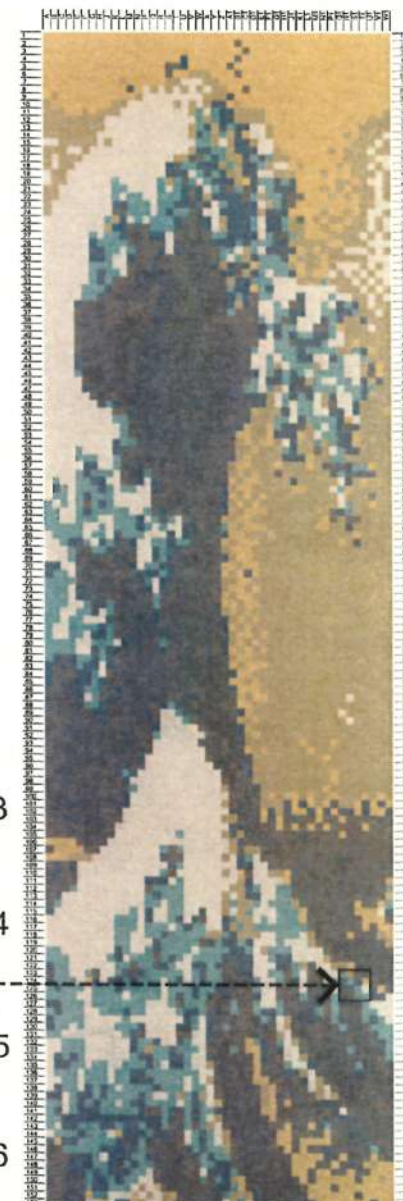
from numbers to colours, to wave image

Each colour has been given a number, and each square within the grid has been assigned the colour number corresponding with the original tile colour. Once the concrete substrate has been prepared, and the grid laid out, colour will be applied to each square according to its colour number. This is graphically represented on sheet A-4, Methodology, of the Development Permit application drawing set.

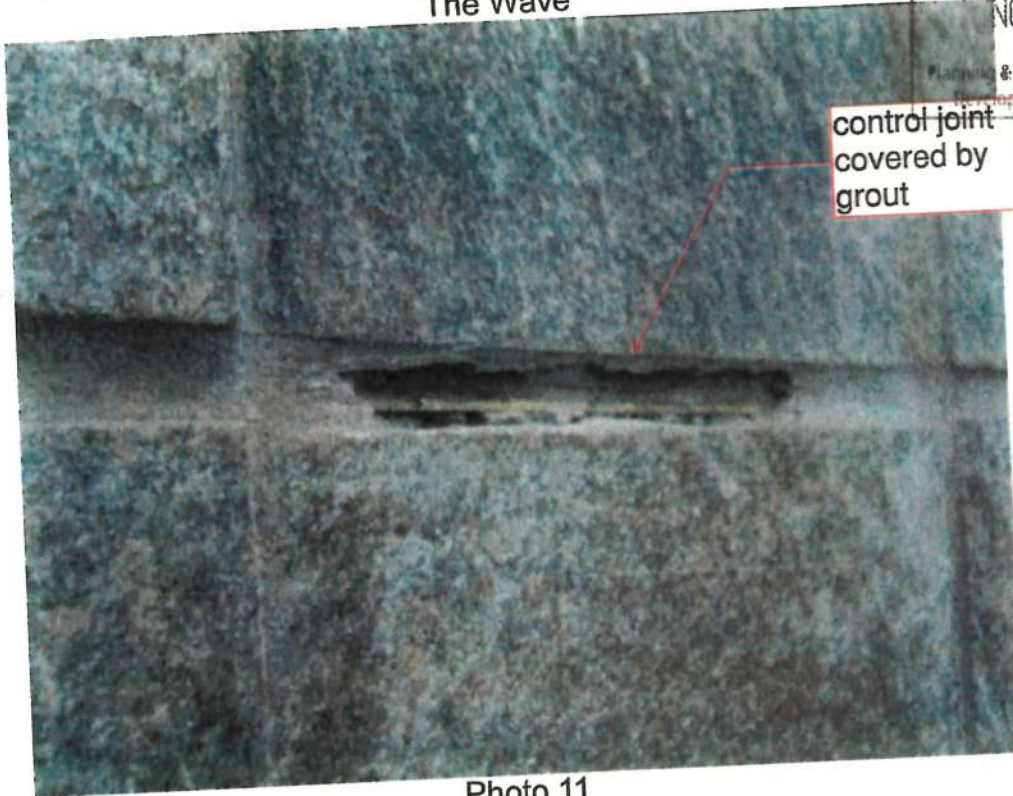
Photo 11

control joint
covered by
grout

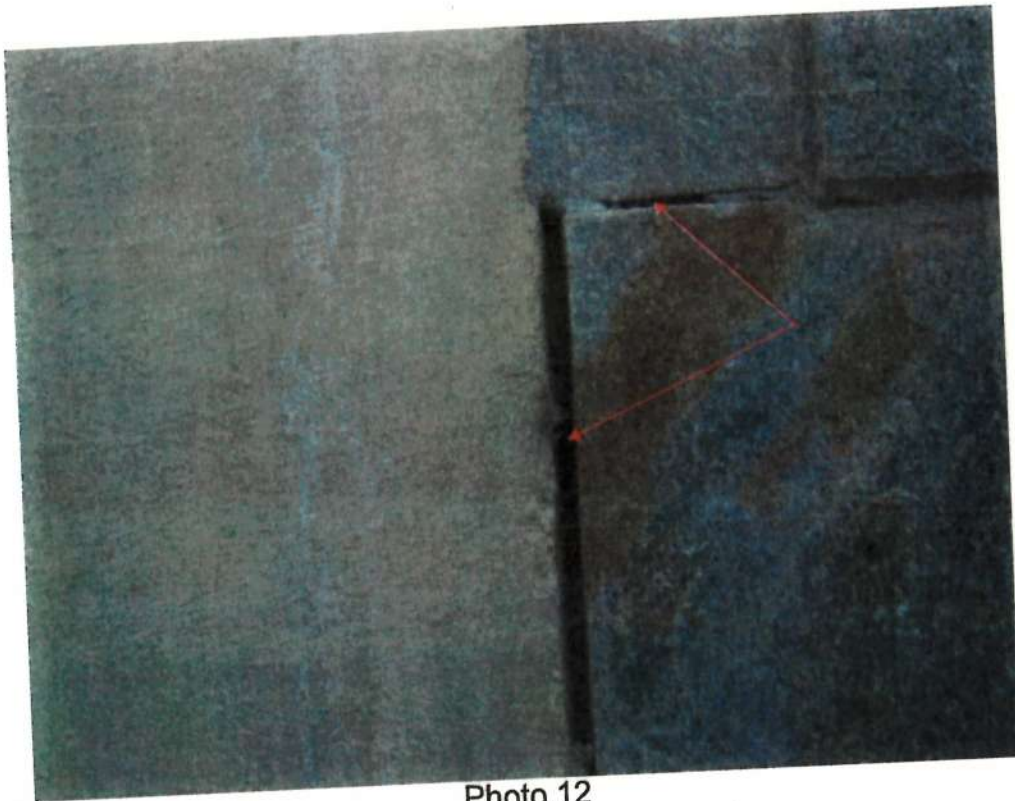
Photo 12

- The joint between the stone and the concrete structure was filled with mortar. The mortar had failed in locations providing an opening for water entry (Photo 12).
