1070 Joan Crescent

Heritage Alteration Permit Application

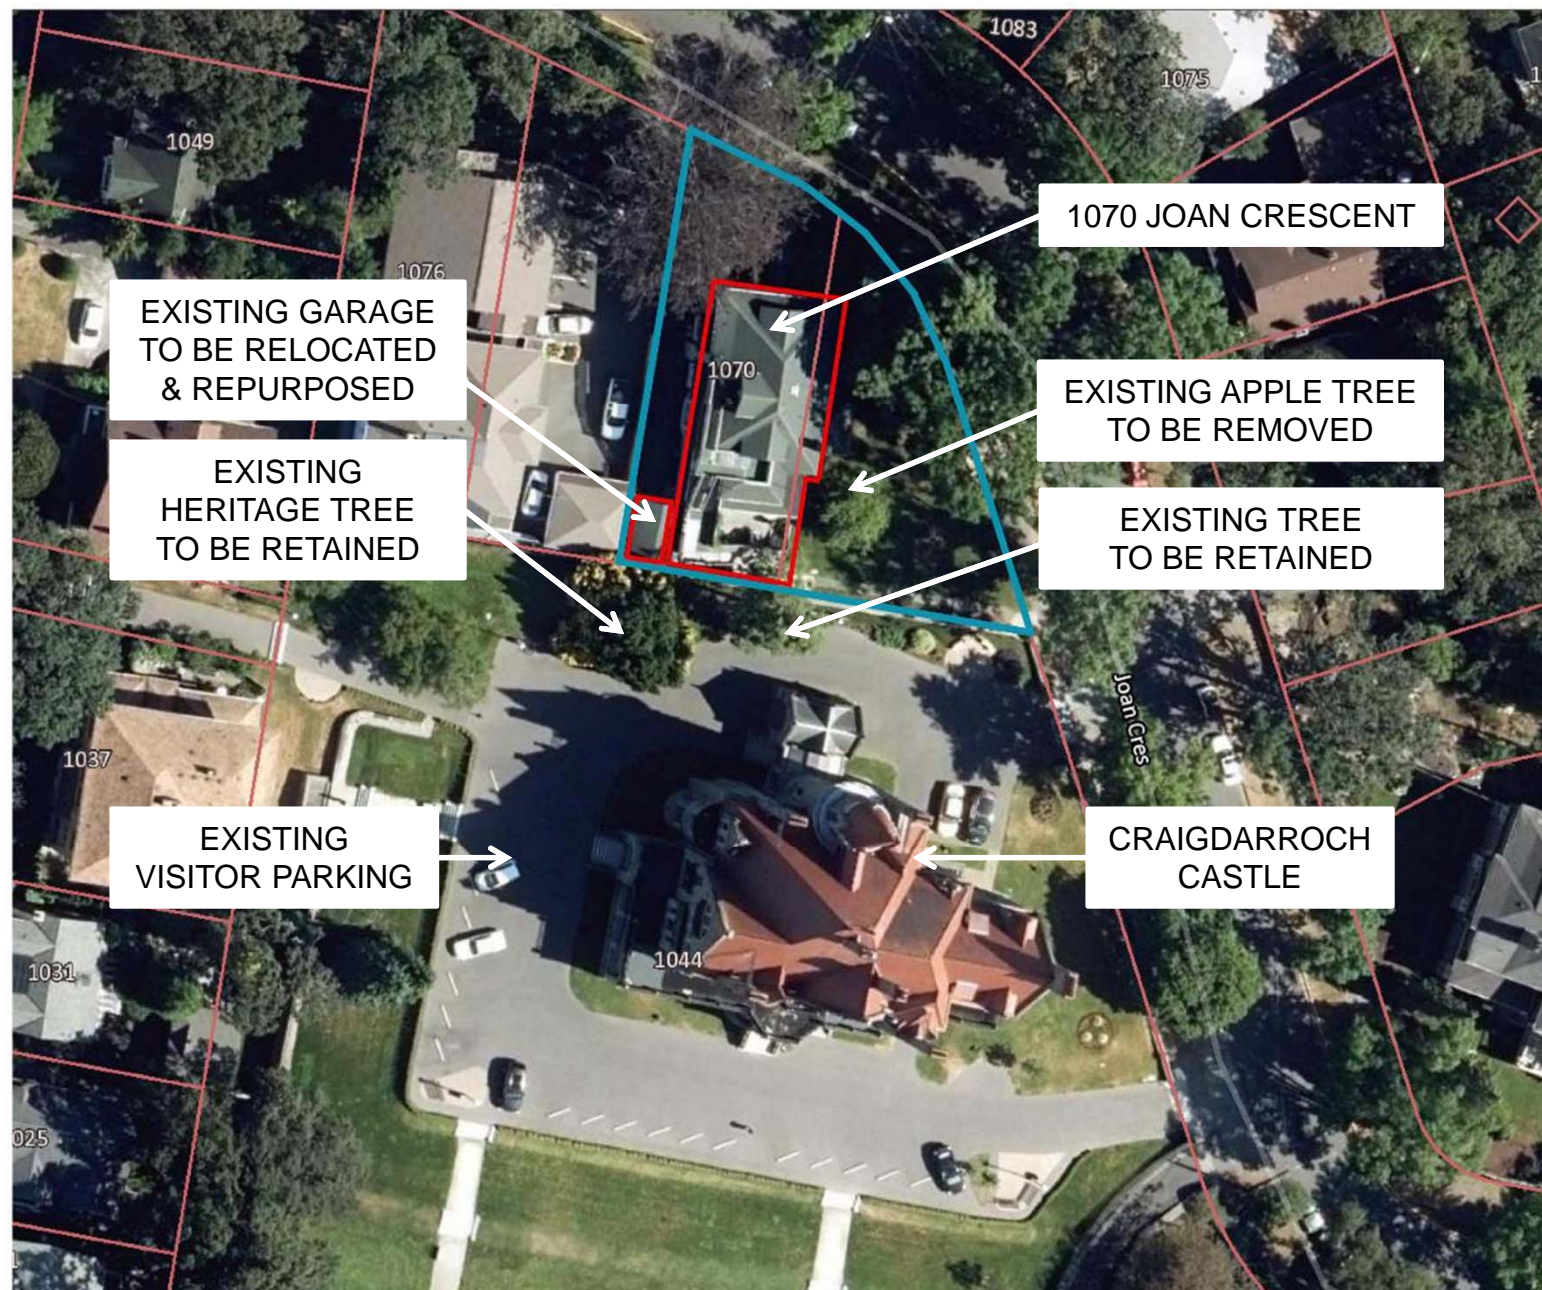
1070 JOAN CRESCENT

EXISTING GARAGE
TO BE RELOCATED
& REPURPOSED

EXISTING
HERITAGE TREE
TO BE RETAINED

EXISTING APPLE TREE
TO BE REMOVED

EXISTING TREE
TO BE RETAINED

EXISTING
VISITOR PARKING

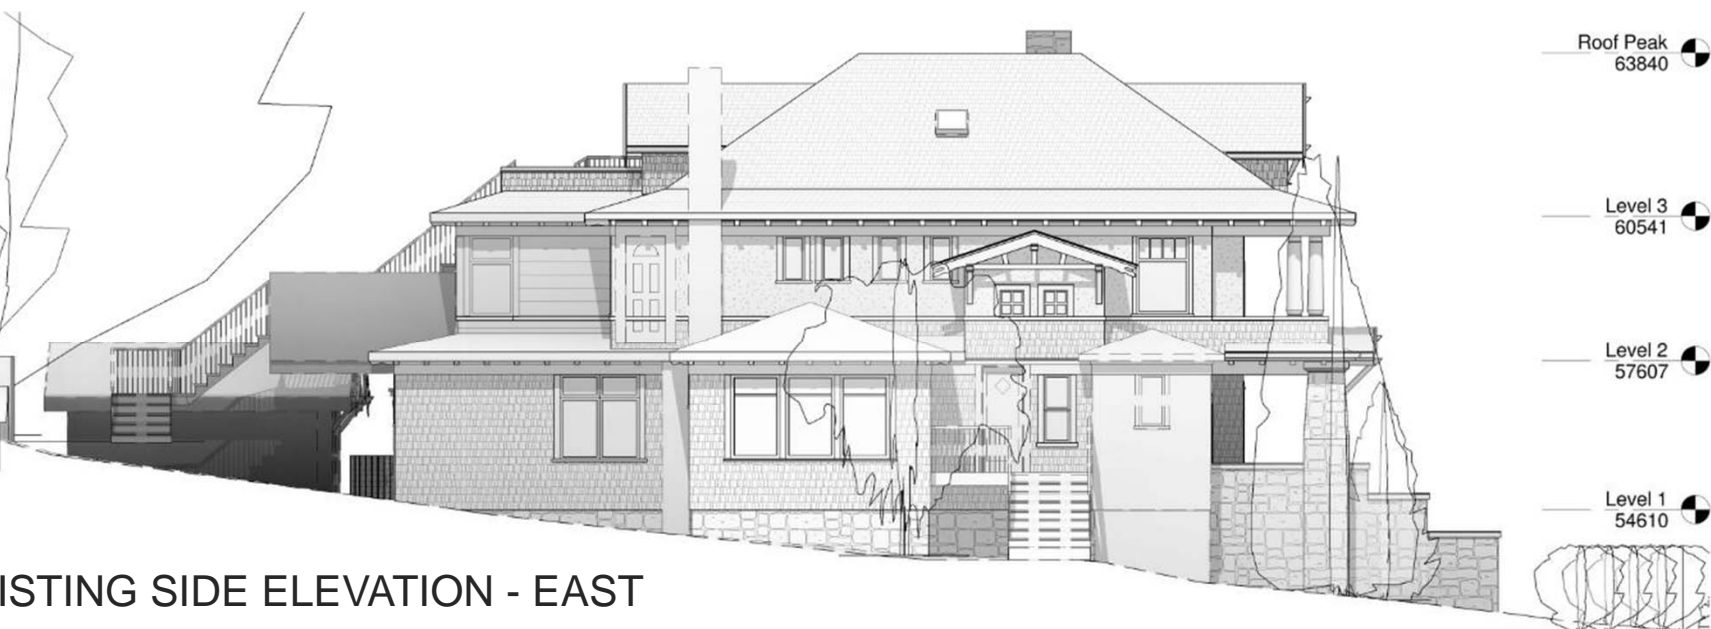
EXISTING SIDE ELEVATION - EAST

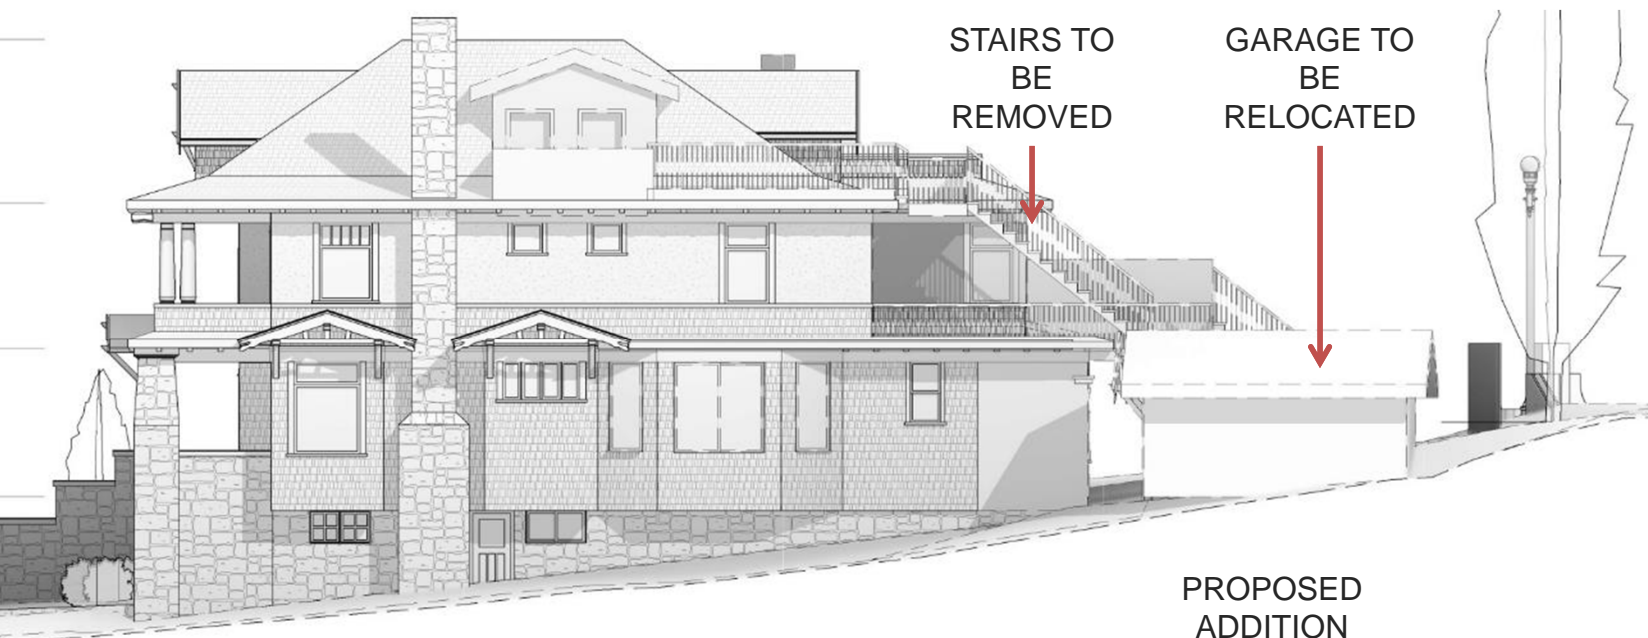
EXISTING SIDE ELEVATION - WEST

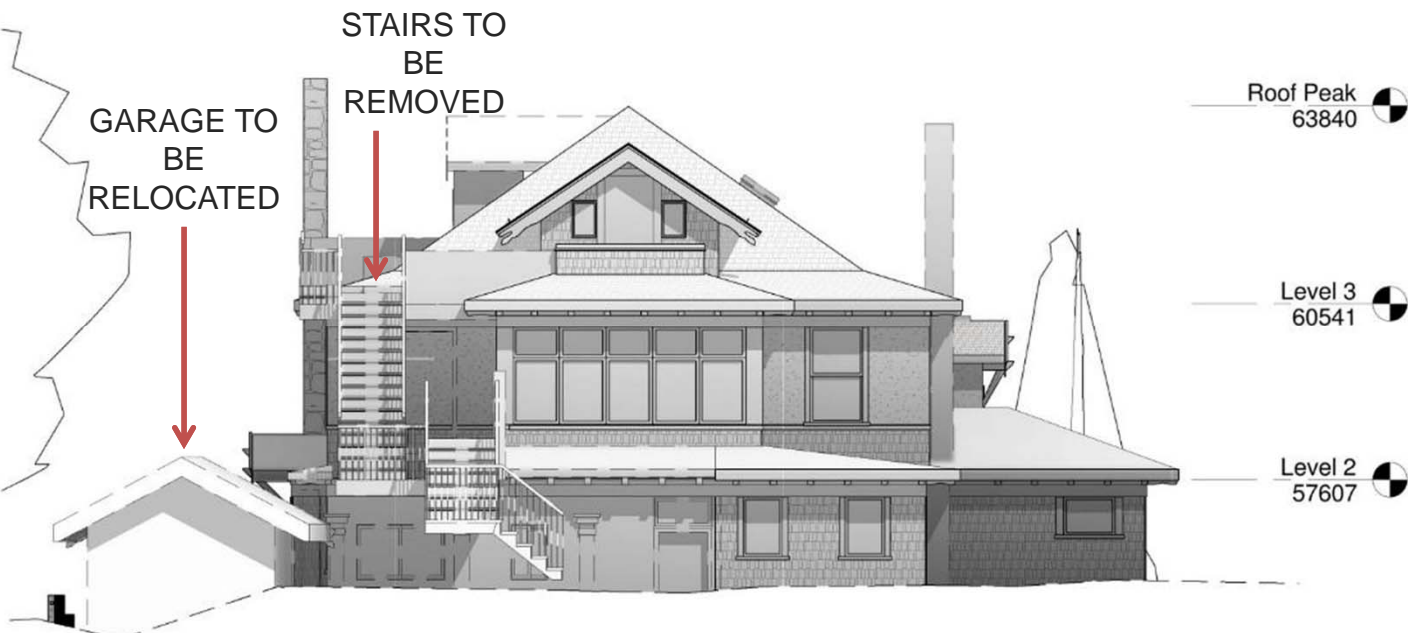
EXISTING REAR ELEVATION - SOUTH

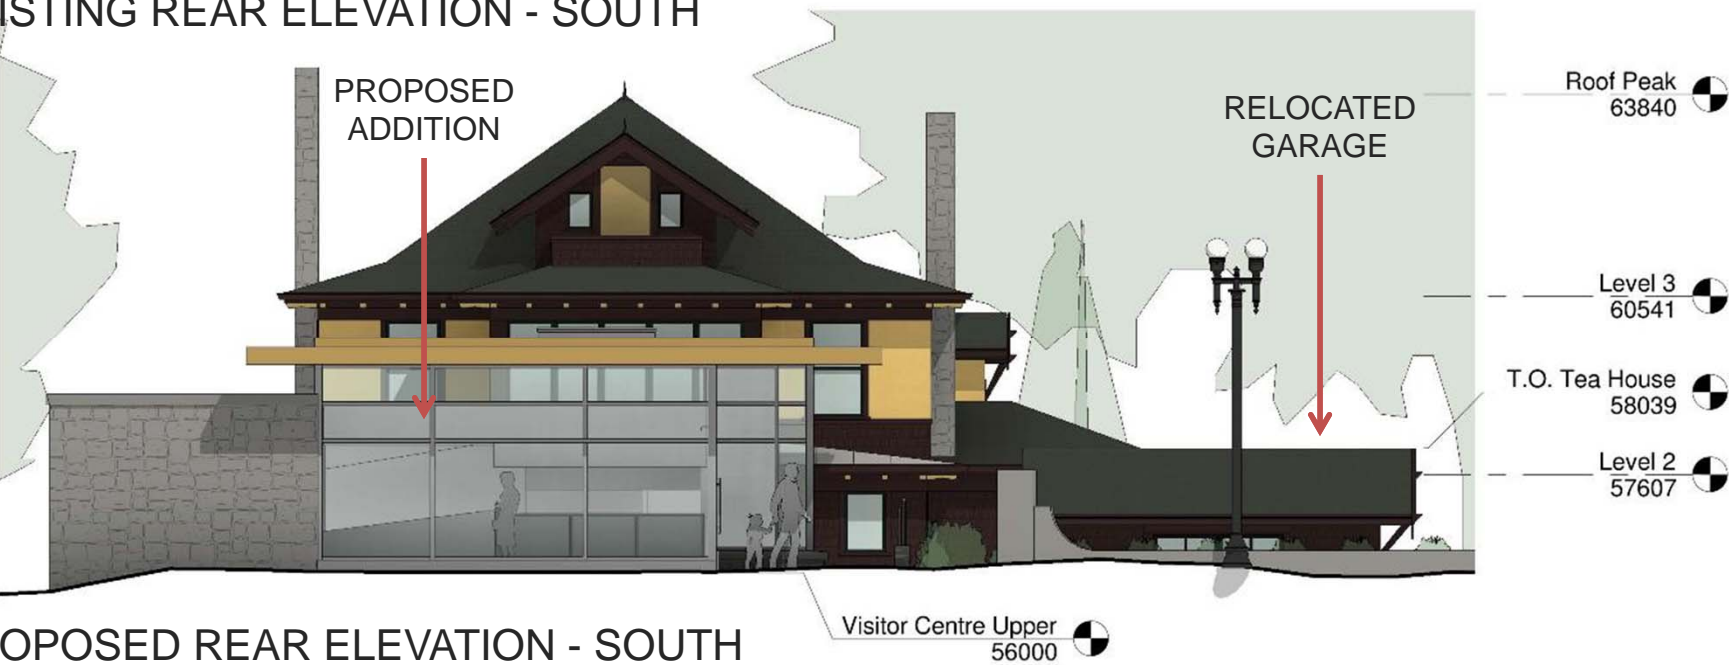
PROPOSED REAR ELEVATION - SOUTH

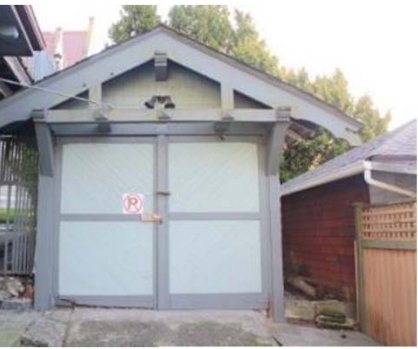
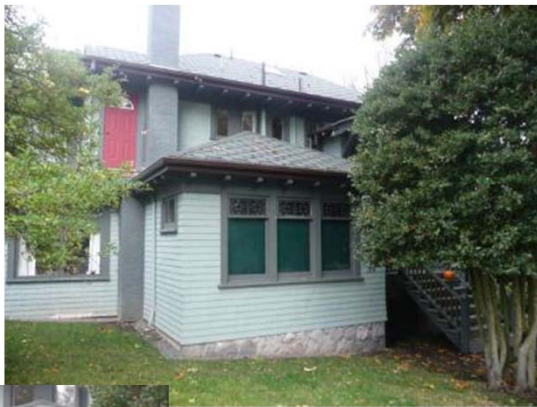
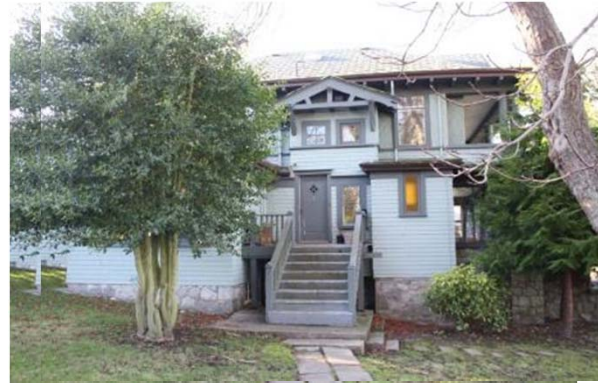
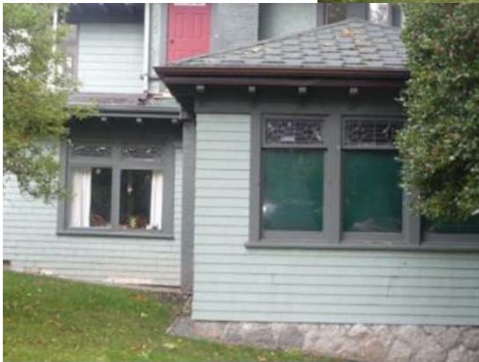
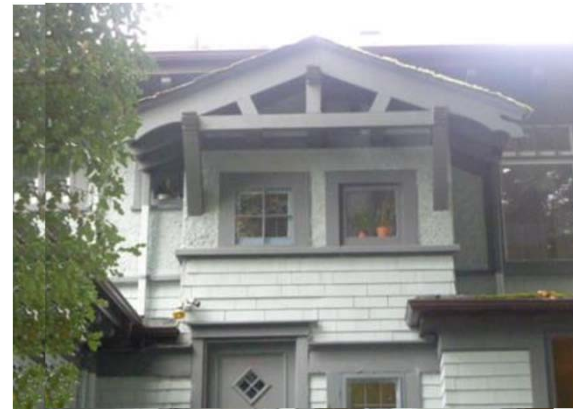
CHARACTER PHOTOS

The placement of the house in its steeply sloped garden with its existing relationship of heights of interior floor levels to the angled exterior ground levels.

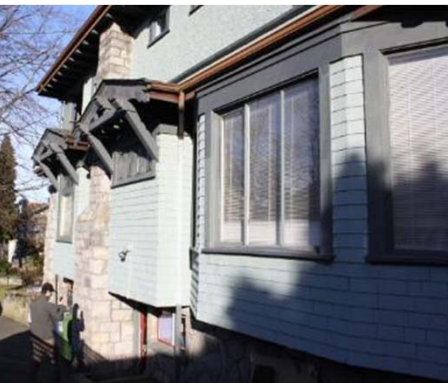
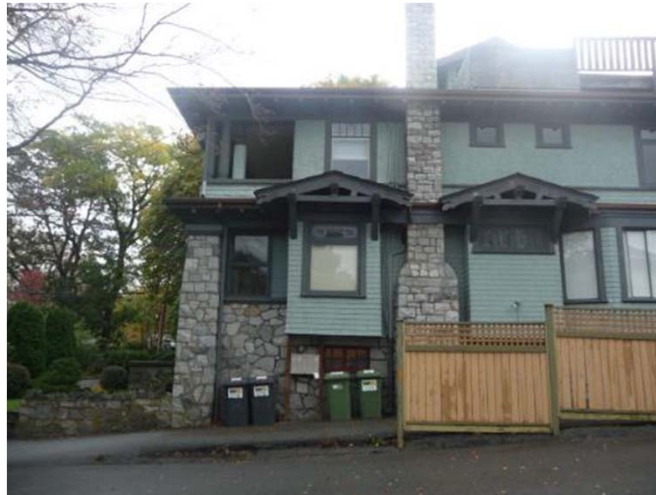
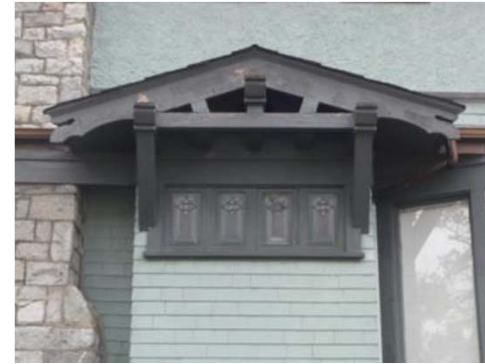
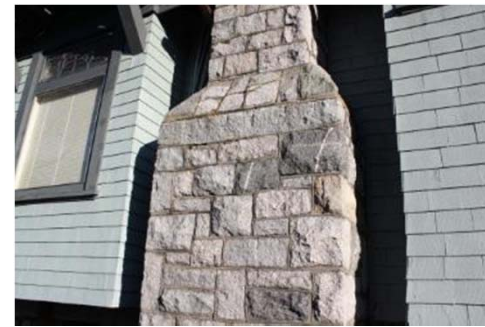
CHARACTER PHOTOS

The original detailed massing of all building facades dating to the time of construction, including porches, exterior staircase, gables; windows, and roof planes.

The historic exterior building materials dating to the time of construction, including the granite foundations, front stairway; porch pillars and chimney, extensive wood shingling, and wood and rough-cast stucco wall coverings.

The original and rare detached garage with Arts & Crafts gable and shingle exterior.
