CAPITAL PARK, VICTORIA

521 SUPERIOR STREET

DRAFT CONSERVATION PLAN - JUNE 2014

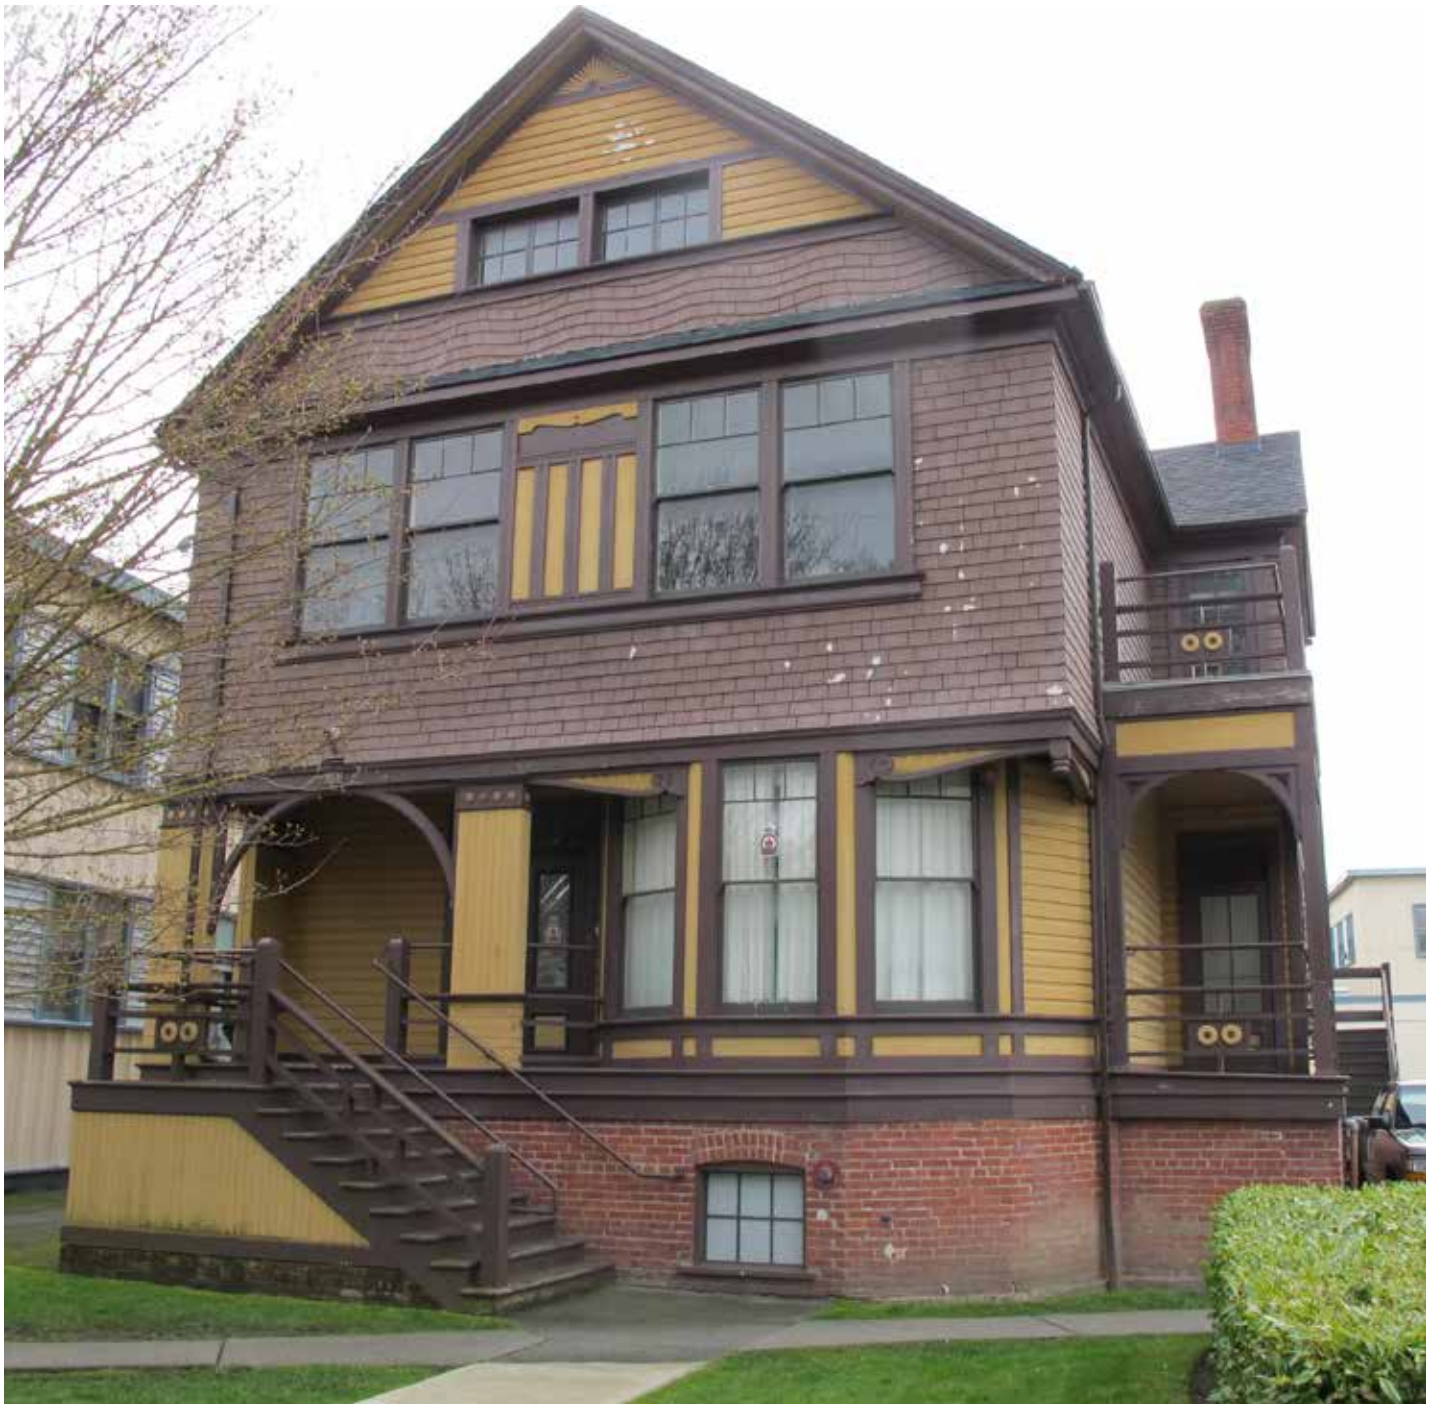
Front elevation.

The historic house's residential form, scale and massing as expressed by two and one-half storey height, picturesque roofline with steeply-pitched, front-gabled roof with projecting side gables, recessed corner porch with inset entry and three-sided bay, and double height corner porch on west elevation is a character-defining elements of the historic house, which should be preserved. A large shed-roofed extension is extant on the rear side of the house, but the floor plan as noted in the Victoria 1891 (updated to 1895) Fire Insurance Map suggests the rear shed-roofed extension is original to the 1892 house. A large exterior exit stair has been installed on the rear of the building, adjacent to the shed-roofed extension, which is unsympathetic to

Conservation Strategy: Preservation and Rehabilitation

- Preserve the overall form, scale and massing of the building.
- Remove unsympathetic rear exit stair addition.
- The historic front façade should be retained.

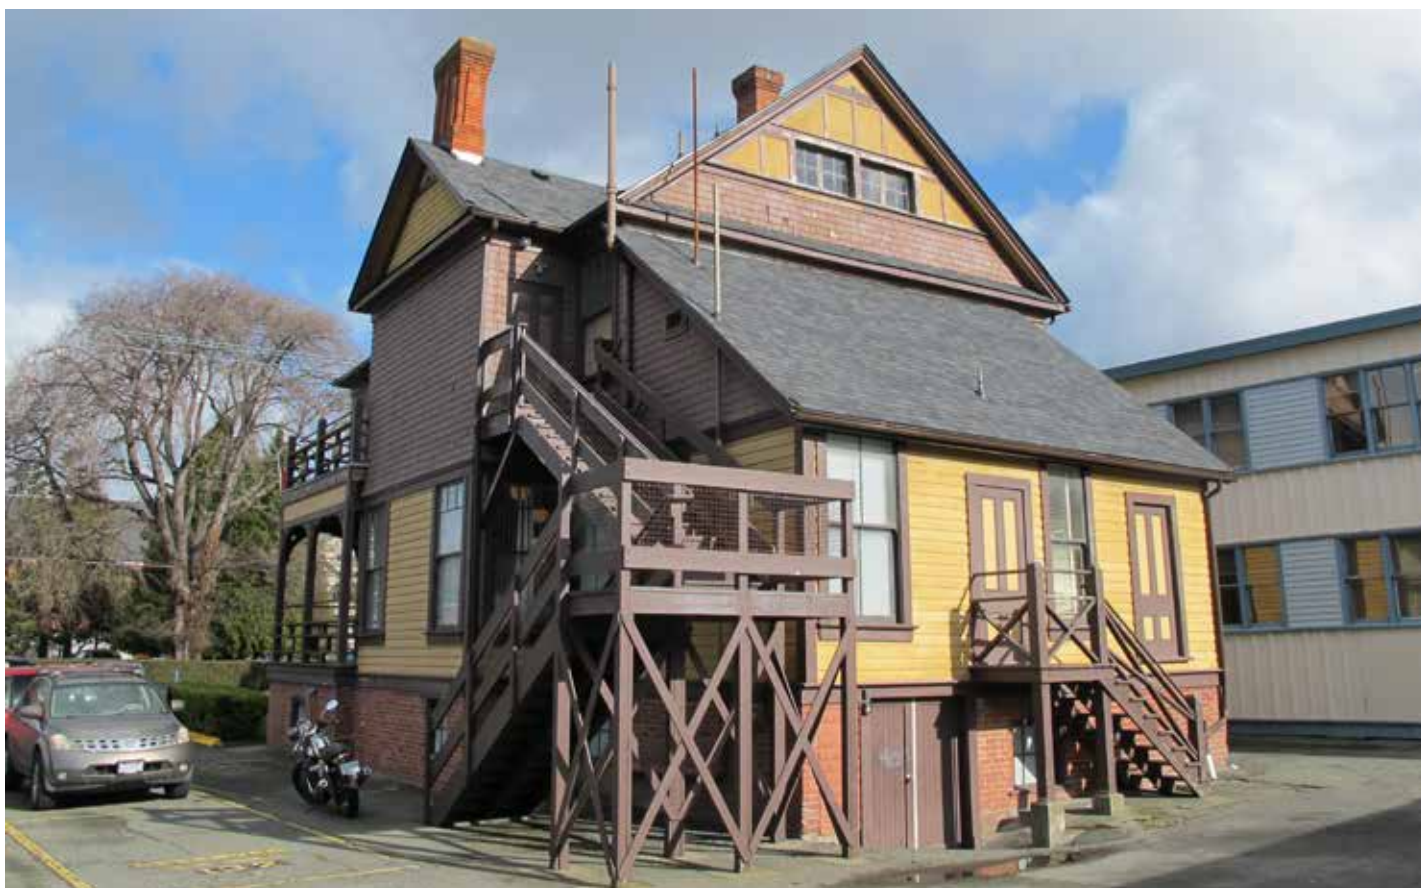
Rear elevation - note external stair addition.

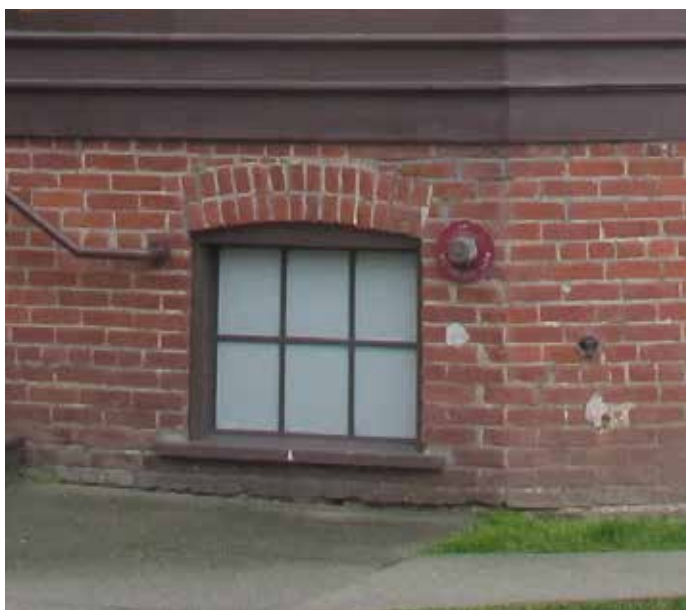
The Jameson Residence features exposed red brick foundations, which are a character-defining element, and are original to the 1910 relocated house. Due to the proposed relocation of the house, new foundations will be required. Concrete is a suitable material for new foundations, but all visible exterior surfaces above-grade should be finished in brick to match original. If possible, salvage original brickwork and reinstate following relocation of the house. If bricks are not salvageable, then all exterior surfaces of brick foundation should be well documented to ensure new foundations accurately replicate originals, including window openings, brick bond and pointing profile. Any new material should match original. Front foundation window openings should be reinstated as per original, but side and rear window opening configuration in foundation may be rehabilitated.

Red brick foundations.

- New foundations are required at the new site, and concrete is a suitable material.
- Salvage original foundation brickwork and reinstate following relocation of the house. Brick can be reinstated as an exterior veneer if concrete is to be used for foundations at new location. Any new material above ground should match original in appearance, as viewed from the exterior. Red brick should be used, in a matching configuration to original.

- Front window openings at foundation level should be retained. Side and rear configuration may be rehabilitated.
- To ensure the prolonged preservation of the new foundations, all landscaping should be separated from the foundations at grade by a course of gravel or decorative stones, which help prevent splash back and assist drainage. Any landscaping should be set back from the exterior elevations of the house to help prevent against unnecessary moisture damage.

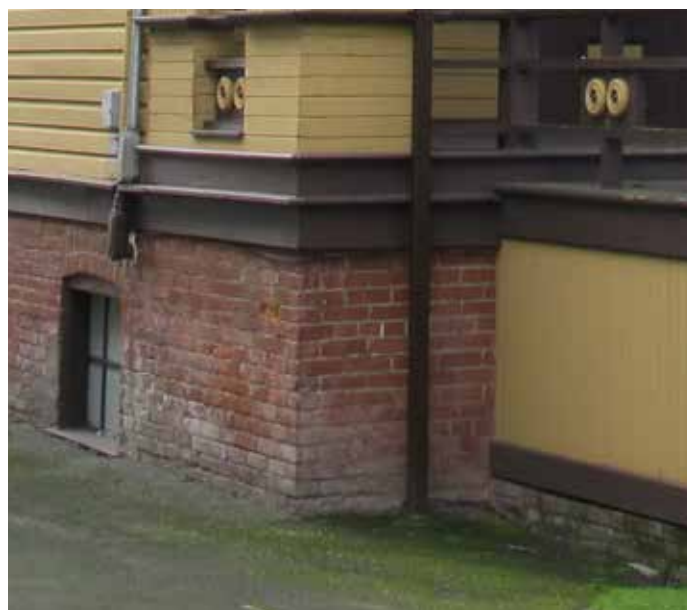
Red brick foundations, vertical wood skirting around porch.

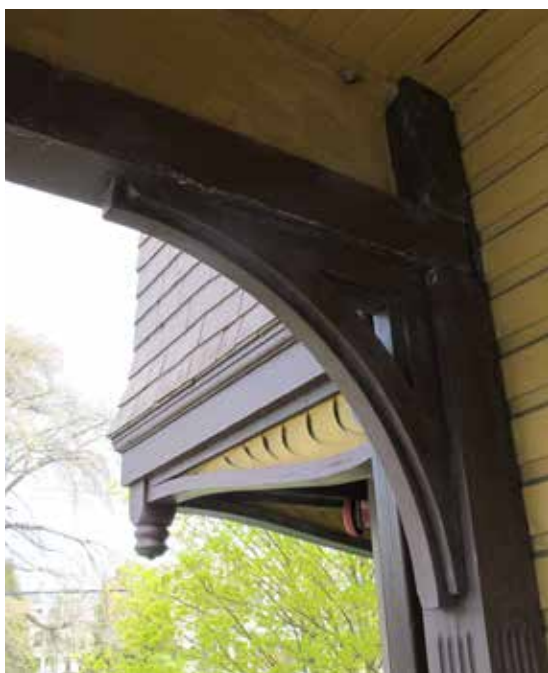
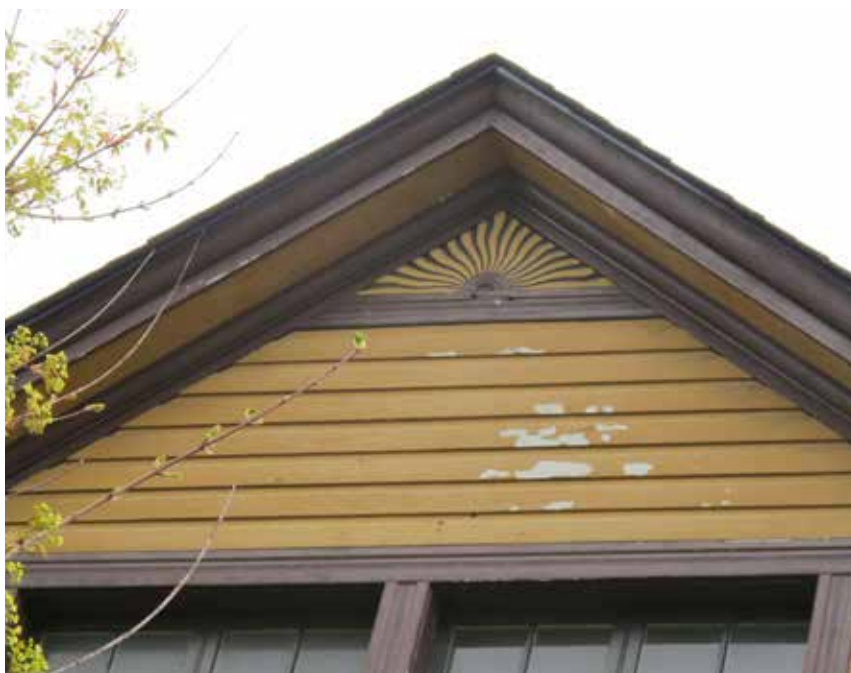
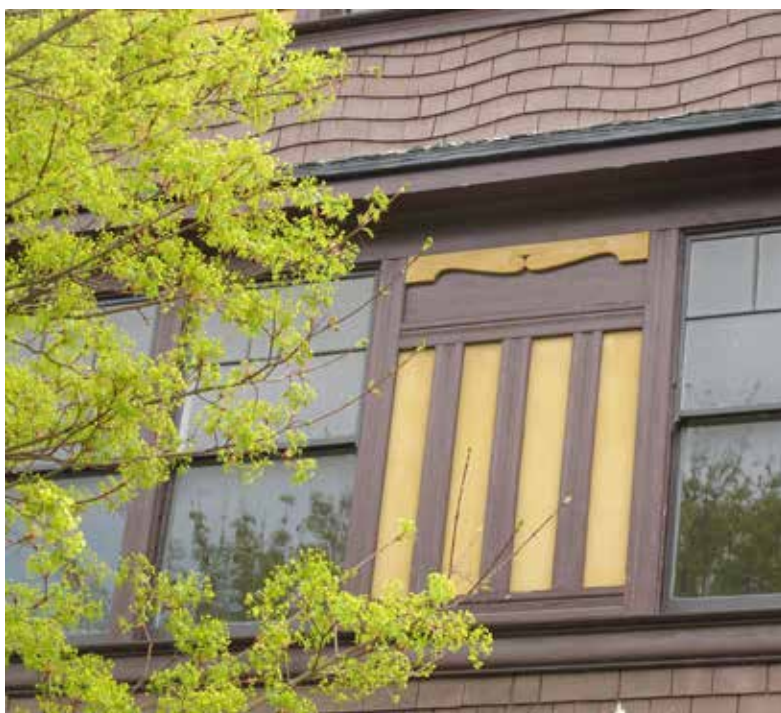
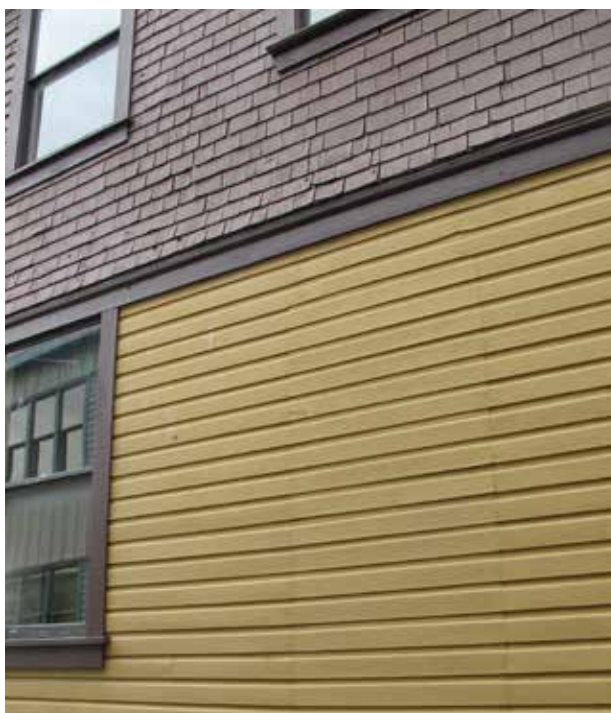
The rectangular shingle siding is located within the bell-cast second-storey of the house, and in the lower portions of the roof gables. The shingles appear to be in fair condition, with localized areas of detachment and physical damage. A number of shingles also demonstrate cupping and warping, and may require repair or replacement. Any loose shingles should be reattached, and repaired as required. Most exterior painted surfaces demonstrate a high degree of weathering. Any loose exterior paint should be sanded down, and any damaged wood elements should be repaired, cleaned and prepared for repainting. If any original exterior wood material is too damaged to repair, then original fabric should be documented and replaced in-kind to physically and visually match original.

Exterior wood details.

- Due to the integrity of wood frame structure, the exterior walls should be preserved through retention and in-situ repair work.
- Preserve the original wood-frame structure of the historic building.

- Replace damaged siding to match existing in material, size, profile and thickness, as required. Secure any loose shingles.
- Design structural or seismic upgrades so as to minimize the impact to the character-defining elements.

- Any existing trim should be preserved, and new material that is visually physically compatible with the original should be reinstated when original fabric is missing or damaged beyond repair. Combed and/or textured lumber is not acceptable. Hardi-plank or other cementitious boards are not acceptable.

- Preserve historic fabric of the exterior elevations during the relocation of the house, including the wood-frame structure with shingle and horizontal drop siding, wood sash windows and front-gabled roof structure as much as possible.

- Paint exterior wood elements according to colour schedule devised by Heritage Consultant.

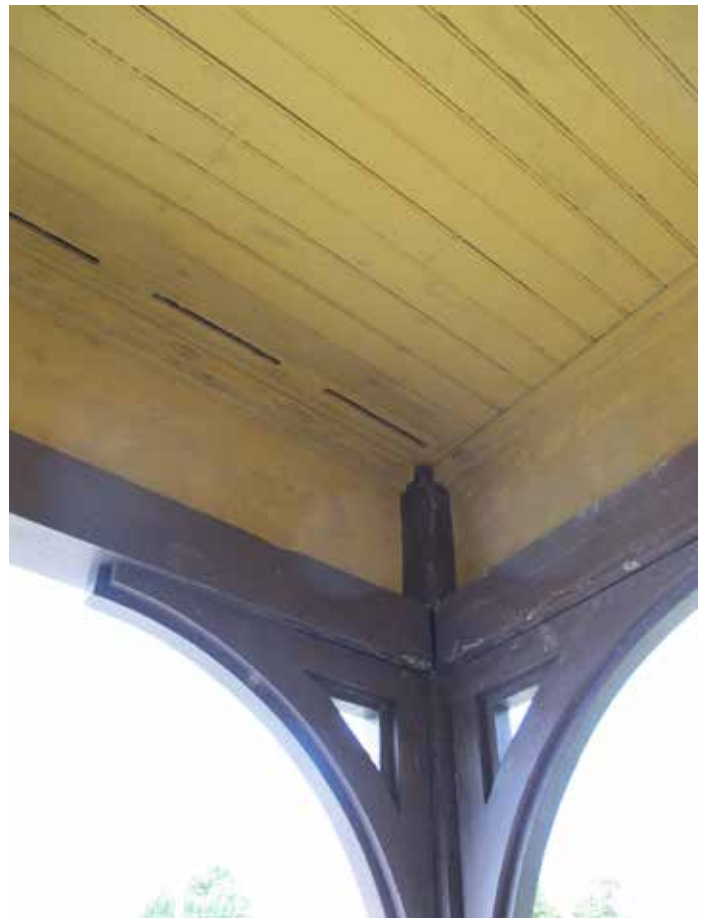
Most exterior wood surfaces show a high degree of weathering, with localized evidence of physical damage. All exterior wood surfaces should be inspected to determine the condition of the base material, and repaired as required. If historic fabric is too damaged to repair, then replace in-kind with physically and visually consistent material to match original. All exterior surfaces should be cleaned and any loose paint sanded down to prepare for repainting.

Wood soffit and detailed columns.

- Corner porch with inset entry should be preserved.
- Original wood detailing, including the wood balustrade, soffit, arched trimwork and detailed columns should be preserved. Repair as required, and prepare all exterior wood surfaces for repainting.

- If original wood fabric is too deteriorated to repair, then replace in-kind with physically and visually consistent material. Combed and/or textured lumber is not acceptable. Hardi-plank or other cementitious boards are not acceptable.
- Original lower height of the balustrade should be retained, with alternate compliance methods utilized to achieve the required height. New Possible alternative materials may be glass panels, metal pipe rails or a combination of both.
- Paint exterior wood elements according to colour schedule devised by Heritage Consultant.

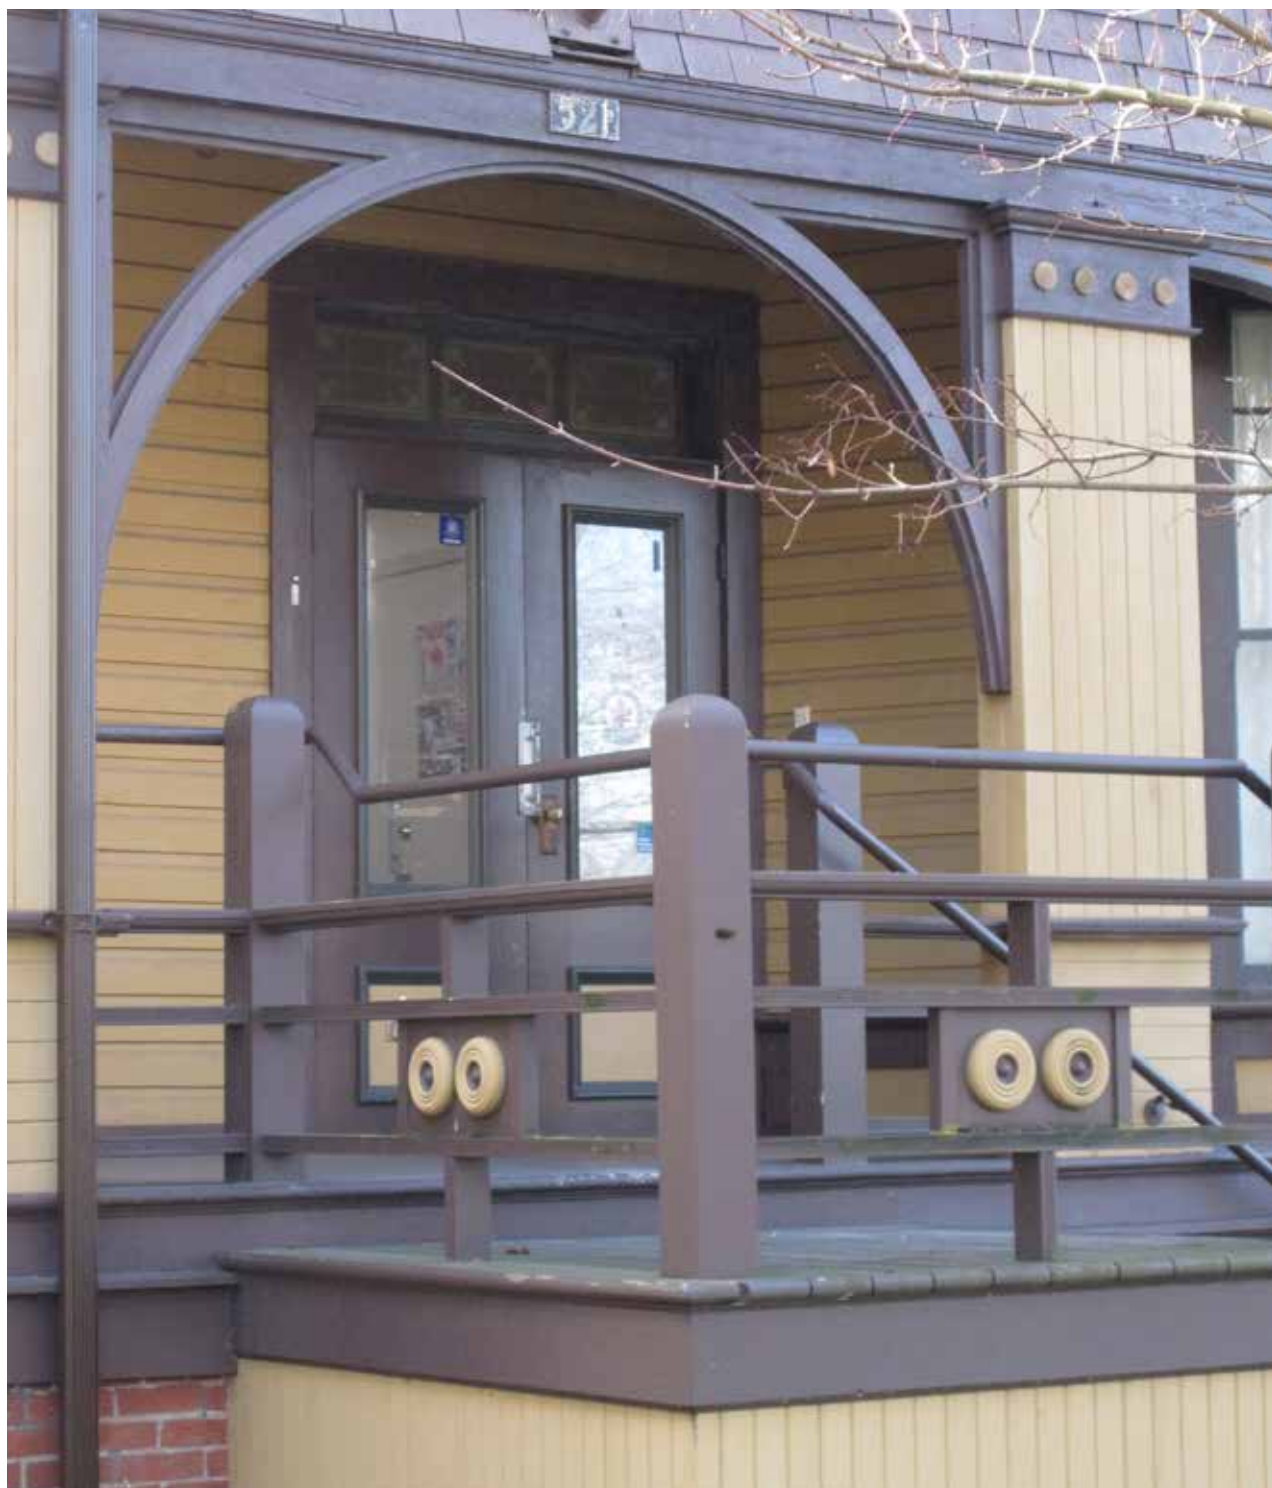
Front porch.

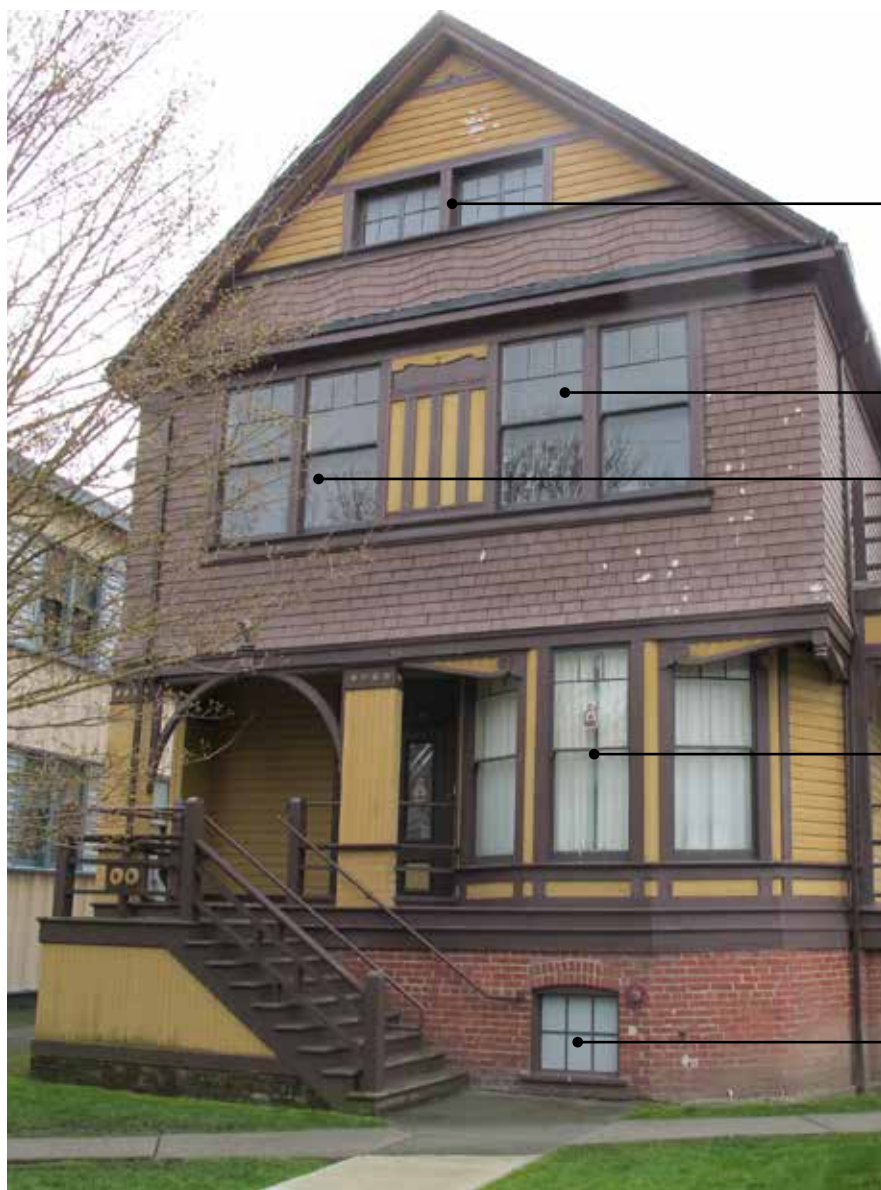
An initial visual review suggests the windows are in working condition, but weathering and physical damage can be seen on the exterior surfaces of the windows. In addition, the paint appears to be damaged on a number of exterior sash elements, and will require repair and repainting to ensure prolonged protection of the historic wood windows. The windows also feature both rectangular and scroll-cut window aprons and wood trim, which should also be preserved. Reference **Section 4.3.4: Exterior Wood Frame Walls** for recommendations on how to preserve wood trimwork.

4x multi-paned wood sash casement
Treatment: Preservation and Repair

2x 4-over-1 double hung wood sash w/ horns
Treatment: Preservation and Repair

3x 4-over-1 double hung wood sash w/ horns
Treatment: Preservation and Repair

- Retain existing window sashes; repair as required; install replacement matching sashes where missing or beyond repair. Preserve and repair as required, using in kind repair techniques where feasible.

- Overhaul, tighten/reinforce joints. Repair frame, trim and counterbalances.
- Each window should be made weather tight by re-puttying and weather-stripping as necessary.

Front elevation: All windows should be preserved and repaired, as required, with the exception of basement level multi-paned window.

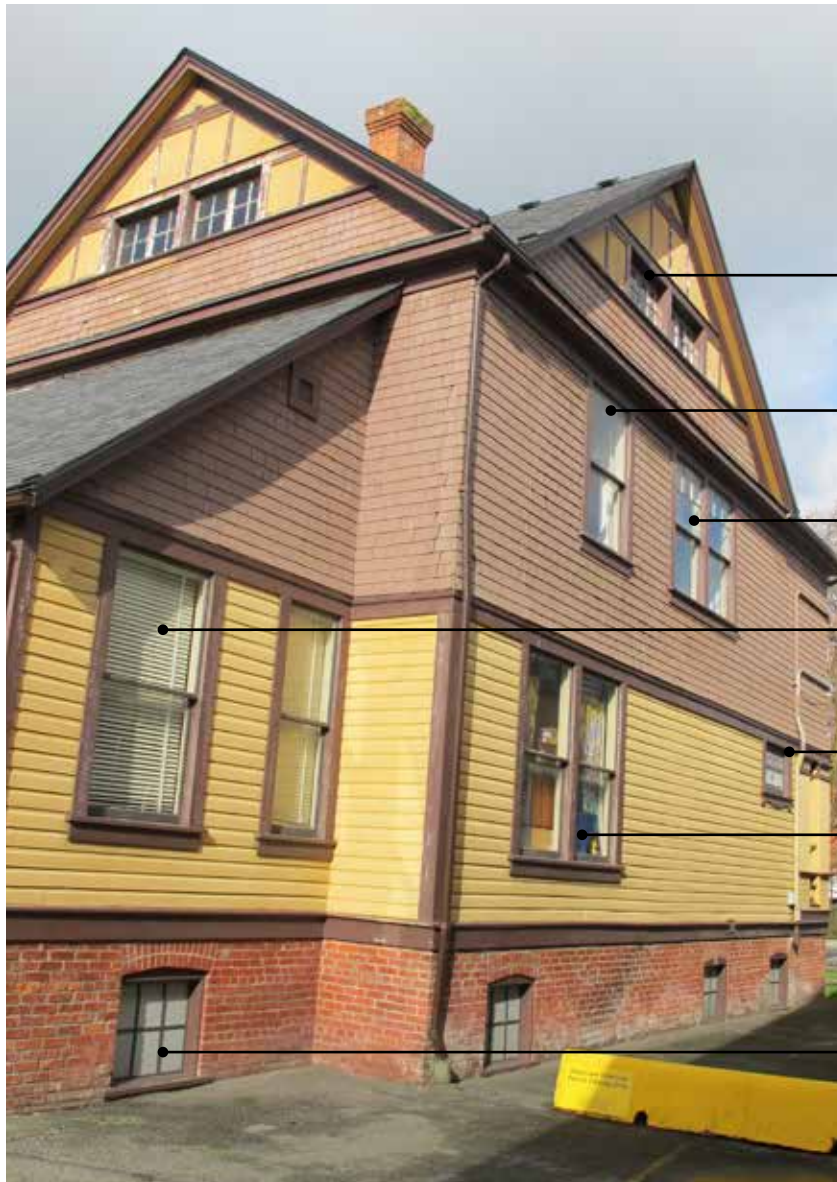
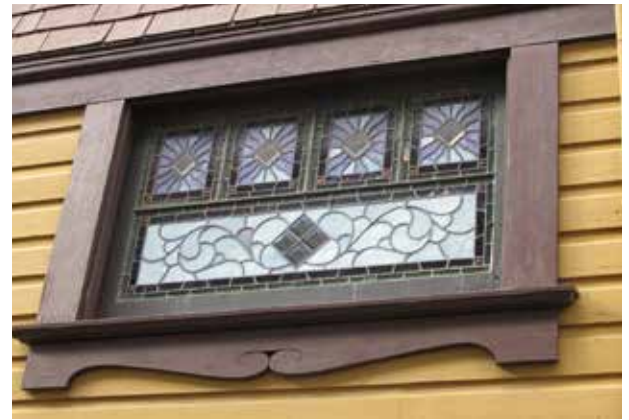
Close-up image of stained glass window.

4x multi-paned wood sash casement

1x Leaded stained glass, fixed (see image above)

- Preserve leaded stained-glass window.
- Inspect for condition and complete detailed inventory to determine extent of recommended repair or replacement.

East side elevation: Window configuration may be rehabilitated, as required. Stained glass window should be preserved.

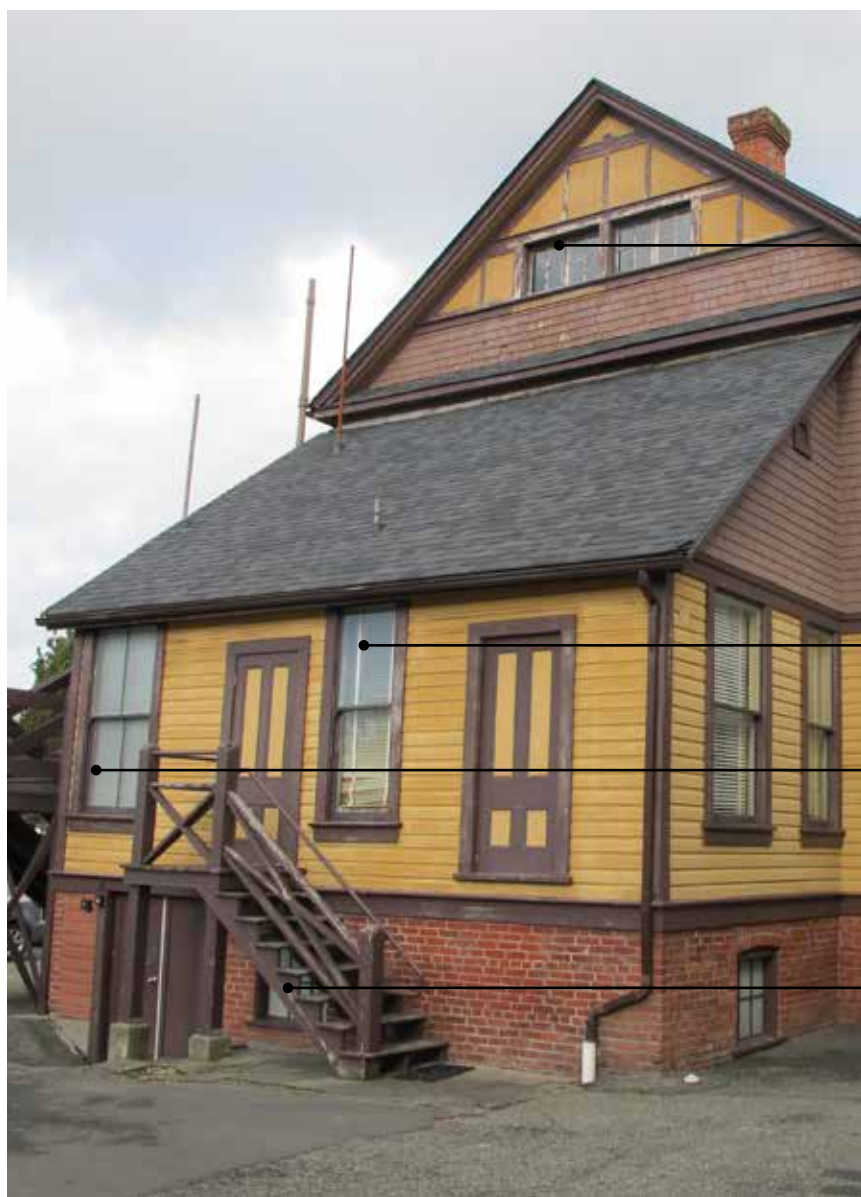
4x multi-paned wood sash casement
Treatment: Rehabilitation, as necessary

1x 1-over-1 double-hung wood sash w/ horns
Treatment: Rehabilitation, as necessary

Rear elevation: Window configuration may be rehabilitated, as required.

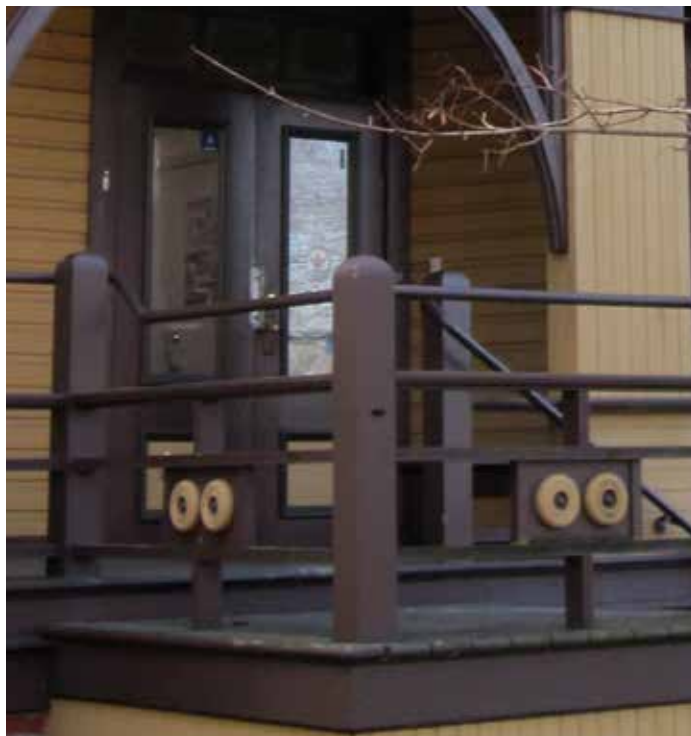
The house features an original panelled double wooden front door glazed insets and etched-glass transom above. Original panelled balcony doors with multi-paned glazed insets and transoms are also extant. All aforementioned doors are a character-defining elements of the historic house, and should be preserved. The front and balcony doors appear to be in working condition with minimal damage. However, a closer inspection is required to determine the full condition of the leaded glass transom windows above the doors, to determine what level of repairwork is required. The front door is protected from the elements due to its inset location within the recessed entry porch, and exterior wood surfaces appear to be in fair condition. The balcony door required a closer inspection, and should be repaired as required.

Front door and balustrade.

- Preserve original panelled double wooden front door with leaded glass transom and original panelled balcony doors with multi-paned glazed insets and transoms.
- Retain the door openings in their original locations, and preserve and repair all original doors, as possible.
- Retain and repair original wood doors, as required. Prepare all exterior wood surfaced for repainting, according to colour schedule devised by Heritage Consultant.
- Any new doors should be visually compatible with the historic character of the building.

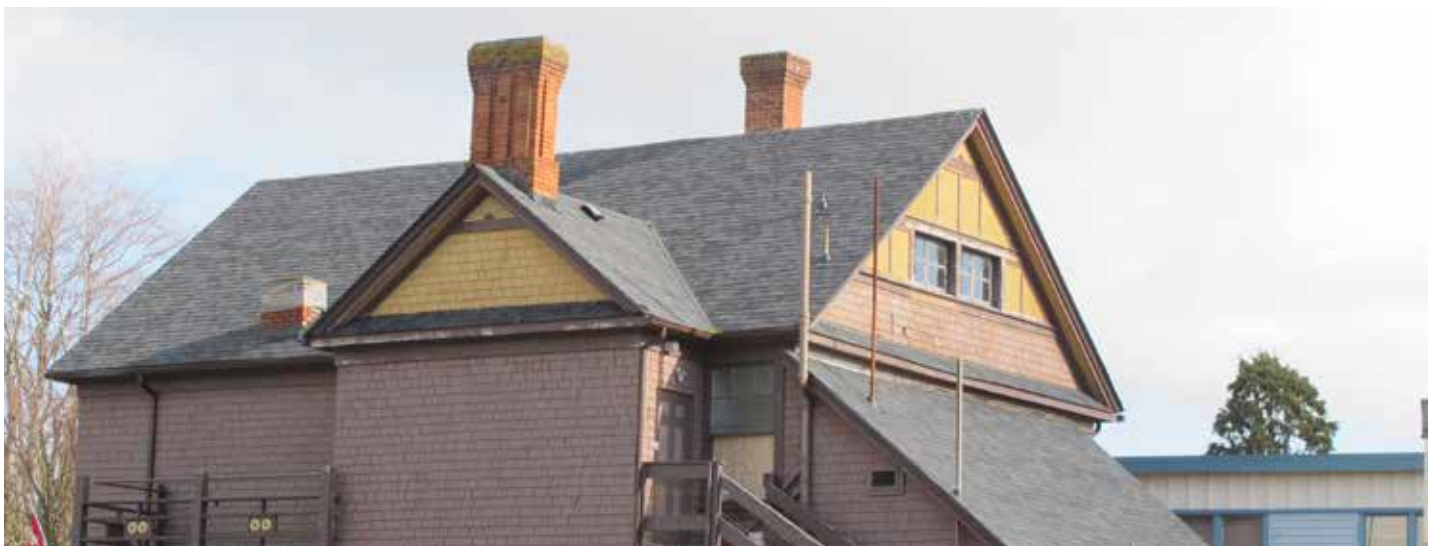
The Jameson Residence features a picturesque roofline with steeply pitched front gabled roof with projecting gable ends. The gable ends feature unique detailing, including a mix of wave-patterned wood shingles and drop wood siding, full width window trim and half-timbering. The Queen Anne Revival style roofline with associated detailing is a character-defining element, and should be preserved and repaired as required.

Despite moving to a new location in the early 1900's, the roofline and overall form of the structure has remained true to the original design. The only apparent alteration is the replacement of the original cedar shingles with asphalt shingles. Exterior wood detailing appears to be heavily weathered, and required repair. If wood detailing is too damaged to repair, then replace in-kind with physically and visually consistent material.

Front-gabled roof configuration.

- Wood elements should be repaired, or replaced in-kind as required. Combed and/or textured lumber is not acceptable. Hardi-plank or other cementitious boards are not acceptable.

- Design and install adequate rainwater disposal system and ensure proper drainage from the site is maintained. Paint all drainage system elements according to colour schedule devised by Heritage Consultant.

- Clean and prepare wood surfaced for repainting. Repaint according to colour schedule devised by Heritage Consultant.

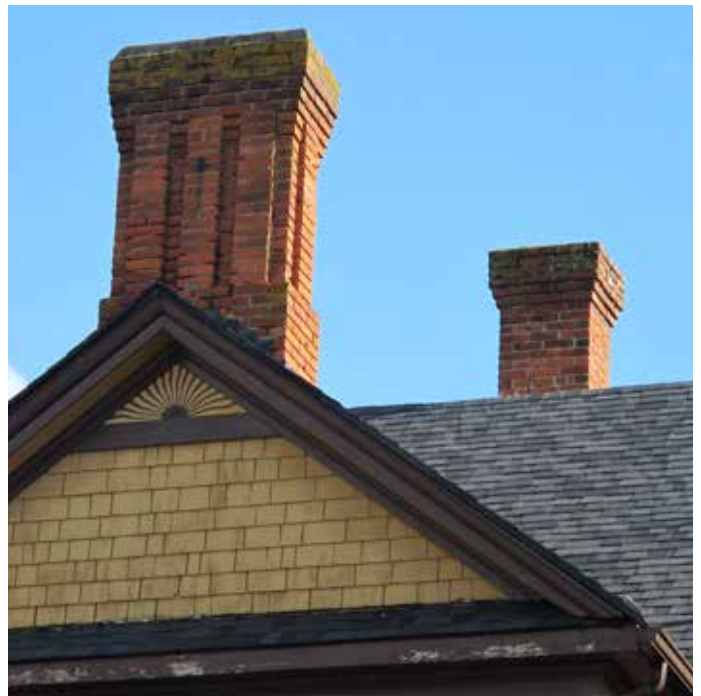
The west side elevation chimney should be retained, but the rearmost internal chimney may be removed. The altered chimney should be restored to its original condition, with bricks salvaged from rear chimney to match original. If available, reference archival photographs for more accurate representation of the original chimney. The two chimneys to be retained are not able to be relocated with the house, and will be salvaged and reinstated following relocation.

Corbelled red brick chimneys.

- Prior to relocation of house, carefully document and salvage all chimney brickwork, and reinstate in original configuration following relocation of the house.
- Preserve the westernmost chimney in its original configuration, if possible.
- Reconstruct altered internal chimney, as possible, to match existing chimneys in detailing. If early archival photographs are available, reference photos for accurate chimney reconstruction. Use salvaged bricks from chimney that is to be removed.
- Chimneys will require structural stabilization and seismic upgrading.
- If desired, fireplaces may be converted to gas systems. Alternatively, if no internal fireplaces are desired, fireplaces may be removed and chimneys can be stabilized within attic space, and their exterior appearance above the roofline preserved.

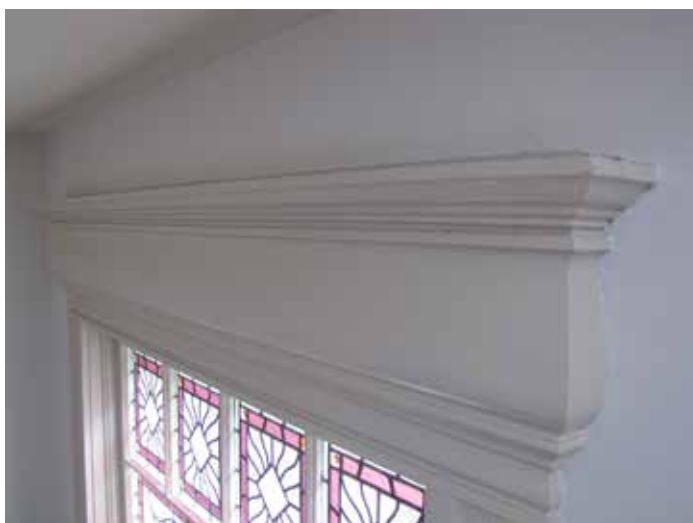
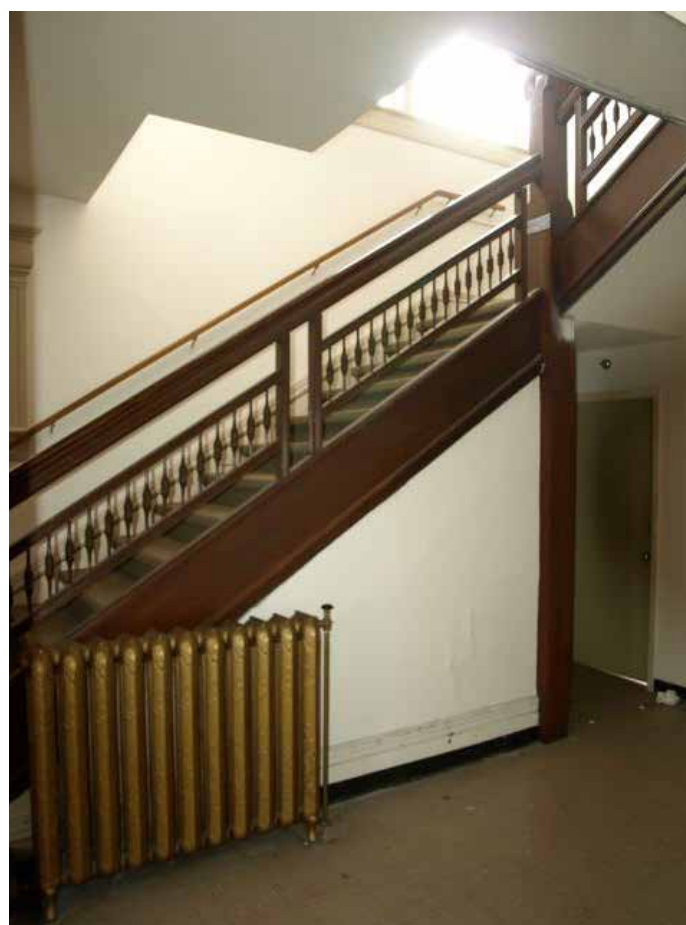
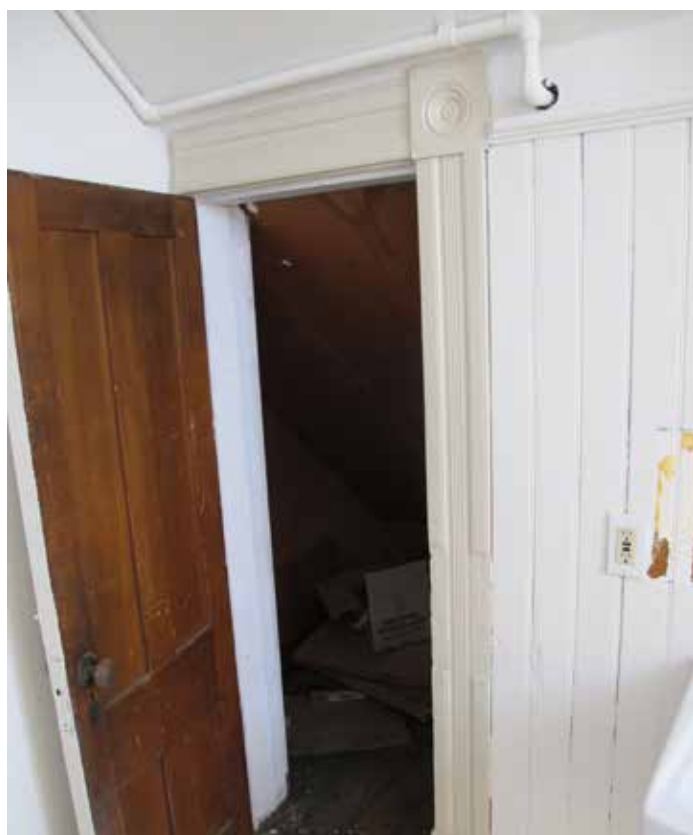
Surviving interior features.

- Interior features should be investigated further to determine if they can be retained during the rehabilitation process.
- Rehabilitation measures may be introduced to accommodate functional needs or building code upgrades, as required.
