# CAPITAL PARK, VICTORIA

539 SUPERIOR STREET

DRAFT CONSERVATION PLAN - JUNE 2014

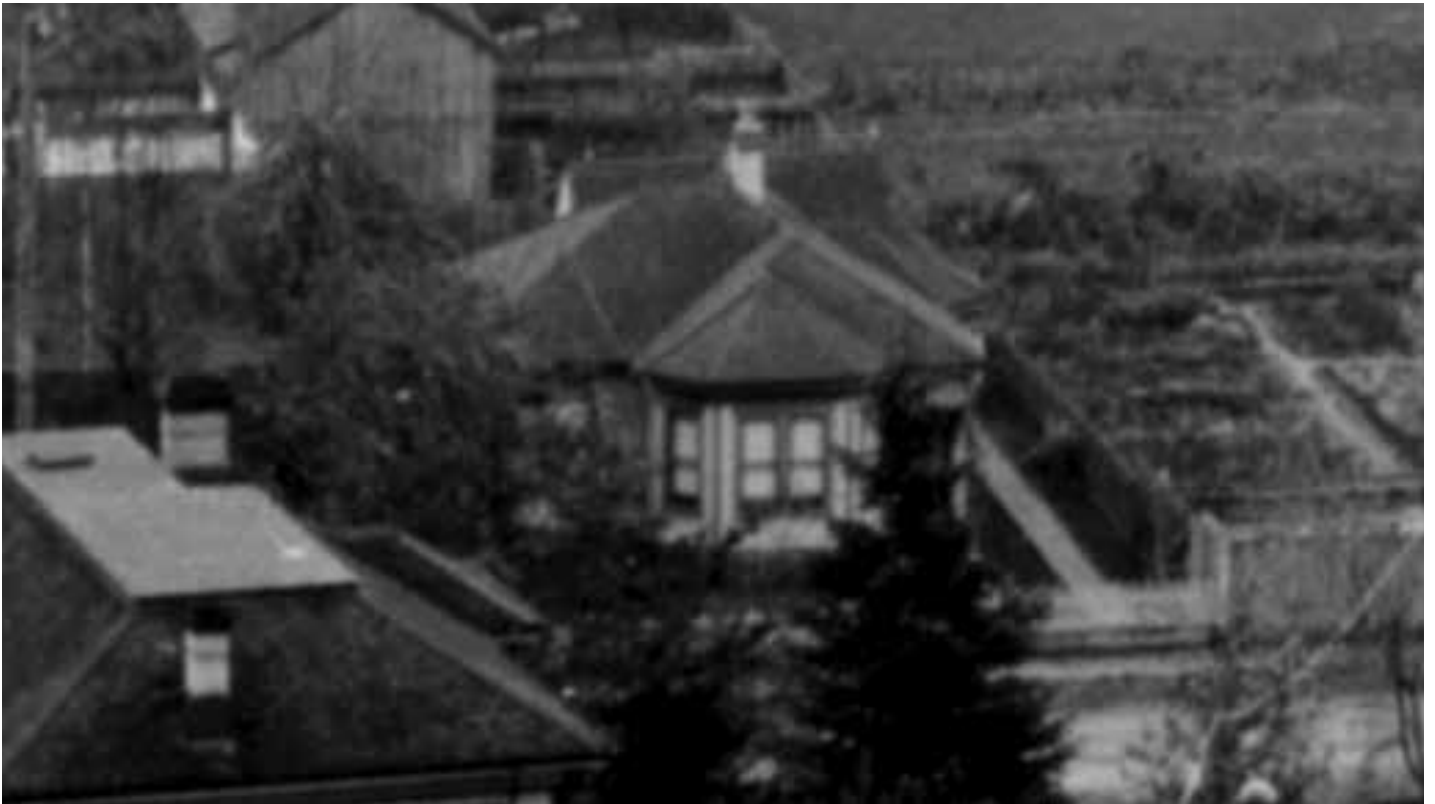
*View from Parliament Buildings, circa 190-, detail below showing close-up view of 539 Superior.  
[British Columbia Archives B-01799]*

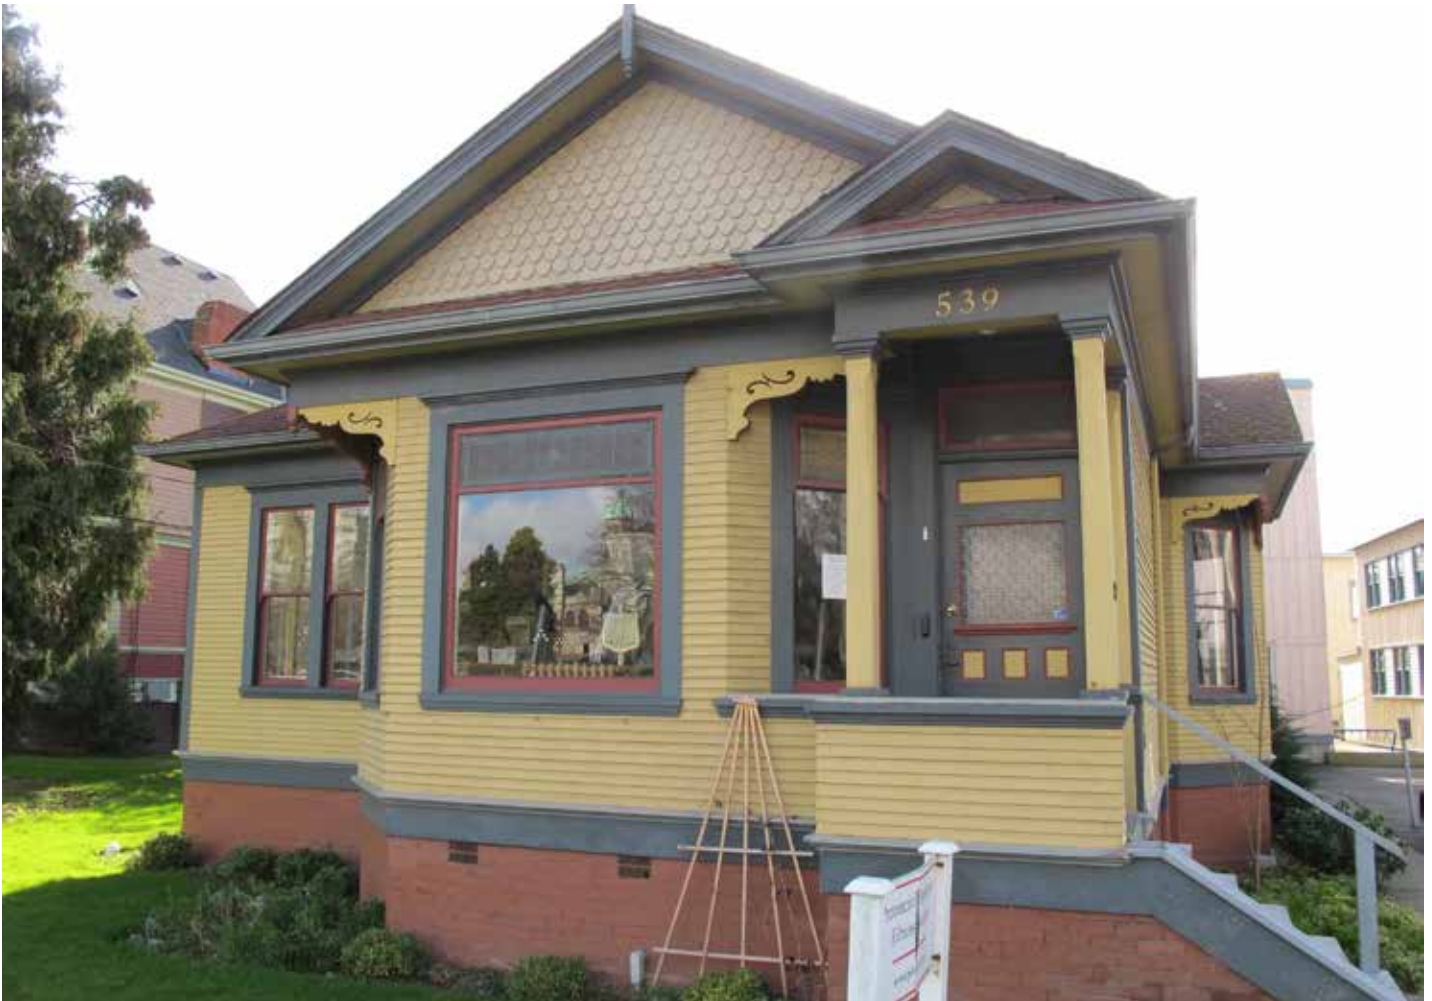
*Front elevation.*

- Preserve the overall form, scale and massing of the building.
- The historic front façade should be retained.

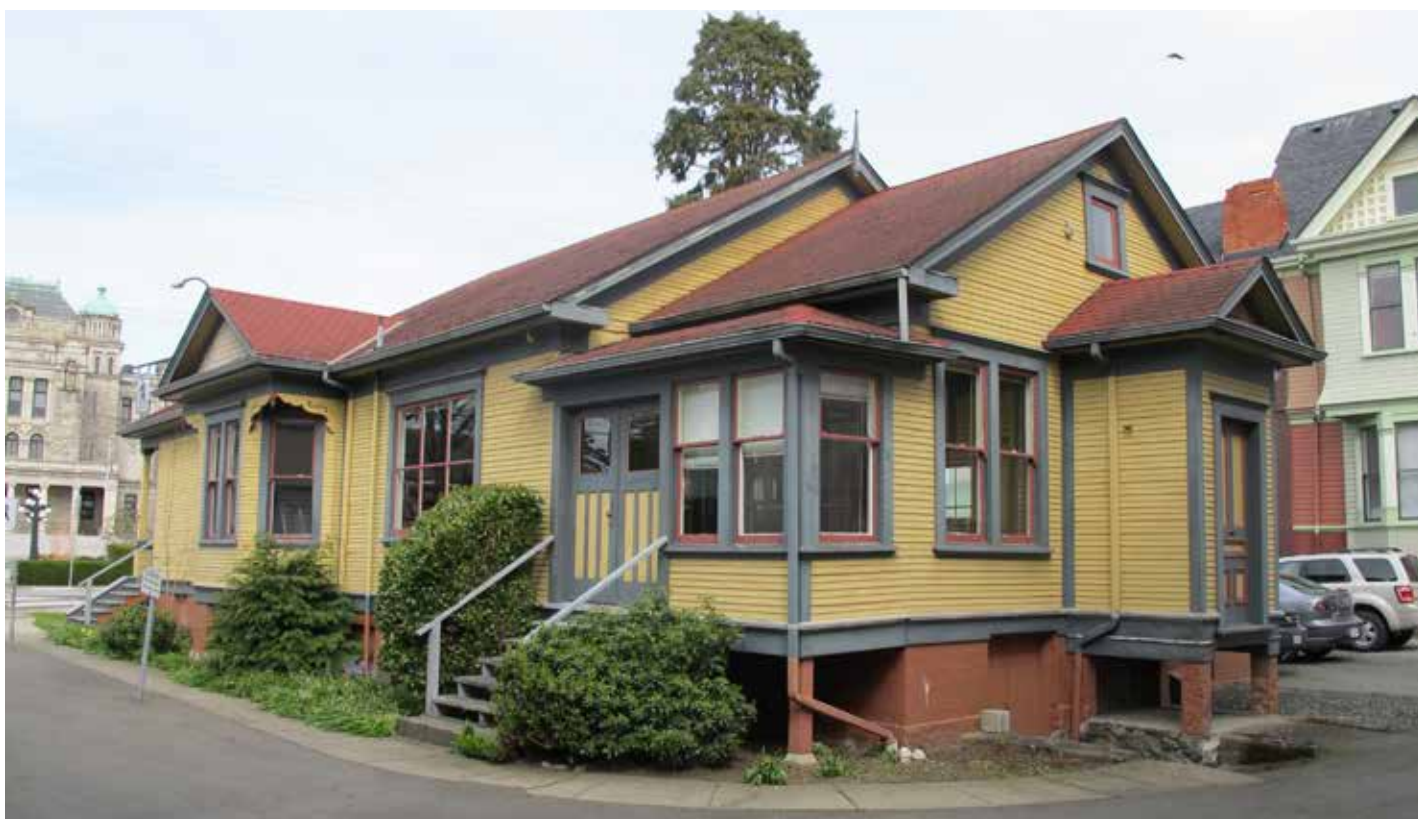
*View of back corner of house.*

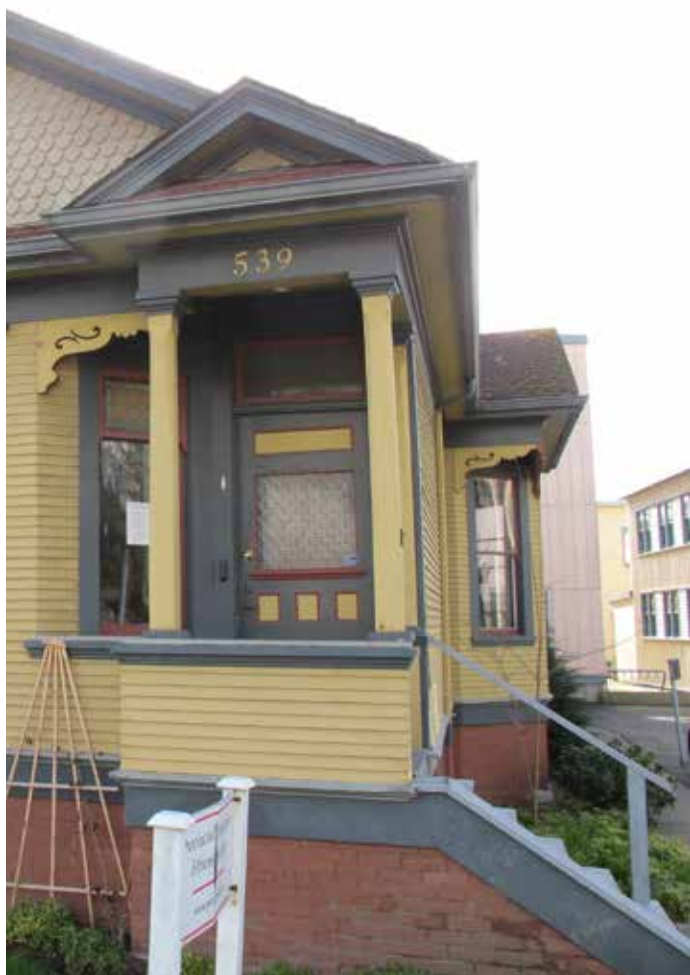
The John Residence features a corner entry porch supported by chamfered columns. The entry porch was an early intervention to the house, and is a character-defining element that should be preserved. All exterior wood surfaces should be inspected, and repaired or replaced in-kind as required.

The house features original balustrade on the entry porch. Heritage homes of this vintage were typified by a low balustrade of approximately 24" in height. To ensure the heritage character of the house is preserved, the low balustrade should be preserved and alternate compliance measures should be explored in order to meet code requirements. Such alternate compliance measures may include the use of metal pipe rail and glass panels to make up the remaining height. The new railing should be continuous down the front stair, as currently the front stairs are missing an appropriate railing.

**Corner entry porch.**

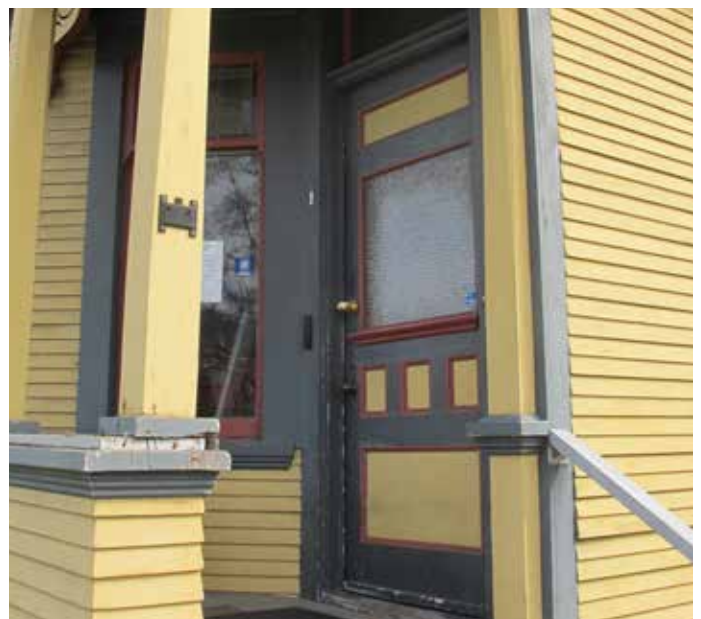
*Front door.*

- Preserve character-defining front wood panelled door with glazed inset and transom. Retain all side and rear significant wood doors, as possible.
- Retain the door openings in their original locations, and preserve and repair all original doors.
- New doors should be visually compatible with the historic character of the building.

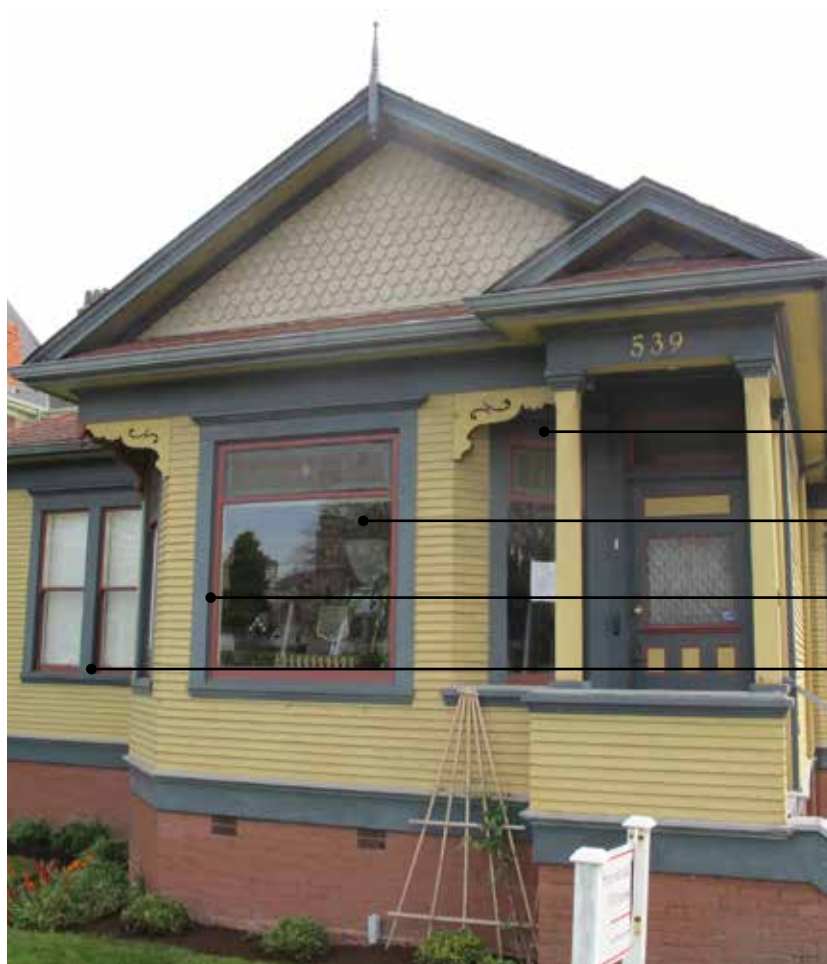
**1x 1-over-1 double-hung wood sash w/ stained glass**  
Treatment: Preservation and Repair

**1x 1-over-1 fixed wood sash w/ stained glass**  
Treatment: Preservation and Repair

**2x 1-over-1 double-hung wood sash w/ horns**  
Treatment: Preservation and Repair

*Front elevation: All windows should be preserved and repaired.*

- Inspect for condition and complete detailed inventory to determine extent of recommended repair or replacement.
- Retain existing window sashes; repair as required; install replacement matching sashes where missing or beyond repair.

- Inspect all leaded stained glass windows, and repair as required. All original stained glass should be preserved.
- Preserve and repair as required, using in kind repair techniques where feasible.

- Overhaul, tighten/reinforce joints. Repair frame, trim and counterbalances.
- Each window should be made weather tight by re-puttying and weather-stripping as necessary.

- Retain historic glass, where possible. Where broken glass exists in historic wood-sash windows, the broken glass should be replaced. When removing broken glass, the exterior putty should be carefully chipped off with a chisel and the glazier's points should be removed. The wood where the new glass will be rested on should be scraped and cleaned well, and given a coat of linseed oil to prevent the wood from absorbing the oil from the new putty. The new glass should be cut 1/16-1/8th smaller than the opening to allow for expansion and irregularities in the opening, to ensure the glazing does not crack due to natural forces. Window repairs should be undertaken by a contractor skilled in heritage restoration.

- Replacement glass to be single glazing, and visually and physically compatible with existing. Obscure or clear glass is acceptable.
- Prime and repaint as required in appropriate colour, based on colour schedule devised by Heritage Consultant.

- Brace windows with temporary inserts while relocating the house, to ensure they are not damaged in the process. Alternatively, should the windows require removal for repair, reinstate repaired windows following relocation of the house.

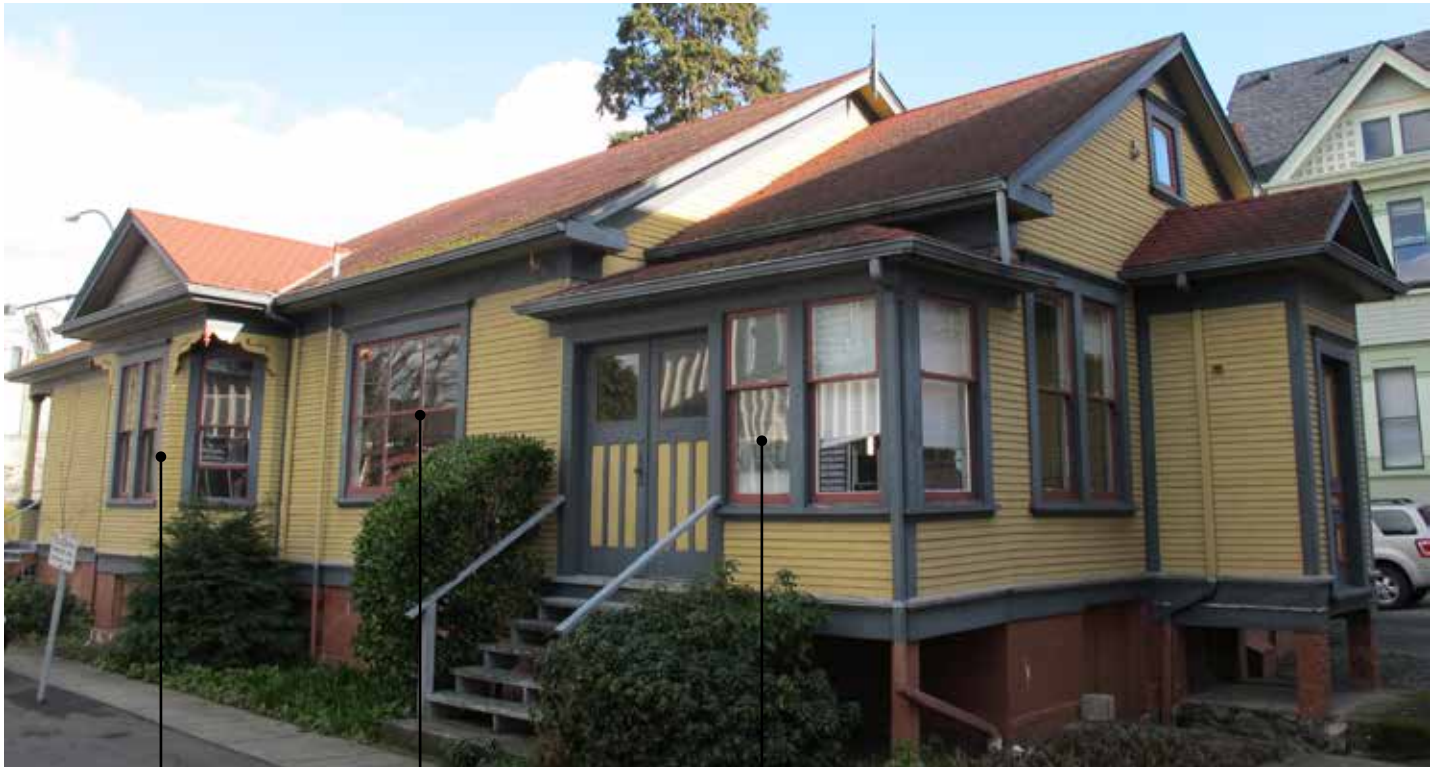
*West side elevation: Windows may be rehabilitated, as required.*

**2x 1-over-1 double-hung wood sash**  
Treatment: Rehabilitation, as necessary

**1x multi-paned wood sash fixed**  
Treatment: Rehabilitation, as necessary

**4x 1-over-1 double-hung wood sash w/ horns - in bay**  
Treatment: Rehabilitation, as necessary

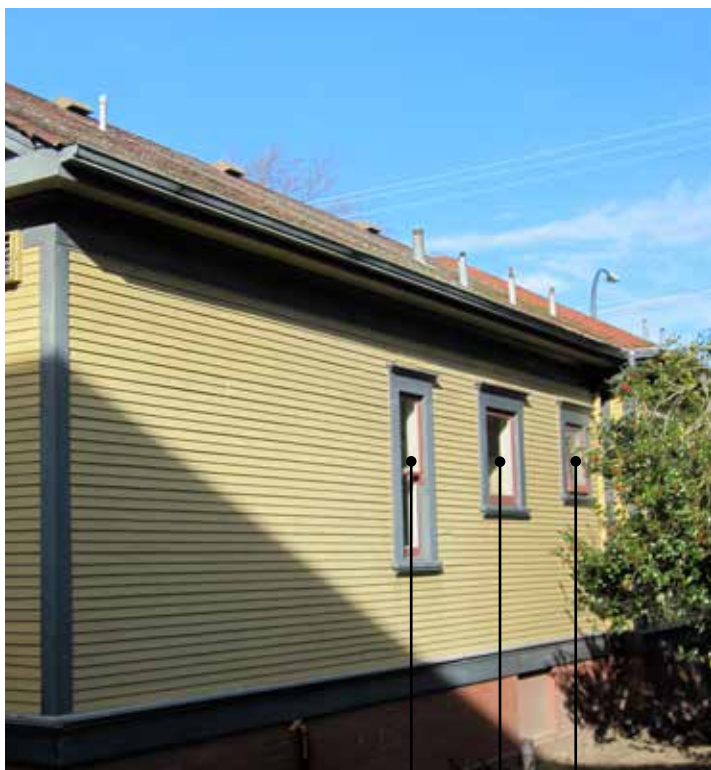
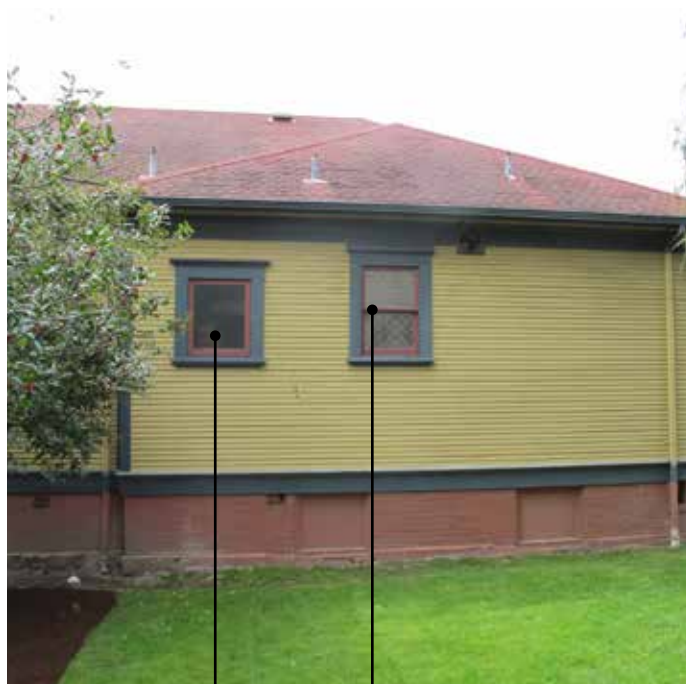
*East side elevation: Windows may be rehabilitated, as required.*

**1x 1-over-1 double-hung wood sash**  
Treatment: Rehabilitation, as necessary

**1x casement wood sash**  
Treatment: Rehabilitation, as necessary

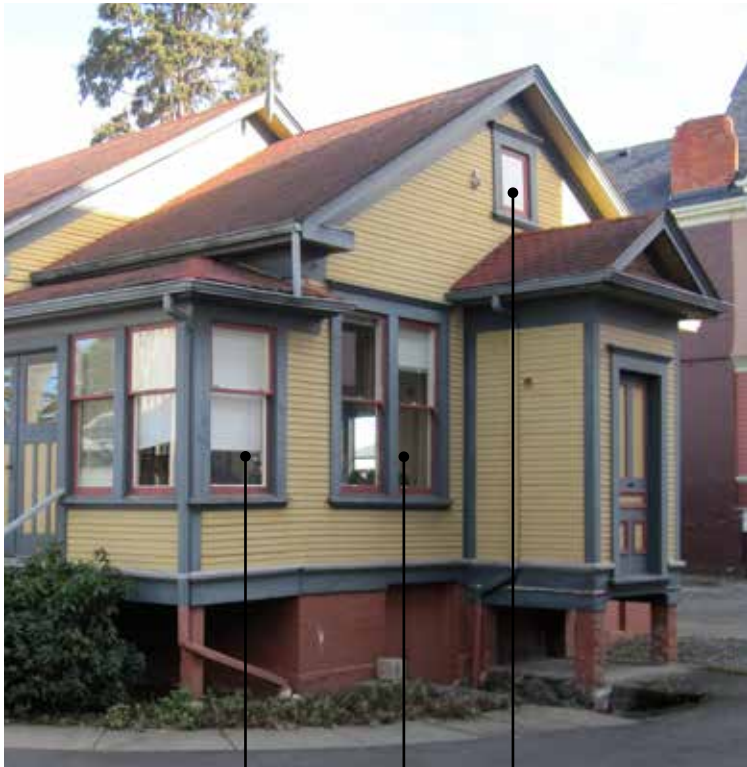
*Rear elevation: Windows may be rehabilitated, as required.*

**1x casement wood sash**

Treatment: Rehabilitation, as necessary

**1x 1-over-1 double-hung wood sash**

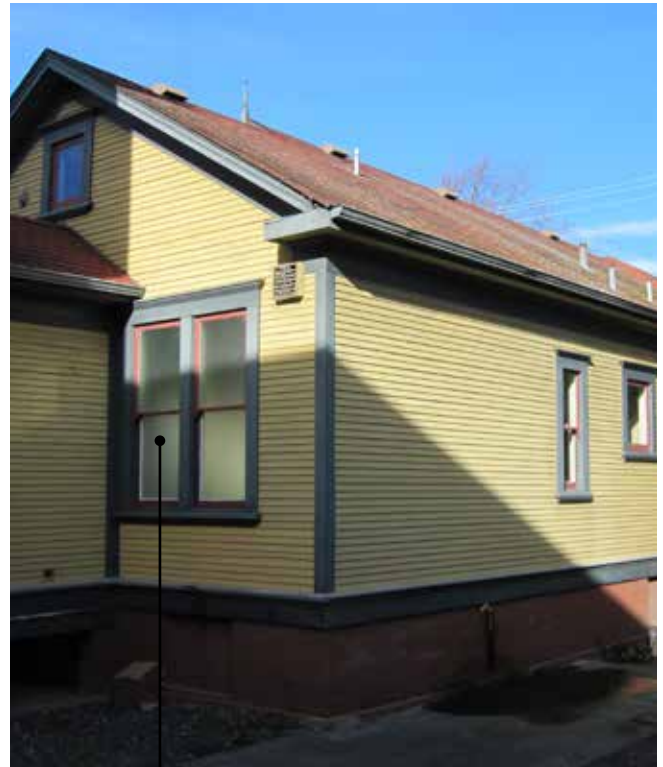
**2x 1-over-1 double-hung wood sash w/ horns**

Treatment: Rehabilitation, as necessary

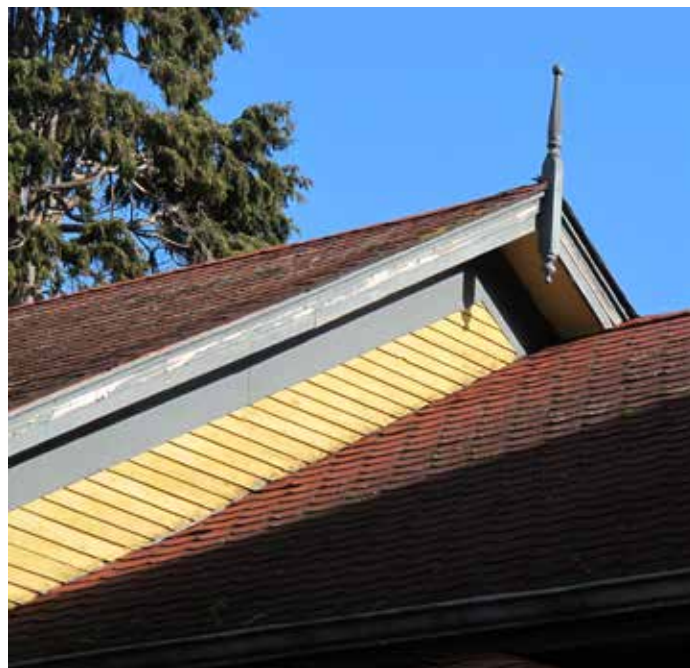
The roof should be preserved and stabilized during relocation. The asphalt shingles are not sympathetic to the historic house, and should be replaced with cedar shingles if possible. Exterior wood detailing appears to be heavily weathered, and requires repair. If wood detailing is too damaged to repair, then replace in-kind with physically and visually consistent material. The roofing material is in poor condition, and requires replacement.

*Roof detailing.*

- Preserve the roof structure in its current configuration, as expressed by its varied front-gabled roof, projecting front-gabled porch with triangular pediment and hip-roofed side addition.
- Roof cladding system requires replacement. Cedar shingles are the preferred material, but duroid, asphalt or fibreglass shingles are acceptable.
- Retain the original bargeboards and fascia boards, as well as the soffit and any exposed roof elements.
- Design and install adequate rainwater disposal system and ensure proper drainage from the site is maintained. Paint all drainage system elements according to colour schedule devised by Heritage Consultant.

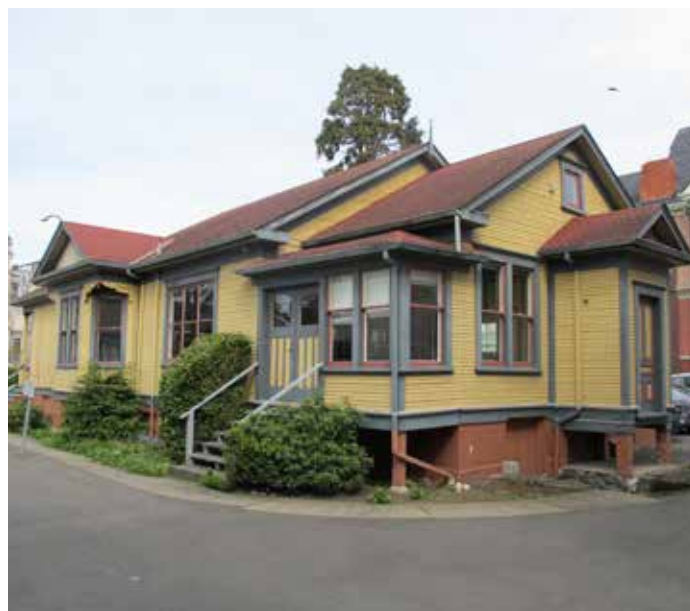
*Roof configuration.*

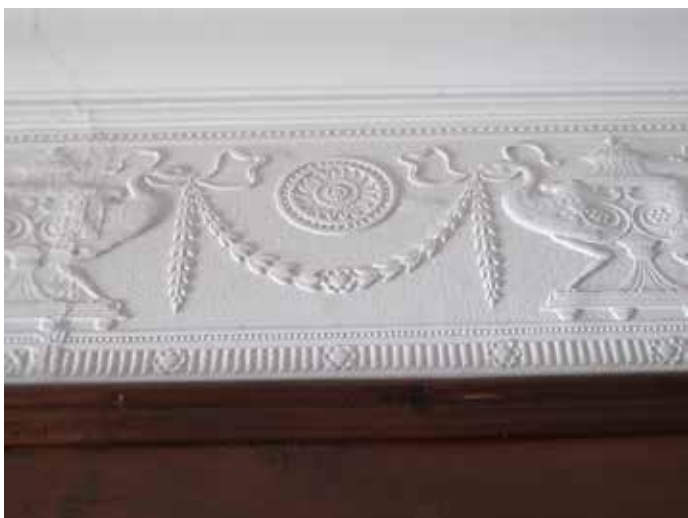
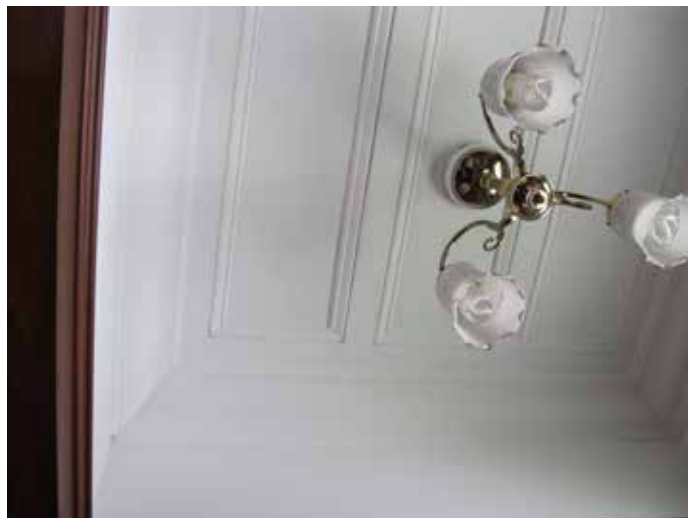
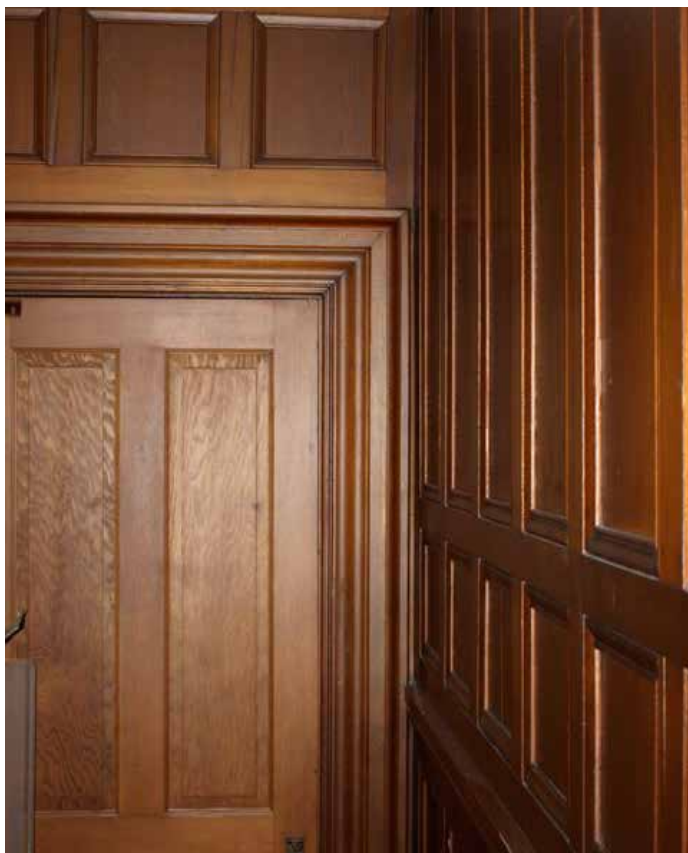
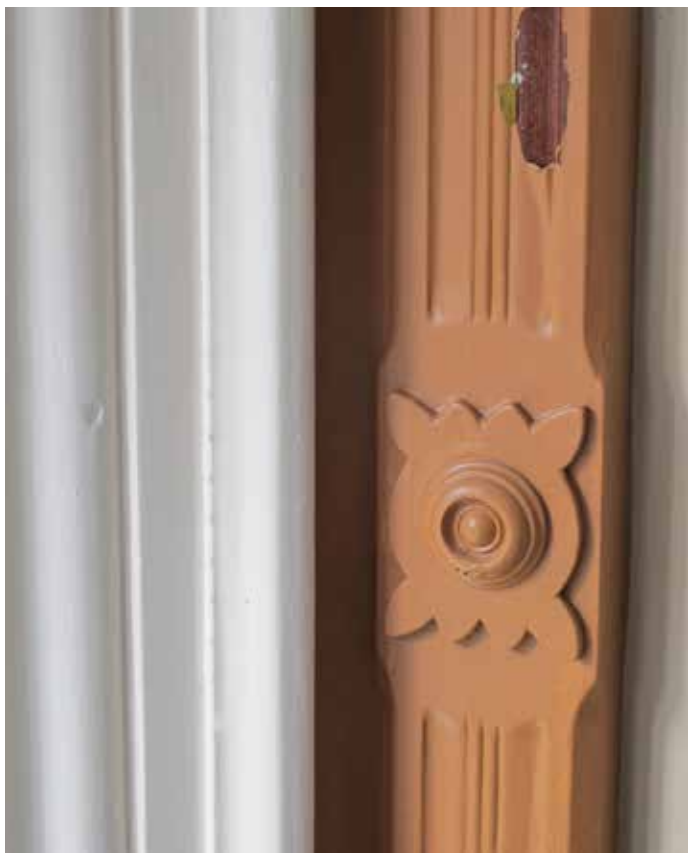
The John Residence features a number of original interior features. The entryway features unpainted wooden-panelled front vestibule and hallway, coffered wooden ceiling in vestibule, panelled hallway door with original hardware, and plaster ceiling in hallway with lincrusta frieze. The dining room features wooden panelling and trim in bay, wainscoting, panelled wooden doors, some with transoms, wooden door and window casings and wide wooden baseboards. Most interior features appear to be in fair condition. The wood is stained and varnished, and appears to be in good condition with evidence of wear and tear on projecting surfaces. Interior elements should be inspected, and repaired as required. It is not known at this time which features will be retained.

*Surviving interior features.*

- Interior features should be investigated further to determine if they can be retained during the rehabilitation process.
- Rehabilitation measures may be introduced to accommodate functional needs or building code upgrades, as required.
