CAPITAL PARK, VICTORIA

545 SUPERIOR STREET

DRAFT CONSERVATION PLAN - JUNE 2014

5. CONSERVATION RECOMMENDATIONS

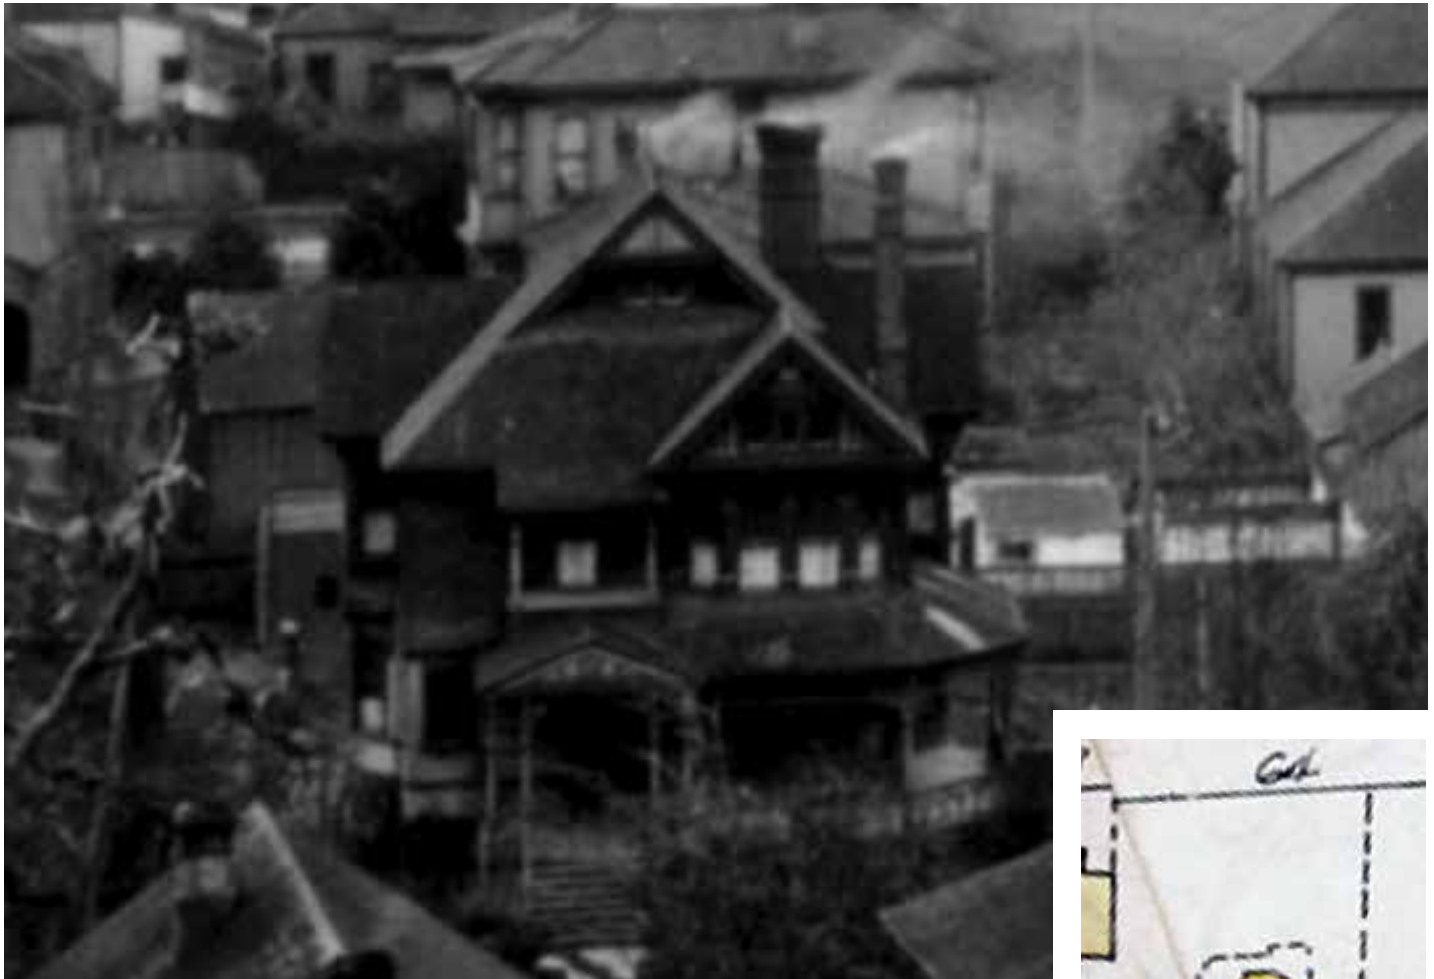
Above: View from Parliament Buildings, circa 190-, detail below showing close-up view of 545 Superior, with original wraparound verandah, and shed-roofed balcony at second floor front. [British Columbia Archives B-01799]

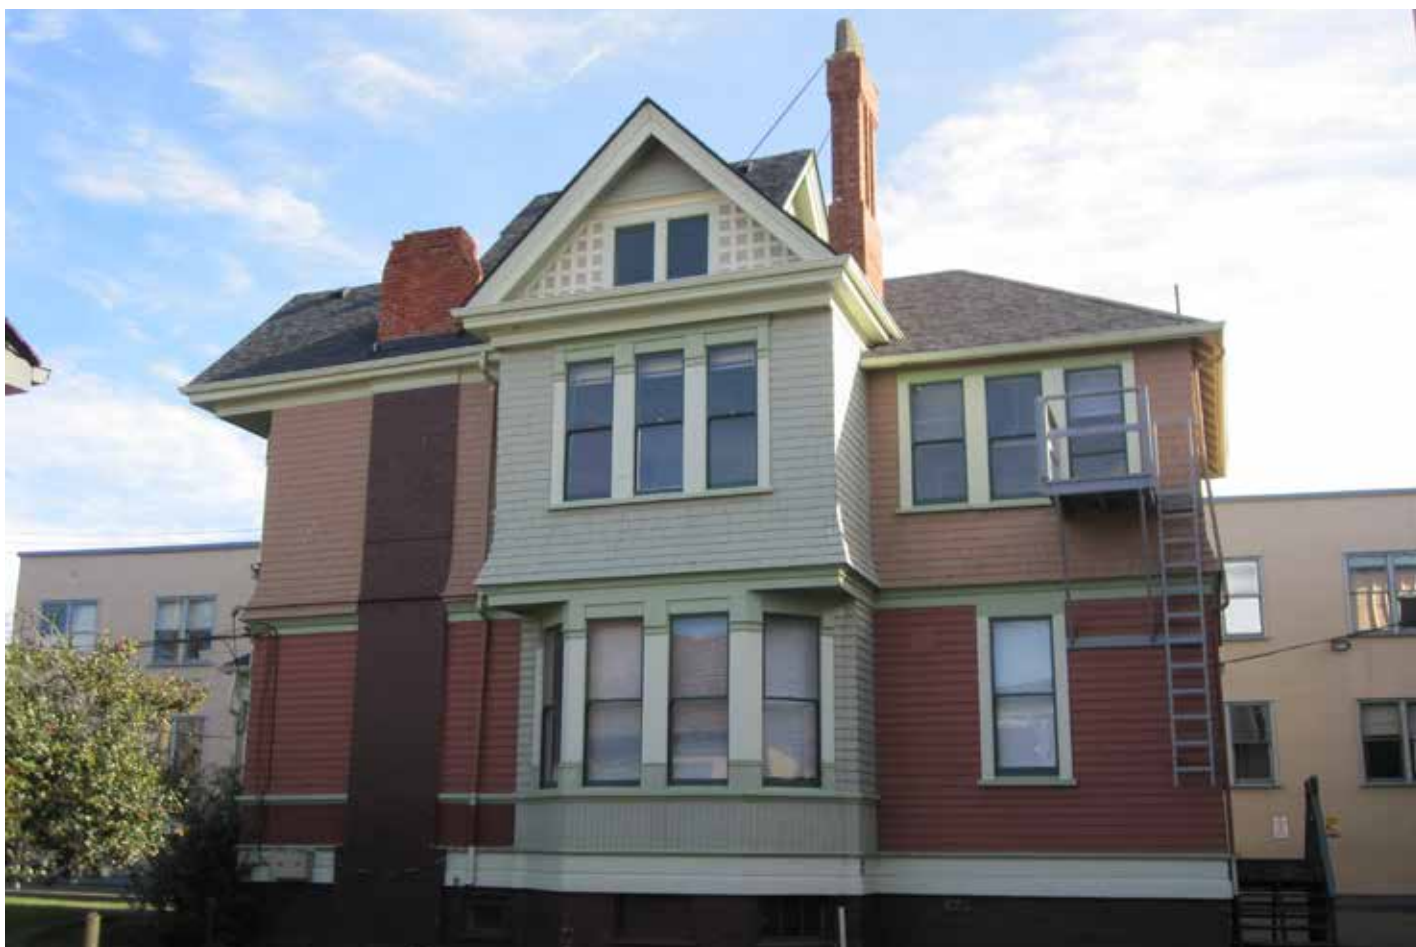
West side elevation.

The house features original exposed brick foundations, which is a character-defining element of the historic house. The brick is currently painted, and appears to be in good condition. Due to the proposed relocation of the house, new foundations will be required. Concrete is a suitable material for new foundations, but all visible exterior surfaced above-grade should be finished in brick to match original. If possible, salvage original brickwork and reinstate following relocation of the house. Depending on condition of brickwork, bricks can be stripped or repainted according to colour schedule devised by Heritage Consultant. Front foundation window openings should be reinstated as per original, but side and rear window opening configuration in foundation may be rehabilitated.

- New foundations are required at the new site, and concrete is a suitable material.
- Salvage original foundation brickwork and reinstate following relocation of the house. Brick can be reinstated as an exterior veneer if concrete is to be used for foundations at new location. Any new material above ground should match original in appearance, as viewed from the exterior. Red brick should be used, in a matching configuration to original.

- To ensure the prolonged preservation of the new foundations, all landscaping should be separated from the foundations at grade by a course of gravel or decorative stones, which help prevent splash back and assist drainage. New vegetation but should be set back from the exterior elevations of the house to help prevent against unnecessary moisture damage.

- Front window openings at foundation level should be retained. Side and rear configuration may be rehabilitated.

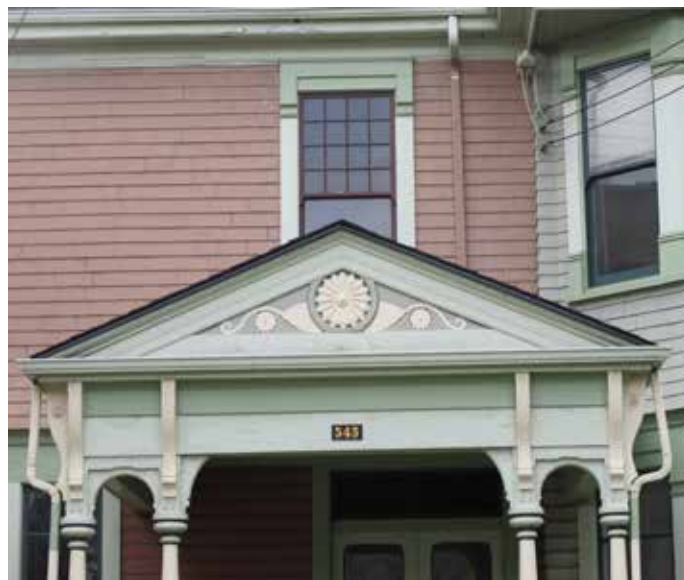
The exterior wood detailing is original to the historic house, and has been retained in its original configuration and placement. An initial visual review suggests the exterior wood-frame elements, including siding and trim, are in fair condition with evidence of moderate weather damage. The exterior painted surfaces appear to be worn, and paint is failing in a number of locations. Additionally, a number of shingles appear to be damaged and split. Proper maintenance of painted wood surfaces is essential in ensuring the protection of historic wood material. Further investigation is required into the condition of all wood surfaces, and any localized damage should be repaired. All exterior wood surfaces should be repainted according to colour schedule devised by Heritage Consultant.

Wood detailing in front-gabled verandah roof.

- Due to the integrity of wood frame structure, the exterior walls should be preserved through retention and in-situ repair work.
- Preserve the original wood-frame structure of the historic building.
- Preserve original siding on all elevations, if possible, and clean surface for repainting.
- Preserve all original exterior trimwork and detailing on all exterior elevations, including within the roof gables.

- Investigate all exterior wood elements to determine condition of material.
- Repair or replace in kind any material that is too damaged to repair. All interventions should be sensitive to the historic fabric of the house, and any new material should match historic original in material, size, profile and thickness. Combed and/or textured lumber is not acceptable. Hardi-plank or other cementitious boards are not acceptable

- Prepare all wood surfaces for repainting. Cleaning procedures should be undertaken with non-destructive methods. Areas with biological growth should be cleaned using a soft, natural bristle brush, without water, to remove dirt and other material. If a more intense cleaning is required, this can be accomplished with warm water, mild detergent (such as Simple Green©) and a soft bristle brush. High-pressure power washing, abrasive cleaning or sandblasting should not be allowed under any circumstances.

- Paint all exterior wood surfaces according to colour schedule devised by Heritage Consultant.

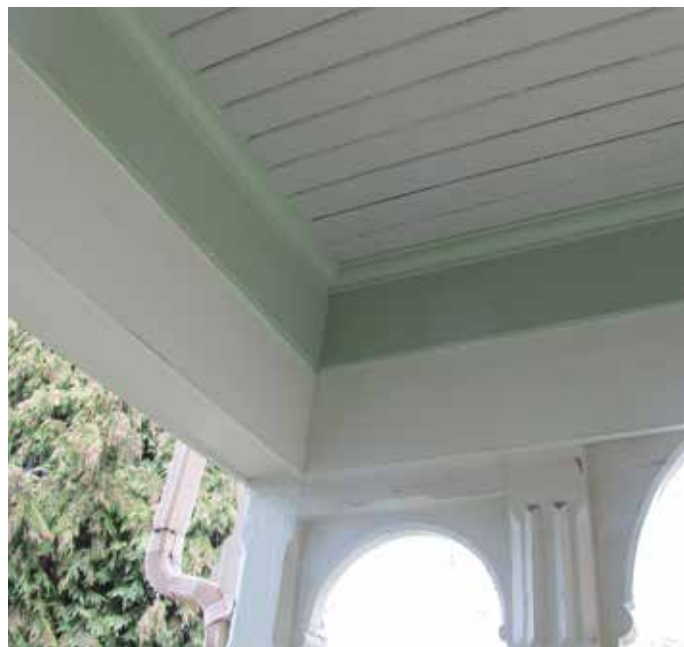
Wood soffit in front verandah.

- Investigate and repair all wood elements according to recommendations listed in **Section 6.3.4: Exterior Wood Frame Walls**.
- Prepare all wood surfaces for repainting. Cleaning procedures should be undertaken with non-destructive methods. Areas with biological growth should be cleaned using a soft, natural bristle brush, without water, to remove dirt and other material. If a more intense cleaning is required, this can be accomplished with warm water, mild detergent (such as Simple Green©) and a soft bristle brush. High-pressure power washing, abrasive cleaning or sandblasting should not be allowed under any circumstances.

- Paint all exterior wood surfaces according to colour schedule devised by Heritage Consultant.

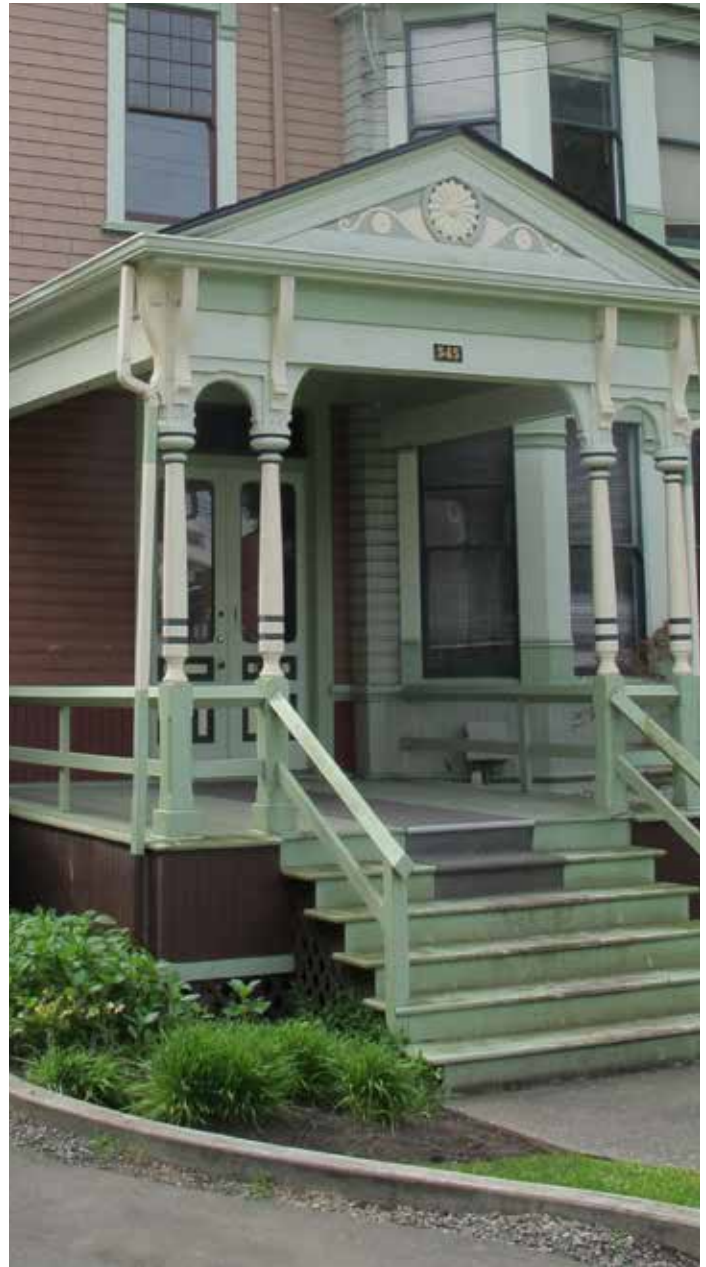
Front-gabled verandah.

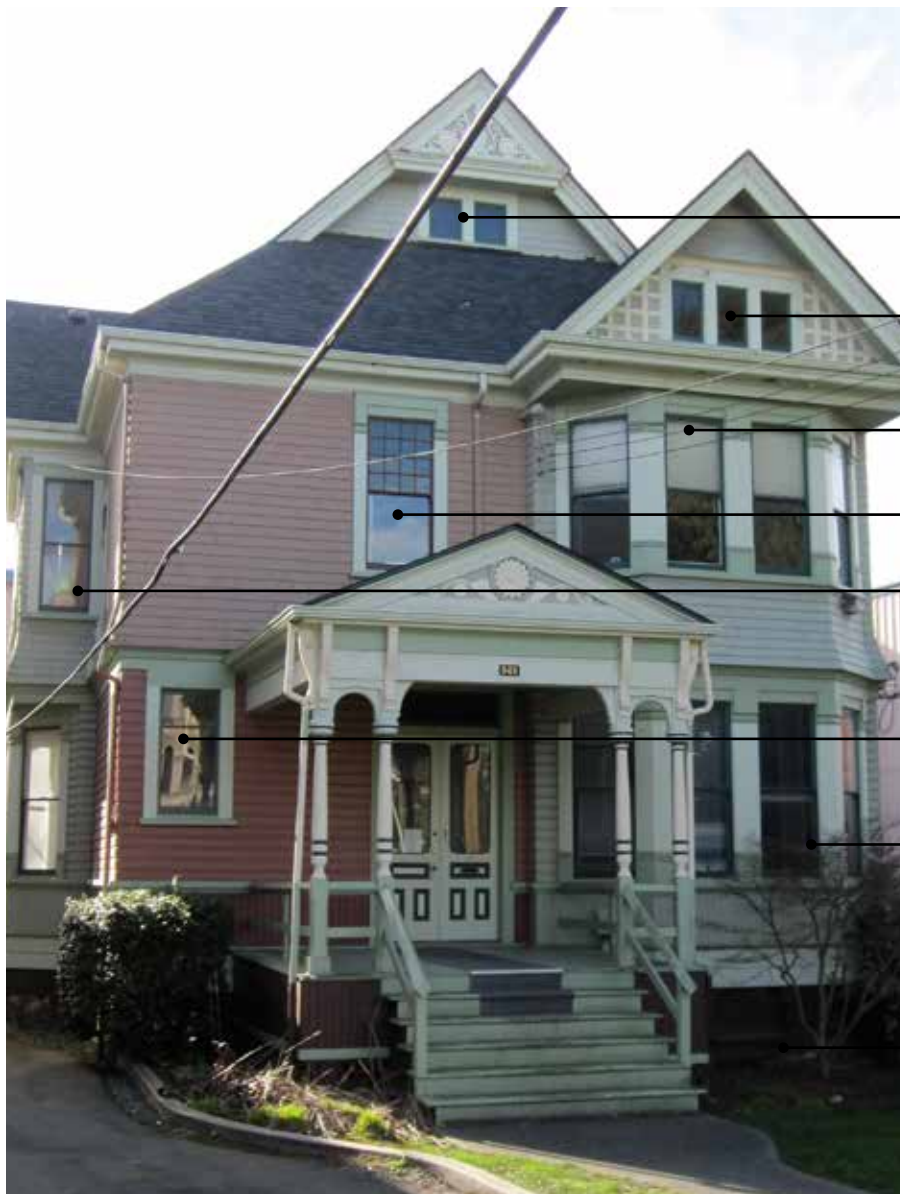
The Black Residence features original fenestration, including 1-over-1 double-hung wooden sash windows with horns, 16-over-1 double hung wooden sash window and stained glass. The windows are character-defining elements of the historic house, and should be preserved. Side, rear and basement window assemblies may be rehabilitated, as necessary, in response to functional changes in interior floor plans.

Most window groupings feature continuous window sills, and appear to be in working condition. Each window should be inspected to determine the full condition of each unique assembly, and should be repaired as required. Original window configuration should be preserved, and each window restored to its original condition.

2x wood sash casement
Treatment: Preserve and Repair

3x wood sash casement
Treatment: Preserve and Repair

4x 1-over-1 double-hung wood sash w/ horns
Treatment: Preserve and Repair

1x 16-over-1 double-hung wood sash w/ horns
Treatment: Preserve and Repair

**2x 1-over-1 double-hung wood sash w/ horns
(1 on either side of elevation)**
Treatment: Preserve and Repair

1x multi-paned wood sash casement
Treatment: Preserve and Repair

1x basement level window, infilled
Treatment: Preserve and Repair

Front elevation: Windows should be preserved and repaired.

- Preserve all original wood sash windows, as possible. Side, rear and basement window assemblies may be rehabilitated, as necessary.
- Inspect for condition and complete detailed inventory to determine extent of recommended repair or replacement.

- Retain existing window sashes; repair as required; install replacement matching sashes where missing or beyond repair.
- Preserve and repair wood-sash windows as required, using in kind repair techniques where feasible.

- Preserve stained glass windows, repair as required.
- Overhaul, tighten/reinforce joints. Repair frame, trim and counterbalances.
- Each window should be made weather tight by re-puttying and weather-stripping as necessary.

- Retain historic glass, where possible. Where broken glass exists in historic wood-sash windows, the broken glass should be replaced. When removing broken glass, the exterior putty should be carefully chipped off with a chisel and the glazier's points should be removed. The wood where the new glass will be rested on should be scraped and cleaned well, and given a coat of linseed oil to prevent the wood from absorbing the oil from the new putty. The new glass should be cut 1/16-1/8th smaller than the opening to allow for expansion and irregularities in the opening, to ensure the glazing does not crack due to natural forces. Window repairs should be undertaken by a contractor skilled in heritage restoration.

- Replacement glass to be single glazing, and visually and physically compatible with existing.
- Prime and repaint as required in appropriate colour, based on colour schedule devised by Heritage Consultant.

- Brace windows with temporary inserts while relocating the house, to ensure they are not damaged in the process. Alternatively, should the windows require removal for repair, reinstate repaired windows following relocation of the house.

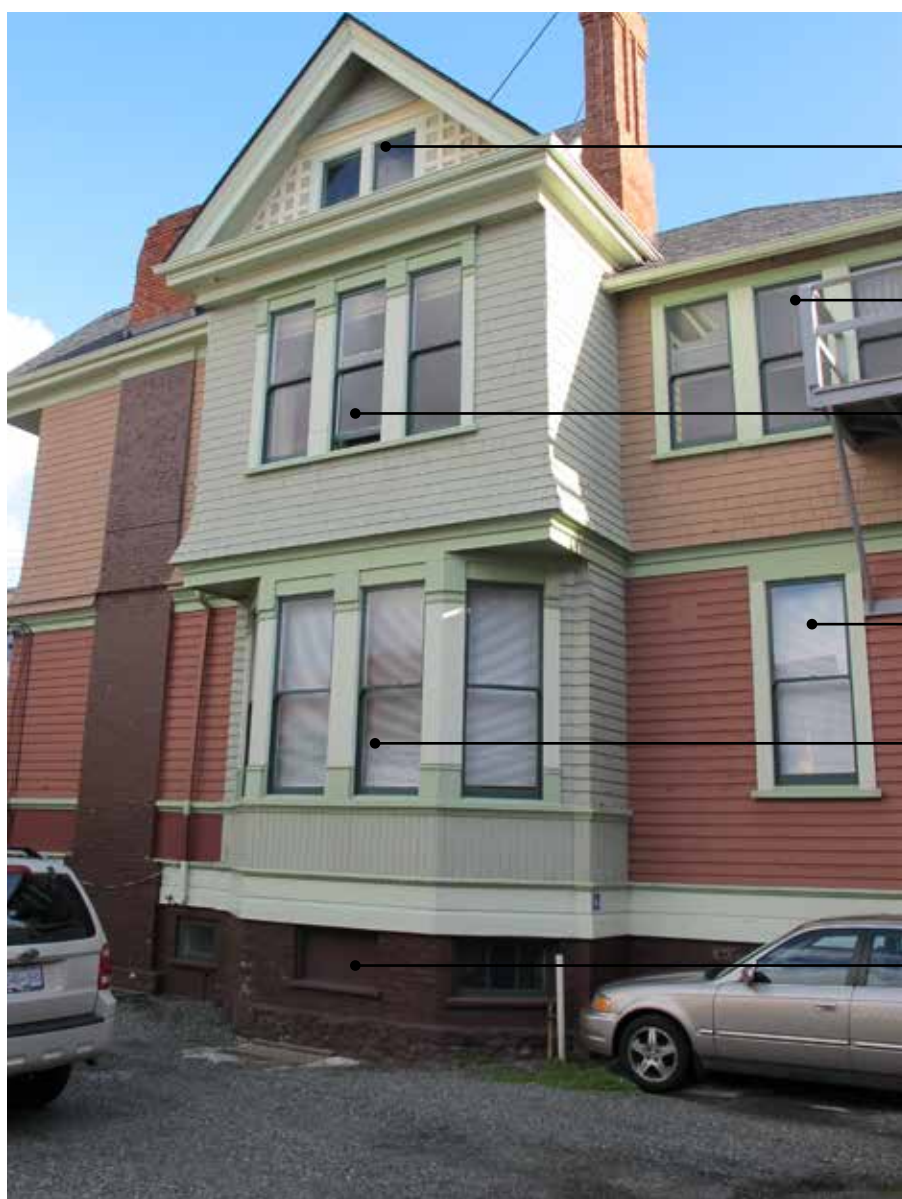
2x wood sash casement

West side elevation: Window configuration may be rehabilitated, as required.

Treatment: Rehabilitate, as necessary

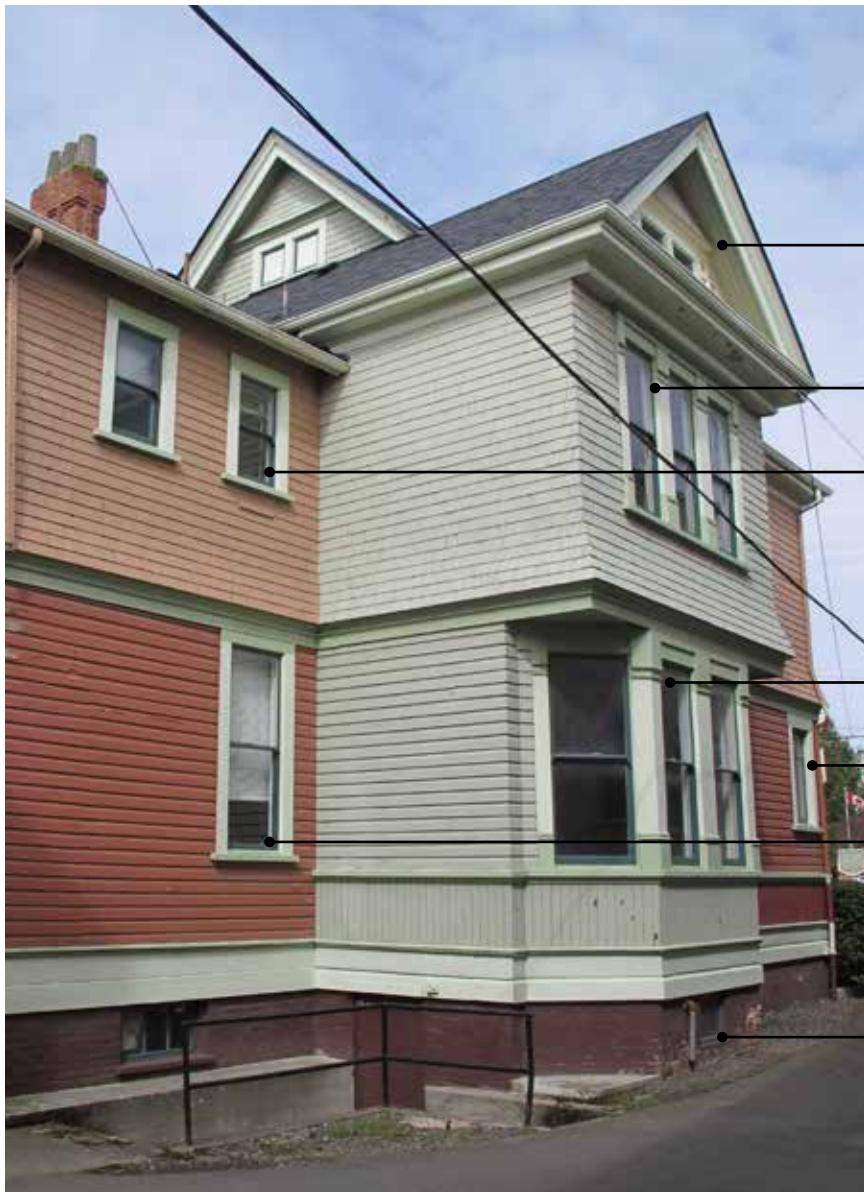
2x wood sash casement

East side elevation: Window configuration may be rehabilitated, as required.

Treatment: Rehabilitate, as necessary

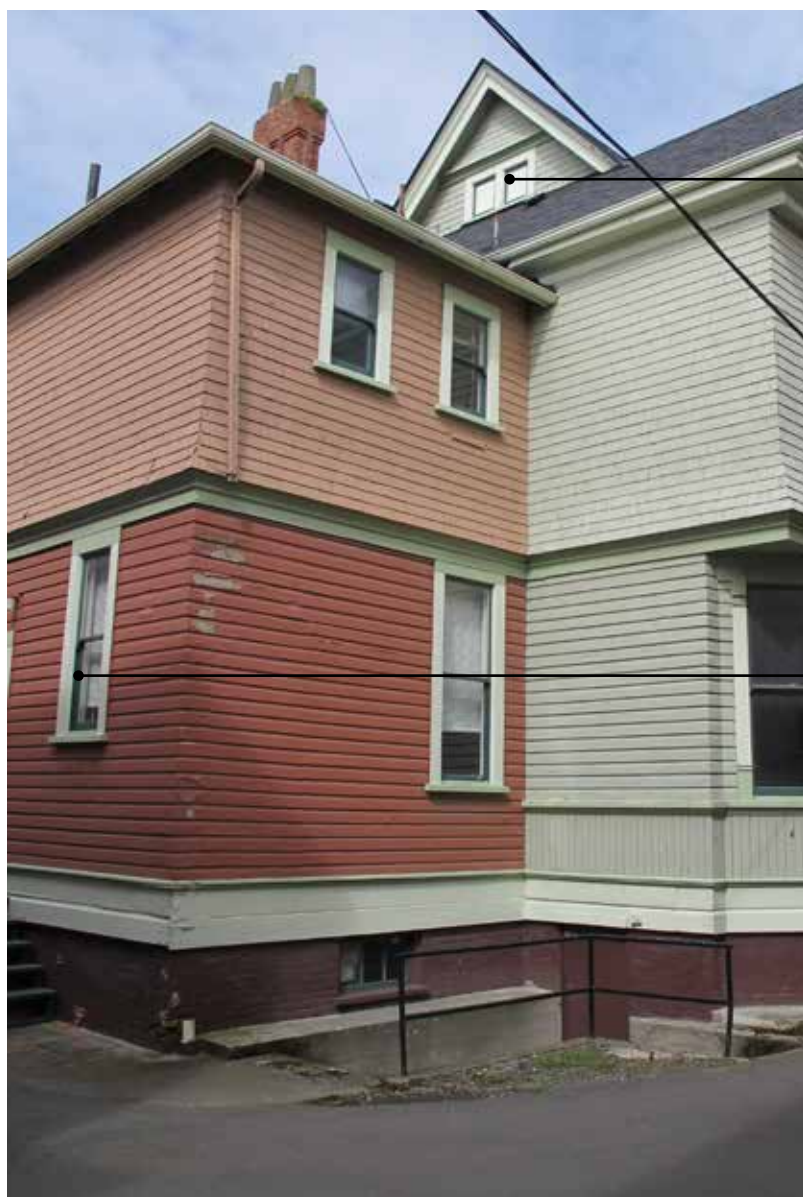
2x wood sash casement
Treatment: Rehabilitate, as necessary

2x 1-over-1 double-hung wood sash w/ horns
Treatment: Rehabilitate, as necessary

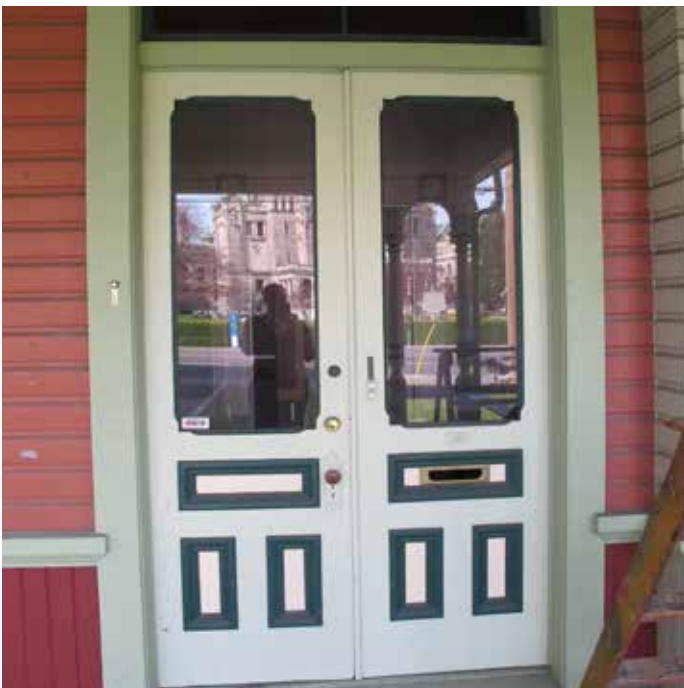
Front door.

The Black Residence features a double-leaf panelled wooden front door with glass insets and transom above. The front door is original to the historic house, and should be preserved. The glass insets are rectangular in shape, and three smaller wood panel details are inset below. The front door appears to be in working condition, and should be inspected further to ensure the hardware is functional and the wood is in good condition. Exterior wood surfaces should be repainted according to colour schedule devised by Heritage Consultant.

- Retain the door openings in their original locations, and preserve and repair all original doors.
- Preserve original from doors with glass insets.
- New doors should be visually compatible with the historic character of the building.

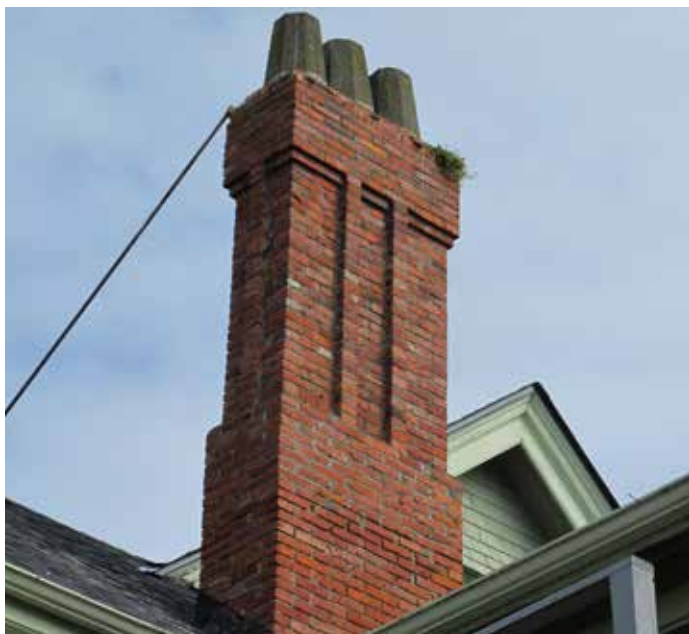
Red brick chimney.

Conservation Recommendation: Rehabilitation

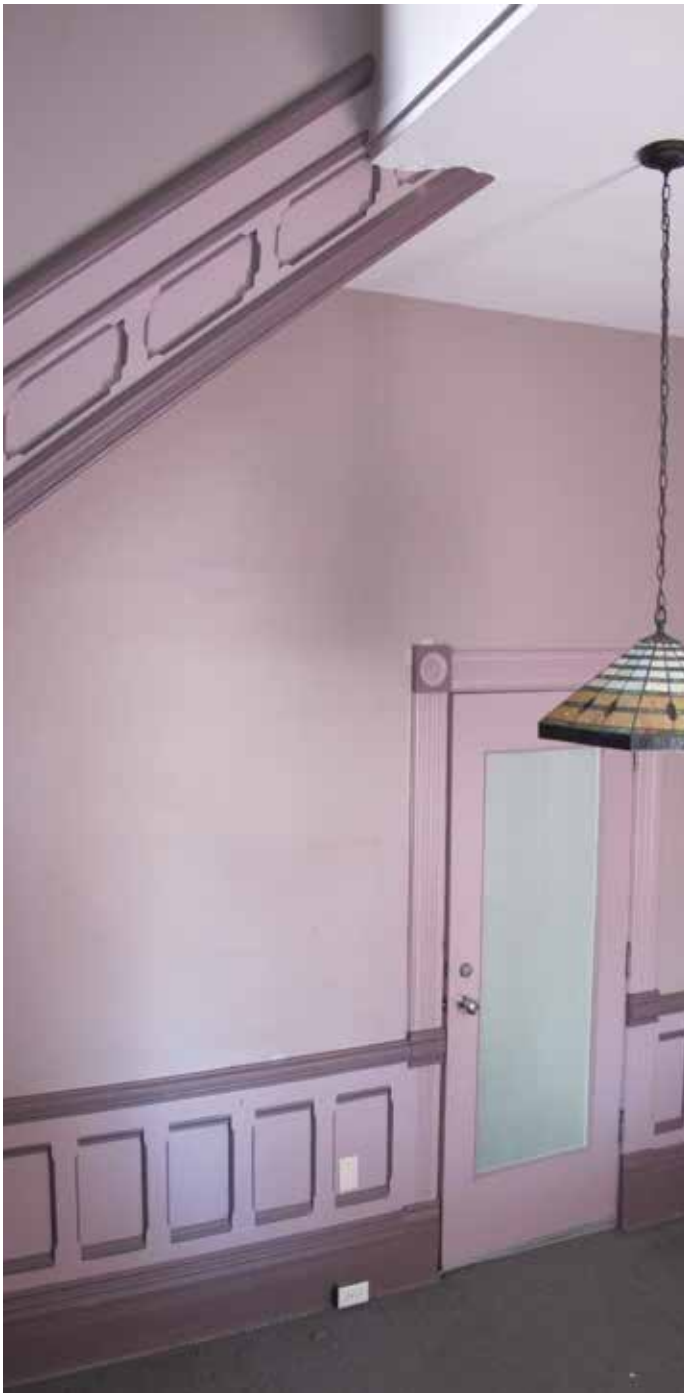
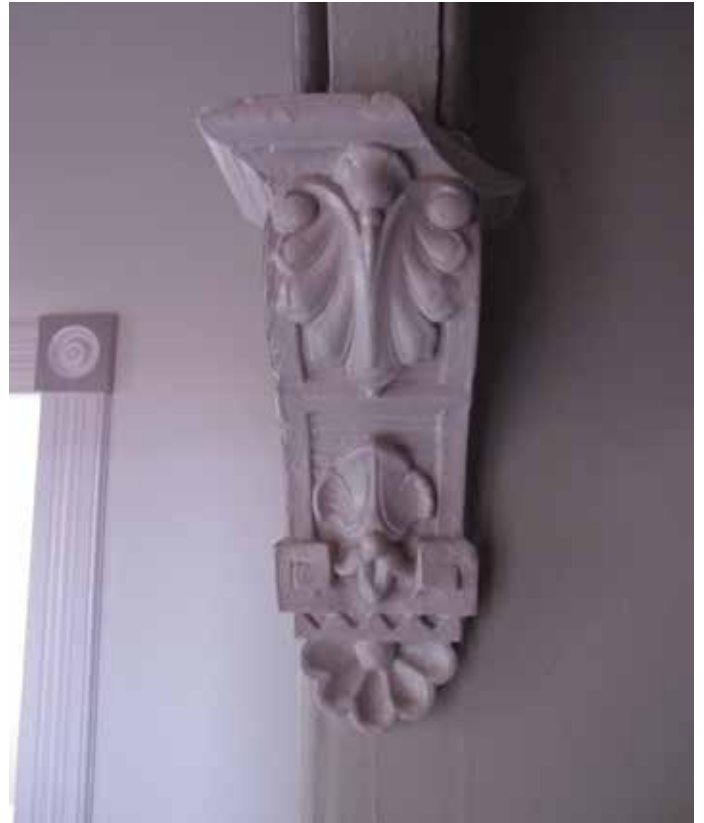
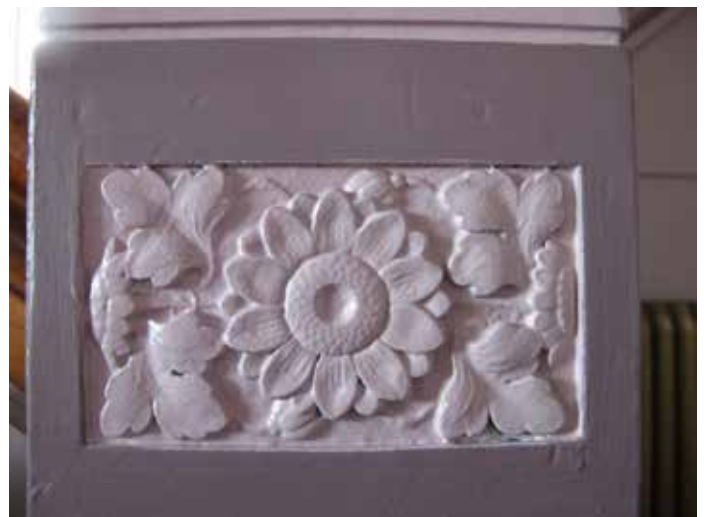
Surviving interior features.

- Interior features should be investigated further to determine if they can be retained during the rehabilitation process.
- Rehabilitation measures may be introduced to accommodate functional needs or building code upgrades, as required.
