CAPITAL PARK, VICTORIA

526 MICHIGAN STREET

DRAFT CONSERVATION PLAN - JUNE 2014

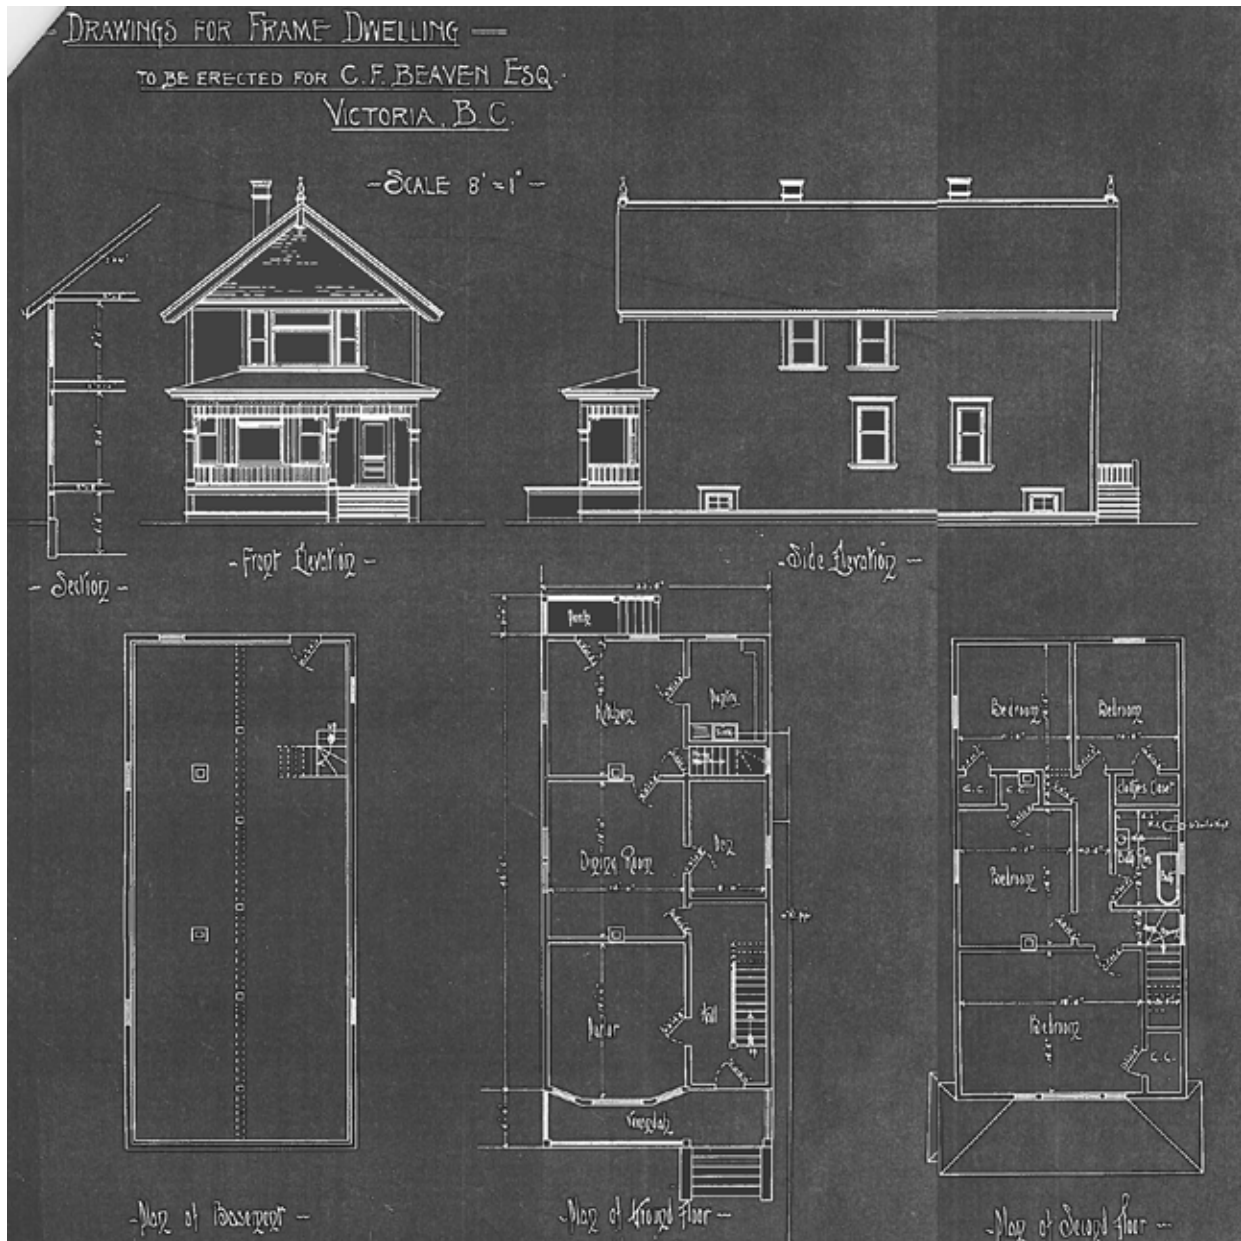
Set of architectural plans prepared for Charles F. Beaven for the construction of a house for his daughter, Mary Ellen Macabe, at 526 Michigan Street, 1911. Note differences in some details from what was constructed, such as the verandah columns and balustrades, front door assembly, shingles in gable end, etc.; some alterations such as the third floor windows and dormers may have occurred after construction.

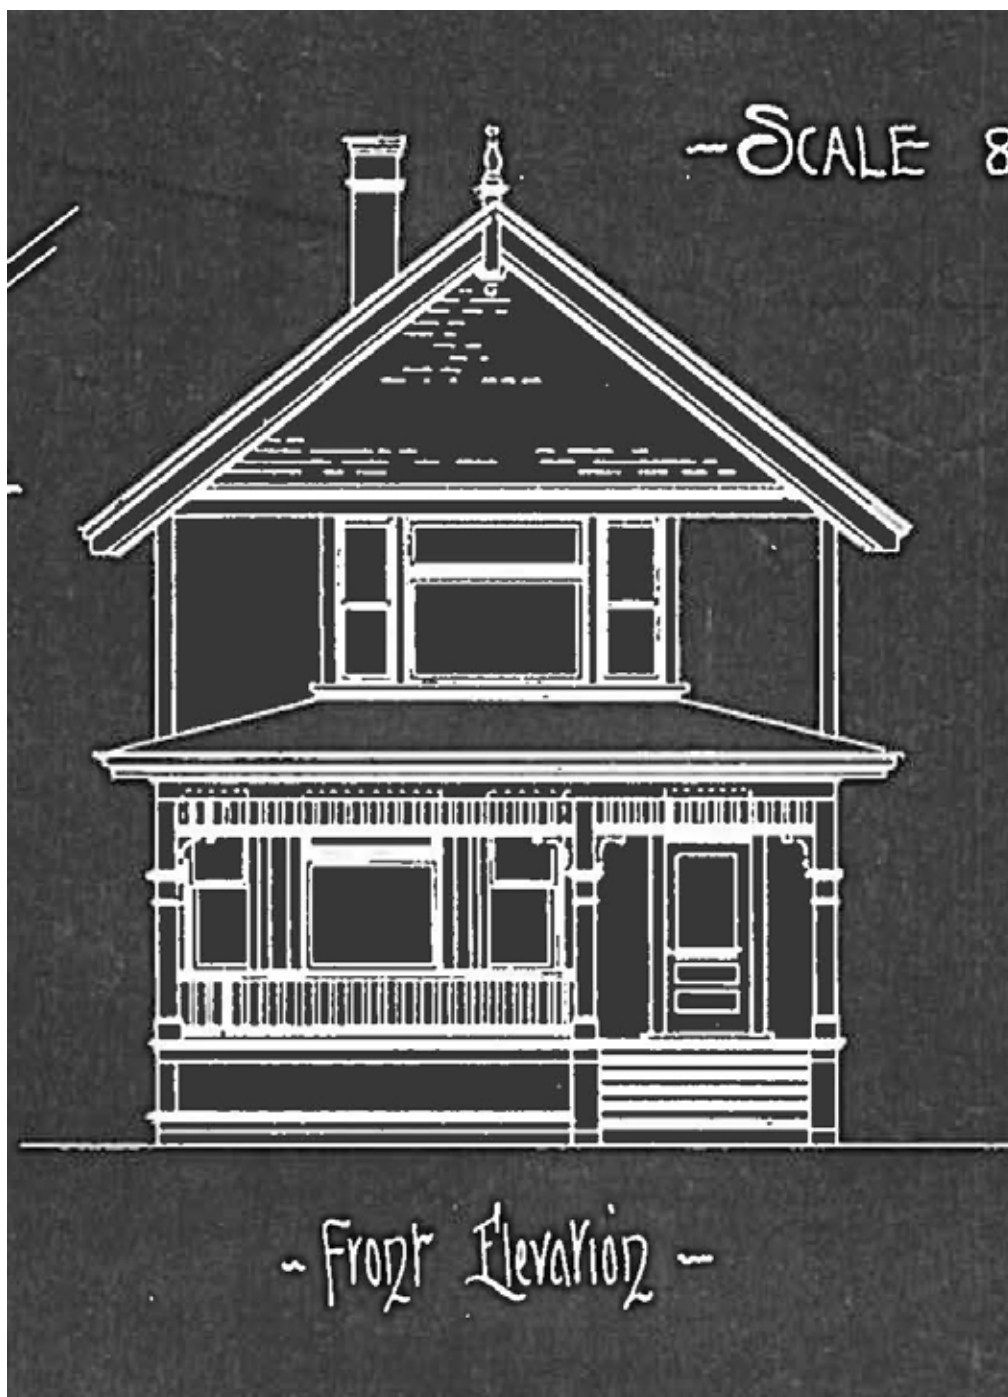
Architectural plans (detail).

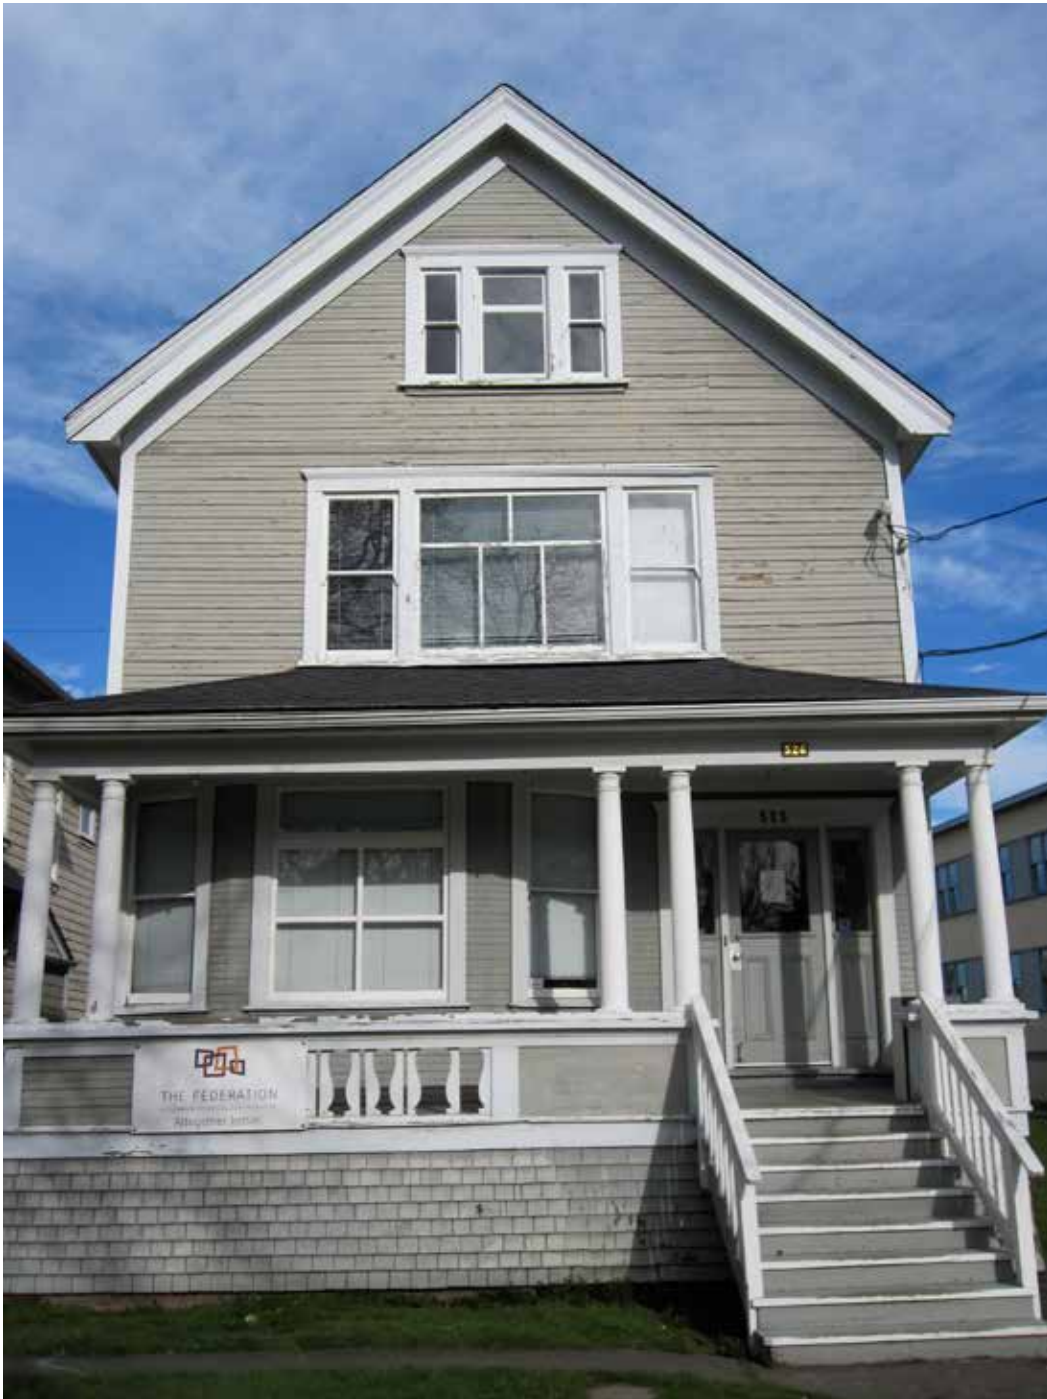
Front elevation.

Conservation Strategy: Preservation

- Preserve the overall form, scale and massing of the building.
- The historic front façade should be retained.

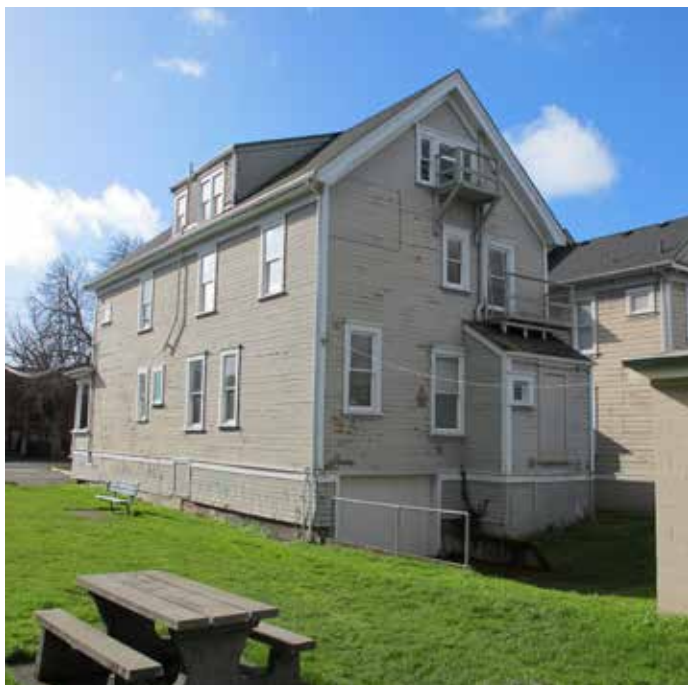
Rear and east side elevation.

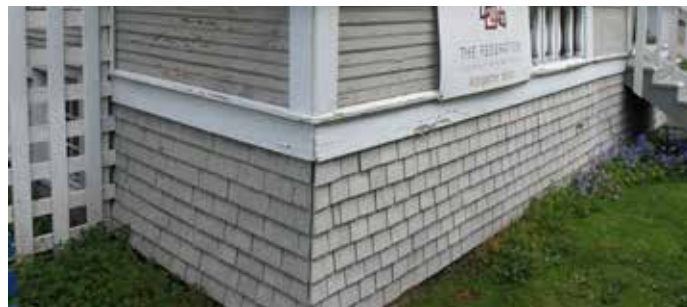
The Beaven/Macabe Residence features bellcast shingle siding at foundation level, clad over concrete foundations. The shingle siding is a character-defining element of the historic house, and should be preserved. Prior to relocation, all shingle siding should be carefully documented and salvaged, and reinstated following relocation of the house. If foundation siding is in too poor condition to salvage, then new physically and visually compatible replica siding should be installed. Concrete is a suitable material for foundations at the new site.

Shingle siding on foundation.

Due to the susceptibility of wood to water damage, ensure wood skirting is not in direct contact with the ground. A gravel course should be installed around the perimeter of the foundations, and the wood skirting should be separated from the ground plane. This will help eliminate water damage to the wood elements along the foundation line.

- Salvage bellcast shingle foundation siding and reinstate following relocation of the house. If wood is too damaged to salvage, replace in-kind with replica wood skirting.
- New foundations are required at the new site. Concrete is a suitable material, and will be concealed behind the reinstated wood siding.
- To ensure the prolonged preservation of the new foundations and restored siding, all landscaping should be separated from the foundations at grade by a course of gravel or decorative stones, which help prevent splash back and assist drainage.

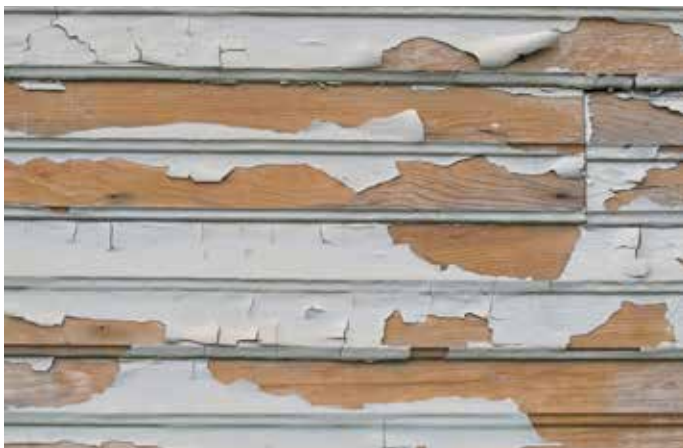
All exterior woodwork demonstrates extensive weathering, with a high degree of paint damage on all exterior surfaces. Further investigation is required to determine if deterioration is superficial or if damage penetrates through to the wood elements. As part of the rehabilitation scheme, all exterior wood elements will be preserved and repaired as required. If wood elements are too deteriorated to repair, then original fabric will be replaced in-kind with physically and visually compatible replica material.

Condition of exterior painted wood surfaces.

- Due to the integrity of wood frame structure, the exterior walls should be preserved through retention and in-situ repair work.
- Preserve the original wood-frame structure of the historic building.

- Preserve original siding on all elevations, if possible, and clean surface for repainting.
- Preserve all exterior wood detailing, including window trim, cornerboards and scroll-cut verandah balusters.

- Replace damaged siding to match existing in material, size, profile and thickness.
- Design structural or seismic upgrades so as to minimize the impact to the character-defining elements.

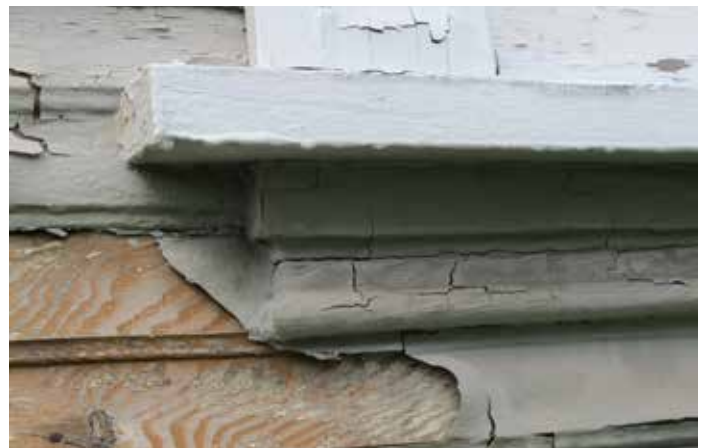
Condition of exterior painted wood surfaces.

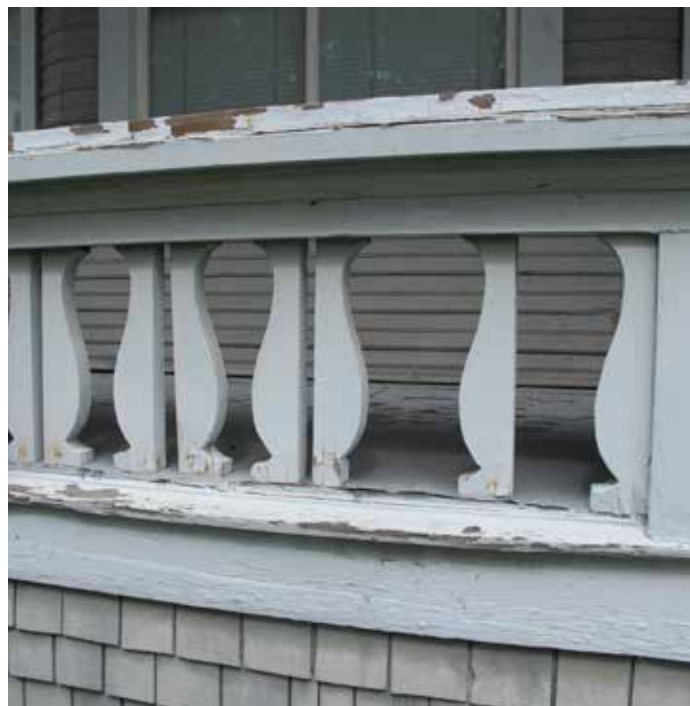
The house features a full-width open front verandah with paired, lathe-turned Doric columns and closed balustrades with distinctive scroll-cut verandah balusters within a rectangular opening. The original narrow verandah has been retained in its original configuration with original detailing. The verandah with its associated detailing is a character-defining element of the historic house, and should be preserved. The exterior wood surfaces on the front porch are heavily weathered, and demonstrate a high degree of paint damage. The structural closed balustrade bases beneath the columns appear to be splitting, and should be assessed. All exterior surfaces should be inspected, and repaired according to recommendations outlined in **Section 5.4: Exterior Wood-Frame Walls**.

Scroll-cut balustrade.

- Preserve full-width front verandah with paired, lathe-turned Doric columns and closed balustrades with distinctive scroll-cut verandah balusters within a rectangular opening.
- Investigate condition of wood balustrade and structure beneath columns. Repair and stabilize as required.
- Repair all exterior wood surfaces, or replace in-kind any material that is too deteriorated to repair.
- Original lower height of the balustrade should be preserved, with alternate compliance methods utilized to achieve the required 42" height. Top of restored wood balustrade should be 24". New Possible alternative materials may be glass panels, metal pipe rails or a combination of both.

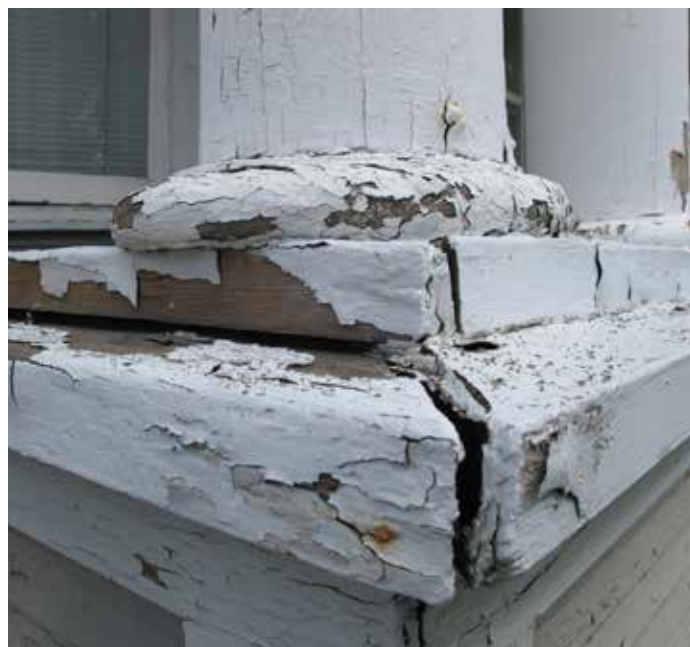
Column base at balustrade.

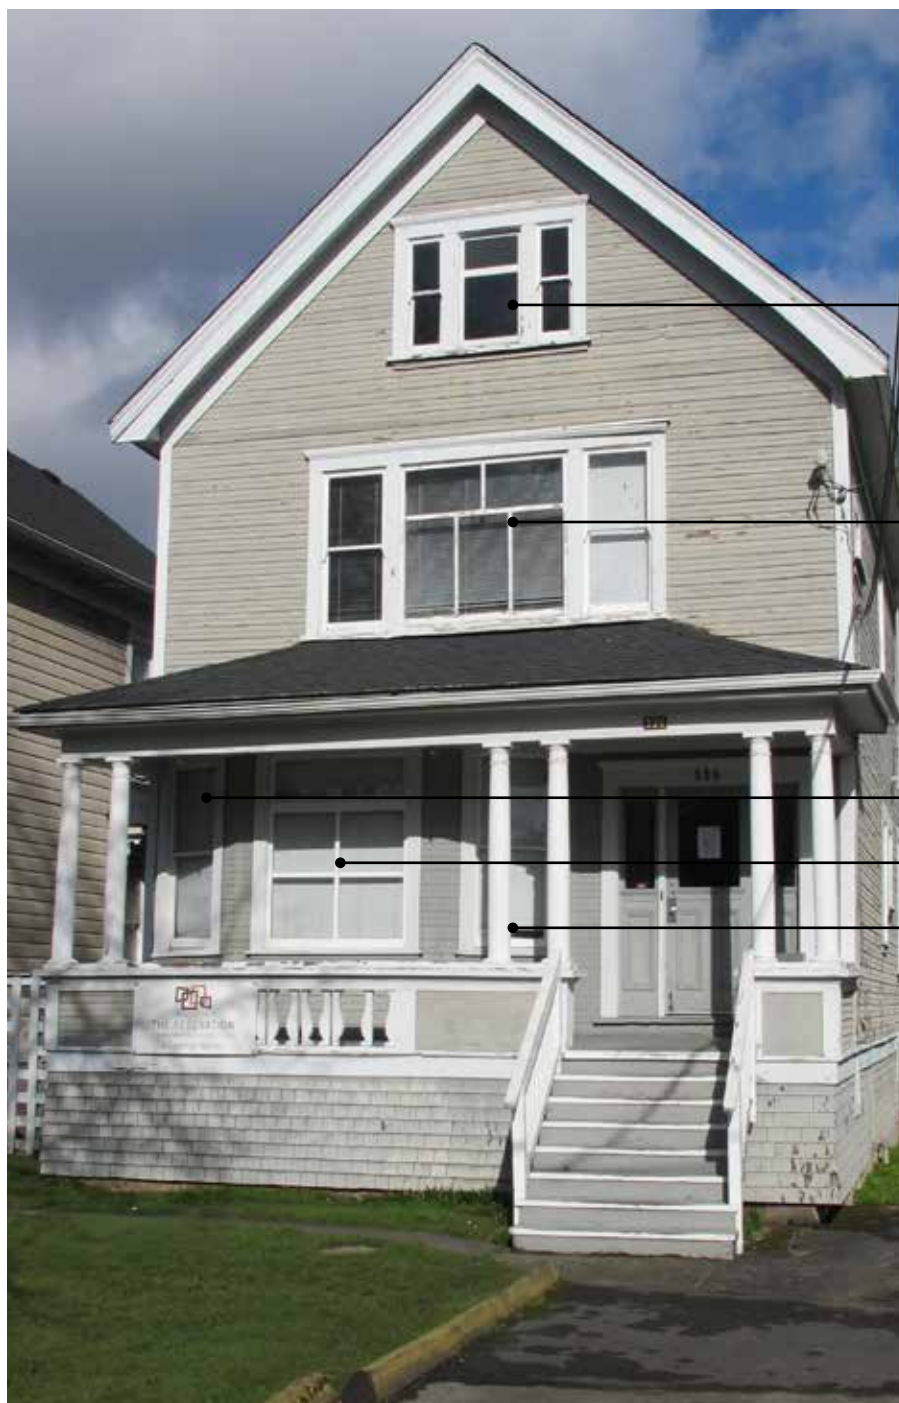
The majority of original windows have been retained, and the front window assemblies have been altered. Other windows were added in early renovations. All exterior wood surfaces demonstrate heavy weathering with extensive paint damage. As part of the rehabilitation scheme early window configuration should be preserved, and early wood sash window assemblies should be retained and repaired, as possible. All windows should be inspected, to determine extent of repair or replacement. Any windows that require replacement should be in matching configuration to original.

2x 1-over-1 double hung wood sash w/ horns
1-over-1 single hung wood sash

2x 1-over-1 double hung wood sash
2-over-3 single hung wood sash

- Inspect for condition and complete detailed inventory to determine extent of recommended repair or replacement.
- Retain existing window sashes; repair as required; install replacement matching sashes where missing or beyond repair.

- Preserve and repair as required, using in kind repair techniques where feasible.
- Overhaul, tighten/reinforce joints. Repair frame, trim and counterbalances.

- Each window should be made weather tight by re-puttying and weather-stripping as necessary.
- Retain historic glass, where possible. Where broken glass exists in historic wood-sash windows, the broken glass should be replaced. When removing broken glass, the exterior putty should be carefully chipped off with a chisel and the glazier's points should be removed. The wood where the new glass will be rested on should be scraped and cleaned well, and given a coat of linseed oil to prevent the wood from absorbing the oil from the new putty. The new glass should be cut 1/16-1/8th smaller than the opening to allow for expansion and irregularities in the opening, to ensure the glazing does not crack due to natural forces. Window repairs should be undertaken by a contractor skilled in heritage restoration.

Front (south) elevation: Windows should be preserved and repaired.

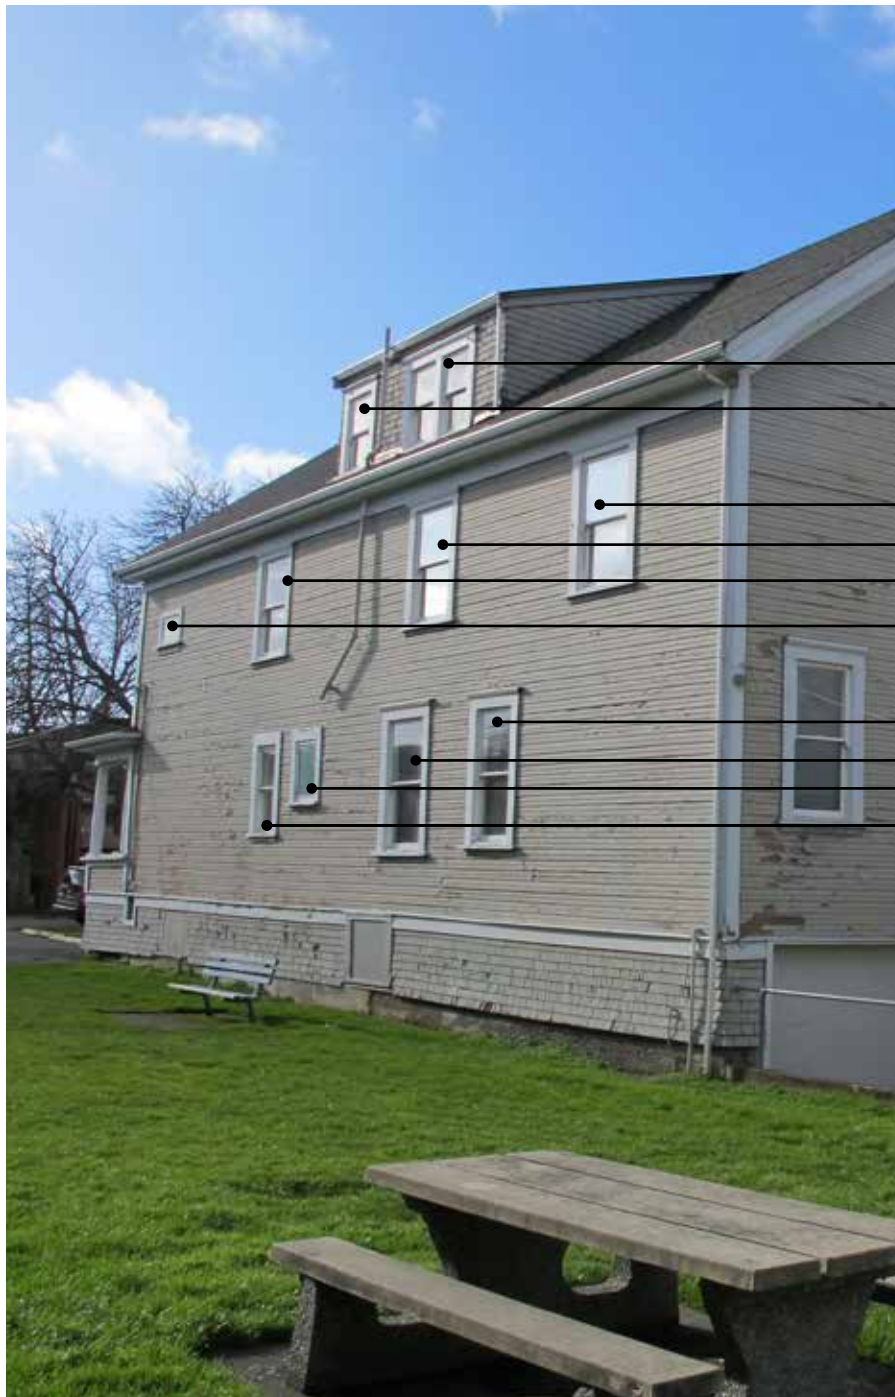
2x 1-over-1 double hung wood sash w/ horns

1-over-1 double hung wood sash w/ horns

Side (east) elevation: Window configuration may be rehabilitated, as required.

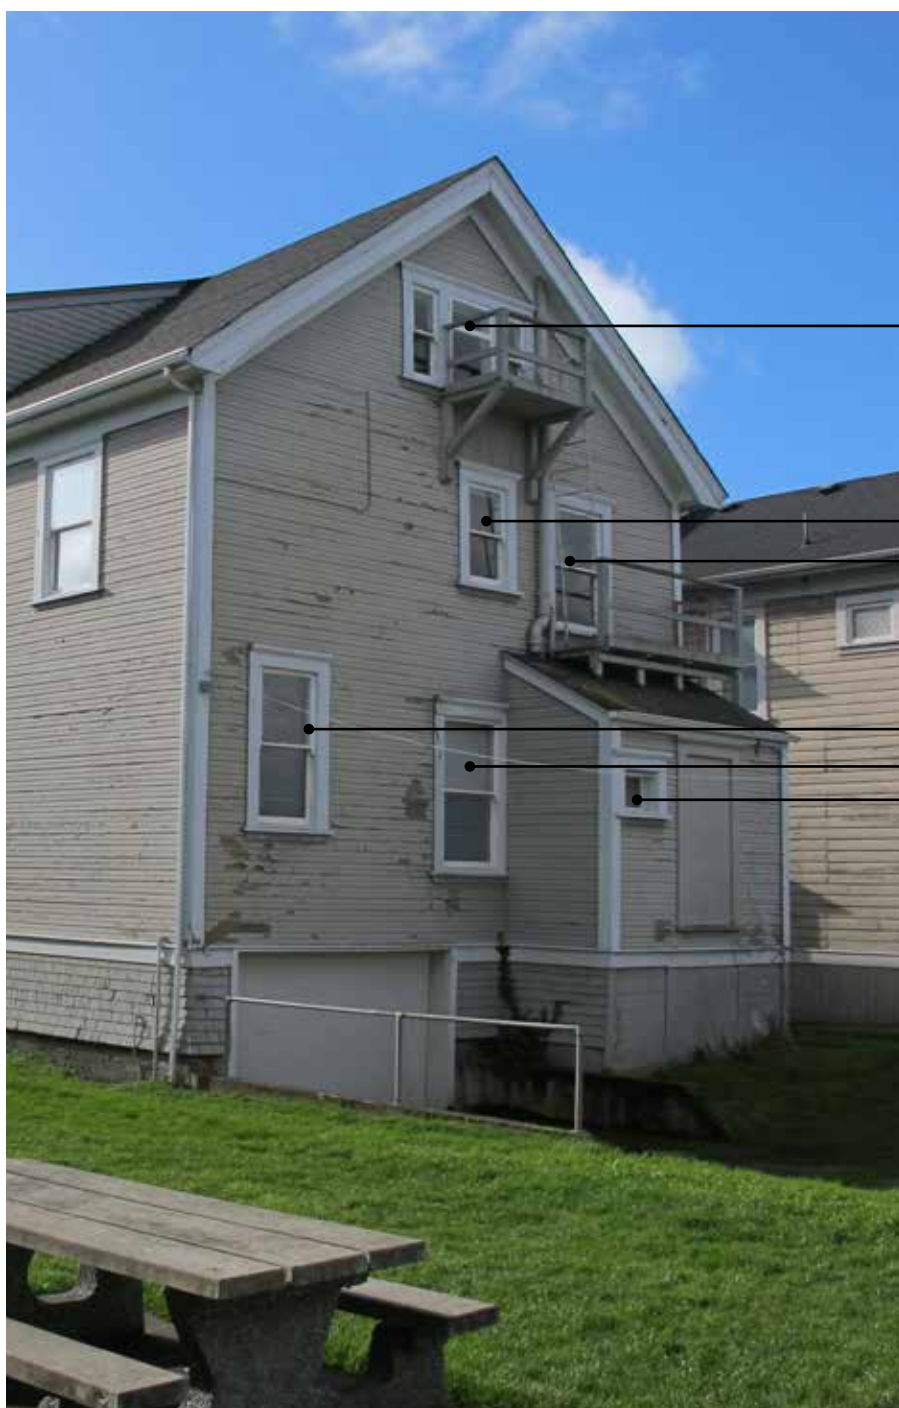
2x 1-over-1 double hung wood sash w/ horns
1-over-1 single hung wood sash Casement
(fire egress)

1-over-1 double hung wood sash w/ horns
1-over-1 double hung wood sash w/ horns

Rear (north) elevation: Window configuration may be rehabilitated, as required.

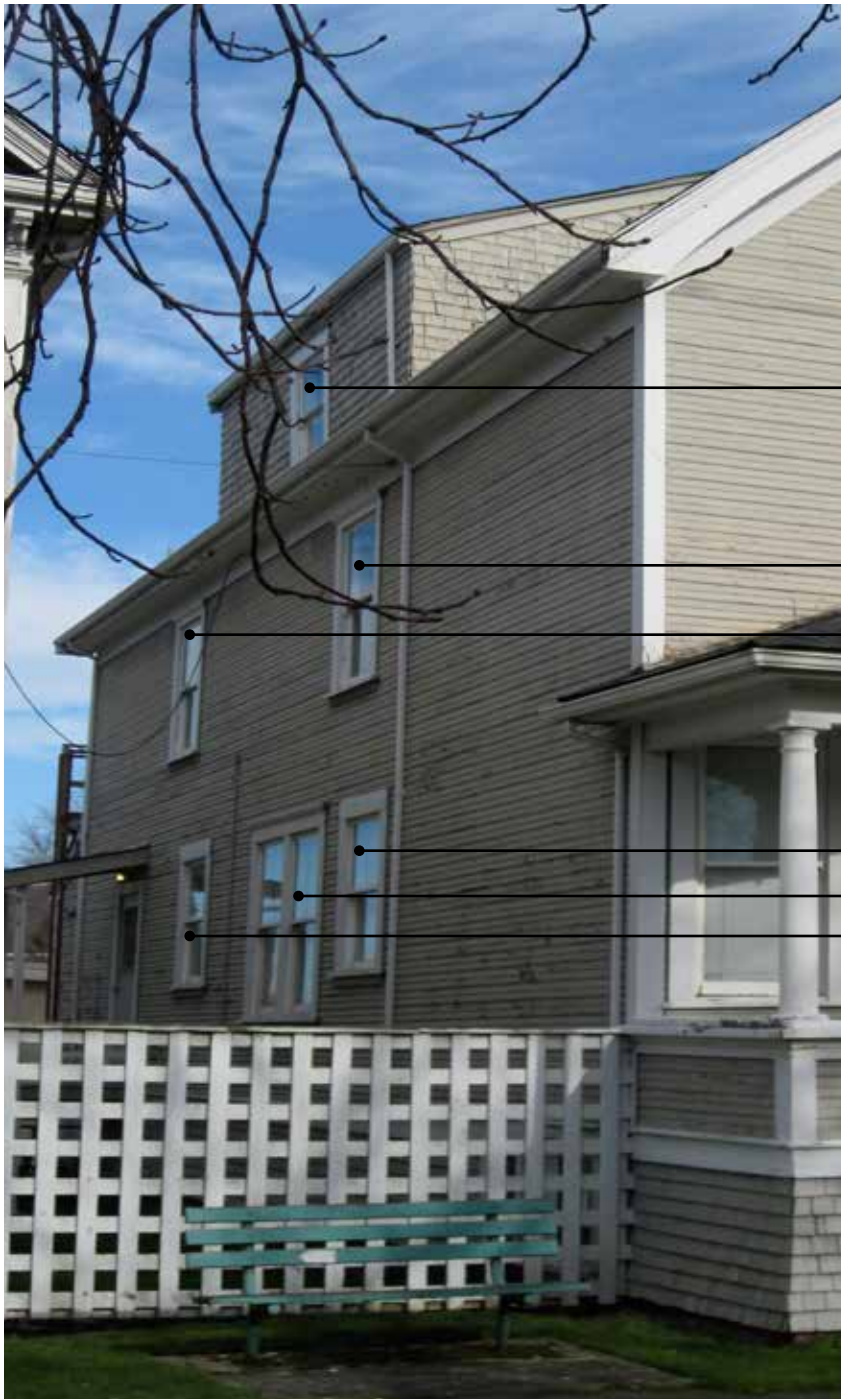
1-over-1 double hung wood sash with horns

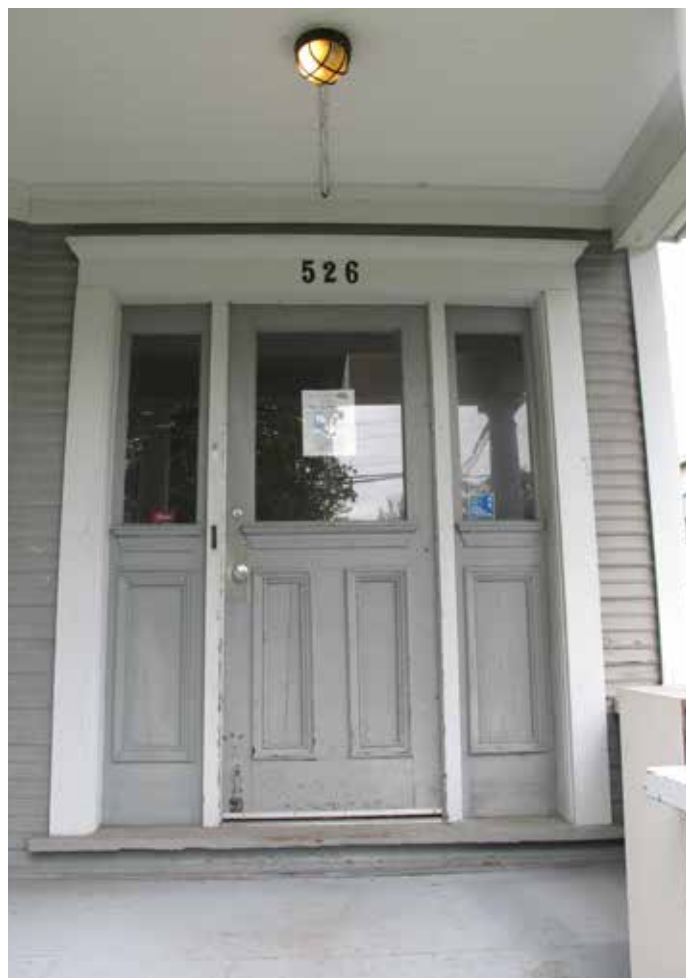
The door and sidelights are currently painted, and an initial review suggests the door to be in fair condition with a notable crack in the front door panel. Further investigation is required to determine the full condition of the original front door. Retain and repair front door, as required. Original side and rear doors should also be retained and repaired, if possible.

Front door with sidelights.

- Preserve the door openings in their original locations, and retain and repair all original doors, as possible.
- Preserve original wood paneled front door with glazing and sidelights. Repair as required.
- Any new doors should be visually compatible with the historic character of the building.
- Prepare exterior wood surface for refinishing. Prime and repaint as required in appropriate colour, based on colour schedule devised by Heritage Consultant.

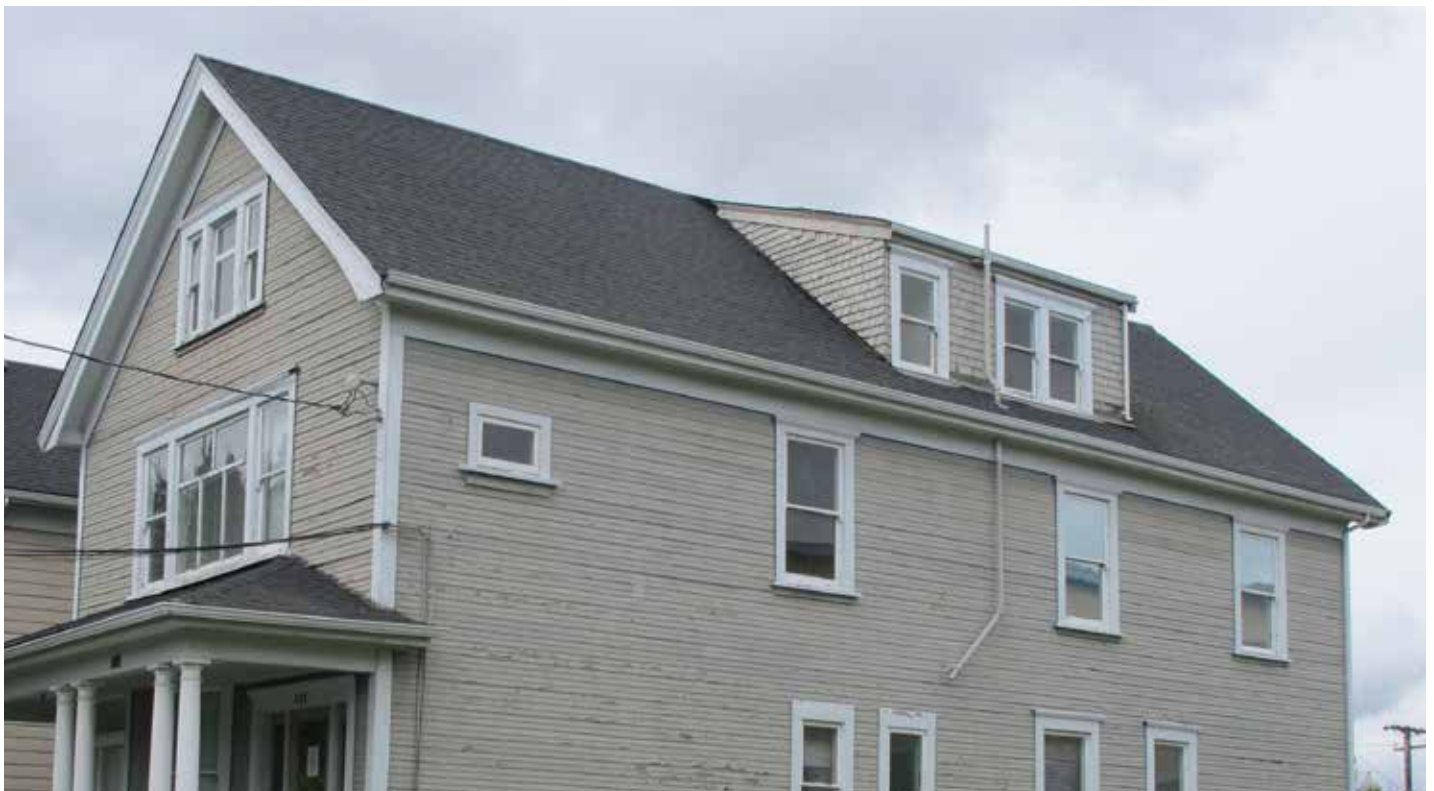
The Beaven/Macabe Residence features a front-gabled roof with small shed dormers on the side elevations. The original roofing configuration has been retained, including original wood features such as wood bargeboard and trim. The shed dormers are clad in shingle siding, consistent with the siding along the foundation level. The original front-gabled roof structure with shingle-clad shed dormers is a character-defining element of the historic house, and should be preserved.

The original roofing material has been replaced with asphalt shingles, and all exterior wood surfaces demonstrate heavy weathering and paint damage. As part of the proposed rehabilitation scheme, the original roofing configuration will be preserved, including all original character-defining wood trim. Exterior wood surfaces should be inspected to determine the full condition of all wood material, and will

Roof configuration with shed dormer.

- Preserve the roof structure in its current configuration, as expressed by its simple front gabled roof structure with shed dormers on the side elevations.
- If required, roofing membrane and cladding system may be rehabilitated. Cedar shingles are the preferred material, but duroid, asphalt or fibreglass shingles are acceptable.
- Retain the original bargeboards and trim.
- Design and install adequate rainwater disposal system and ensure proper drainage from the site is maintained. Paint all drainage system elements according to colour schedule devised by Heritage Consultant.

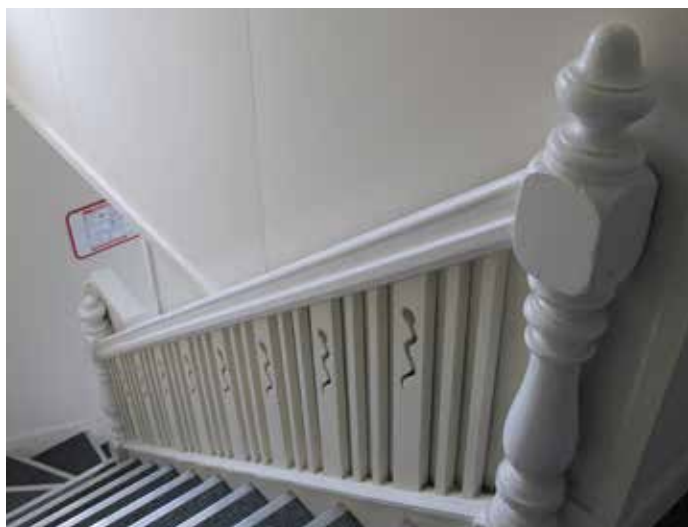
Original interior woodwork and newel posts.

- Interior features should be retained, if possible.
- Rehabilitation measures may be introduced to accommodate functional needs or building code upgrades, as required.
