Planning and Land Use Committee Report
For the Meeting of June 5, 2014

Date: May 22, 2014 **From:** Murray G. Miller, Senior Heritage Planner
Subject: **1284-1298 Gladstone Avenue and 2000-2004 Fernwood Road**
Heritage Alteration Permit Application #00181
Proposal to undertake alterations and recreate the cornice.
Registered Heritage within DPA 6B (HC): Small Urban Villages Heritage
Zoned: C-1 Limited Commercial District

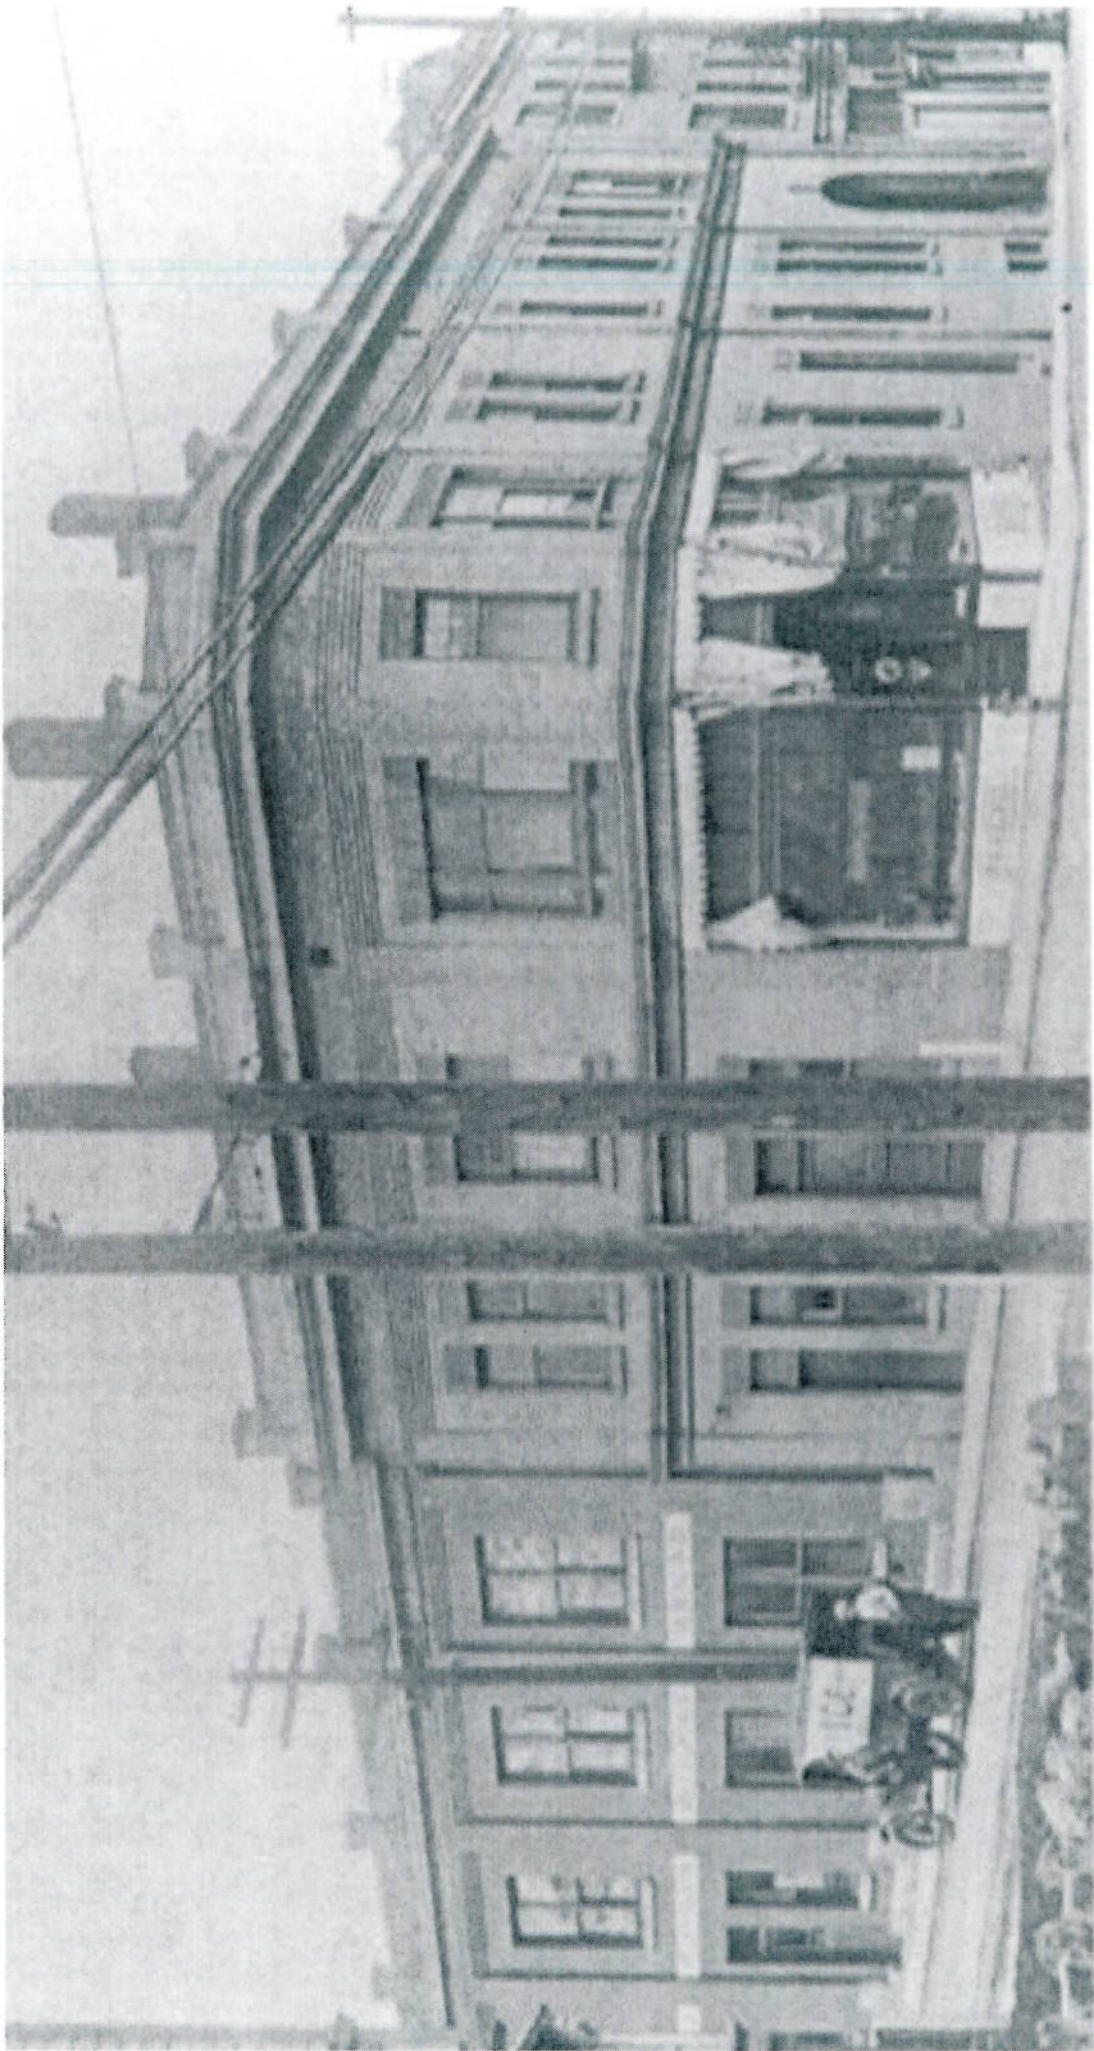
1280-98 Gladstone/2000-04 Fernwood, showing altered corner shopfront and the round-arched entryway to the right, 1920s
