**Subject:** Rezoning Application No.00502 for 727 Johnson Street

DR. GARESCHÉ STABLES & OFFICES  
727 JOHNSON STREET  
VICTORIA, B.C.

## CONSERVATION PLAN

## 5.0 CONDITION REVIEW & CONSERVATION RECOMMENDATIONS

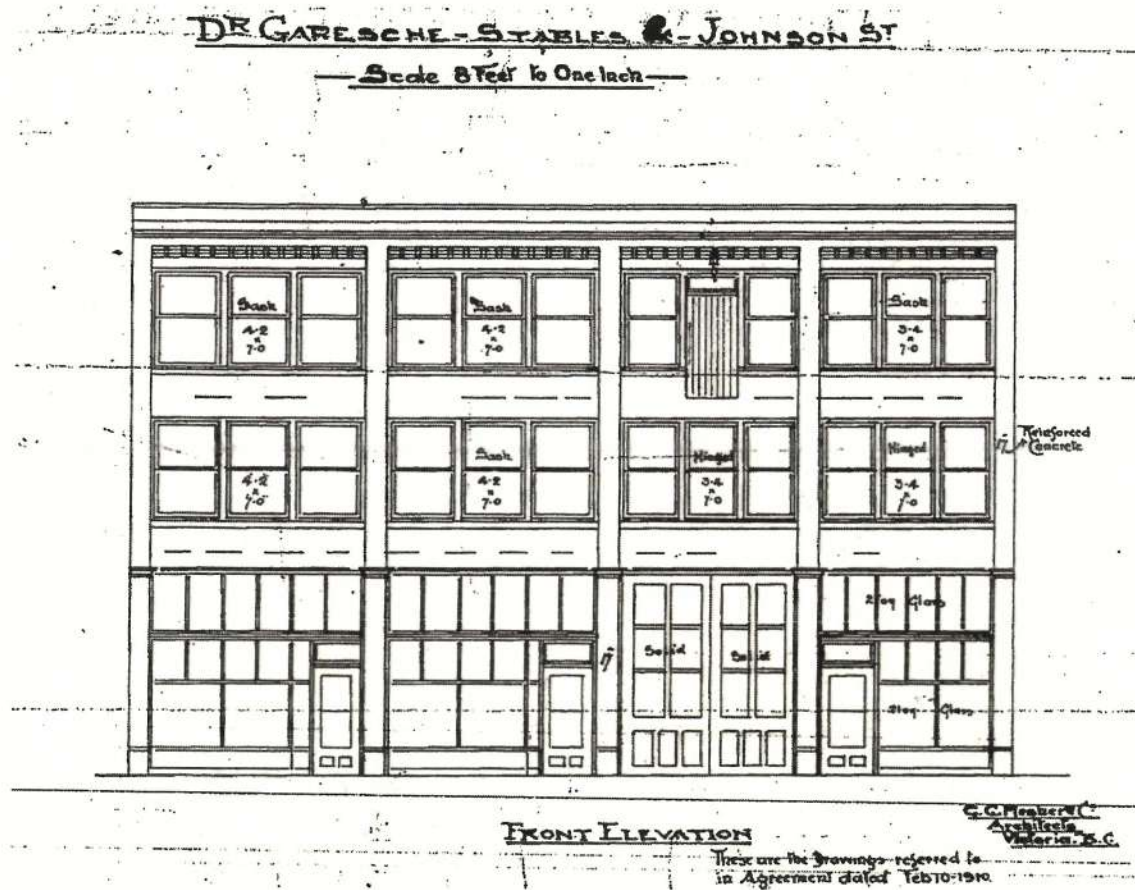
Alterations were made to the storefronts in 1962 when the ground floor became the temporary premises of the Bank of Nova Scotia. An extensive alteration, designed by architect L.O. Lund in December 1967, inserted a retail arcade at the ground level; at that time the front elevation windows and storefronts were completely altered.

Above: Original Appearance, 1910 [City of Victoria Plans]. Below: 1967-68 alterations [City of Victoria Plans].

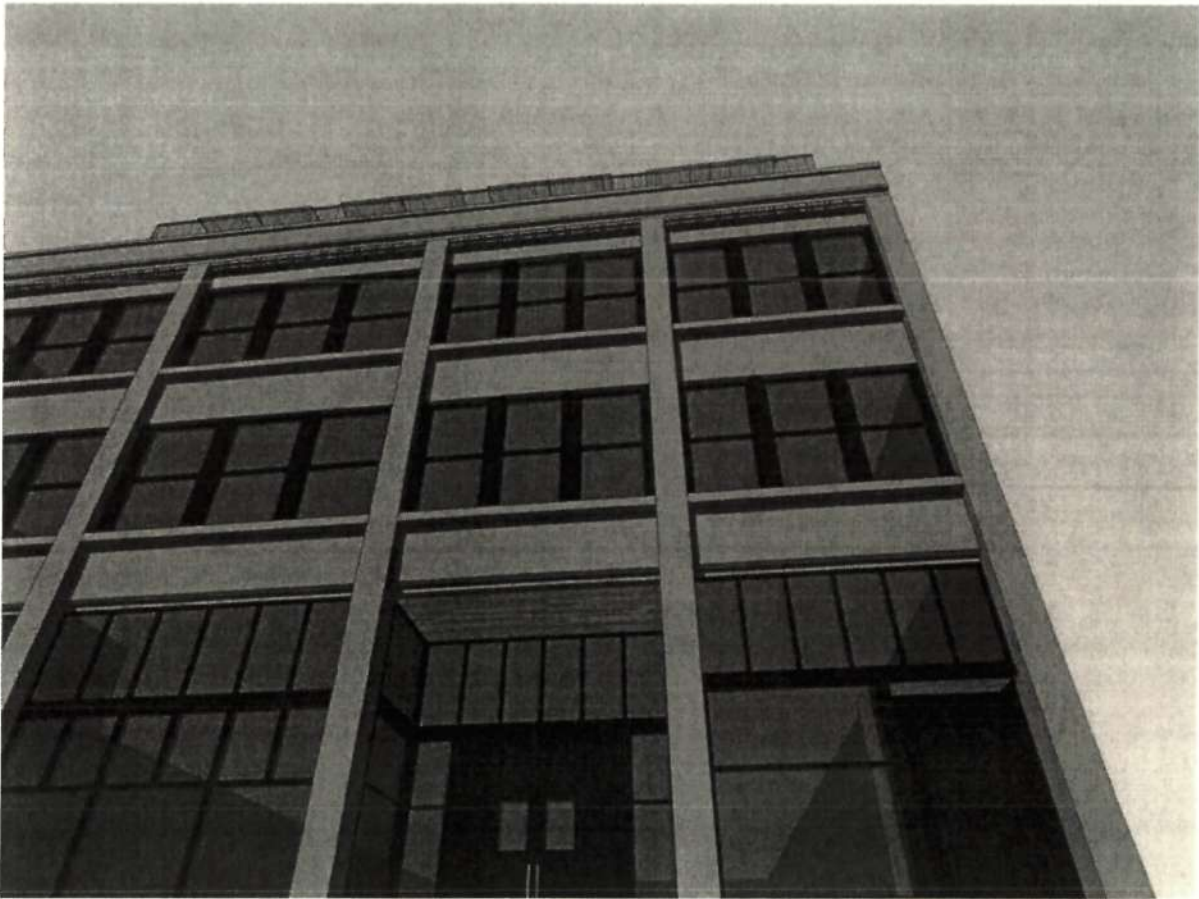
Rendering of proposed facade [Studio One Architecture Inc.]

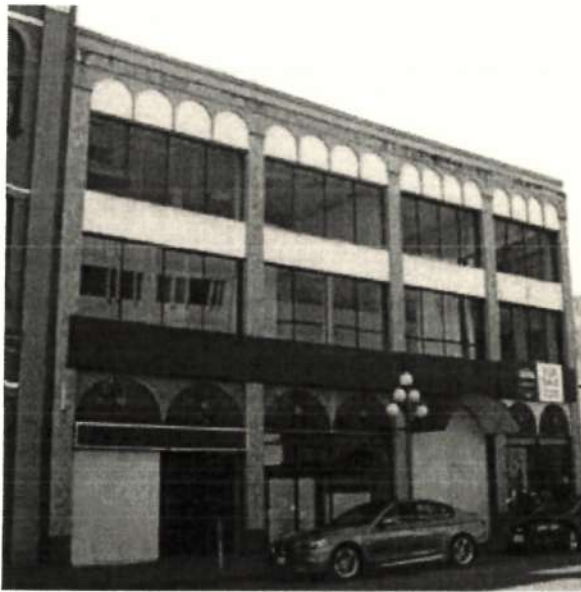
Left: North-facing façade

The building has no basement or crawl space. The foundation, as shown in the archival drawings, was built over solid clay or gravel. It consists of a concrete strip foundation supporting the load-bearing walls and masonry footings with rising 6" x 6" timber posts supporting the timber floor above. A concrete slab was constructed at the southeast corner, where the carriage wash was located.

- The existing foundation may be rehabilitated to meet structural and seismic requirements.

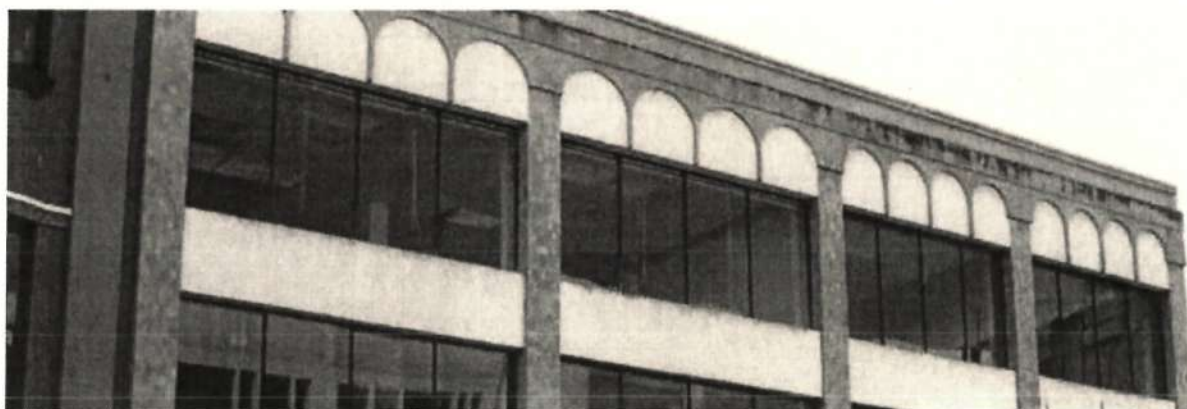
Arched window headers

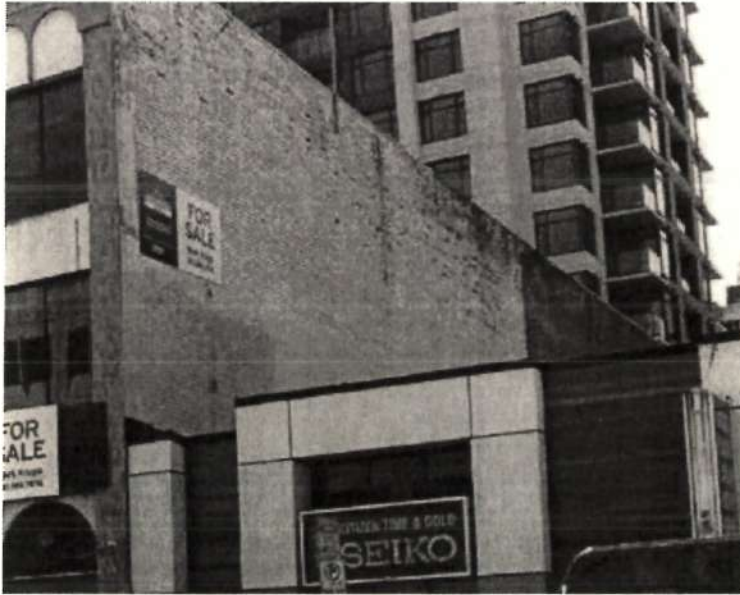
The side walls are built with common red brick. While the neighbouring Maynard Court is three storeys high and covers the eastern side wall of the historic building, the westfacing brick wall is exposed from the second floor up due to the adjacent one-storey building. Half of the brick wall on the west wall is painted, and the other portion remained unpainted. It is currently proposed to retain and seismically upgrade the side walls. The existing condition of the west wall should be further investigated. When viewed from the street, weathering and other damage to the brick wall was observed, e.g. spalling, water staining and organic growth.

West elevation with painted and unpainted brick

- Undertake complete condition survey of condition of the brick walls and note any damage and deterioration, e.g. spalling, missing bricks, unsound or missing mortar, organic growth, metal inserts, wholes in brickwork, paint etc.

- Retain sound exterior brickwork. Deteriorated exterior masonry that can be repaired.
- Cleaning, repair and repointing specifications to be reviewed by Heritage Consultant.

- All redundant metal inserts and services mounted on the exterior walls should be removed or reconfigured.
- Any holes in the brick should be filled or replaced to match existing.

- Overall cleaning of the brick on all elevations should be carried out. Do not use any abrasive methods that may damage the fireskin surfaces. Use a soft natural bristle brush and mild water rinse. Only approved chemical restoration cleaners may be used. Sandblasting or any other abrasive cleaning method of any kind is not permitted.

- Repoint all exposed brickwork by raking out loose mortar material to a uniform depth. Take care that the arrises of the brick are not damaged. Work should only be undertaken by skilled masons. Do not use power tools to cut or grind joints; hand-held grinders may be used for the initial raking of horizontal joints after test samples have been undertaken and only if approved by the Heritage Consultant. Repoint mortar joints with new mortar that matches existing in consistency, composition, strength, colour and pointing profile; note the finely tooled profile of the original mortar joints.

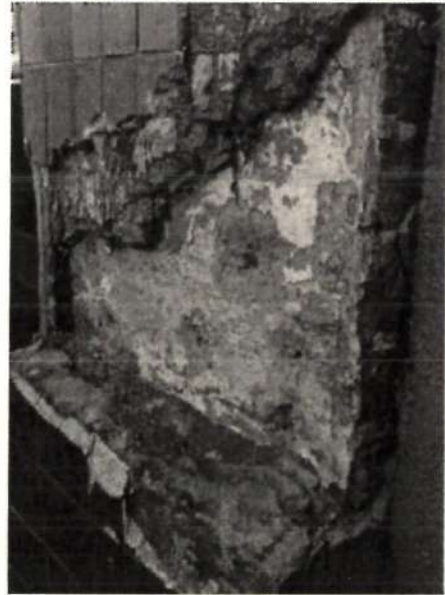
Concrete column under later materials

- Carefully remove stucco, tiles and other later materials with minimal damage to the historic concrete façade underneath.
- Preserve any original concrete elements, e.g. corbelling, that may still be extant.
- Assess the condition of the concrete façade and note any existing damage, e.g. cracks, missing material and detailing.
- Analyze the concrete matrix and strength through material testing so that suitable repair patching material can be selected.
- Restore missing architectural details based on surviving examples or archival documentation.
- Restore the concrete front façade to its historic 1910 appearance and paint according to the colour schedule.

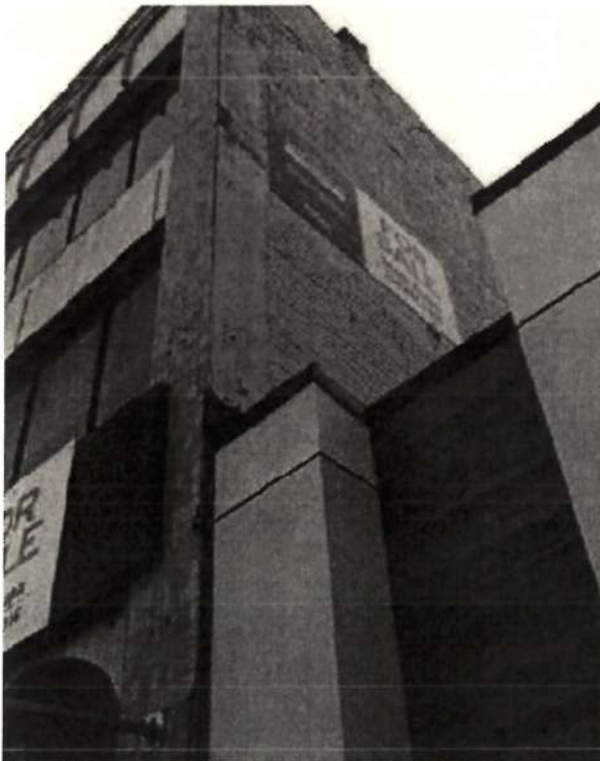
Painted west wall

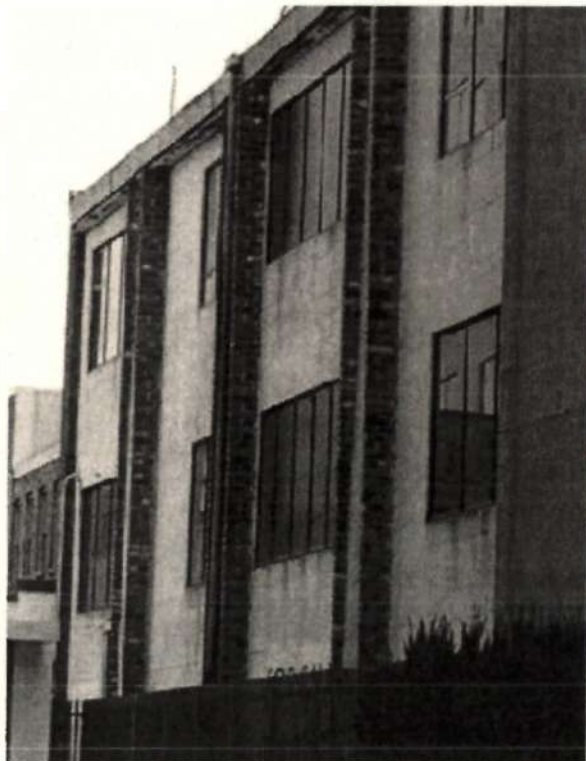
Rear wall consisting of concrete blocks with brick-clad columns

- Preserve the original concrete street façade and rear and side elevations in situ.
- All redundant metal inserts and services mounted on the exterior walls should be removed or reconfigured.
- All structural and seismic upgrades should be carried out from the inside, in particular on the front façade in order to preserve exterior character-defining elements.
- Cleaning of historic masonry should be carefully done and without damage to the surface area. Test trials are required for review by the consultants.

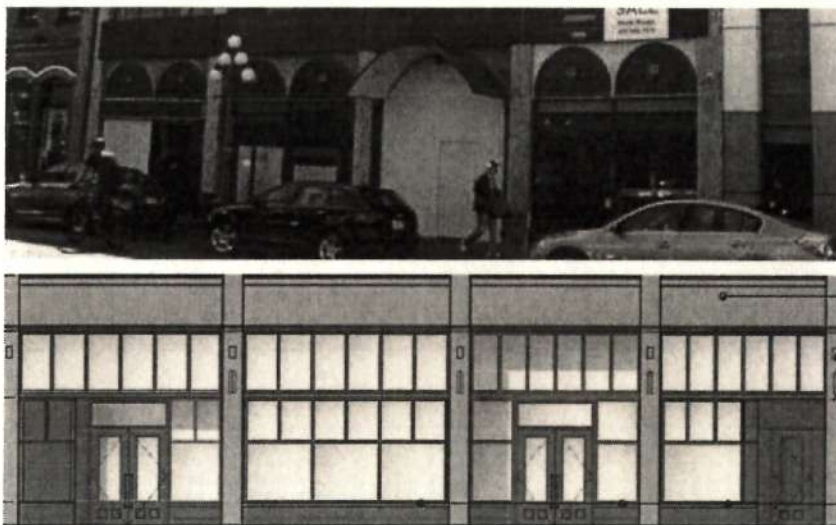
Top: Current storefront; Bottom: Proposed [Studio One Architecture Inc.]

- Rehabilitate the existing ground level of the front façade based on archival documentation and to reflect the new mixed-use of the building.
- New wood storefronts and entryways and transoms with true-divided glass will be designed.
- The ground floor of the rear elevation will retain the historic bay configuration while meeting functional requirements of the commercial-residential building.
- Provide shop drawings for review by the Heritage Consultant.

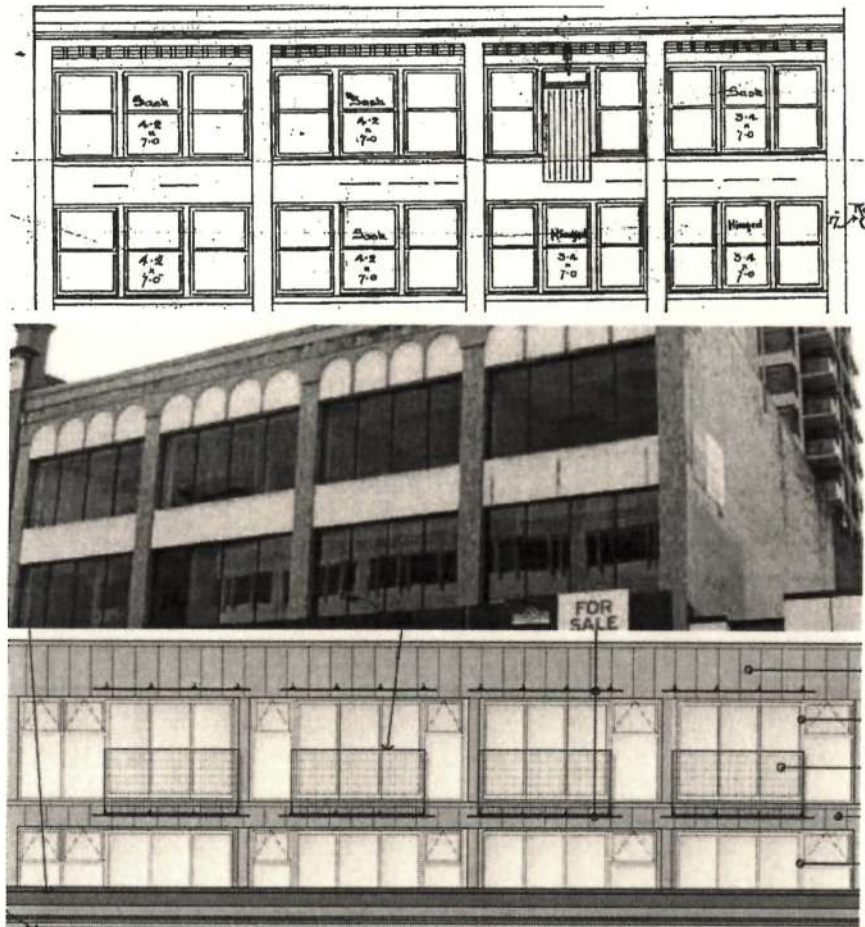
The historic building featured originally banked upper floor windows in tripartite configuration on the front and rear elevations. All original double-hung wooden sash windows were replaced with later aluminum units. During this process the tripartite window configuration on the front façade was retained, while the rear elevation was entirely redesigned.

Top: Detail of Upper Floor Windows from Original Plan, 1910 [G.C. Mesher Co., Architects, City of Victoria Plans]; Middle: Current windows; Bottom: Proposed [Studio One Architecture Inc.]
