HERITAGE REVITALIZATION AGREEMENT (816 GOVERNMENT STREET and 811-813 WHARF STREET) BYLAW

HERITAGE REVITALIZATION AGREEMENT

Conservation Plan

Heritage Building Proposed Interventions

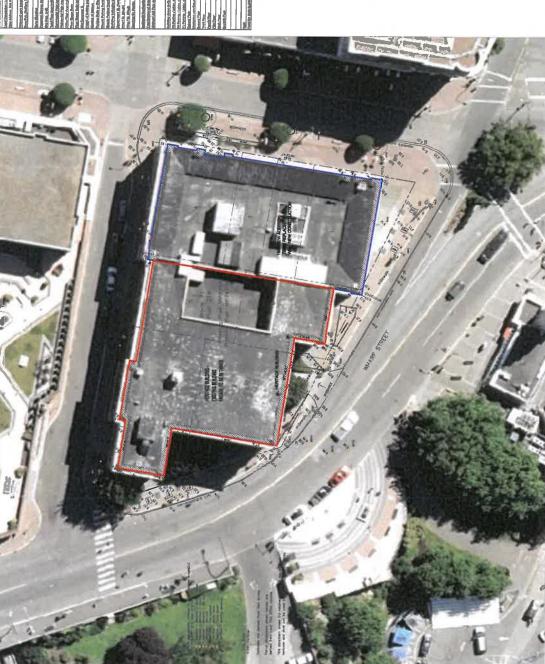
EXSTING SITE FLAN

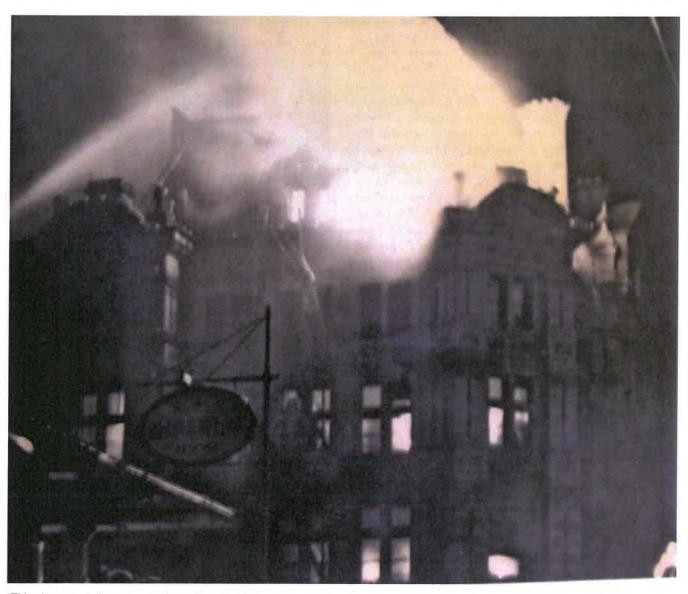
"This photograph illustrates the intensity of the Blaze that caused heavy losses to Government offices last Monday night. The picture was taken when the fire was at its height and shows the flames being driven over the roofing by the wind. At the left hand side is shown a stream of water from one of the pumpers being directed at the seat of the blaze from the ground on the south side of the building. The light in the windows is not fire, but a reflection thrown back from surrounding buildings." *Daily Colonist* [Victoria], January 20, 1937, page 1.

At 11:05 on the evening of January 18, 1937, a devastating fire broke out on the two upper floors of the Post Office building. Severe cold caused problems in the maintenance of water pressure to fight the blaze; one hydrant was found to be partially frozen and a fire had to be built around it to heat it and thaw it our before it would function properly. Extensive damage occurred in the hour and a half before the fire was brought under control, and further damage was caused by water on the lower floors.

The heavy copper sheeting on the roofs and the sides of the cupolas is believed to have saved the building from greater damage. The copper prevented the flames from breaking through to the other parts of the ornamental roof. Before the fire was completely out the copper retained a red-hot glow.

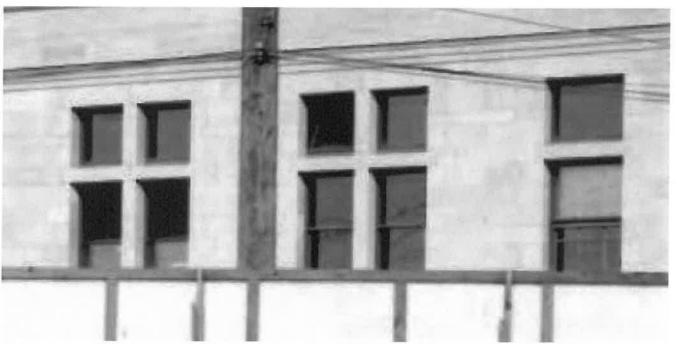
1915 - Note operable transom window.

- Inspect for condition and complete detailed inventory to determine extent of recommended rehabilitation.
 Determine if new sash can be inserted in original frames, where retained. If so, consider double-glazed units.
- Install window frames of appropriate colour.

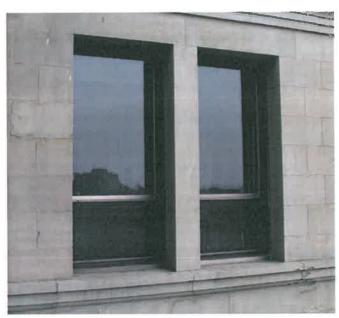
Existing windows - exterior.

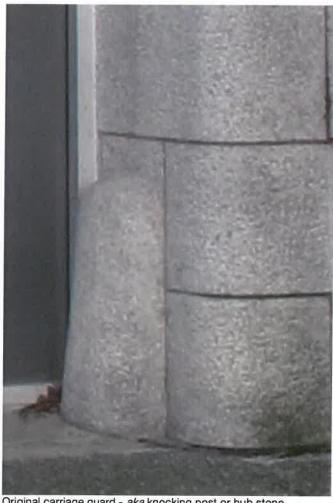
Original carriage guard - aka knocking post or hub stone.

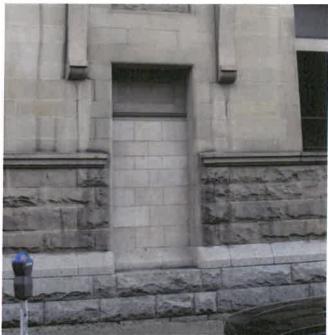
2014 - Infilled doorway.

- Retain existing openings for functional uses.
- Re-open blocked entries.
- Determine functional requirements of new uses. Introduce any proposed new openings in an appropriate manner. Refer to Standard #11: Make the new work physically and visually compatible with, subordinate to and distinguishable from the historic place.

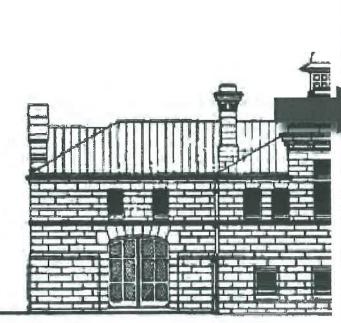
1898 - Original carriageway configuration.

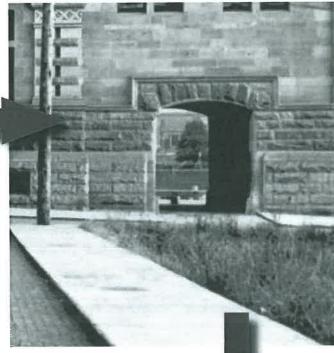
1914-16 - Raised arch over opening.

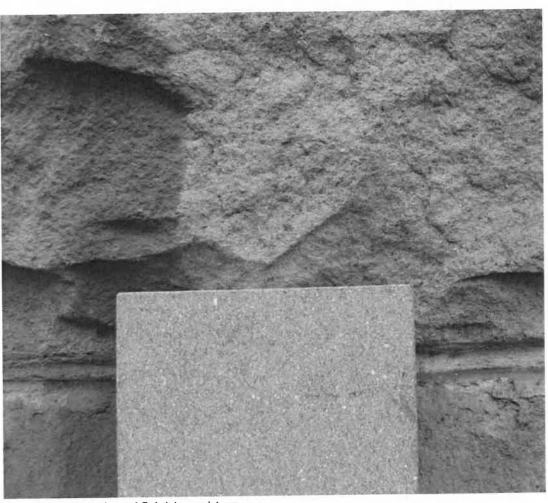
Potential match to cleaned Gabriola sandstone

- Sandstone is a soft stone, and prone to damage when intensively cleaned. Extreme caution should be taken to ensure the gentlest means possible are used to clean the sandstone.
- Remove dirt using a soft bristle brush. More severe stains should be cleaned using a mild detergent.
- Abrasive cleaning and power washing are prohibited.

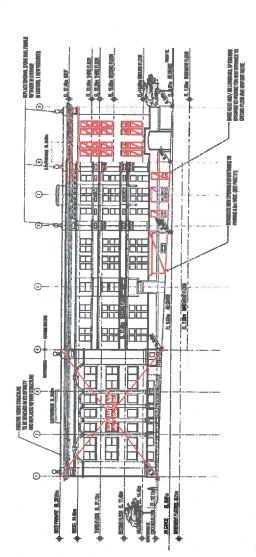
NORTH ELEVATION CONTEMPLATED ALTERATIONS TO WINDOW OPENINGS

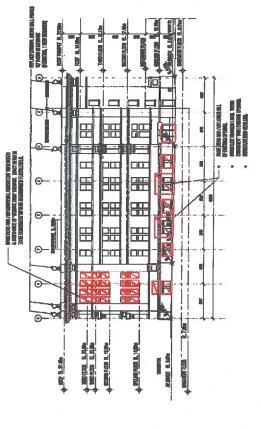
WEST ELEVATION CONTEMPLATED ALTERATIONS TO WINDOW OFFINIOSS SCALE 1:400

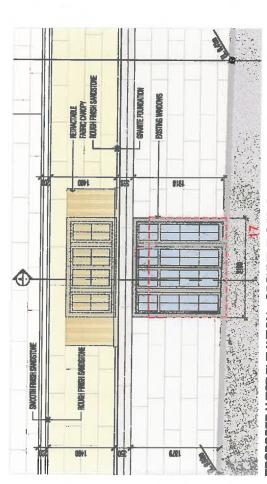
EXISTING WEST ELEVATION - GROUND FLOOR OPENING 17 SCALE 1:50

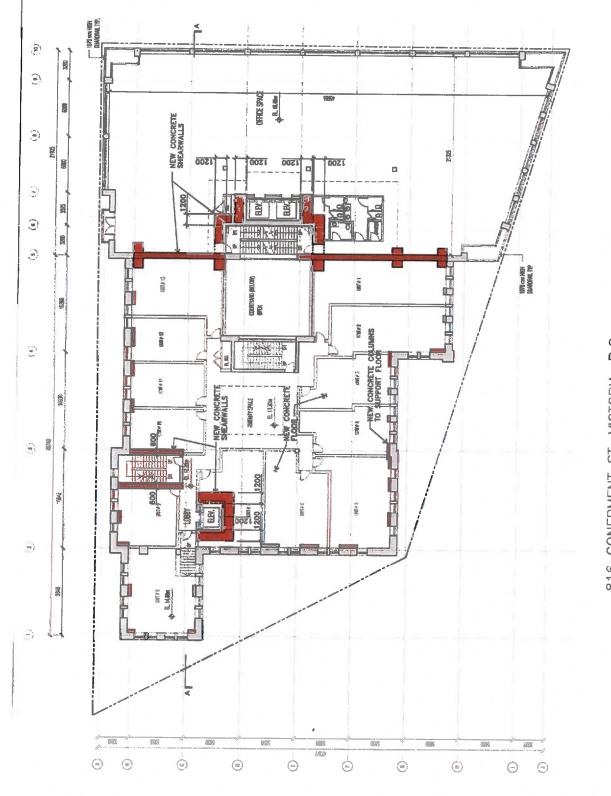
816 CONCRETE SHEARWALLS SK-1

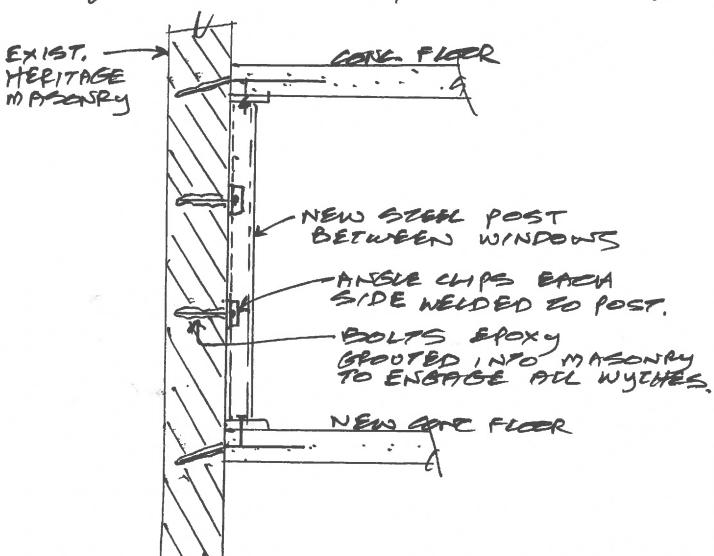
SK3

SHOWING NEW STEEL POST TO BEFEE SLENDER MASONRY WALLS.
