**Arborist Report for Development Purposes**  
**Re: Proposed Redevelopment, and Construction**

**Site Location: 2501 Blanshard St.**  
**Ryan Senechal ON-1272AT, TRAQ, BC WDTA 3013P**  
**June 24th, 2024**

For D’AMBROSIO architecture + urbanism  
 2960 Jutland Road, Victoria, BC V8T 5K2  
 Attn. Julie Brown  
 Re: Proposed Rezoning and redevelopment at 2501 Blanshard St.

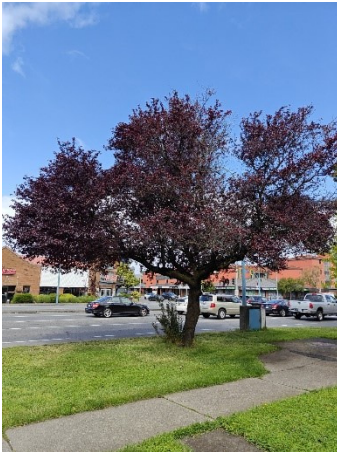
2501 Blanshard Street Inventory of Trees											
#	Species	DBH (cm)	Height (m)	Width (m)	PRZ (m)	Structural Condition	Health Condition	Bylaw protected	Action	Condition Notes	
M1	<i>Prunus cerasifera</i>	40	11	13	5	Fair	Fair	Yes	TBD	Water sprouts at the base of the tree. Minor deadwood.	
M2	<i>Prunus subhirtella</i>	53	8	8	6	Poor	Fair	Yes	TBD	Dead branch (10 cm diameter) on south side of canopy. Water sprouts on trunk.	
M3	<i>Prunus cerasifera</i>	77	11	13	9	Fair	Good	Yes	TBD	Ganoderma is present on the northwest side of the base of the trunk.	
M4	<i>Nyssa sylvatica</i>	9	5	2	1	Good	Good	TBD	TBD	/	
M5	<i>Prunus cerasifera</i>	46	9	10	6	Fair	Good	Yes	TBD	Included bark between stems at 3 meters height.	
M6	<i>Nyssa sylvatica</i>	7	4	1	1	Good	Good	TBD	TBD	/	
M7	<i>Prunus cerasifera</i>	34	11	10	4	Good	Good	Yes	TBD	/	
M8	<i>Prunus subhirtella</i>	58	11	12	7	Fair	Fair	Yes	TBD	Poor foliage density in upper canopy. Minor dead wood (<5 cm).

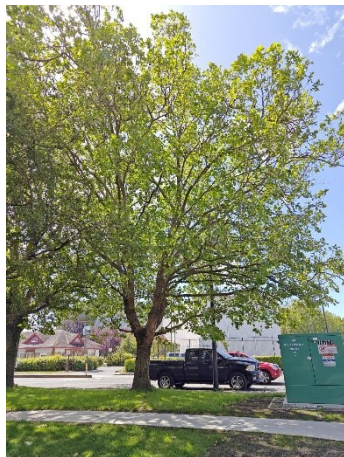
#	Species	DBH (cm)	Height (m)	Width (m)	PRZ (m)	Structural Condition	Health Condition	Bylaw protected	Action	Condition Notes
M26	<i>Platanus x acerifolia</i>	53	20	22	6	Fair	Good	Yes	TBD	Deadwood above the sidewalk closest to buildings (<5 cm diameter).
M27	<i>Platanus x acerifolia</i>	63	20	22	8	Fair	Good	Yes	TBD	/
M28	<i>Platanus x acerifolia</i>	61	19	22	7	Fair	Good	Yes	TBD	Minor deadwood (<5 cm diameter).
M29	<i>Larix decidua 'Pendula'</i>	45	14	9	5	Fair	Fair	Yes	TBD	Shaded out on the west side by neighboring London plane.
M30	<i>Acer pseudoplatanus</i>	87	14	11	10	Poor	Fair	Yes	TBD	Multi stem measured at 28 cm, 27 cm, and 32 cm diameter.
M31	<i>Platanus x acerifolia</i>	79	16	20	9	Fair	Good	Yes	TBD	Root heaving asphalt sidewalk by ~10 cm.
M32	<i>Platanus x acerifolia</i>	67	14	20	8	Fair	Good	Yes	TBD	Minor deadwood (<5 cm diameter).
90	<i>Thuja plicata 'zebrina'</i>	58	14	9	7	Fair	Good	Yes	TBD	Quad stem above DBH, raised significantly to approximately 6 meters.

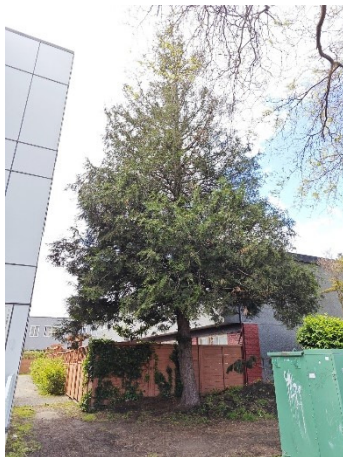
91	<i>Thuja plicata 'zebrina'</i>	55	14	14	7	Fair		Yes	TBD	No tag. Raised significantly for building and road clearances. Stub cuts and flush cuts are present.
98	<i>Thuja plicata</i>	37	14	12	4	Good	Fair	Yes	TBD	Crown density fair. Debris and soil piled up around the base of trunk.
100	<i>Gleditsia triacanthos</i>	65	30	24	8	Fair	Fair	Yes	TBD	Excessive thinning and lions tailing pruning. Epicormic growth on the trunk. A recent limb failure occurred on the northeast side (~15 cm diameter at failure point).
101	<i>Gleditsia triacanthos</i>	65	20	18	8	Fair	Fair	Yes	TBD	Exposed root flare with mechanical damage. Trunk lean of ~10°. Deadwood (<5 cm diameter). Over extended branches, and past canopy thinning observed.
103	<i>Thuja occidentalis</i>	24	3	2	3	Fair	Fair	TBD	Remove	Maintained as shrub, multi stem w included bark (14 cm, 10 cm diameter)
104	<i>Juniperus virginiana</i>	23	8	9	3	Fair	Fair	TBD	Remove	Crown dieback (minor) on Blanshard side. Located at proposed building entry.

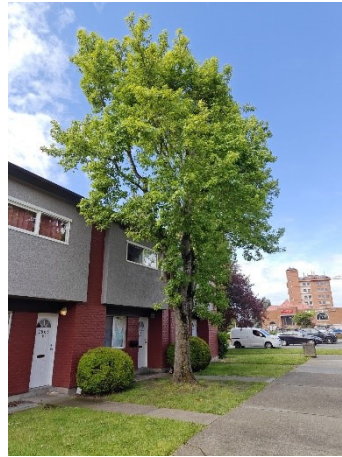
105	<i>Juniperus virginiana</i>	37	13	9	4	Fair	Fair	Yes	TBD	Canopy thinned and raised. Lions tailing pruning visible.
106	<i>Liquidambar styraciflua</i>	46	20	16	6	Fair	Good	Yes	Remove	Codominant stems at ~4 m height. Included bark on multiple stems. Dense canopy (visibility limited). Located at proposed building entry. Located at proposed parkade footprint.
107	<i>Thuja plicata</i>	67	17	9	8	Poor	Fair	Yes	Remove	Large stem previously removed at 1 m resulting in a 35 cm height wound. Mechanical damage present on trunk. Located at proposed pathway.
108	<i>Thuja plicata</i>	59	16	7	7	Fair	Fair	Yes	Remove	Multiple codominants at 2 m height with included bark. Clearance pruning from building. Asymmetrical canopy. Mechanical injury on trunk. Located at proposed pathway.
109	<i>Sorbus intermedia</i>	30	4	1	4	Poor	Poor	Yes	TBD	No live foliage remaining in canopy. Basal water sprouts are only remaining live growth. Pollarded in past.
