HALL BLOCK

727-729 YATES STREET, VICTORIA, BC

CONSERVATION PLAN

AUGUST 2017

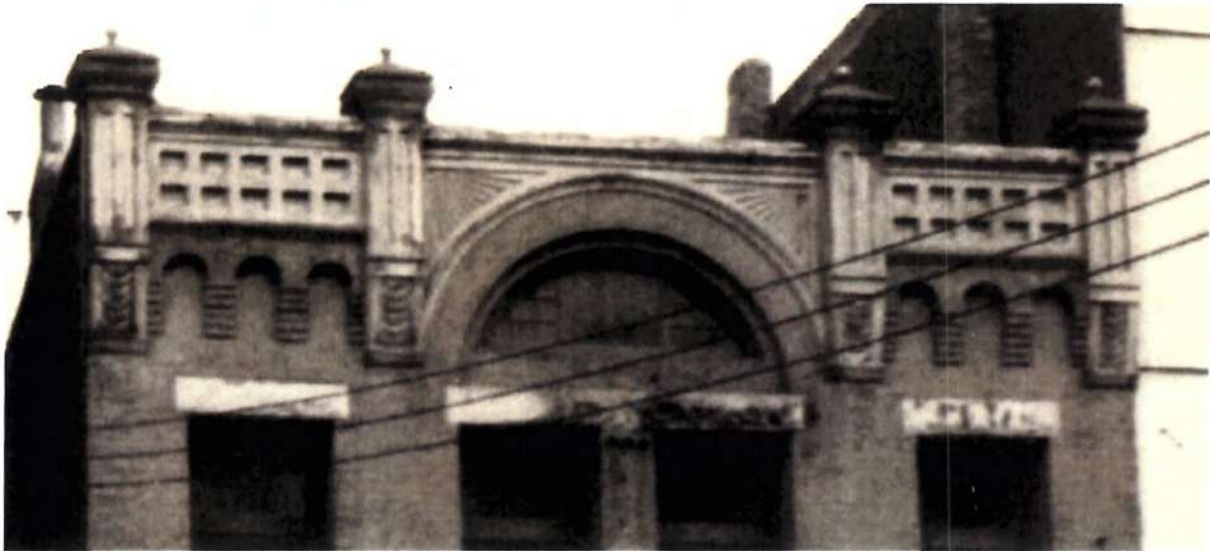
Archival photo showing parapet of the historic front facade with original architectural metalwork.

Conservation Recommendation: Restoration

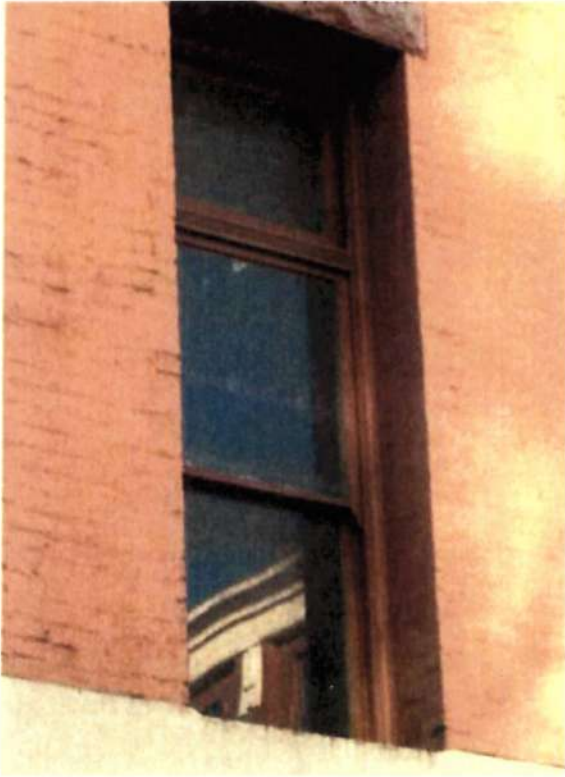
The historic front facade of the Hall Block features four original, tall window openings above the storefront level, characterized by surviving, original double-hung wood window assemblies with fixed, transom light. Above the paired window openings at the central bay is an arched window opening that is characterized by true divided multi-light, fixed wood window assembly.

In general, the extant original windows are in good condition, with minor signs of deterioration as a result of natural weathering. All original wood windows contribute to the historic character of the Hall Block, and should be preserved, and repaired as necessary.

Conservation Strategy: Preservation

- Inspect for condition and complete detailed inventory to determine extent of recommended repair.
- Retain existing window sashes; repair as required.
- Preserve and repair as required, using in kind repair techniques where feasible.
