CONSERVATION PLAN PLAZA HOTEL

603 PANDORA AVENUE, VICTORIA, B.C.
MAY 2013

DONALD LUXTON
ASSOCIATES INC.

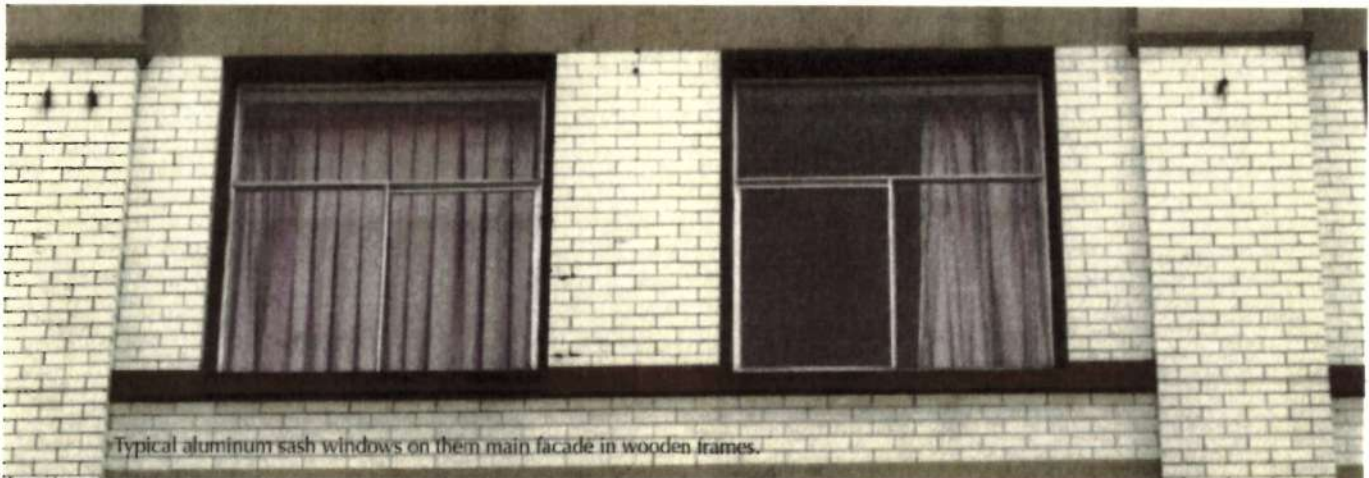
Details of the wooden frames and mouldings on the main facade.

- Preserve original windows on the front facade. New window sash on this facade should match historic windows in terms of material, style, detail and profile thickness where archival evidence is available.
- Replicate details such as missing mouldings based on salvaged samples.
