D. Clark Arboriculture  
 2741 The Rise Victoria B.C. V8T-3T4  
 (250)474-1552 (250)208-1568  
 clarkarbor@gmail.com  
 www.dclarkarboriculture.com  
 Certified Arborist PN-6523A  
 ISA Tree Risk Assessor CTRA 459

To: Erin Flanagan  
 CC: Jane Waters  
 From: Darryl Clark  
 Permit #: In application  
 Date: 3/13/2019  
 Re: 1708 Coronation Ave.

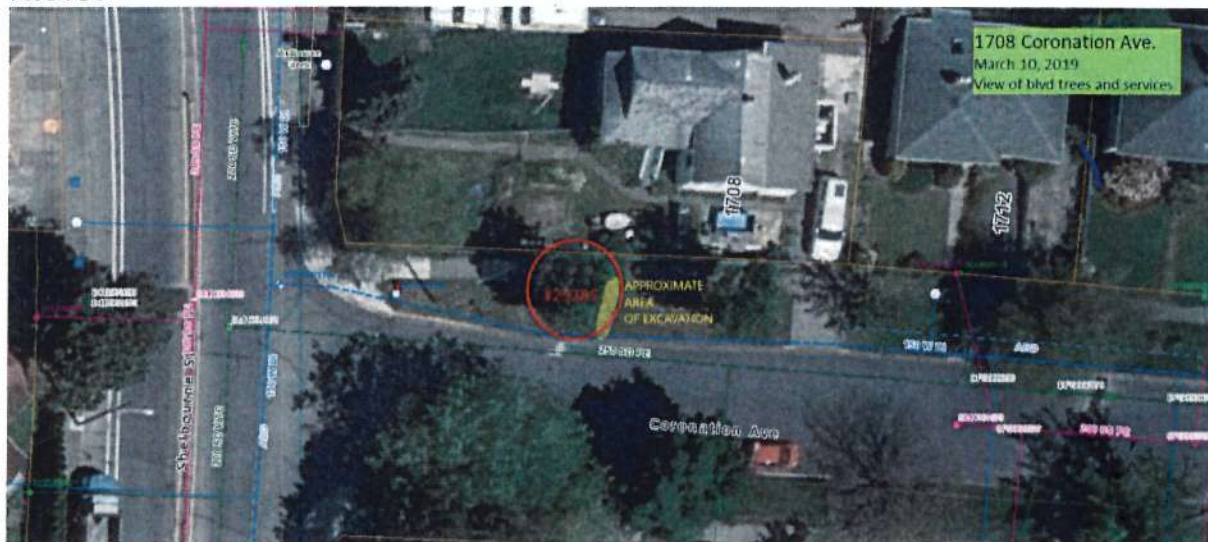
- The purpose of this trench was to expose any roots that may cause a conflict with a proposed driveway
- Excavation was undertaken by hand (shovel) 1.6m east of tree #25385
- Excavation was observed to a depth of approximately 38cm at the deepest point
- (2) roots approximately 1cm in diameter were exposed

1708 Coronation Ave. Root Impact Record					
#	Species	Date of Excavation	<1cm-2.4cm	2.5cm-5cm	>5cm
25385	<i>Acer rubrum (columnar)</i>	March 10, 2019	2	0	0

There is no expected overall impact to the health and structural condition of tree #25385 from excavation activities. Excavation for the installation of a driveway to service a new duplex can proceed. Mechanical excavation (machine dig) can proceed but should be supervised/inspected at the westerly edge by the project arborist. Excavation should not be undertaken until approved tree protection fencing is installed by the builder and approved by the project arborist. There is a second tree (#25386)
