Re: Wilson Walk Development Proposal

Limited Hazardous Materials Investigation

220 Wilson Street, Victoria, BC

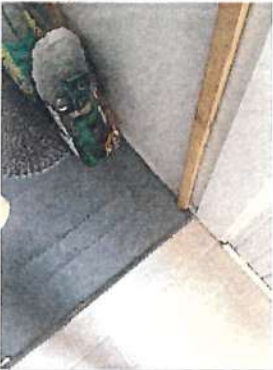
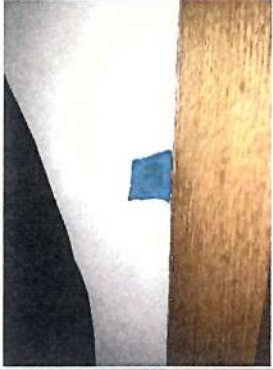
<p>Sample: 18969 - 7 Unit/Location: Unit 4 - Kitchen 2 layers Description: Sheet vinyl flooring Asbestos: None detected</p>	<p>Sample: 18969 - 8 Unit/Location: Unit 4 - Bedroom closet - Smooth Description: Plaster Asbestos: None detected</p>

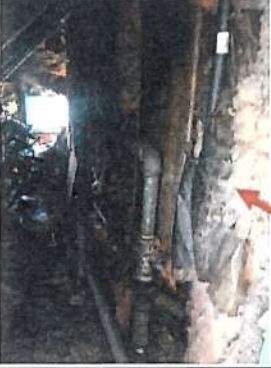
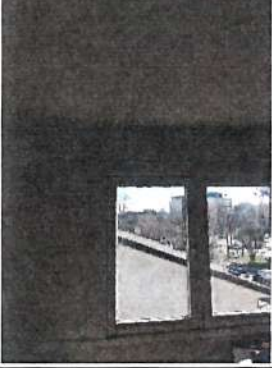
<p>Sample: 18969 - 15 Unit/Location: Unit 3 - Attic wall paper-backed fibreglass Description: Insulation Asbestos: None detected</p>	<p>Sample: 18969 - 16 Unit/Location: Unit 3 - Bedroom/living room wall Description: Drywall joint compound Asbestos: None detected</p>

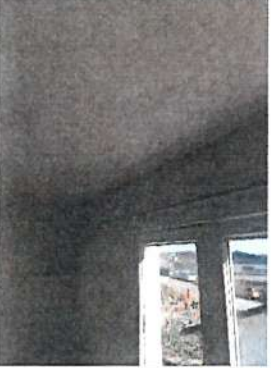
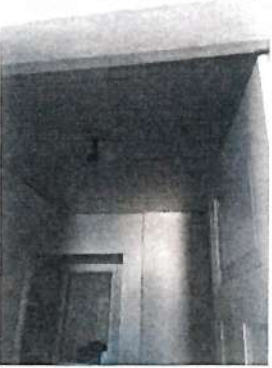
<p>Sample: 18969 - 17 Unit/Location: Unit 3 - Kitchen ceiling Description: Drywall joint compound Asbestos: None detected</p>	<p>Sample: 18969 - 18 Unit/Location: Unit 3 - Bathroom ceiling Description: Ceiling tile Asbestos: None detected</p>

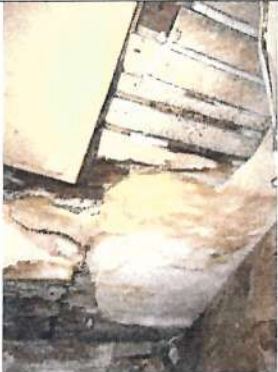
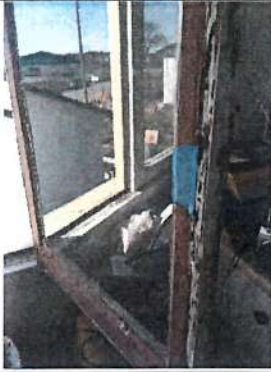
<p>Sample: 18969 - 19 Unit/Location: Unit 3 - Bathroom above ceiling tile Description: Plaster Asbestos: None detected</p>	<p>Sample: 18969 - 20 Unit/Location: Unit 3 - Kitchen window Description: Window putty Asbestos: None detected</p>

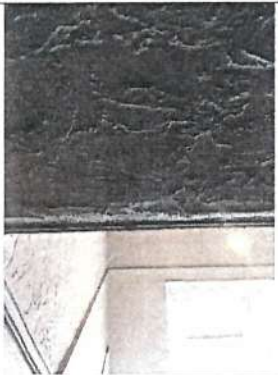
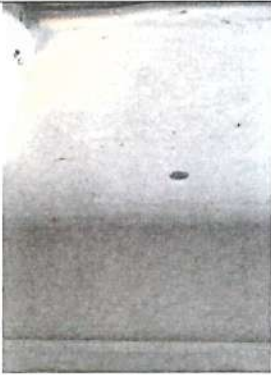
<p>Sample: 18969 - 21 Unit/Location: Common corridor ceiling - Textured Description: Plaster Asbestos: None detected</p>	<p>Sample: 18969 - 22 Unit/Location: Common corridor ceiling - Textured Description: Plaster Asbestos: None detected</p>

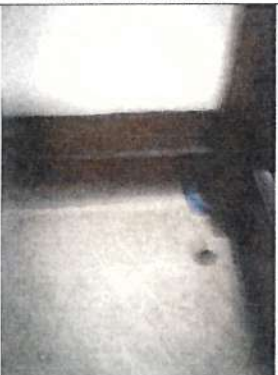
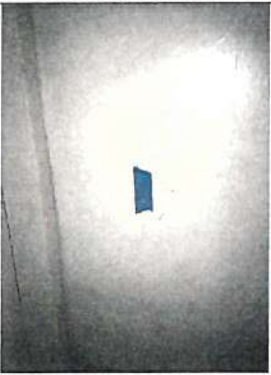
<p>Sample: 18969 - 23 Unit/Location: Unit 2 - Bathroom Description: Sheet vinyl flooring Asbestos: None detected</p>	<p>Sample: 18969 - 24 Unit/Location: Unit 2 - Bathroom Description: Plaster Asbestos: None detected</p>

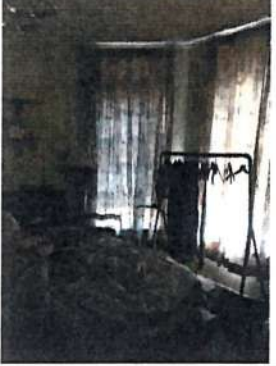
<p>Sample: 18969 - 35 Unit/Location: Unit 1 - Bedroom ceiling Description: Textured ceiling Asbestos: None detected</p>	<p>Sample: 18969 - 36 Unit/Location: Unit 1 - Bedroom wall Description: Plaster Asbestos: None detected</p>

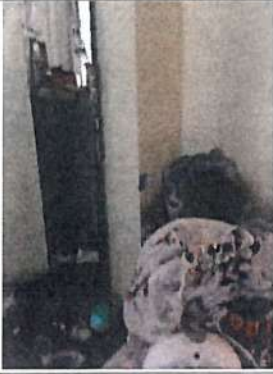
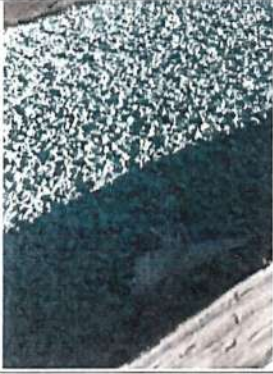
<p>Sample: 18969 - 37 Unit/Location: Unit 1 - Bedroom wall Description: Drywall joint compound Asbestos: None detected</p>	<p>Sample: 18969 - 38 Unit/Location: Exterior - Dormer Unit 3 Description: Stucco Asbestos: None detected</p>

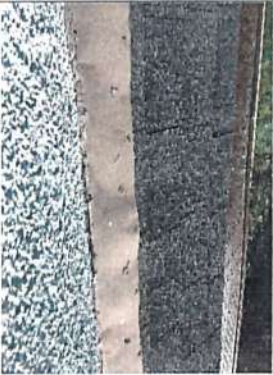
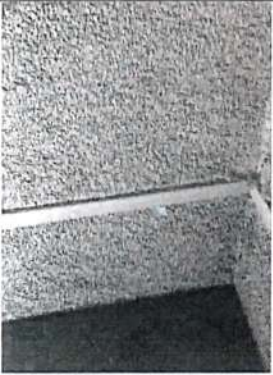
<p>Sample: 18969 - 39 Unit/Location: Roof flashing - Brown Description: Mastic Asbestos: None detected</p>	<p>Sample: 18969 - 40 Unit/Location: Covered front entry Description: Stucco Asbestos: None detected</p>

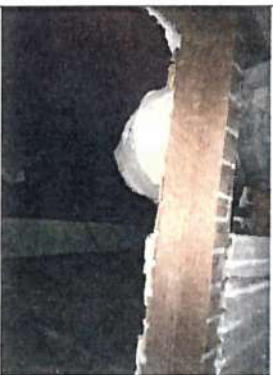
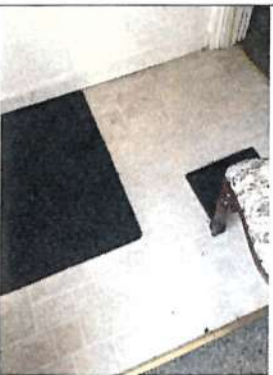
<p>Sample: 18969 - 41 Unit/Location: Unit 5 - Ceiling cavity in closet Description: Plaster Asbestos: None detected</p>	<p>Sample: 18969 - 42 Unit/Location: Unit 5 - Entry Description: Sheet vinyl flooring Asbestos: None detected</p>

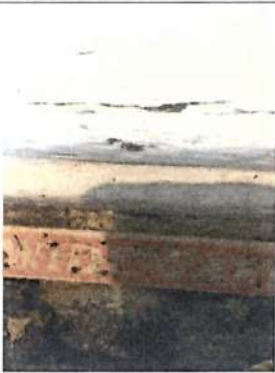
<p>Sample: 18969 - 43 Unit/Location: Hall outside bathroom under carpet Description: Vinyl floor tile Asbestos: None detected</p>	<p>Sample: 18969 - 44 Unit/Location: Living room under carpet Description: Vinyl floor tile Asbestos: None detected</p>

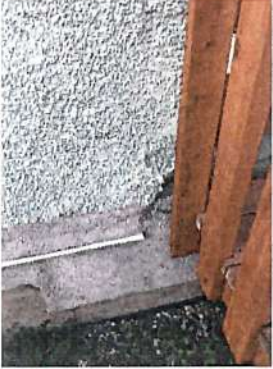
<p>Sample: 18969 - 51 Unit/Location: Exterior - Back Description: Stucco Asbestos: None detected</p>	<p>Sample: 18969 - 52 Unit/Location: Exterior - NE side Description: Stucco Asbestos: None detected</p>
