1139 Burdett Avenue

Heritage Restoration Plan

Stuart Stark, Heritage Consultant, July 2019 www.HeritageConsultants.ca

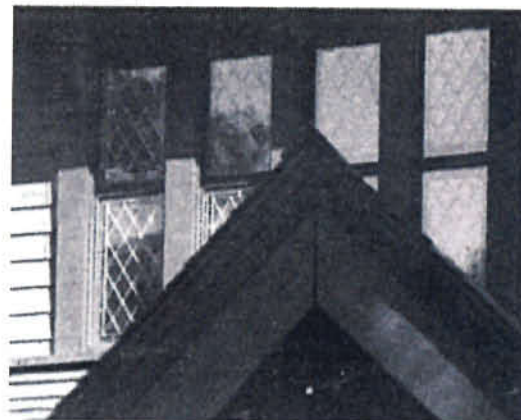
Stained-glass windows at 1139 Burdett Avenue; and windows in the staircase/hall windows from Tiarks' own house on Gorge Road (archival photo. Heritage consultant's collection)

- Repair & restore original wood double-hung windows on North, East and West elevations. Work will include paint stripping, removal and replacement of dried out/damaged glazing putty, replacement of broken or missing sash cords and sash locks, and replacement of missing multi-pane top sash lights in the west gable of the second floor of North (front) elevation; and second floor of West Elevation.
- Remove and replace historically incorrect aluminum windows on South (rear) elevation of West Gable with period-correct wood windows.
- Replace non-original textured glass in original stairway window on east side of the house with stained glass to match the rest of the original stained glass windows. (based on stair windows from other Tiarks designs)

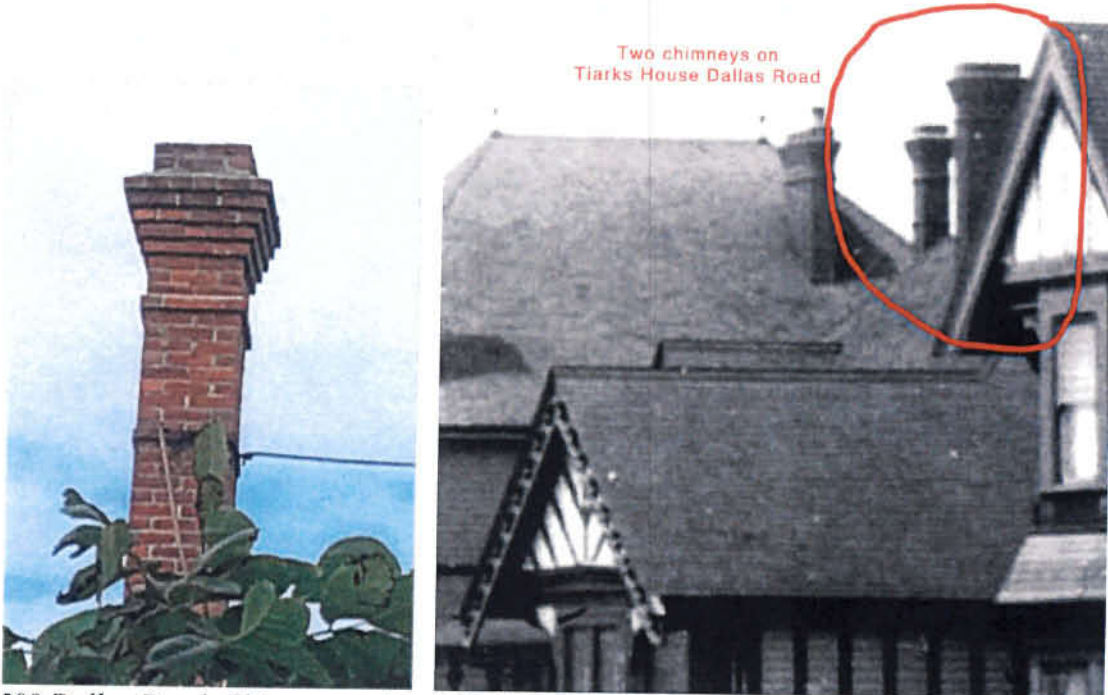
*508 Dallas Road. Chimney on house by Tiarks, built 1895. Archival image c1900
Shows matching chimney design to 1139 Burdett Avenue, so a standard Tiarks' detail*

Repoint/rebuild two chimneys from roof line up, including new concrete chimney caps and metal flue liners for gas fireplaces. The larger of the two chimneys retains its original corbel design, the other one has been rebuilt straight over the years. The intention is to rebuild both to match Tiarks' original design. Research shows these chimneys match the chimney design on the Tiarks house at 508 Dallas Road. (See photos below)
Replace metal flashing & remove improper tar job.

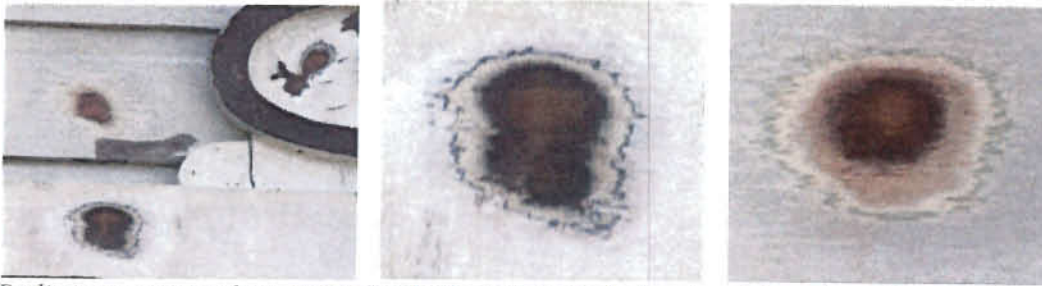
Preliminary paint colour testing by 'bulls-eye' method, showing different paint layers. This investigation was followed by extensive paint sampling for microscopic analysis.

Repaint entire exterior in original paint scheme based on extensive paint investigation; sampling; and microscope analysis.

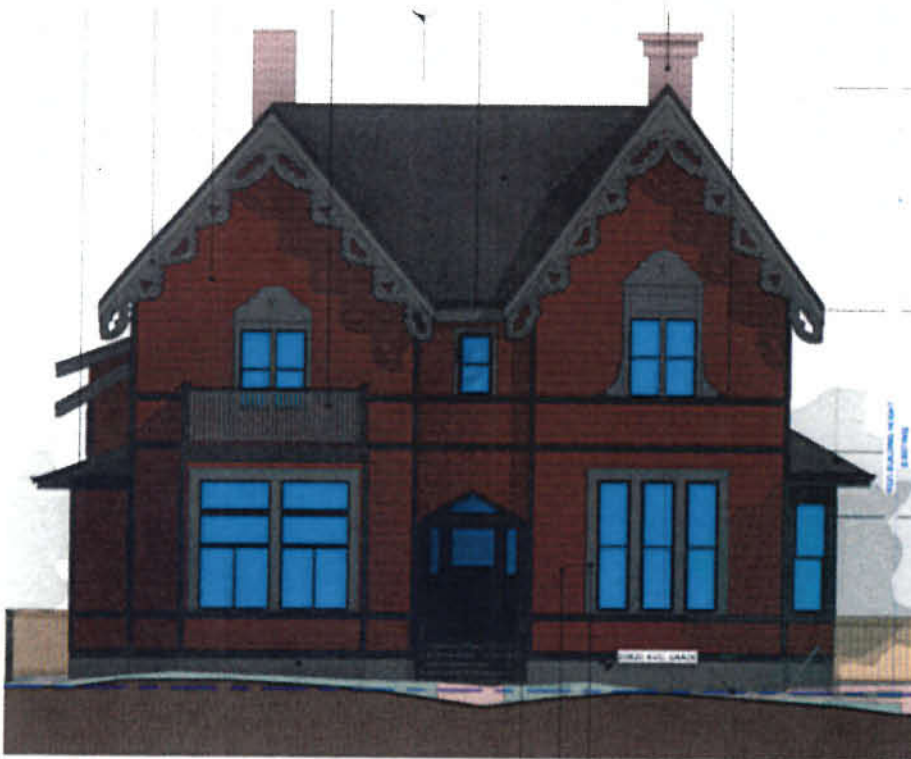
The historically-accurate dark iron-oxide colour scheme with black trim and dark grey bargeboards and window trim was popular in the early 1890s. A few other buildings in Victoria have been recorded with similar colour schemes. The roof would be slate grey-black. See sample board for colours. (Rendering courtesy Christine Lintott architects)

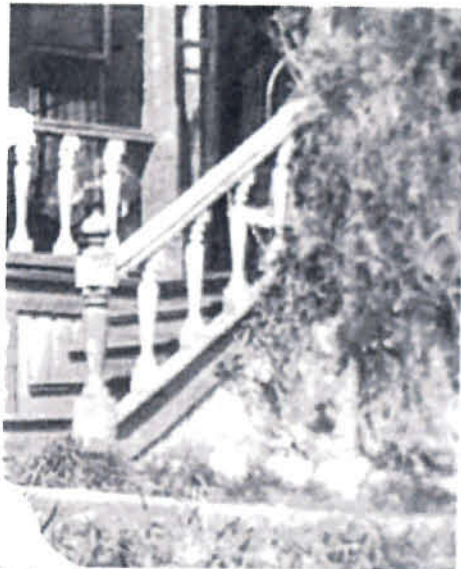
Staircase on *Garrison House*, York Place. (Archive photos courtesy Oak Bay Archives).

1139 Burdett Street only requires a railing on one side, like this example (below) at *Garrison House* on York Place, (designed by Tiarks in 1897; built in 1898; now demolished). It is intended to match the railing at the correct, historic height and increase the height for Code with a black iron railing above.

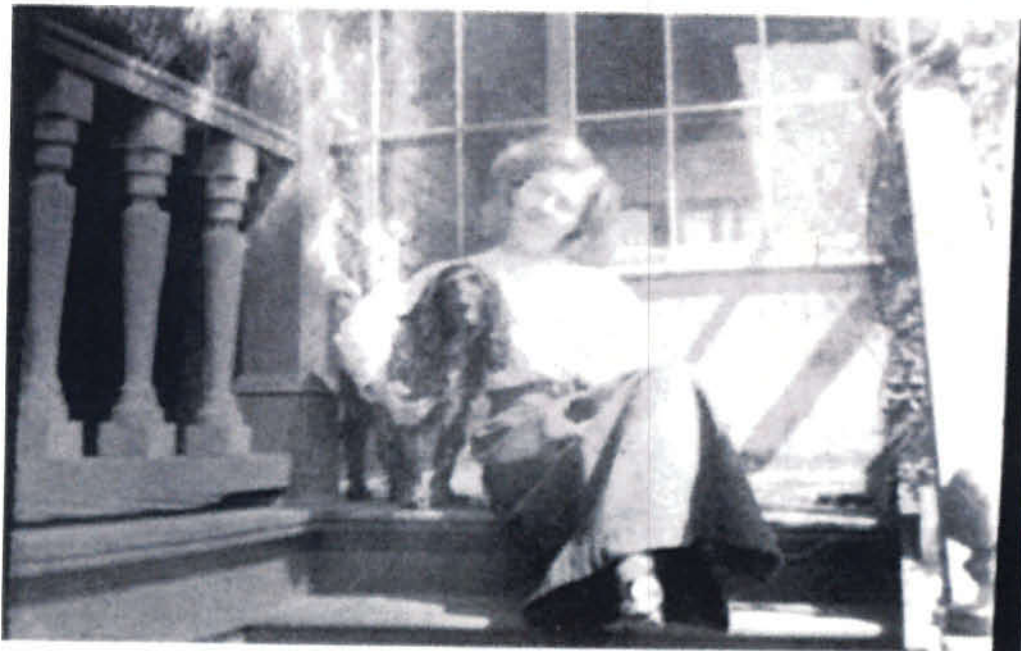
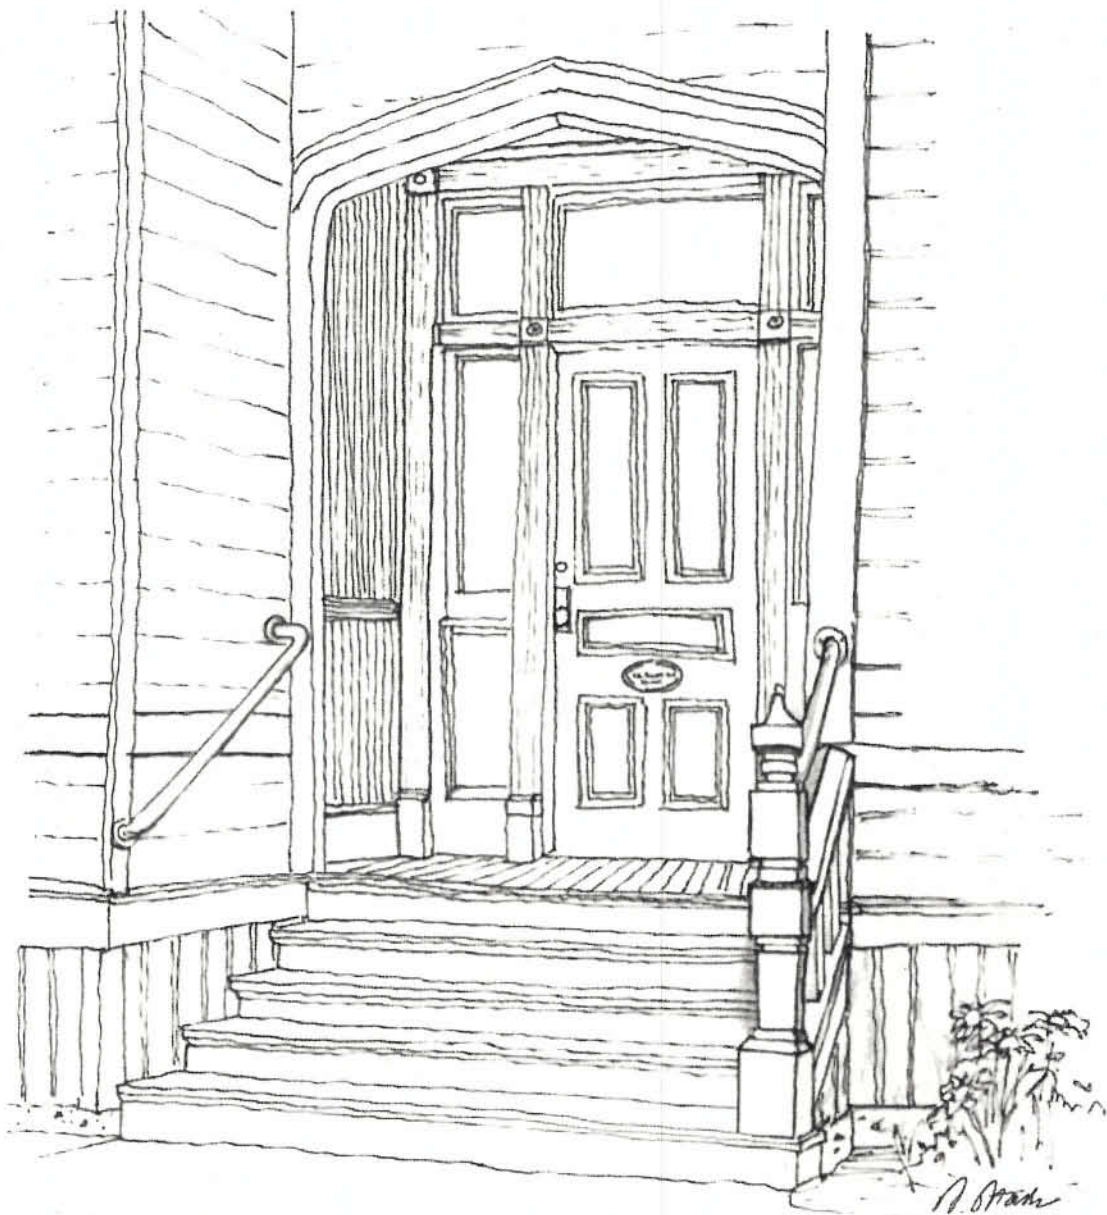
Proposed Staircase Restoration
1139 Burdett Street

Stairs were replaced (probably in the 1990s). They are not in keeping with the heritage design of the house. It is intended to rebuild them in an appropriate style by using other Tiarks-designed stairs as precedents for the restoration. See next page.

- Design of newel post and stairs adapted from Tiarks' design for staircase from *Garrison House*, York Place. (photos on previous page)
- Adapted to take simple pipe railing to meet Code height, which would be painted black, the same as the main trim of the house. The restored wood railing would be at the same height as the original, based on replaced section of damaged trim on the building.
- With the removal of the current electrical box; electrical mast/pipe; and the inappropriate light fixture, the original ornate detailing of the porch will be revealed. It is proposed to work out final stair details with the Heritage Planner.

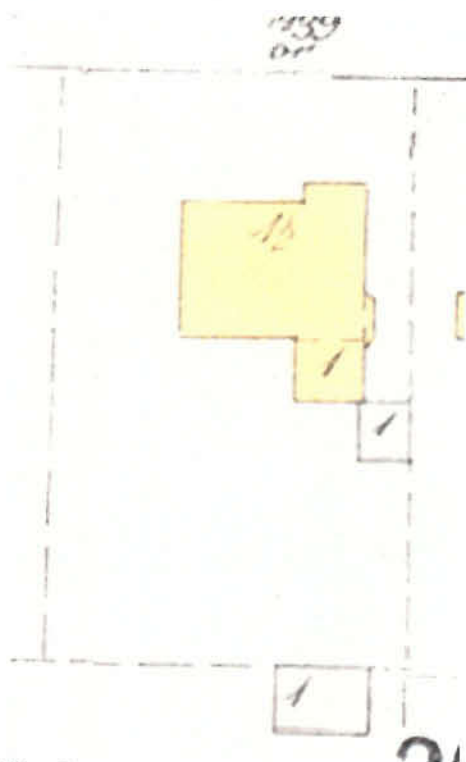
Fire Insurance map 1903

Prior to the 1903 map, there had to have been a window in the SW main floor room. (bottom left on plan) Based on other windows in the house, it was likely a joined pair of double-hung windows facing west, over the side yard garden, in the location of the later bay window. [It is proposed to re-install a pair of wood, double-hung windows in this location]. See submitted architect's plans.

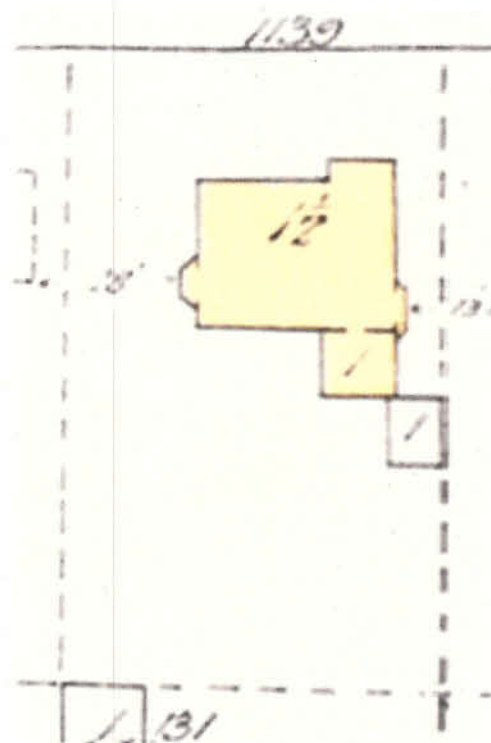
Fire Insurance Map 1911, revised 1913

A bay window on the west elevation was then added by 1911, presumably to enlarge the room (probably used as a Dining Room). At some point, the bay window appears to have been moved to the rear, SW corner of the building (lower left corner in these plans) and made into a five-sided bay window. (See photos on next page) (**Note:** *Possibly this is a mistake on the Fire Insurance Map, but usually these maps are very trustworthy*) The current five-sided bay window contains four matching diamond-paned stained glass upper sash, presumably from the previous bay window.
