PARKWAY APARTMENTS

1050 PANDORA AVENUE, VICTORIA, BC

CONSERVATION PLAN

JULY 2019

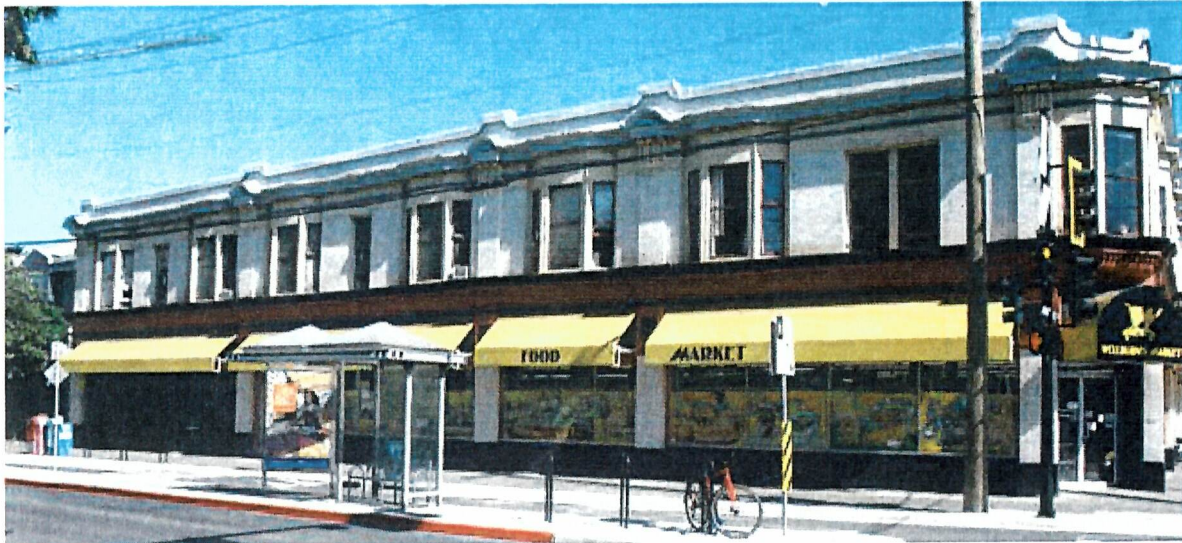
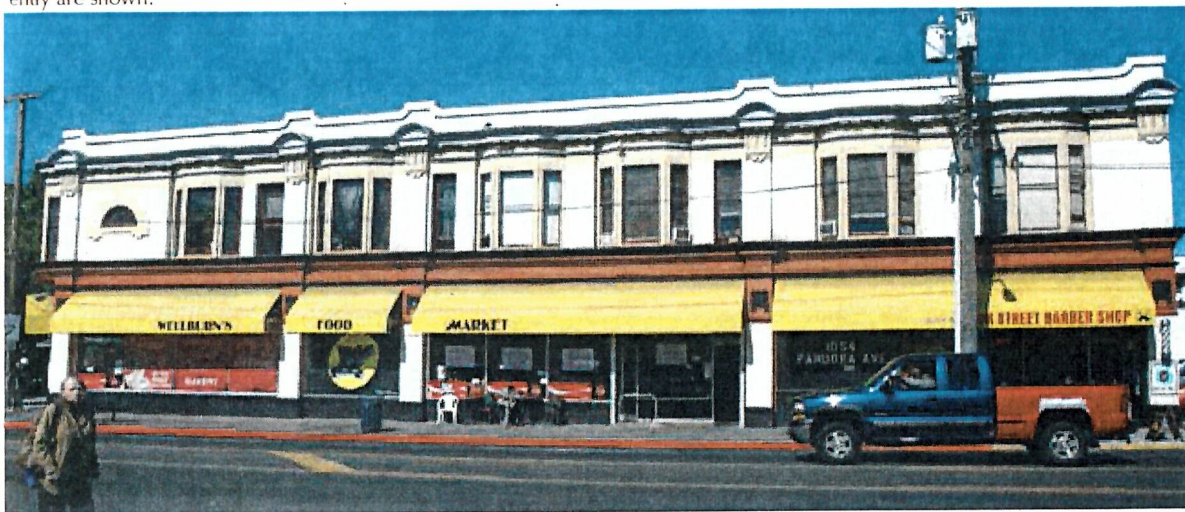
Above and Below: Street façades of Pandora Avenue (above) and Cook Street (below). The building is characterised by its two-storey height, masonry construction, storefront bays, second floor fenestration patterning, storefront and rooftop cornices, parapet, chamfered entry are shown.

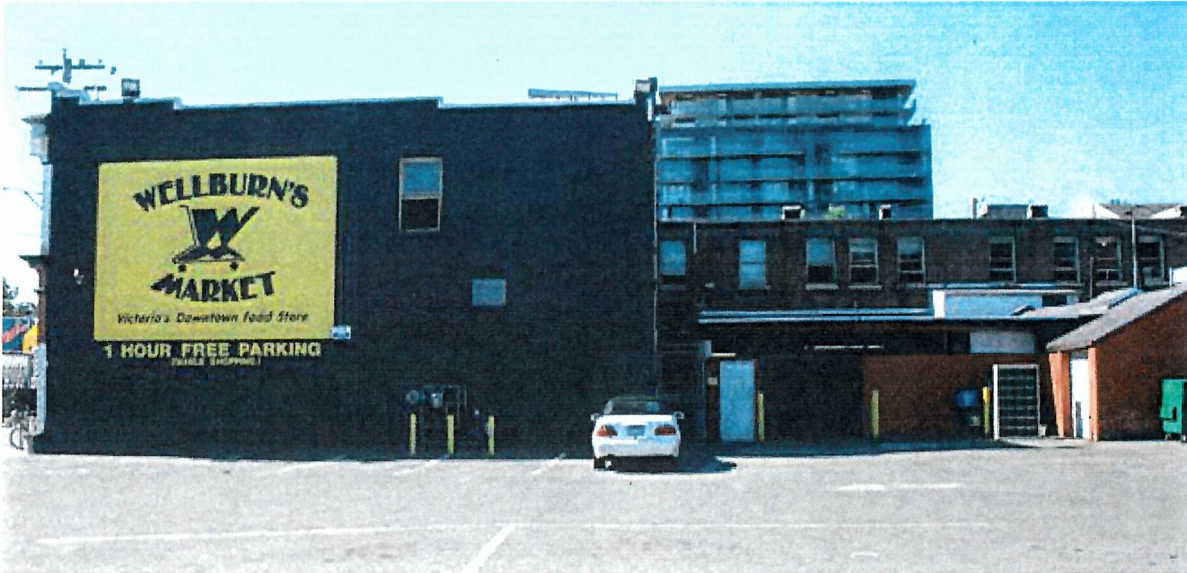
Above: "Non-street" (north) façade of Parkway Apartments showing later added additions to the rear of the building and parking lot located adjacent and to the north of the building.

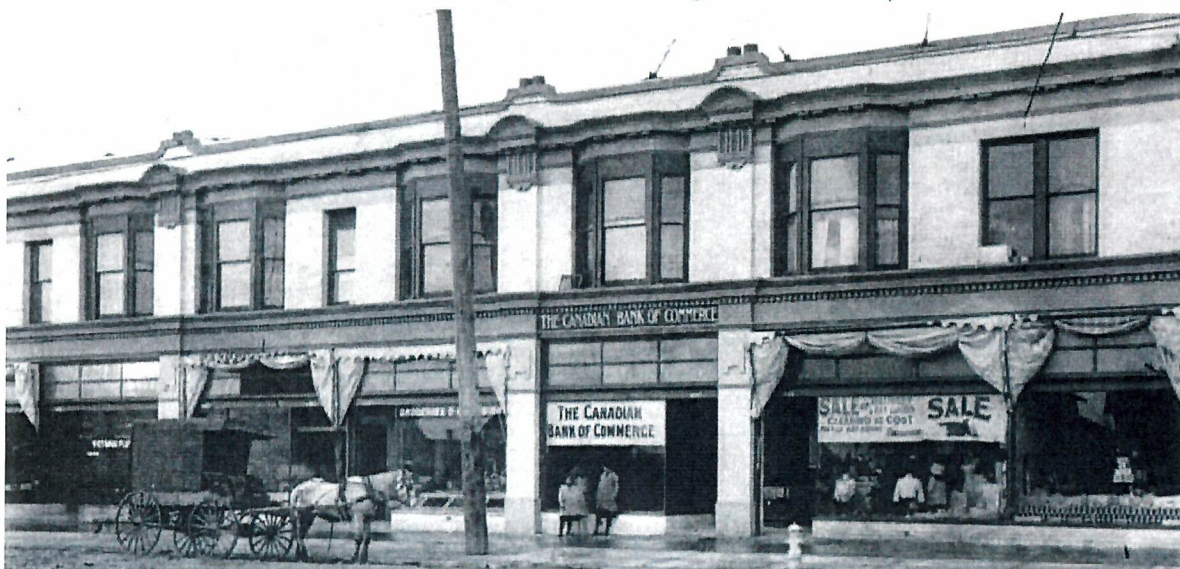
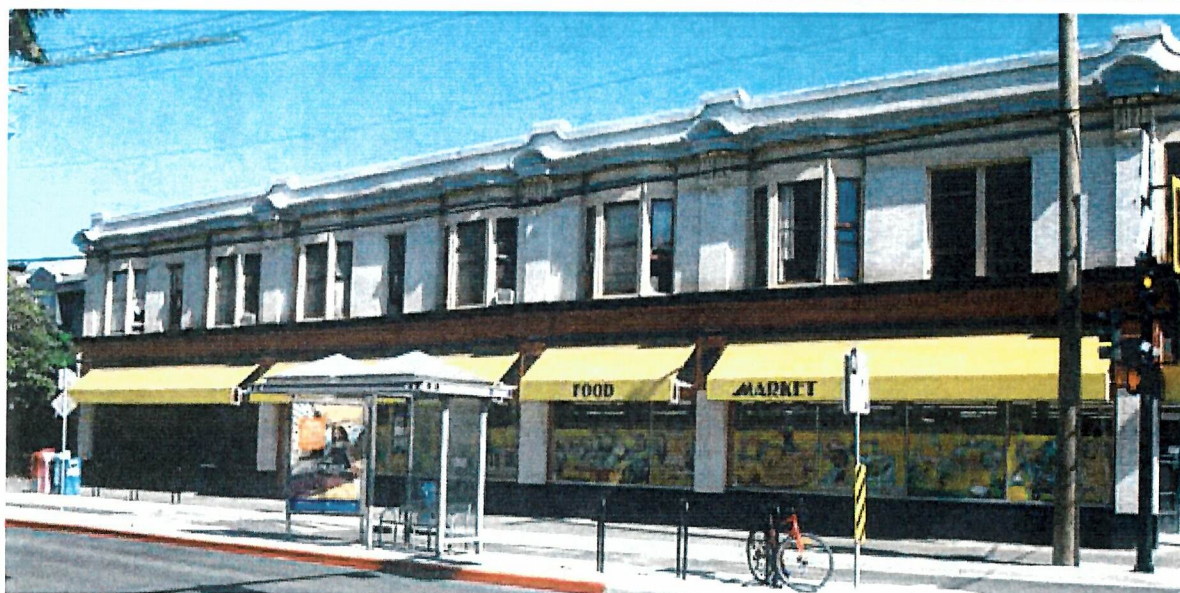
reed glass. Each storefront bay, separated by brick pilasters, possessed either one or two commercial units. The exception was the narrow structural bay on the Cook Street façade which originally was a glazed brick wall with a single door with transom and oval window with decorative surround; which was all removed post-1960.

Above: Ground floor storefronts of Cook Street with original storefront design and assemblies altered and/or removed.
