Tree Preservation Plan Report

11 Chown Place, Victoria BC,
V9A 1H5
CJF Project: 49-19

February 7, 2020

Re: 11 Chown Place, City of Victoria: Proposed new 58 unit seniors residence
Tree Protection Plan Report.

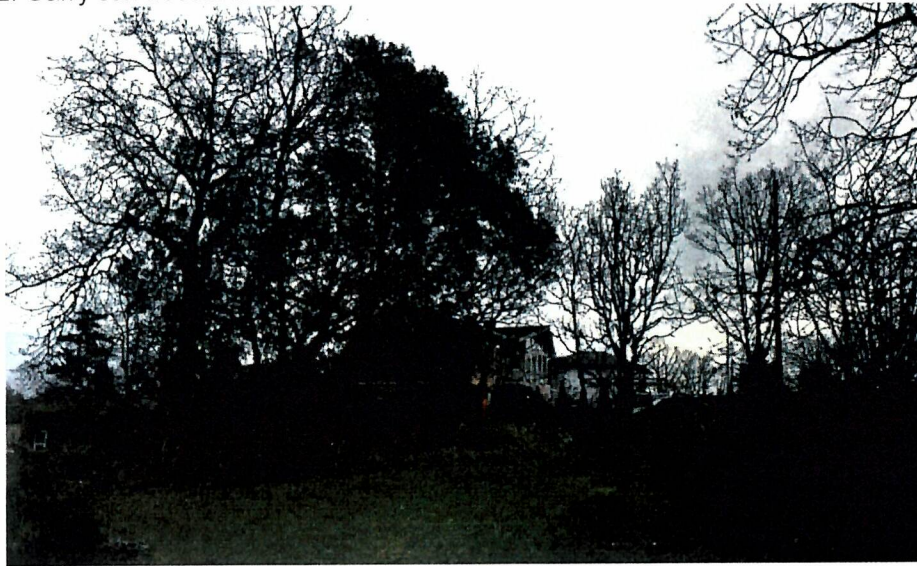
Image 2: Garry oak woodland east.

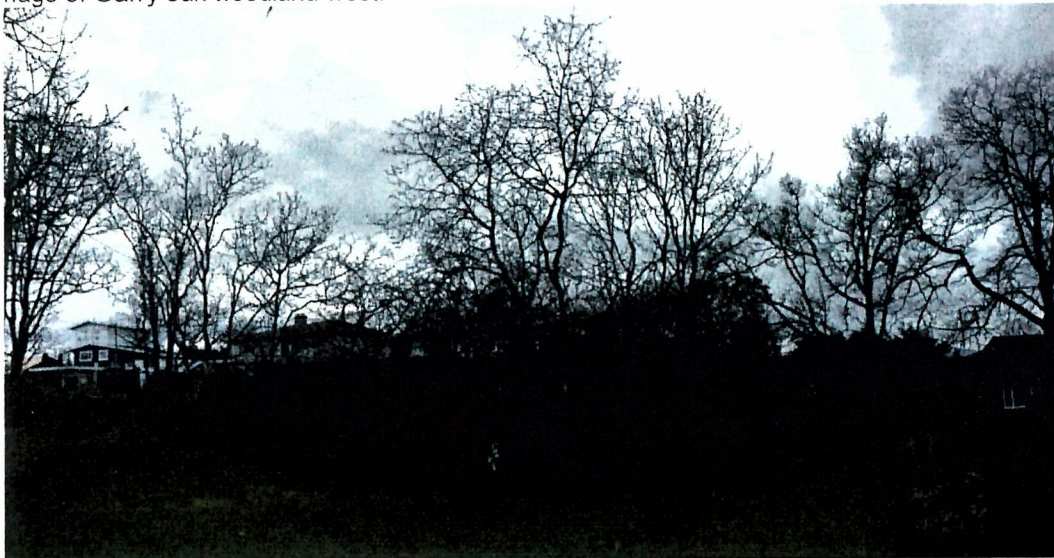
The property also includes a Garry oak (*Quercus garryana*) and Arbutus (*Arbutus menziesii*) woodland near the south property boundary / Irma Street turnaround (see Images 2 and 3). Woodland soils are often thin, punctuated by bedrock, nutrient deficient and subject to seasonal moisture deficit. As a result,

Image 3: Garry oak woodland west.

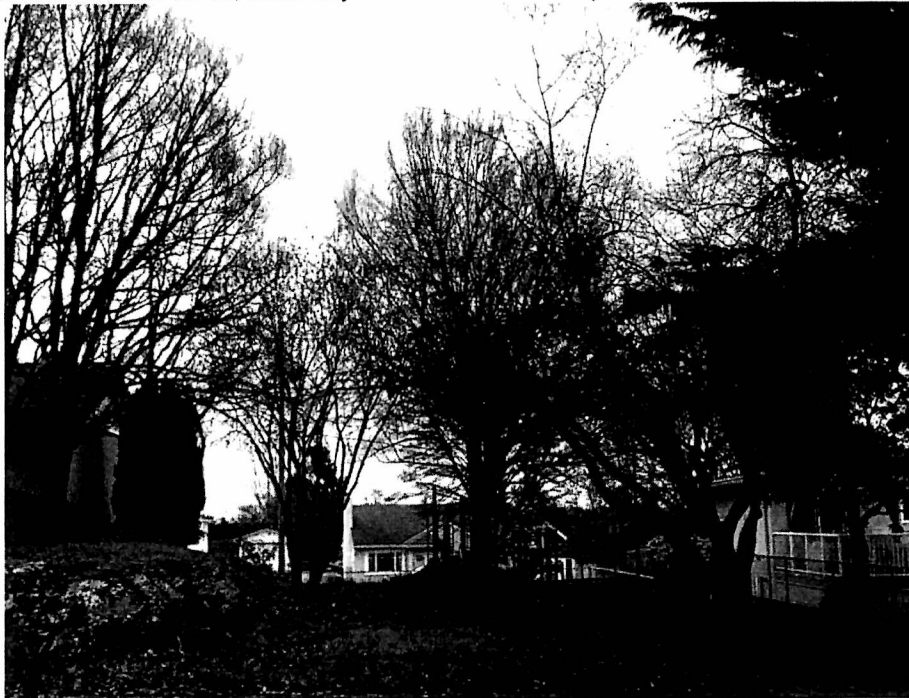
Although part of 11 Chown Place, the east-most portion of the property is known as Balfour Park which contains a children's playground and six inventoried trees (three wholly owned by 11 Chown (ID tags 784-786) and three unknown deciduous whose ownership is shared with 3050 Balfour Avenue (ID tags 781-783). One 11 Chown and all joint ownership trees are identified as 'unknown deciduous' but are believed to be natural infill Elm (*Ulmus sp.*). Balfour Park trees will not be impacted by the proposed development and are not recommended for protection.

Image 9: Balfour Park Trees, boundary unknown deciduous (Elm) at left.

Located well east of the proposed development CJF does not foresee construction impact to any Balfour Park tree. Therefore, no protective measures are recommended in this area.

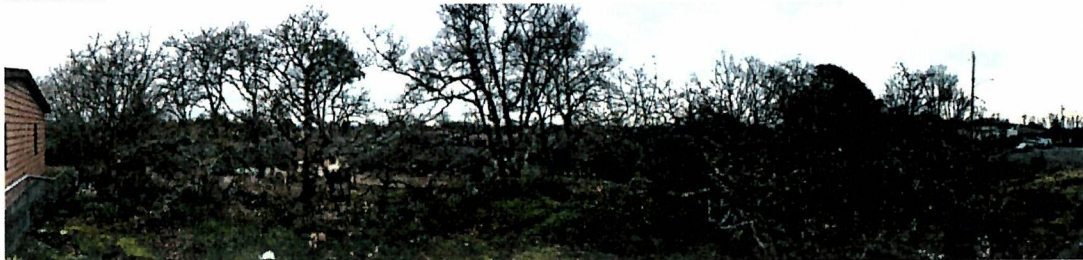
The woodland contains a range of growing conditions; deep moist nutrient rich to shallow nutrient poor soils and bedrock outcrops that have created a highly variable group of trees with a wide range of canopy widths, trunk diameters and structure (see Images 3, 10, 11, 12). The proposed development included a new 1.2m (1200mm) wide gravel pathway beginning behind building 'J' heading south to the Irma Street turnaround. The path will be located within an existing strip of lawn grass bisecting the woodland's east and west halves (see Image 10).

Image 11: Variable height and structure Garry oak woodland trees west of Irma Street property entrance.

Pathway construction will occur within the PRZ of Oaks closest to the woodland boundary. CJF therefore expects root damage but believes careful location, design and Project Arborist oversight will minimize rootplate disruption allowing impacted trees to remain viable. Garry oak canopy clearance pruning may be required to create required safe machine access. East and west halves of the woodland will be protected from construction disturbance by TPF set between the pathway and adjacent Garry oaks (see Appendix 2).
