FRASER WAREHOUSE

1316-18 WHARF STREET, VICTORIA, BC

CONSERVATION PLAN

MAY 2019

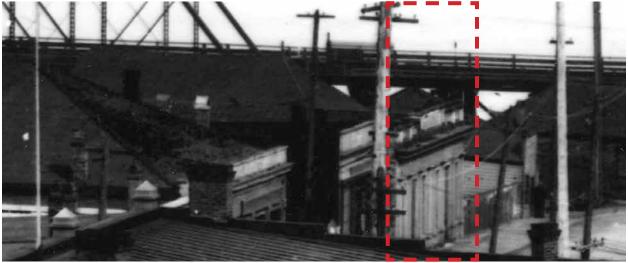
Oblique view of the front façade of the Fraser Warehouse, one of two buildings known now as the Northern Junk buildings.

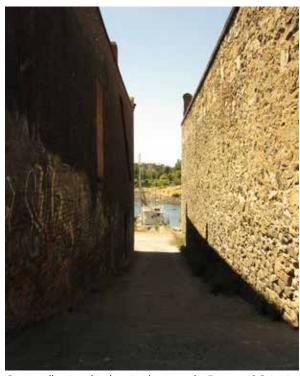
Current alley (south) elevation between the Fraser and Caire & Grancini Warehouse
