MEMORANDUM

Date: March 17, 2020
To: File
From: John O'Reilly, Senior Planner- Heritage
Subject: 506 & 514 Government Street- Final Inspection

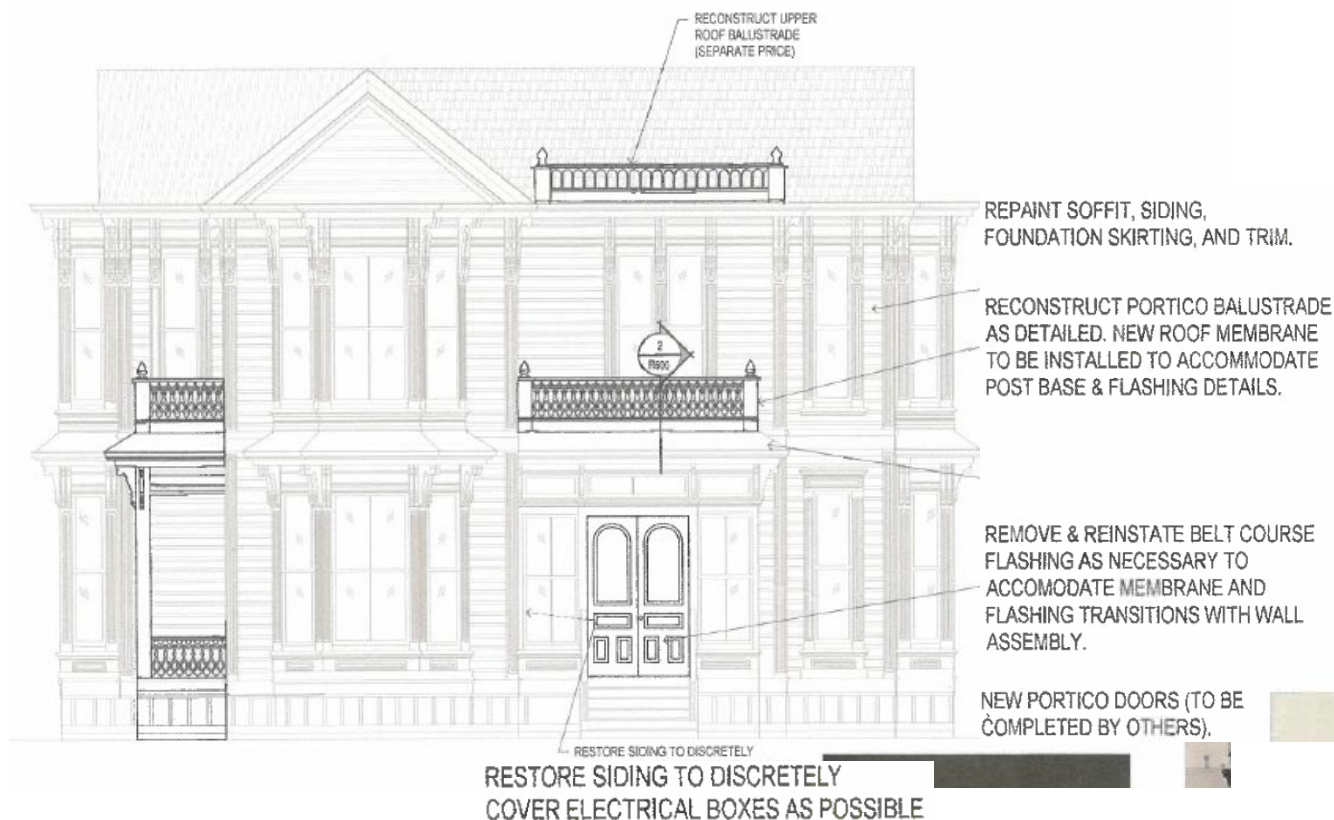
East Elevation R303 from 506 Government Street Conservation Plans dated August 14, 2020 and stamped "Final Approved"

Results of Evaluation of 506 Government Street		
Elevation	Conservation Work	Evaluation
Front (East) Elevation	Reconstruct Upper Roof Balustrade	Completed
	Re-paint soffit, siding, foundation skirting and trim	Whole building re-painted in historically appropriate colours
	Reconstruct portico balustrade as detailed. New roof membrane to be installed to accommodate post base and flashing details	Portico balustrade reconstructed. Scroll cut balusters have accurate proportions. Did not confirm if roof membrane installed.
	Remove and reinstate belt course flashing as necessary to accommodate membrane and flashing transitions with wall assembly	Belt course present on all building elevations. It has been painted in a different colour than the siding to accentuate it.
	New portico doors	Completed and installed
	Restore siding to cover electrical boxes if possible	No electrical boxes observed.
West (side) Elevation	Reinstate dislocated trim	Surveyed trim, it was firmly installed.
