SHEAM & LOW BUILDING

LEE MONG KOW BUILDING

SING LEE BUILDING

VICTORIA'S CHINATOWN NATIONAL HISTORIC SITE, VICTORIA, BC

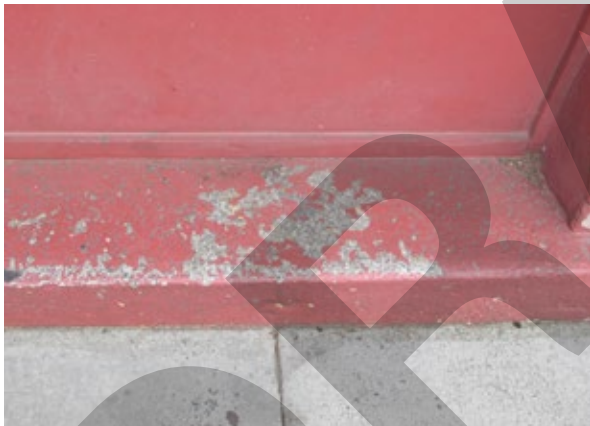
Granite Curbs, 543 Fisgard Street.

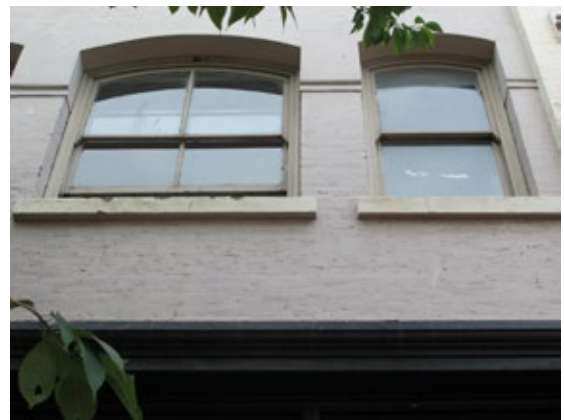
Upper floor original windows of 539-541 1/2 Fisgard Street.

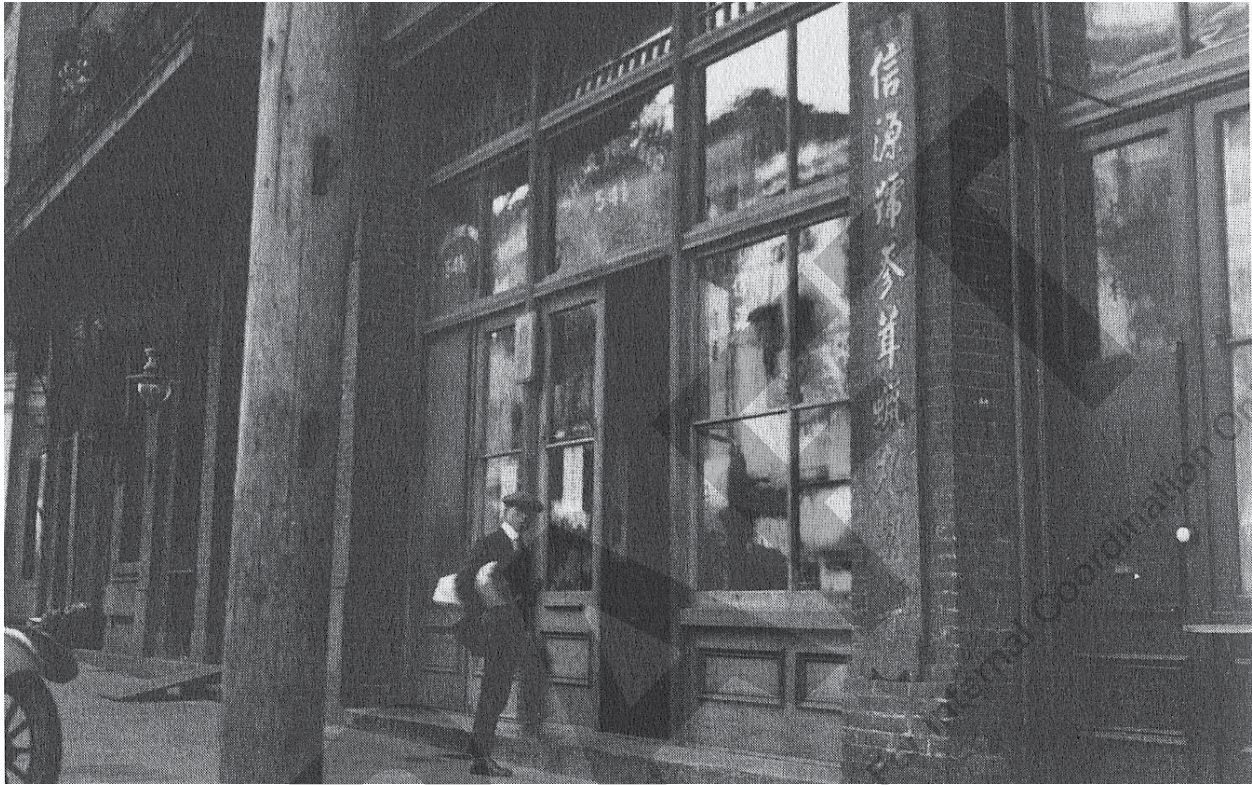
Top: 539-543 1/3 Fisgard in the 1920s; Shon Yuen & Co. at 541 Fisgard. [Lai, Forbidden City, page 148]
Bottom: Photos showing existing storefront configuration as viewed from Fisgard Street.
