**Construction Impact Assessment &
Tree Management Plan**

PREPARED FOR: Jon Floyd
C/O Jawl Properties Ltd.
200 – 1515 Douglas Street
Victoria, BC V8W 2G4

PREPARED BY: Talbot, Mackenzie & Associates
Robert McRae – Consulting Arborist
ISA Certified # PN-7125A
Tree Risk Assessment Qualified

DATE OF ISSUANCE: July 22, 2021

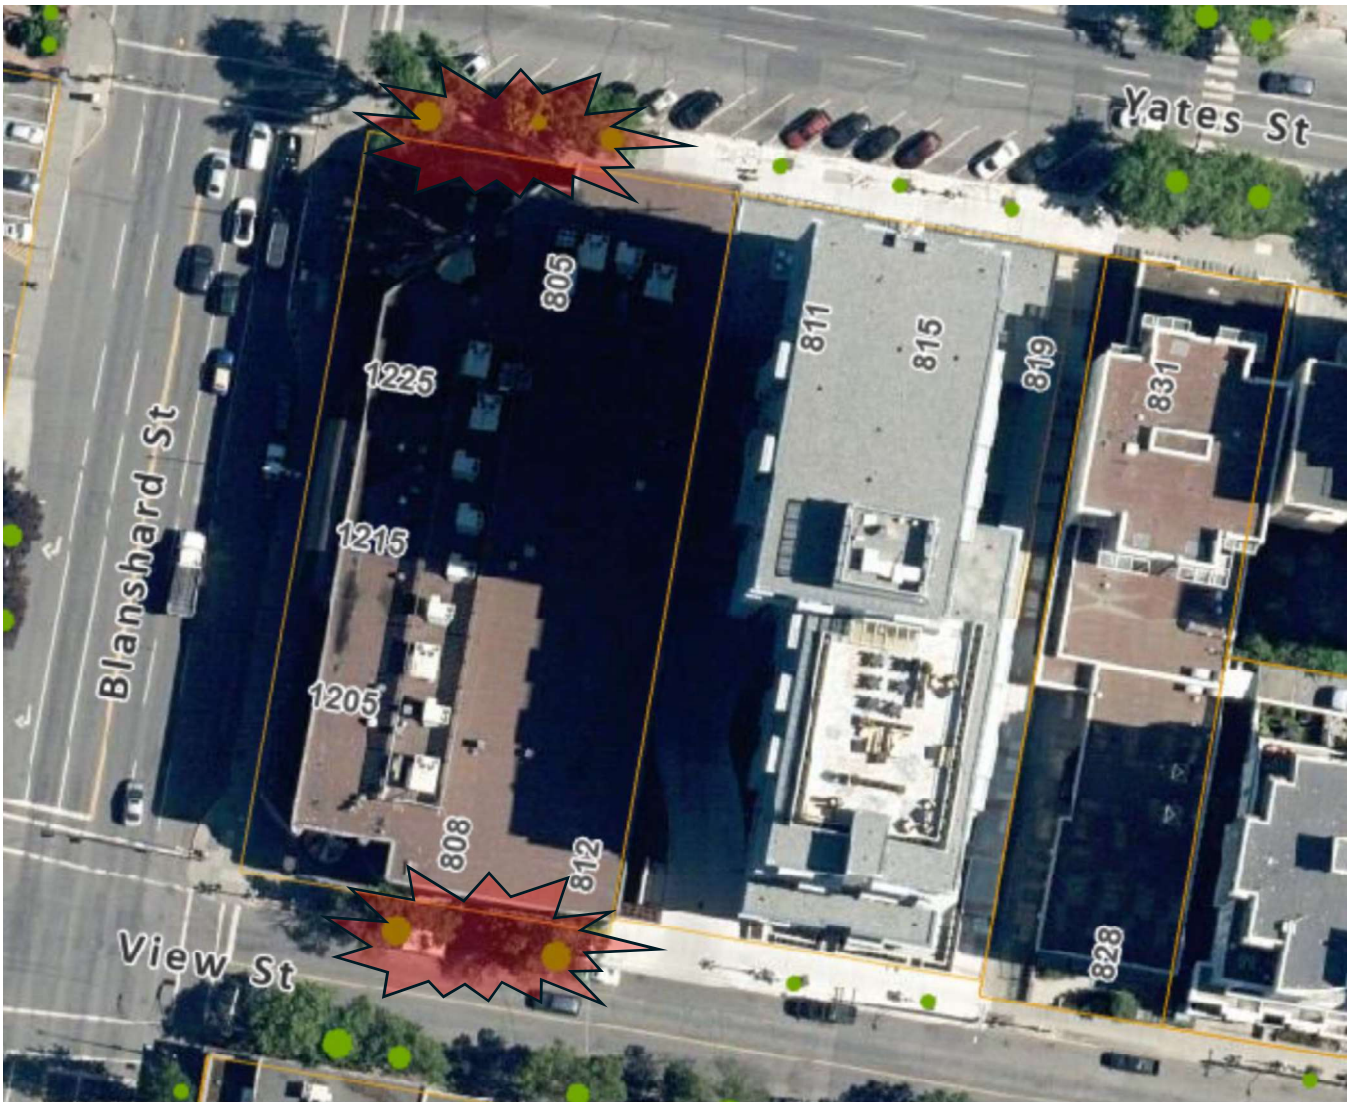
The offsite municipal tree resource consists of a mixture of nonnative tree species growing in grates (surrounded by hardscape) around the perimeter of the subject property (see *figure 1*). Red highlighted areas and dots within indicate the areas and specific locations where the trees grow.

figure 1: Site context air photo: The approximate boundary of the subject site is outlined in Yellow.
