Capital Tree Service Inc.

Arborist Report

722 & 726 Discovery St,

August 17, 2022

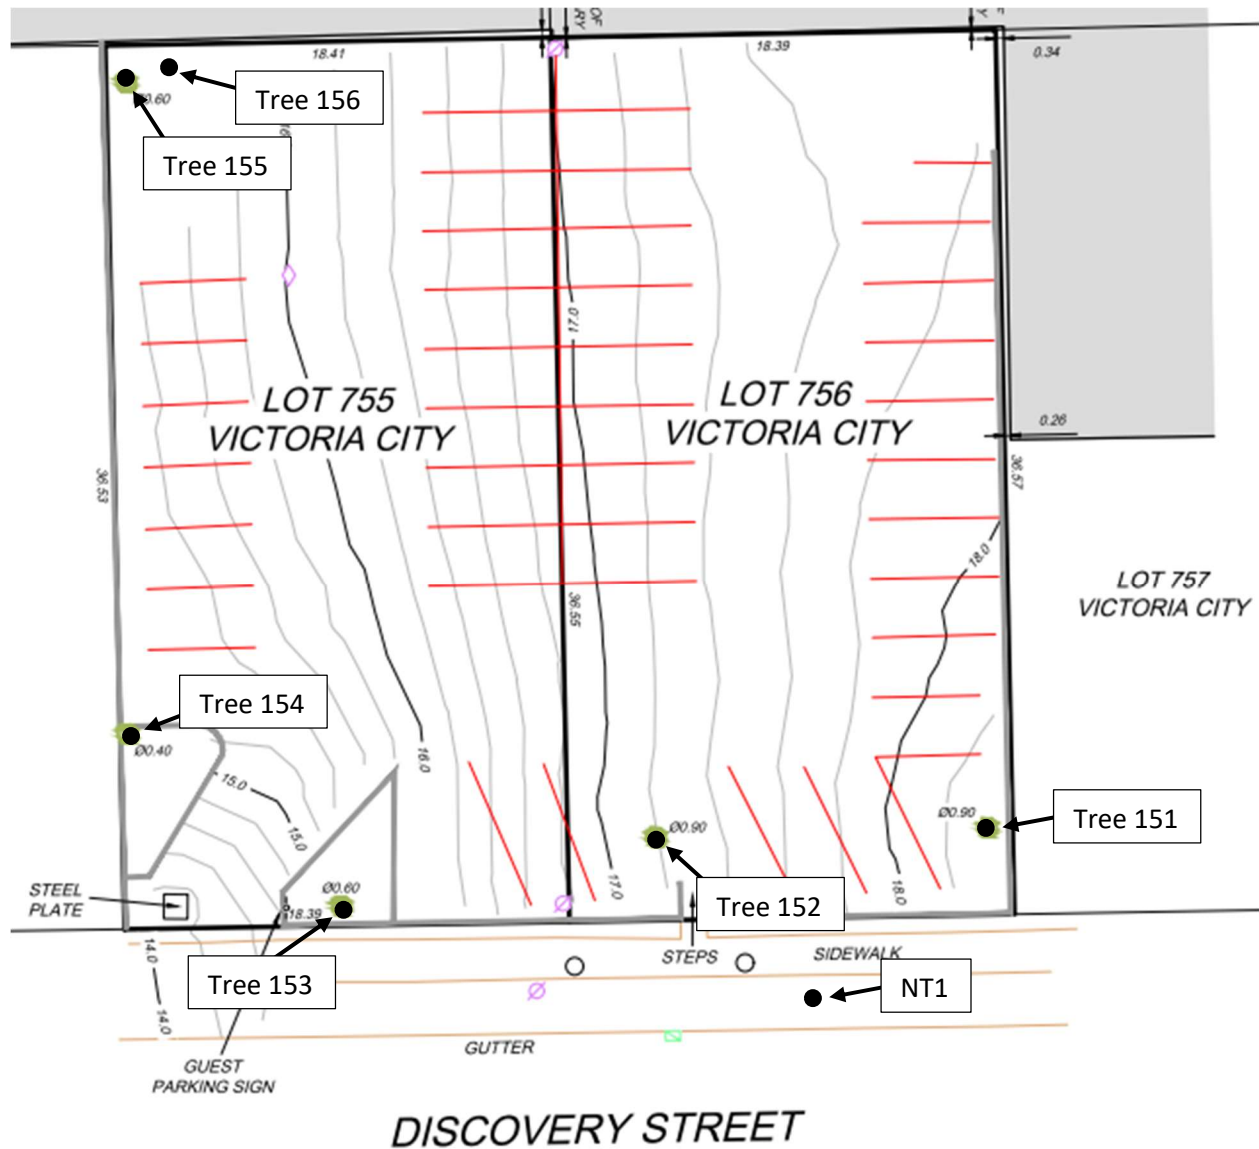
Figure 1. Site Plan and Tree Locations. This site plan depicts the current state of the site and the tree locations. Locations of tree NT1 and 156 have been plotted by CTS for reference and have not been verified by a BC land surveyor.

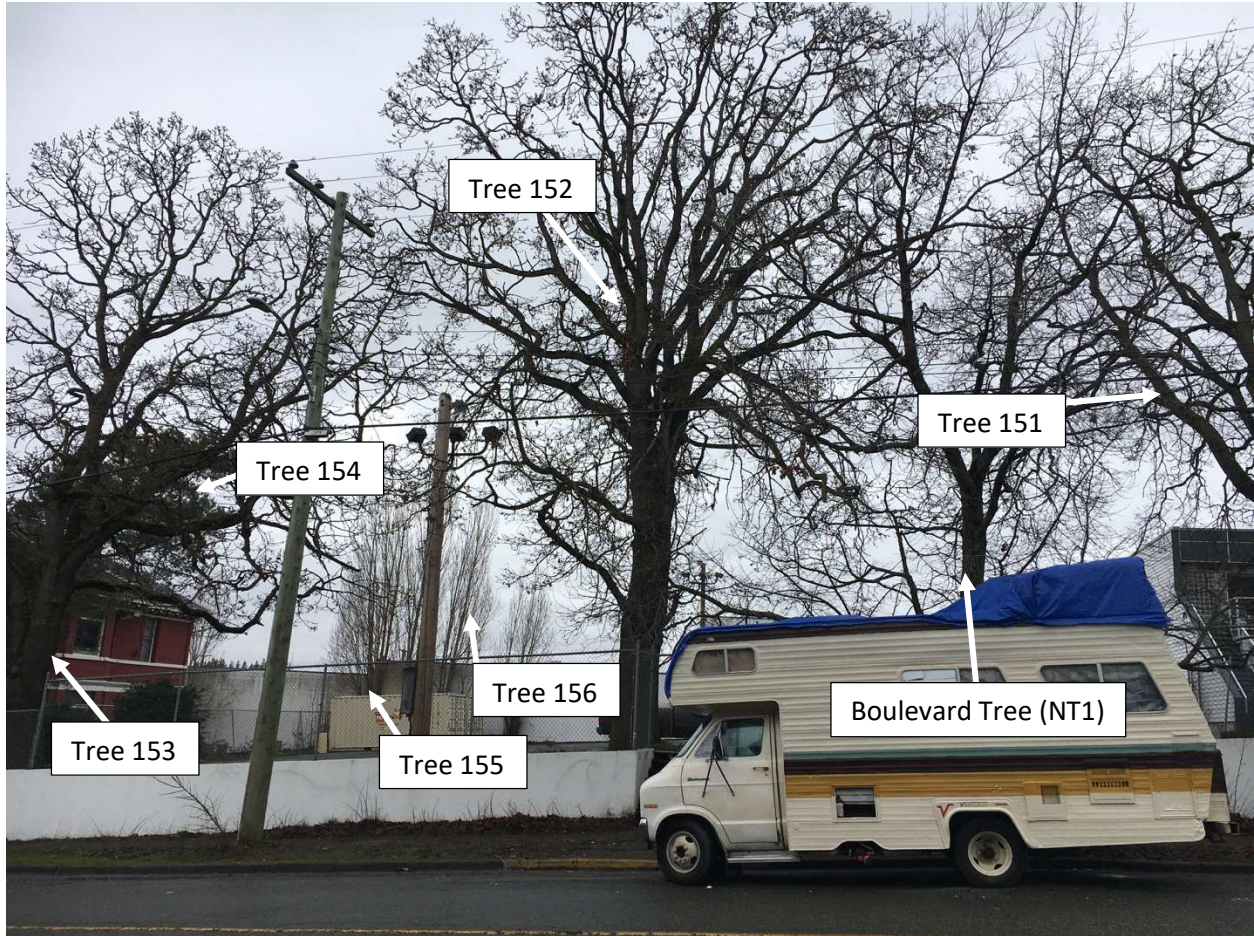
Figure 2. 722 and 726 Discovery St Frontage. Trees are labeled. The Boulevard tree is was not included in this assessment. Tree 154 is the pine behind the Gary oak 153.
